# Frugal Rehabilitation Demonstration (FRD) in Mongolia

## FRD Case Studies Handbook

**Frugal rehabilitation of lands degraded by artisanal and small-scale mining at seventeen sites within nine aimags and fourteen soums across Mongolia.**

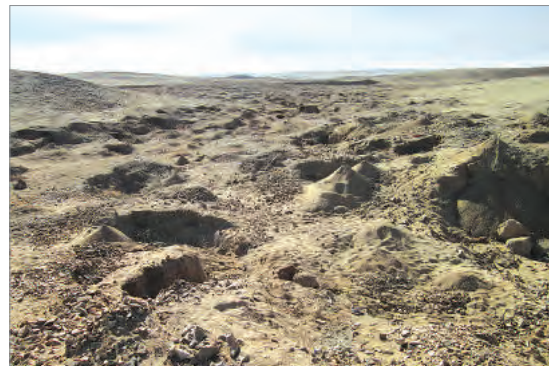
The area to be rehabilitated covered 830 pits with an average depth of 4m. Some pits had additional tunnels. The area also contained 571 waste piles with an average height of 1.5m. All pits and piles were located within a shallow alluvial basin contained within low hills. To the south an active large-scale mining area defined the boundary. Most tunnels had already collapsed and pits were clearly visible as vegetation cover over the site was low. The health and safety risks were therefore not particularly high at this site, although pits would be a hazard to herder interests.

Alluvial ASM degradation before rehabilitation

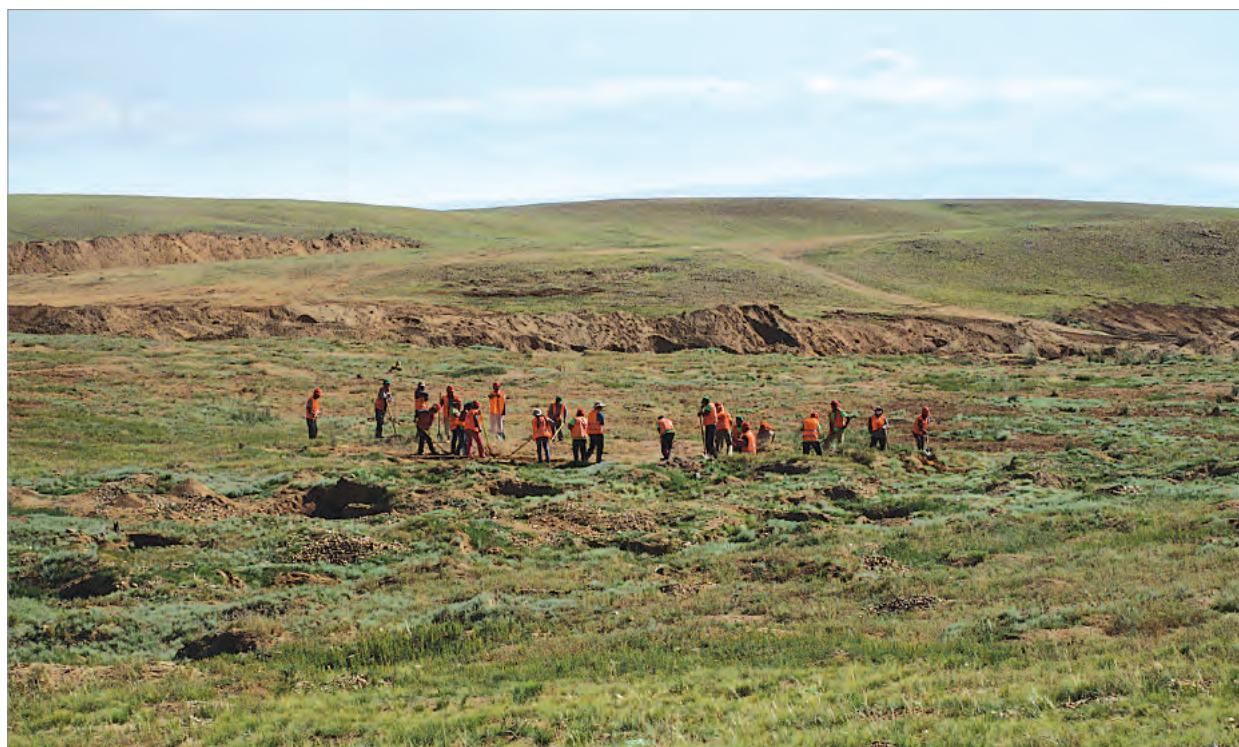
*Technical rehabilitation underway*

Safe demolition of unstable tunnels followed by garbage removal was undertaken as first steps. Pits were manually filled with heavier materials, followed by manual topsoil treatment work. Slopes were re-graded and re-profiled to a maximum of 35 degrees to match original slope profiles. All stockpiles were completely used for filling of the pits and some additional material was brought from a nearby abandoned mine. Machines were not used to avoid compaction. The nearby area being mined and rehabilitated by a mining company provided a useful example of contrasting approaches, between a highly mechanized approach and a manual approach used at the FRD site, with the FRD site indicating much improved capacity for biological recovery.

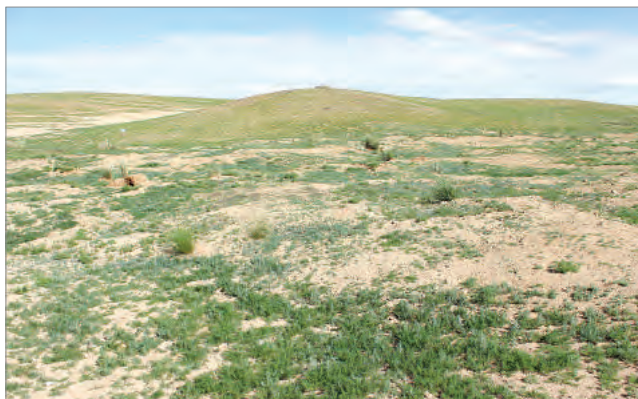
*Biological recovery one year later*

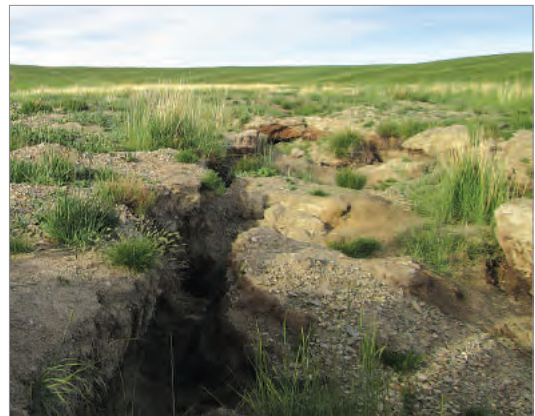
Along a descending alluvial corridor, there were 1445 pits in total with depths 2m in average. The site had 6 big trenches up to 8-12 meters in length and width was 6-8 meters. The average underground tunnel length was 3 meters. Over 1000 waste piles with an average height of a meter were counted. Some of the topsoil cover was removed due to the mining activities. However, natural regeneration of various grass species was significant. The key risks were associated with the high density of deep pits, obscured by tall regenerated vegetation which would have attracted livestock. The site had a medium to high risk for livestock and horses in particular were vulnerable to falling into such shafts.

*Conditions before rehabilitation*

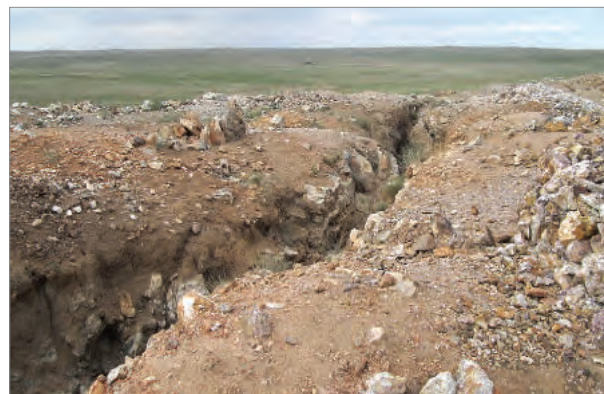
As large volumes of fluor spar were removed for processing, the hard-rock mine created deep vertical pits with underground tunnels and often very lengthy trenches. The total number of pits is insignificant compared to alluvial gold sites, however given the hard-rock nature rehabilitation infilling is a challenge that is dependent upon a mechanized approach. There were 62 pits in total, with an average depth of 30 meters. 124 waste stockpiles were of varying height. In general, Boroodoi had deeper shafts with some reaching 55 meters in depth and up to 200 meters in length. Given that the shafts were linear in nature, almost all vegetation cover was destroyed along these working strips. In addition an informal road network significantly impacted the surrounding environment. Exposure to strong winds means that wind erosion of exposed soils and rehabilitation surfaces is an issue for the sites.

Long deep shafts are typical fluor spar ASM impacts

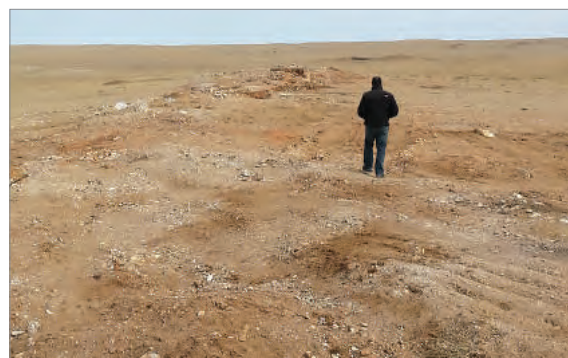
*Mechanized rehabilitation can result in compaction*

the surface, with minimal manual work in finishing off. Such fluorspar technical rehabilitation were very dependent on mechanized approaches resulting in significant compaction of final surfaces. Given the lack of topsoils in the area, such compaction was seen as an obstacle to biological rehabilitation and recovery, preventing moisture and seed penetration which is so important for biological recovery. Heavy rainfall during the work also worsened the compaction problem, as final surfaces dried like concrete. De-compaction work was then prescribed for such areas, although such efforts are limited in effectiveness. (Soil compaction due to heavy machinery use is a key issue which needs to be addressed in general; it is a limiting factor in effectiveness of both frugal and larger-scale rehabilitation efforts). Re-profiling and topsoil management in other areas not so effected were completed by hand tools. Completion at Boroodoi was delayed due to unavailability of heavy machinery. However, all technical rehabilitation was completed.

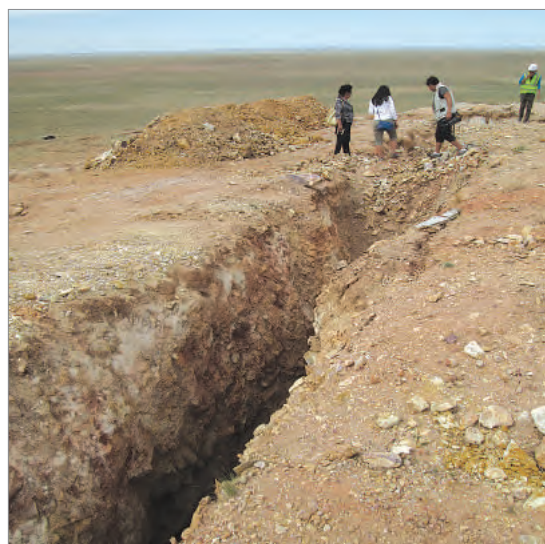
As large volumes of flourspar were removed for processing, the hard-rock mine created deep vertical pits with underground tunnels and often very lengthy trenches. Given the hard-rock nature of rehabilitation, infilling is a challenge that is dependent upon a predominantly mechanized approach. A total number of 91 shafts and 107 stockpiles were recorded for rehabilitation. The average depth of the pits was 24 meters and pile height was 1.3 meters. Some materials from Monrostsvetmet, an abandoned large-scale flourspar mine, were brought for infilling shafts. Given that the shafts were linear in nature, almost all vegetation cover was destroyed along these working strips. In addition an informal road network significantly impacted the surrounding environment. Exposure to strong winds means that wind erosion of exposed soils and rehabilitation surfaces is an issue for the sites. Given proximity to the soum center, some pits had been used as waste disposal sites.

ASM flourspar mining leaves deep hard rock shafts

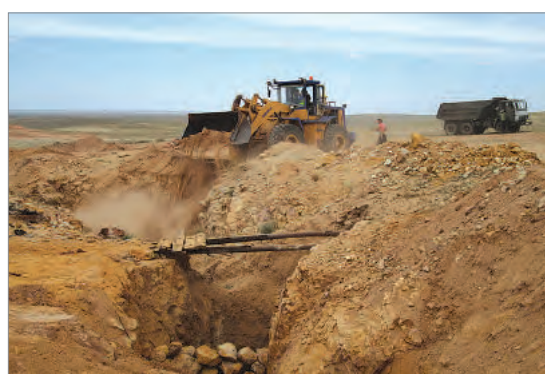
Mechanized infill was necessary

Due to the volume and mass of hard-rock piles, and the depth of shafts to be filled, mechanized use of an excavator was necessary in addition to manual approaches. Topography was mainly level steppe and slopes did not exceed 30°. Importantly, topsoil management was planned, but was largely lost to sites because of the unplanned mining processes, and so topsoil quantities within the sites were not sufficient, and so needed to be brought in from a soum-approved topsoil quarry located near Monrostsvetmet. The overall environment has a low to medium regeneration

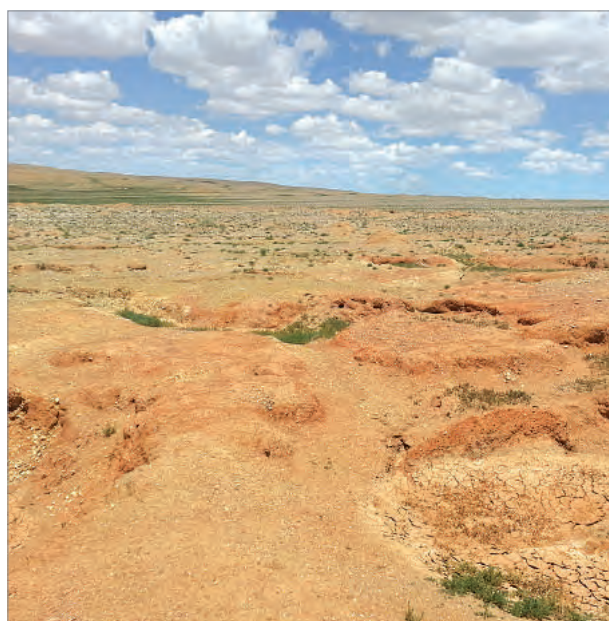
The level of degradation in 5 of the 10 ha was significant but most challenging along the remaining 5 hectares along gullies. Along the open gully, 1200 deep trenches up to 2-25 meters in length, up to 4 meters in diameter, with some shafts up to 20 meters deep, were evident. Most of the topsoil was lost and mixed with subsoils and stones during the mining process. However, natural regeneration of various grass species was significant and a rainy season in the Gobi in 2015 saw much new regeneration of colonizing species in evidence at the site.

ASM degradation at Shar Khoshuu

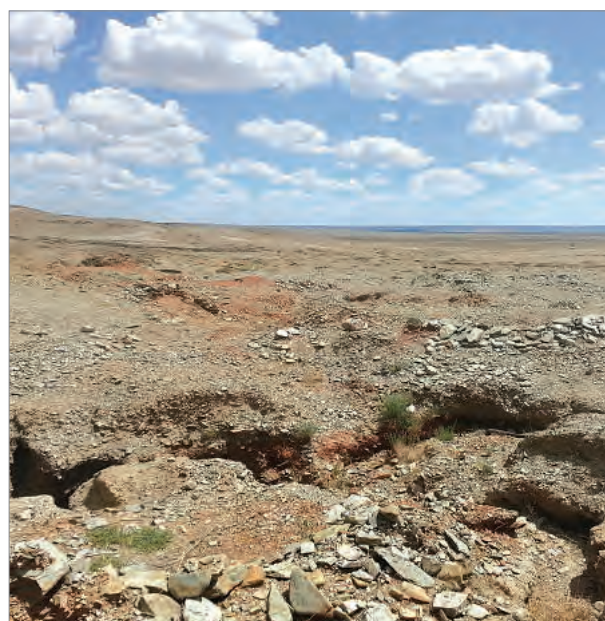
ASM degradation at Khutul

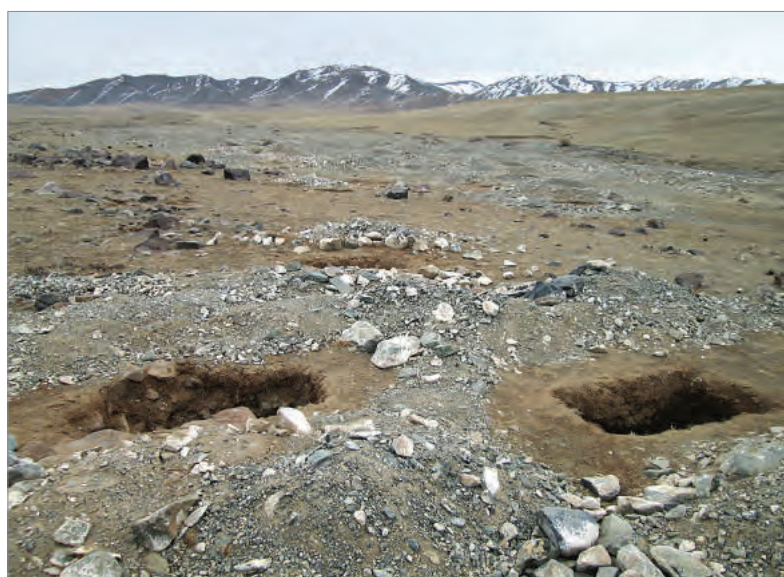
Most underground tunnels had already collapsed and visibility of pits was good, because of typical desert-steppe low vegetation cover. However, the site represented a high safety risk for livestock, because of the high density of vertical pits.

ASM degraded alluvial floodplain

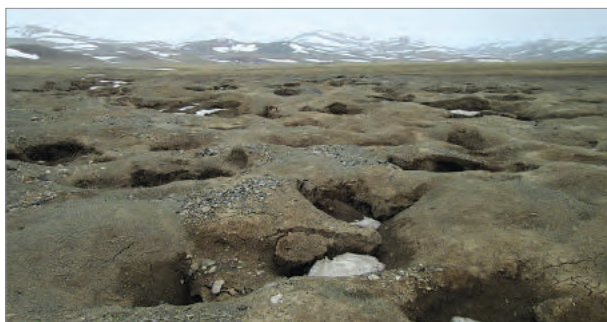
Most tunnels had already collapsed and the visibility of pits was clear as vegetation cover in the site is very low. The site exposed a medium safety risk to livestock due to number, density and proximity to water, as registered by local herders.

Highly degraded alluvial floodplain below Zurkh Tolgoi

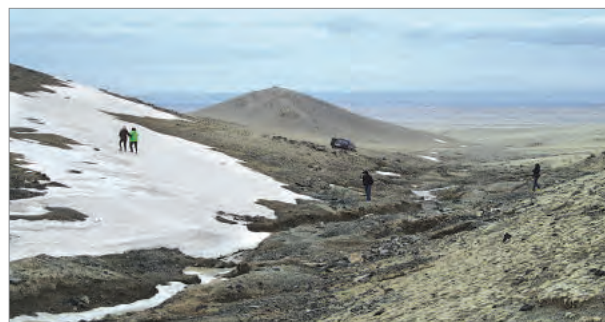
Eroded gully with many pits and shafts

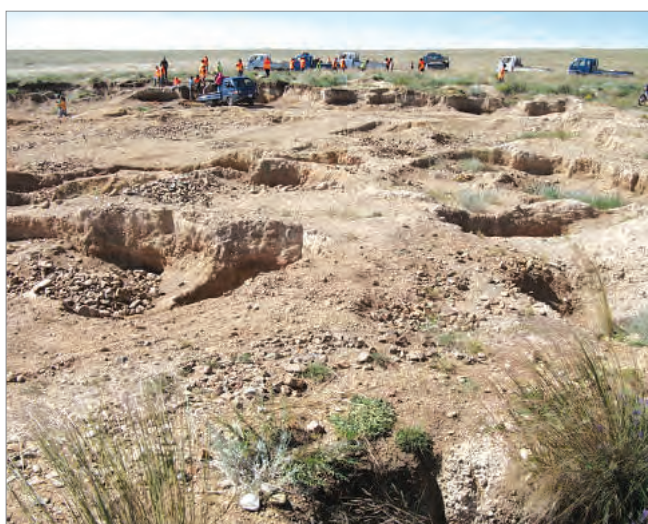
Demolishing castellation areas meant there was high risk of sudden collapse. Underground tunnels are a feature of the wider ASM mining activity generally in the area and a decision was made to attempt FRD at those areas where high risks of subsidence and tunnel collapse were reduced. At the FRD site most tunnels and shafts were deep and densely distributed on gentle slopes. During summer months with tall steppe-grassland vegetation obscuring such shafts, the risk to livestock and wildlife was considered very high, with much local herders’ livestock lost. Mongolian gazelle are also casualties. This was of major concern to the stakeholders.

Extensive areas of tall grass steppe degraded with shafts

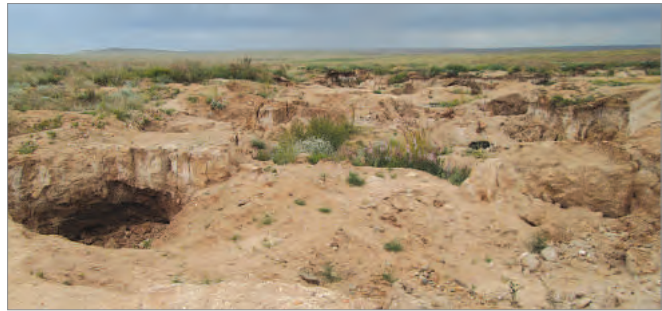
*ASM degradation before rehabilitation*

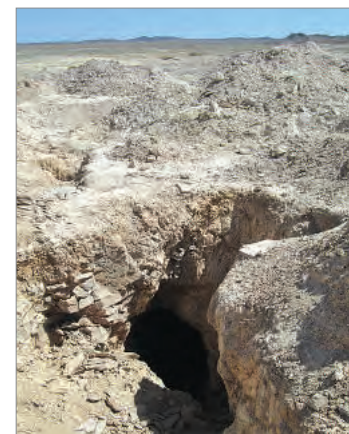
Environmental hazards were associated with high density deep shafts close to each other covered by scarce desert plants. The degree of risk was high to wildlife within the Strictly Protected Area particularly to Khulan (Asiatic Wild Ass), Takhi (Przewalski’s Wild Horse) and Black-tailed (goitered) Gazelle as the area is within core range of these wide-ranging endangered species.

Deep shafts and large piles were extensive over the area

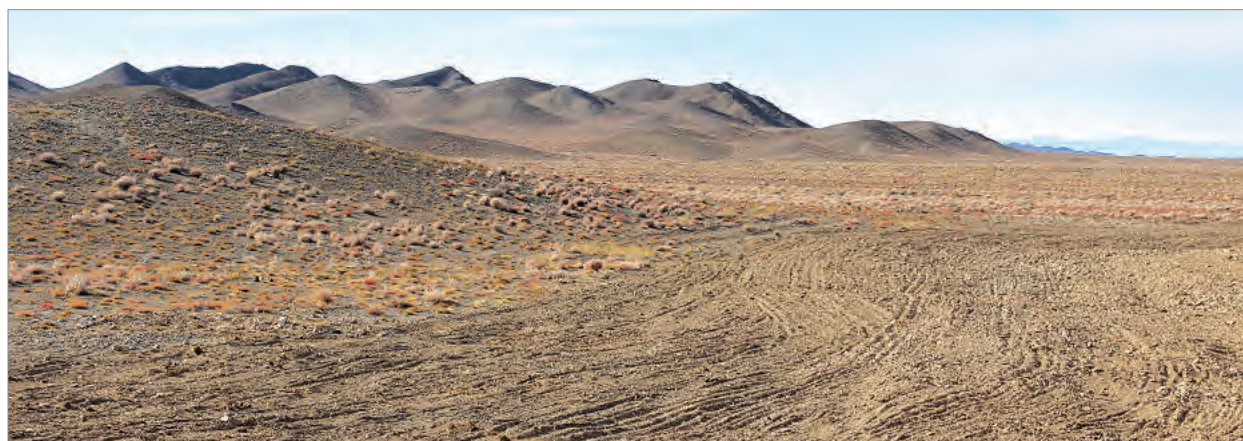
*A grubbing rake helped decompact mechanized surfaces*

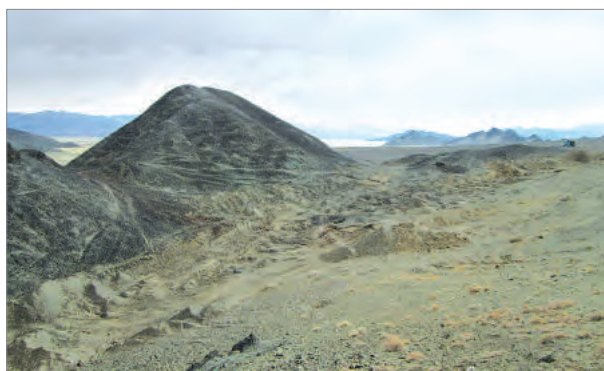
Environmental hazards were associated with high density deep shafts located near a winter herding area, with significant risks for livestock.

*Alluvial ASM before rehabilitation*

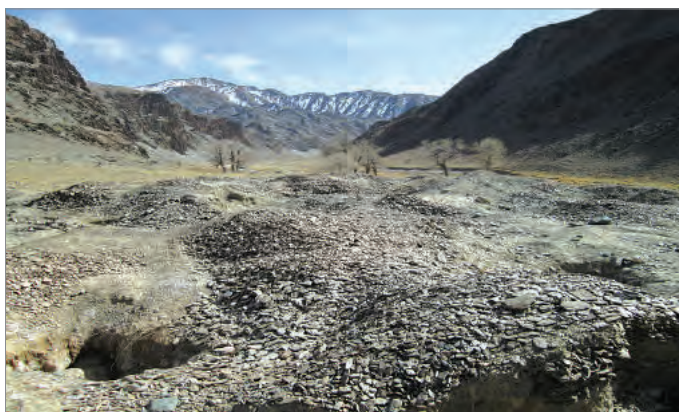
The level of degradation in three sites were significant along the ravine benches where the rehabilitation approach required straightforward infilling of pits and shafts. Most regarding was to a fairly level profile representing the previous bench topography, so there few challenges regarding slope profiling. However, the high density of shafts and mined material stored in adjacent piles meant much material had to be moved and effort required considerable commitment and resources including the careful use of mechanized approaches to complete the heavy lifting.

*Alluvial bench heavily mined*

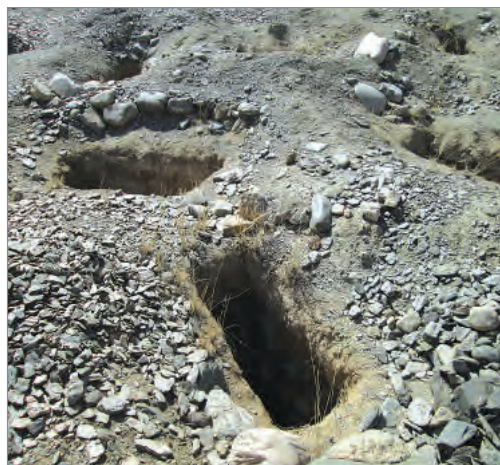
*Typical situation with deep shafts*

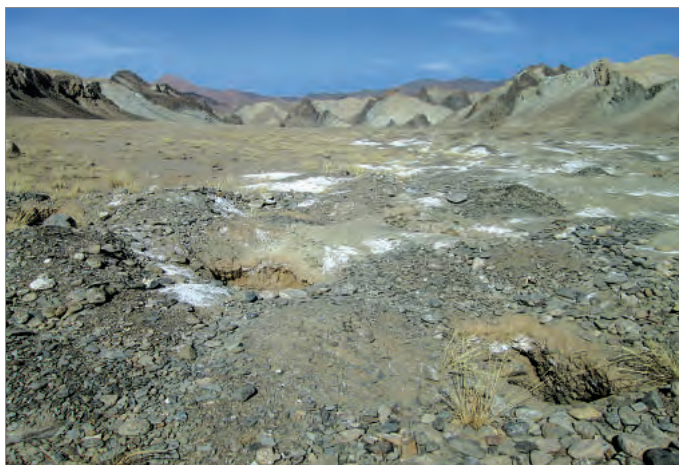
*Degraded open alluvial bench*

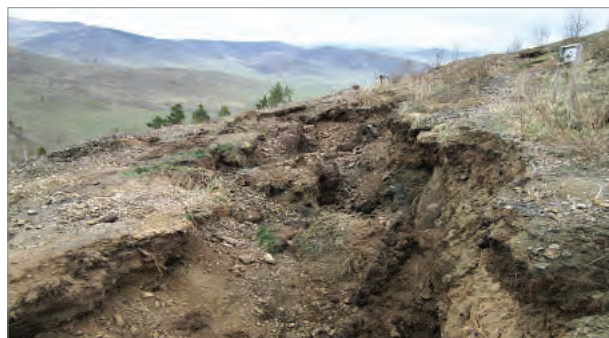
*Hillside degraded with deep hard-rock shafts*

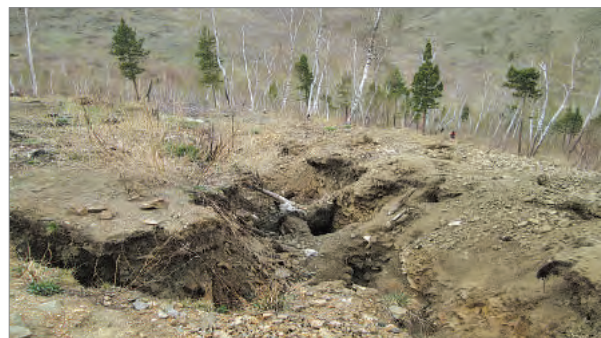
*Deep shafts require much infill*

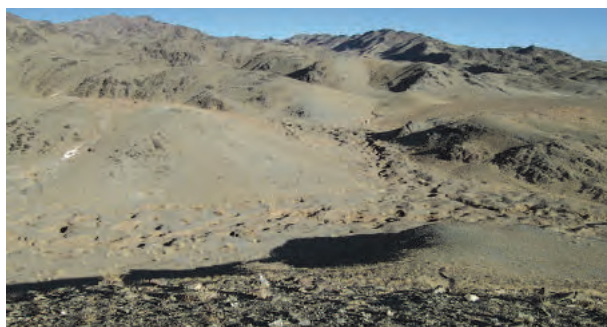
Overview of ASM degraded gullies

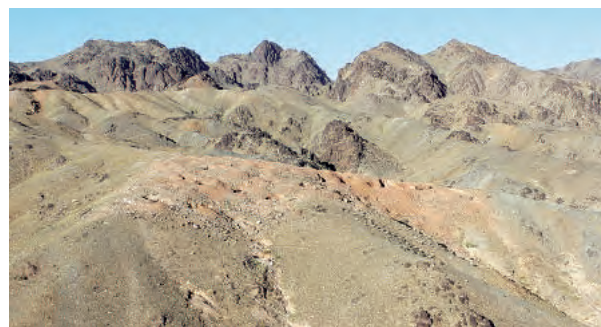
Hard rock mining of ridges

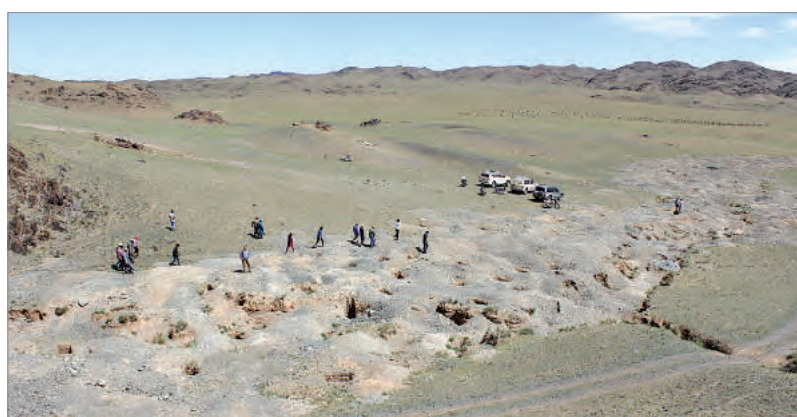
*Dairgat ASM site before frugal rehabilitation*

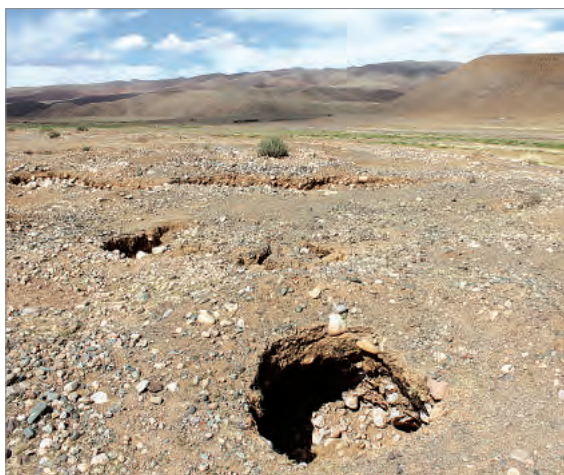
*ASM degradation of alluvial benches Orlogo River*

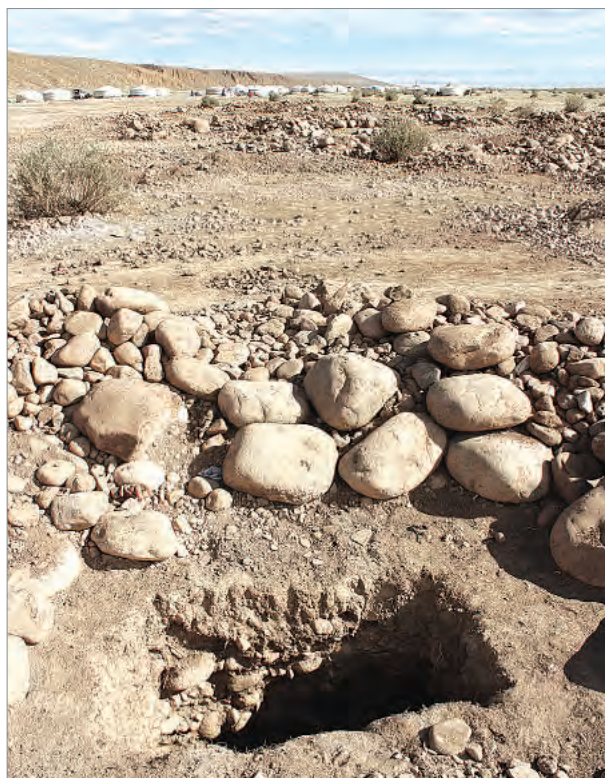
*Degradation with piles of large rocks*
