March 2007  
Issue 3

Welcome to the 3rd edition of the HP LaserJet Product Update Newsletter! This newsletter provides “hot off the press” technical information about the HP LaserJet printers you use and support. Our focus this quarter is on the HP Universal Print Driver (UPD). We know that you have questions about the UPD, and we have the answers! Look inside for information on the latest UPD version 3.1 along with the most popular Frequently Asked Questions from customers like you.

# HP Universal Print Driver

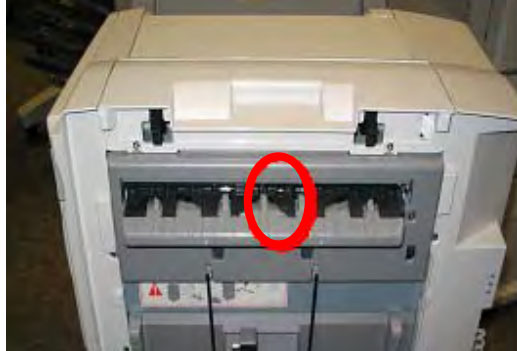
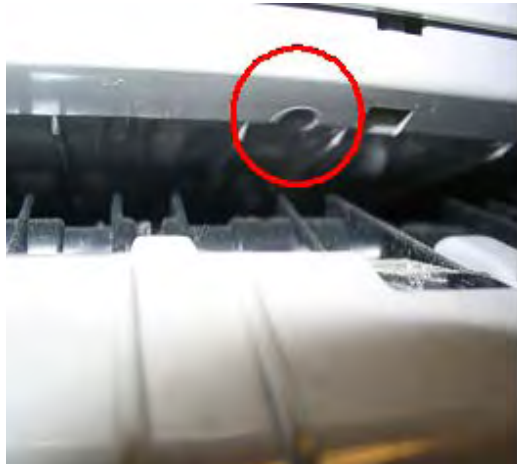
**Location of the optical sensors**

A control panel message of “13.12.21 Jam in Left Accessory” is usually due to contaminated sensors. The flipper assembly’s optical sensors are being blocked or contaminated by environmental dirt/dust or media dust. Cleaning the optical sensors usually resolves this error condition. To clean the optical sensors, follow the steps below.

**The transmitter optical sensor is located in the upper middle part of the flipper assembly**

- Clean the upper optical sensor with a dry, lint-free cloth.

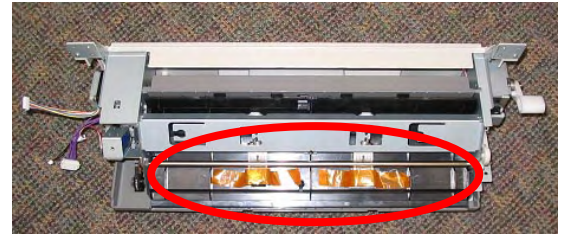
Location of shipping locks and packaging tape

New flipper assemblies have been returned to HP as defective or as a DOA part because of a "13.12.22 Jam in Left Accessory" message appearing on the control panel after a new flipper assembly installation.

HP has evaluated field service returned flipper assemblies (part number 4G1-5219-030CN) and determined that the shipping locks and orange packaging tape was not removed prior to installation in the multi-function finisher. The flipper assemblies were re-tested, and found to work properly when the packaging material was removed.

Ensure that the shipping locks and orange packaging tape have been removed. See the photo below for identification and location of the shipping locks and packaging tape.

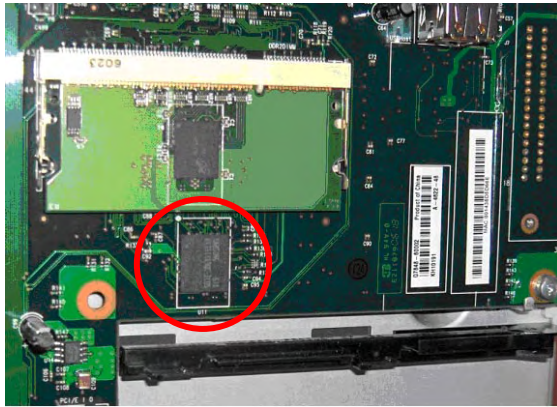
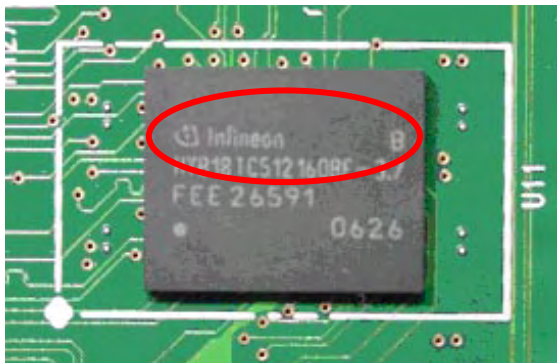
Location of the chip on the formatter board

In some instances the HP LaserJet P3005 printer base and duplex models will start up with a blank display, or will not start up at all. This may be caused by wrong timing values set in firmware version 20060807 02.034.0 in combination with Infineon-B memory chips on the formatter board.

- The printer is an HP LaserJet P3005 base model (Q7812A) or duplex (d) model (Q7813A).
- The printer has Infineon-B memory chips on the formatter as shown in the photos below. This memory chip (U11) is located just below the DIMM slot.
- If the memory chip does not say Infineon B, the blank display is not caused by the issue described above.

### The affected memory chip markings

This issue is caused by incorrect timing values in firmware version 02.034.0 that cause the printer to fail start-up under certain conditions (such as low or high temperatures) without additional memory. Firmware version 02.034.1 or later corrects these timing values. Only several hundred units were built with firmware version 02.034.0, and very few of these will fail because of incorrect timing values.

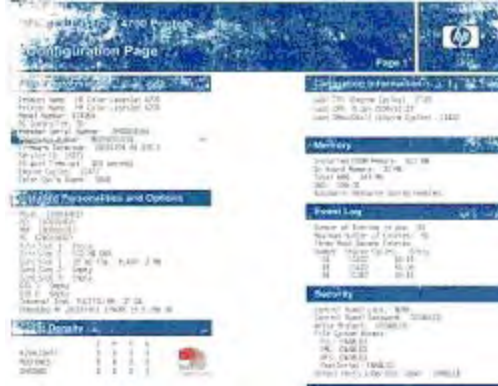
You may experience poor print quality which looks like VERY poor transfer or smudged print. The defect will most likely occur on all media, but print quality is especially poor on heavy glossy media (when the media sensor determines media type). The print quality defect may look like the example below:

### Example of poor print quality

We have identified one possibility for this issue. Sometime after the Paper Input Unit (also called Paper Feed Assembly) has been replaced (and only if it has been replaced) if you perform a "Cold Reset" or "Restore Factory Defaults," the media sensor value from the new Paper Input Unit is erased. To determine if this is the cause, print a Diagnostics Page through the control panel and check to see if the values in row 22, columns A and B are zeros.

If the values are zeros, the media sensor calibration values have been lost and need to be re-entered through the control panel service menu. If the values are *not* zeros, then the media sensor values have *not* been lost and this is not the cause of the failure.

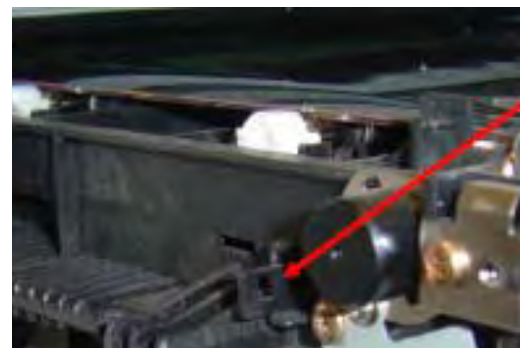
**ITB flag**

The second instance where the “Replace Transfer Kit” message may appear is when the device is not recognizing the presence of the Intermediate Transfer Belt (ITB) for some reason or is sensing that the belt has shifted and is not aligned. In this instance further troubleshooting should be performed. See the workaround in the next column.

1. Print out a Supplies Status Page and check the Image Transfer Kit page count. If it is at 200,000 pages; replace the transfer kit with a new kit (part number C8555A).
2. If the page count is not at 200,000 pages or within 20% of that range (160,000 or higher), check the alignment of the ITB sensor flag, sensor 44.

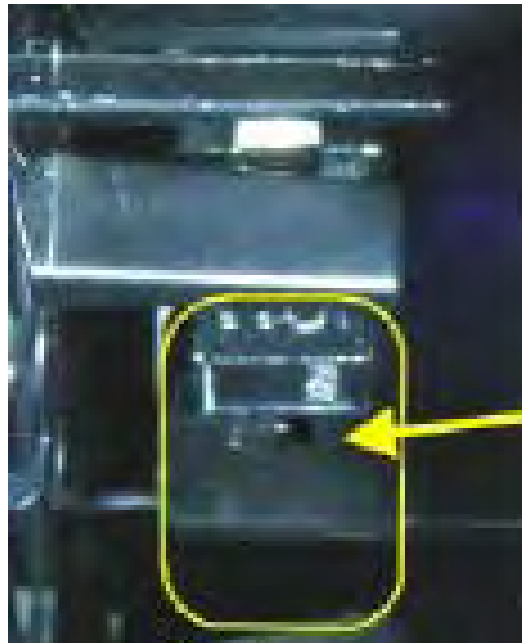
- In the picture below, the tab on the ITB has the hole aligned so the sensor has light passing through. This creates the error message.

**Incorrect alignment—gap between sensor and flag**

Check the seating of the sensor housing, and the sensor itself. If the seating is correct, but the alignment is still off, replace the ITB.

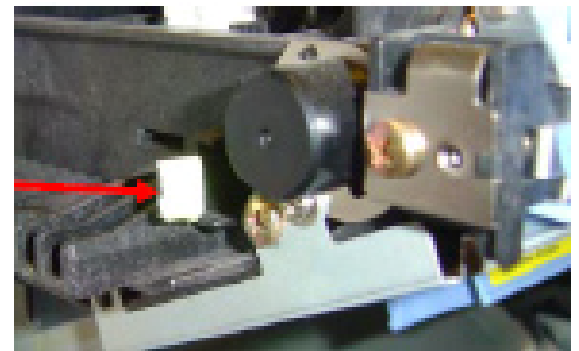
**Tape the flag on the ITB**

Check to see if the sensor is working properly. Tape the flag on the ITB so the hole is covered, making sure it's opaque so light can't get through (see the photo below). Re-insert the ITB.

If the error is still present, replace Sensor 44 (part number WG8-5624-000CN). See pages 262 and 313 in the Service Manual.

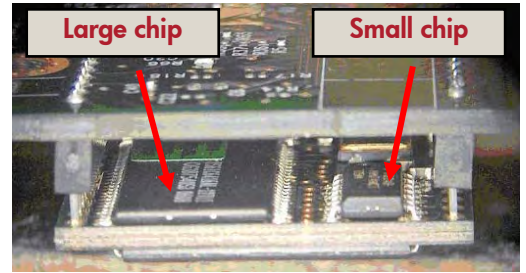
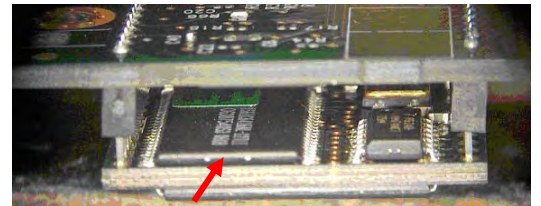
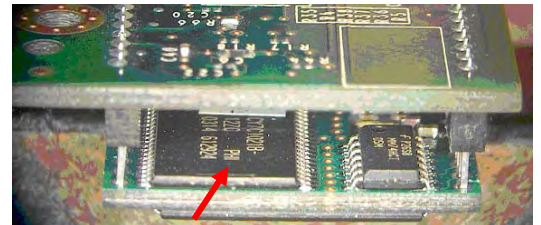
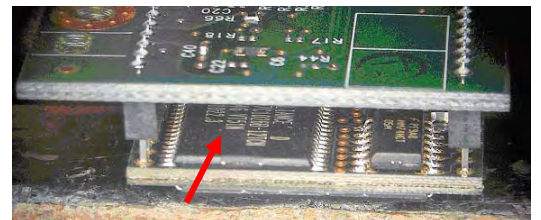
3. Orient the Fax 300 so that the larger PCA is on top in order to view the underside of the smaller PCA. You will see two chips—one large (10 mm by 18 mm) and one small (4 mm by 8 mm). You will need to check the large chip.

4. Check the white text on the large chip. It may be necessary to use a flashlight to see clearly between the two PCAs. The chip will have two, three, or four lines of white text. It is not necessary to read the text, just identify the number of lines.

5. If the chip has only two lines of text it falls within the isolated Fax 300 cards that are known to have this defect.

If the chip contains only two lines of text, replace the Fax 300 card with part number Q3701-60010.

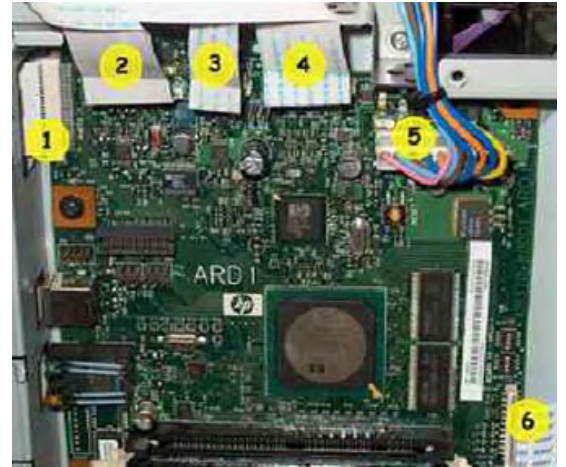
**Cable reference numbers**

Errors can occur with the CM1015/1017 MFP if cable connections to the formatter board are loose, damaged, or not connected. The numbers in the photograph below correspond to the reference numbers in the table below. This table will assist in diagnosing the display messages that are related to cable connection issues.

Reference number	Possible loose connections	Display message or condition with xx firmware	Copy output	Comments
1	CB394-60104 Assembly photo memory card cable (1017 only)	"49 Service Error, Turn off then on"	No response	
2	CB394-60103 ASSY-CABLE-SCAN MODULE/MOTOR	"Scanner Error 12, Turn off then on"	When button is pushed, the screen momentarily reads "copying 1/1." The engine runs for approximately 15 seconds, but there is no copy output.	The 1015 responds the same as the 1017
3	CB394-60102 ASSY-CNTRL PNL CABLE LCD	Blank screen, no lights	No response	The 1015 responds the same as the 1017
4	CB395-60105 ASSY-CNTRL PNL CABLE CGD (1017 only)	Vertical colored lines appear on screen; Ready and Cancel lights flash	Color and black-and-white copy work normally	The 1015 operates normally
5	Power cable	Blank screen, no lights	No response	The 1015 responds the same as the 1017
6	DCC to Formatter FFC	The ready screen appears normal for the first 15 seconds, then reads "Engine communication error"	No output. On the 1017 the screen goes blank with small HP logo across the top. On the 1015, you receive a "49 Error."	The 1015 responds the same as the 1017 except with a "49 Error" when the copy button is pressed

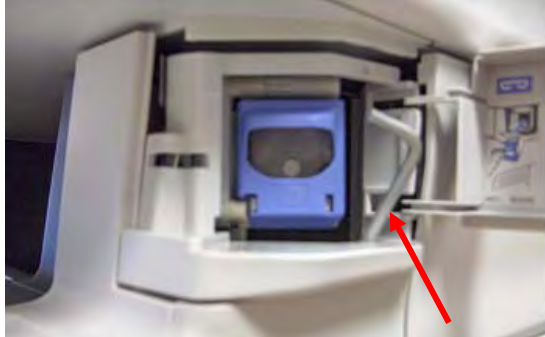
The stapler's actuator rod is coming off during transportation. The stapler will not work and appears to be broken. See the example photo below.

### The actuator rod is out of place

1. Open the stapler's door and grab the stapler's actuator rod using needle nose pliers (or by hand) and insert the stapler's actuator rod back into place.

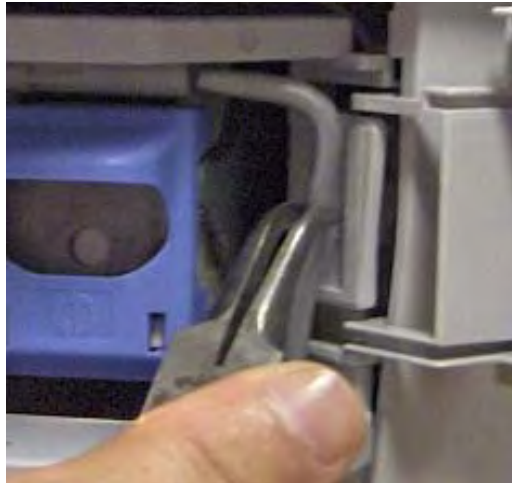
### Reposition the actuator rod

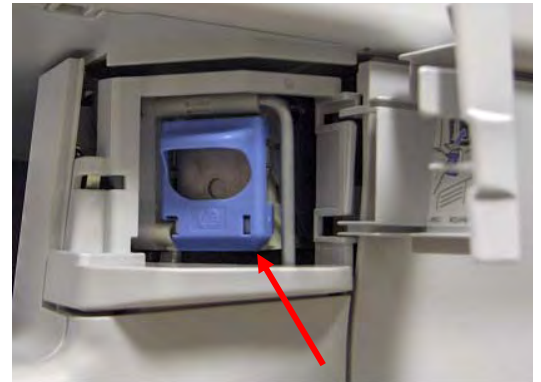
### The actuator rod in its correct place

2. Verify proper installation of the stapler's actuator rod. This picture shows the correct installation.

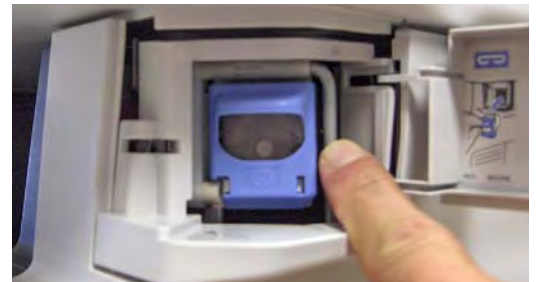
### The actuator rod should move freely

3. Push on the stapler's actuator rod. It has to move freely—you should feel a spring action when pushing the rod inwards.
