Instrument Service Notes For HP Trade Customers

Jim Bechtold/Hewlett-Packard

1992 Bench Briefs' Instrument Service Note Index

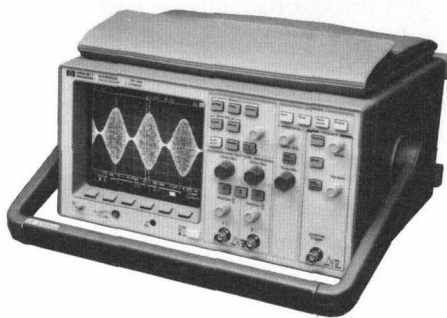
HP 54600A Oscilloscope HP 54601A Oscilloscope

HP 54600A Serial Numbers Affected
0000A00000 / 3220A06532
HP 54601A Serial Numbers Affected
0000A00000 / 3220A04667

The condition exists only if the cabinet handle has been removed, exposing a small hole, which allows access to the interior of the display unit. Because of this, a shock hazard is possible. Contact your nearest HP sales/service office to obtain a free insulator kit, HP P/N 54600-68714.

Order Safety Service Note 54600A-07-S for more information.

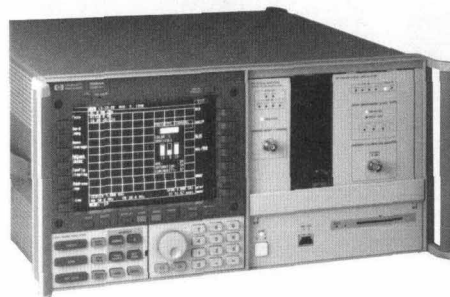
HP 70004A Display

Serial Numbers Affected
0000A00000 / 3040A01050

The right side strap handle, situated on the side of the HP 70004A which accepts modules, may not support the weight of certain configurations. The right side strap handle must be removed and replaced with replacement kit 70004-60032. Order Safety Service Note 70004A-08-S for more information.
