# The Winning Line

A Forensic Engineer's Casebook

Andrew Samuel, BE (Mech), MEngSci, PhD, DrEngFIE Aust  
Professorial Fellow  
University of Melbourne  
*and*  
Principal Consultant  
Engineering Investigations & Associates Pty. Ltd.  
Australia

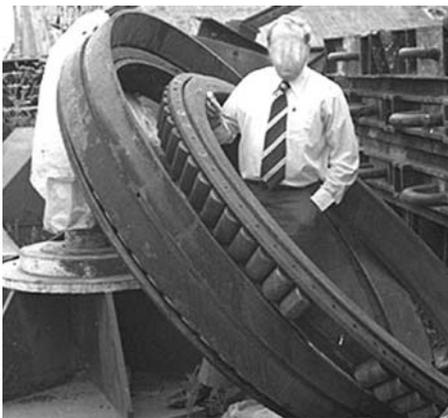
Figure 2.10 Broken main bearing of the MRTA tunnelling machine

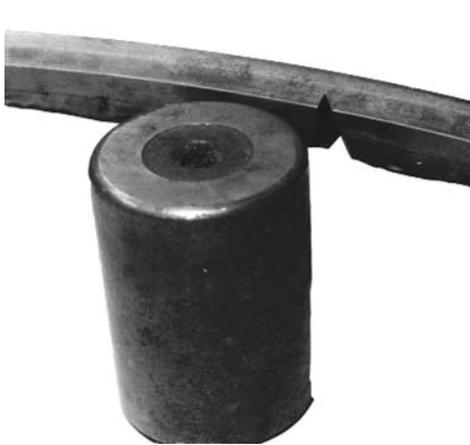
Figure 2.12 Bearing roller and part of the failed bearing cup. The notch was used for establishing material properties

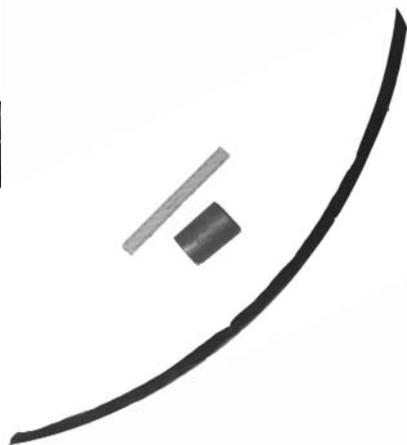
Figure 2.13 Part of the bearing broken away during the accident, with a roller and a 300 mm ruler to indicate scale

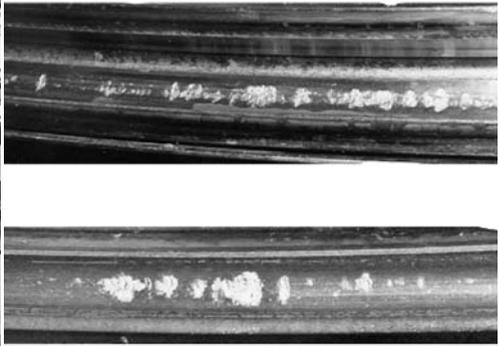
Figure 2.22 Bearing damage. The upper photo shows the damage to the inner (fixed) race. The lower photo is that of the damage to the moving (outer) race

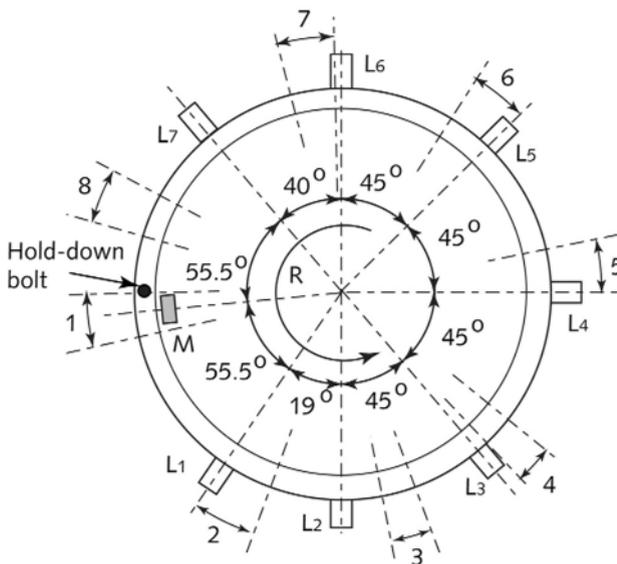
Figure 2.29 Layout of machine showing leg and bearing damage locations on the inner (fixed) bearing surface. The L numbers represent support leg locations, M is the motor drive location, R is the machine rotation direction and the damage locations numbered 1 to 8 were measured arbitrarily from the first hold-down bolt near the location of the motor drive

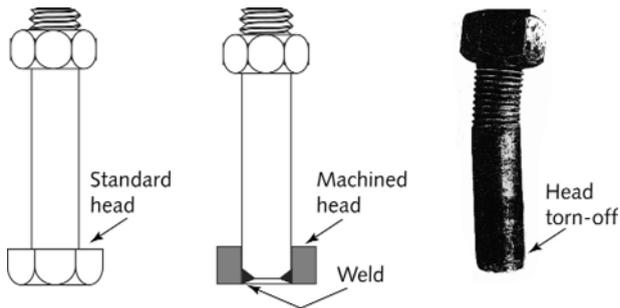
Figure 2.34 The damaged king-pin bolt and schematic sketches of a standard bolt and one similar to that manufactured by Blunt

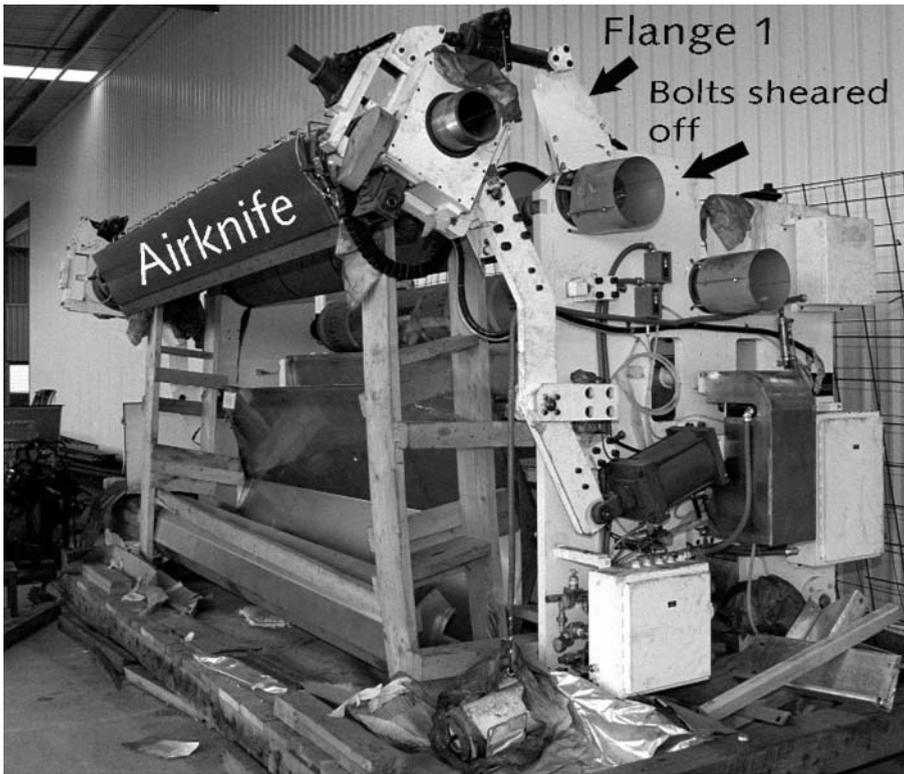
Figure 2.41 General view of the partially unpacked airknife machine in its damaged packaging

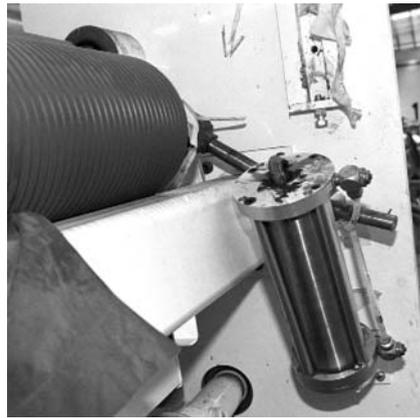
Figure 2.43 View showing roller dislodged from its bearing and damaged air cylinder

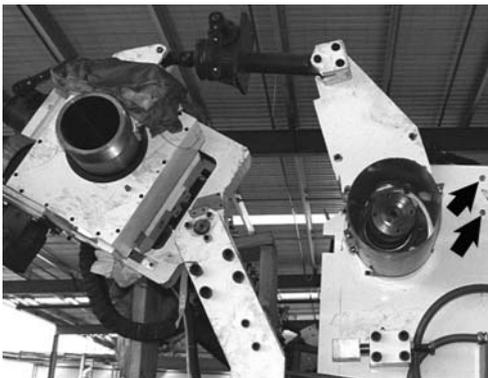
Figure 2.44 Airknife support head and its various adjustments. The arrows show where the flange bolts sheared off

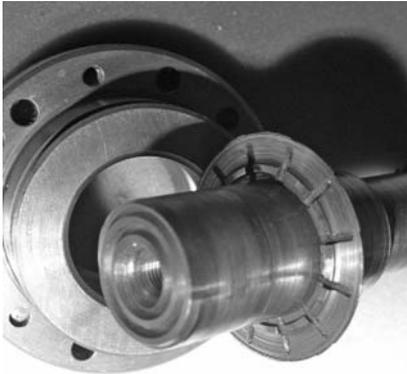
Figure 2.51 Heavily worn thrust face on high-speed journal

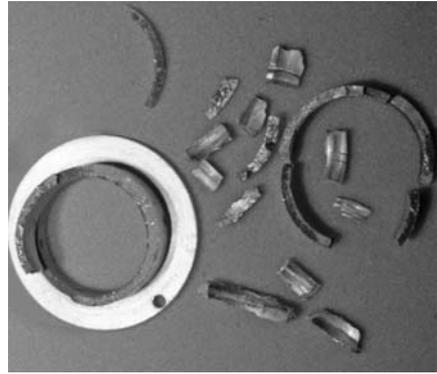
Figure 2.52 Components of bearing shell recovered from seized compressor

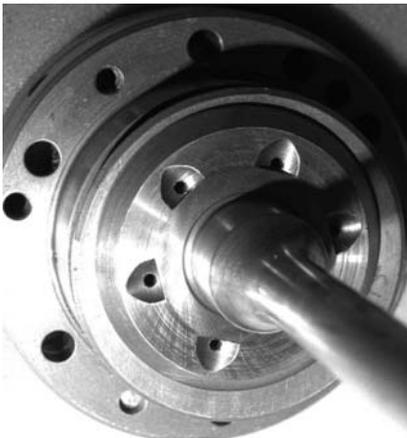
Figure 2.53 Nominally worn thrust face of high-speed shaft replaced in overhaul

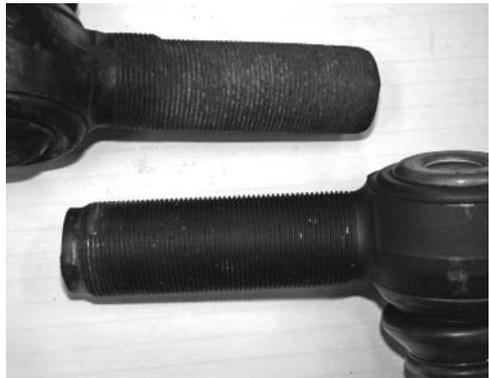
Figure 2.61 Worn knuckle (top) and new knuckle (bottom)

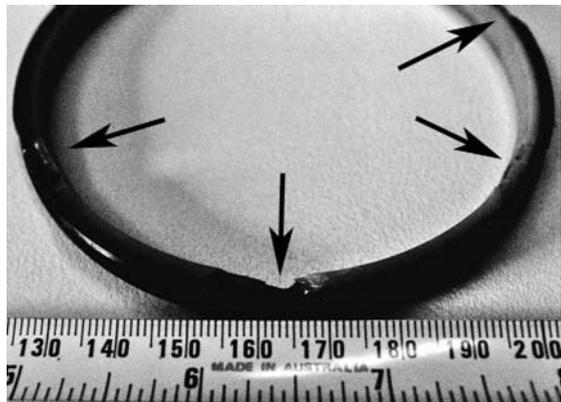
Figure 3.6 Seal damage

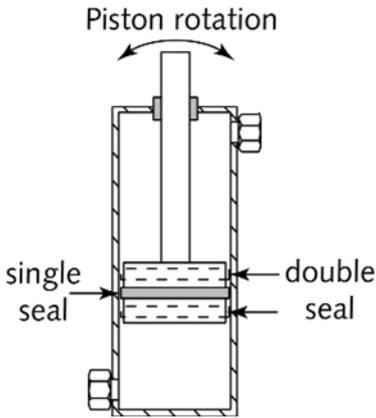
6. The inclusion of mirrored phasing grooves on the inside of their hydraulic cylinders was a serious design error by Truscott. Hydraulic cylinders have a history of reliable operation with smooth internal

Figure 3.13 The basic problem with the Truscott phasing cylinder design

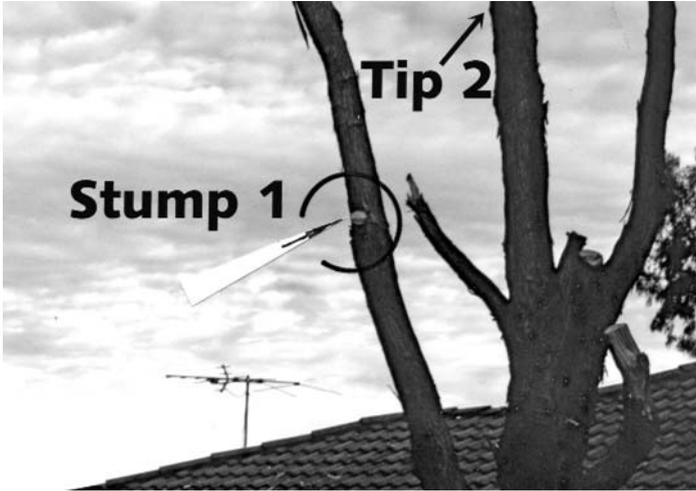
Figure 6.5 Lopped tree after the accident. The lower arrow shows the stump identified by Garibaldi as the stump (Stump 1) from which the branch causing the accident was cut. The upper arrow indicates the tip (identified as Tip 2) of the middle branch of the tree

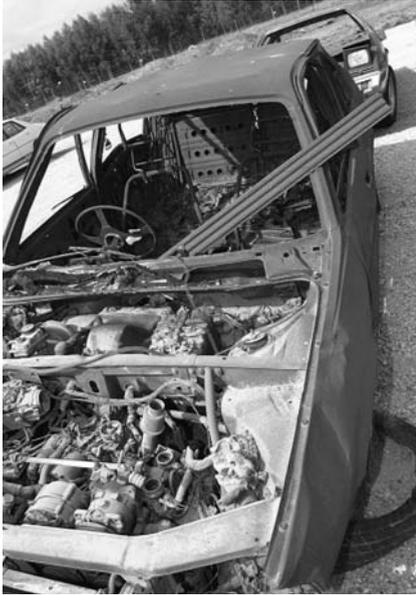
Figure 6.30 View of the burnt-out engine compartment
