HISTORIC STRUCTURE REPORTS
FOR HOUSE 105
AND THE OLD SCHOOL

ADMINISTRATIVE, PHYSICAL HISTORY AND ANALYSIS SECTIONS
SITKA NATIONAL HISTORICAL PARK
SITKA, ALASKA

Prepared By
Paul C. Cloyd E.I.T., Historical Architect

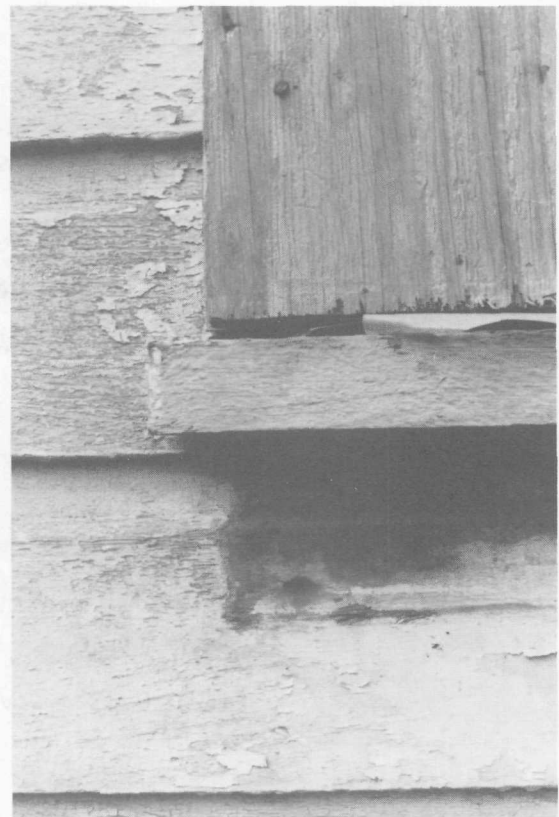
FIGURE 16. Paint ghost detail
indicating found trim is original.

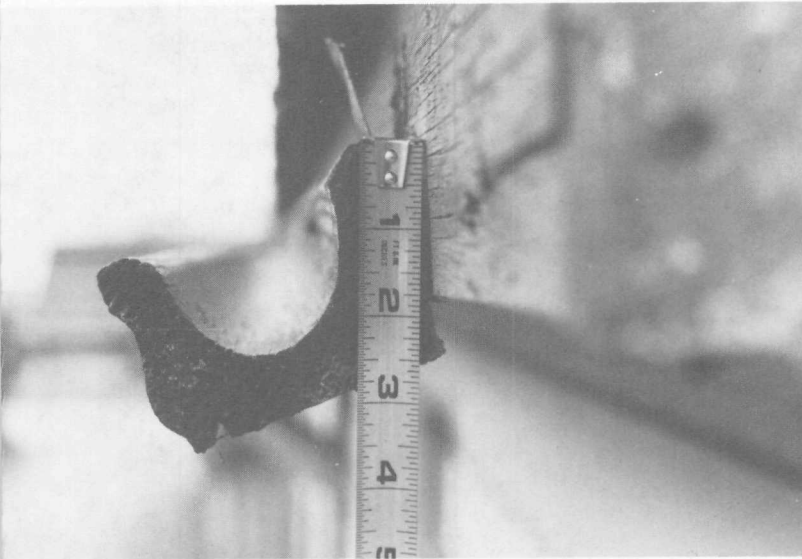
FIGURE 17. Wood gutter detail.

2. One or both chimneys could be rebuilt and used for venting.
3. Repair and restore the wood gutters and treat with fungicide.

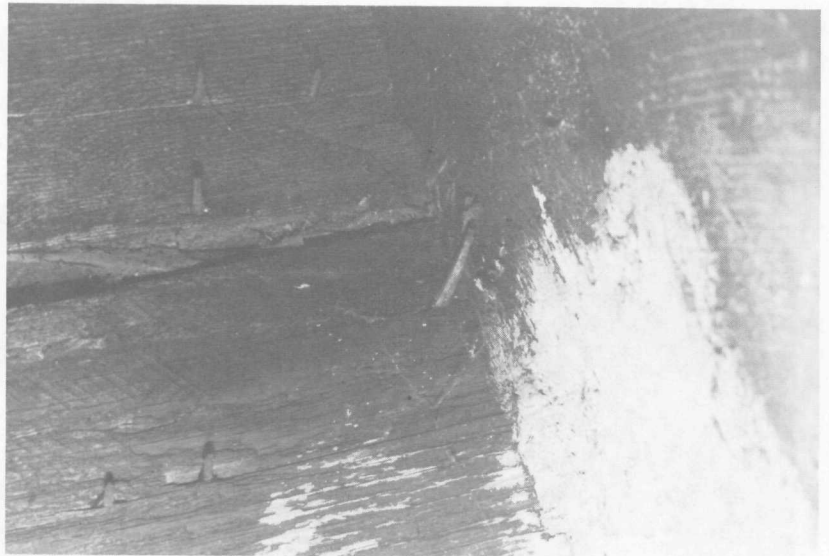
FIGURE 33.
Cut nails used to secure spaced sheathing to rafters.
Wire nails used to attach shingles to sheathing.

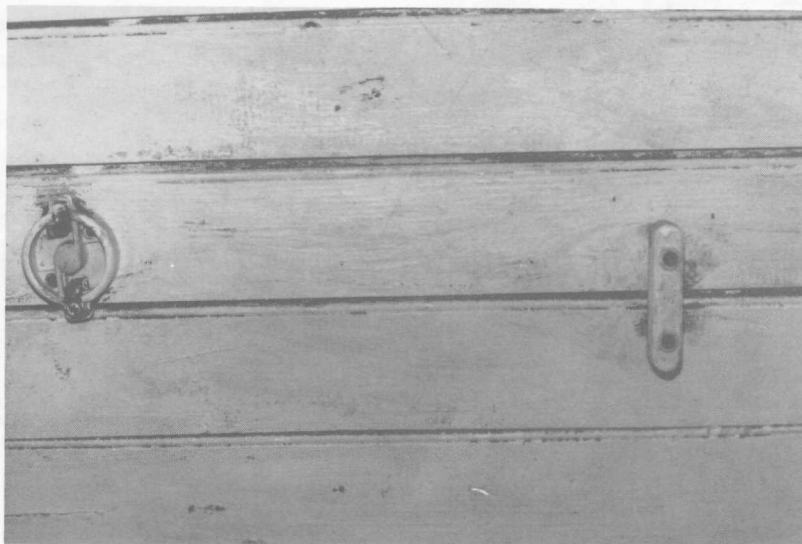
FIGURE 34. Knob and tube wiring system remnants.

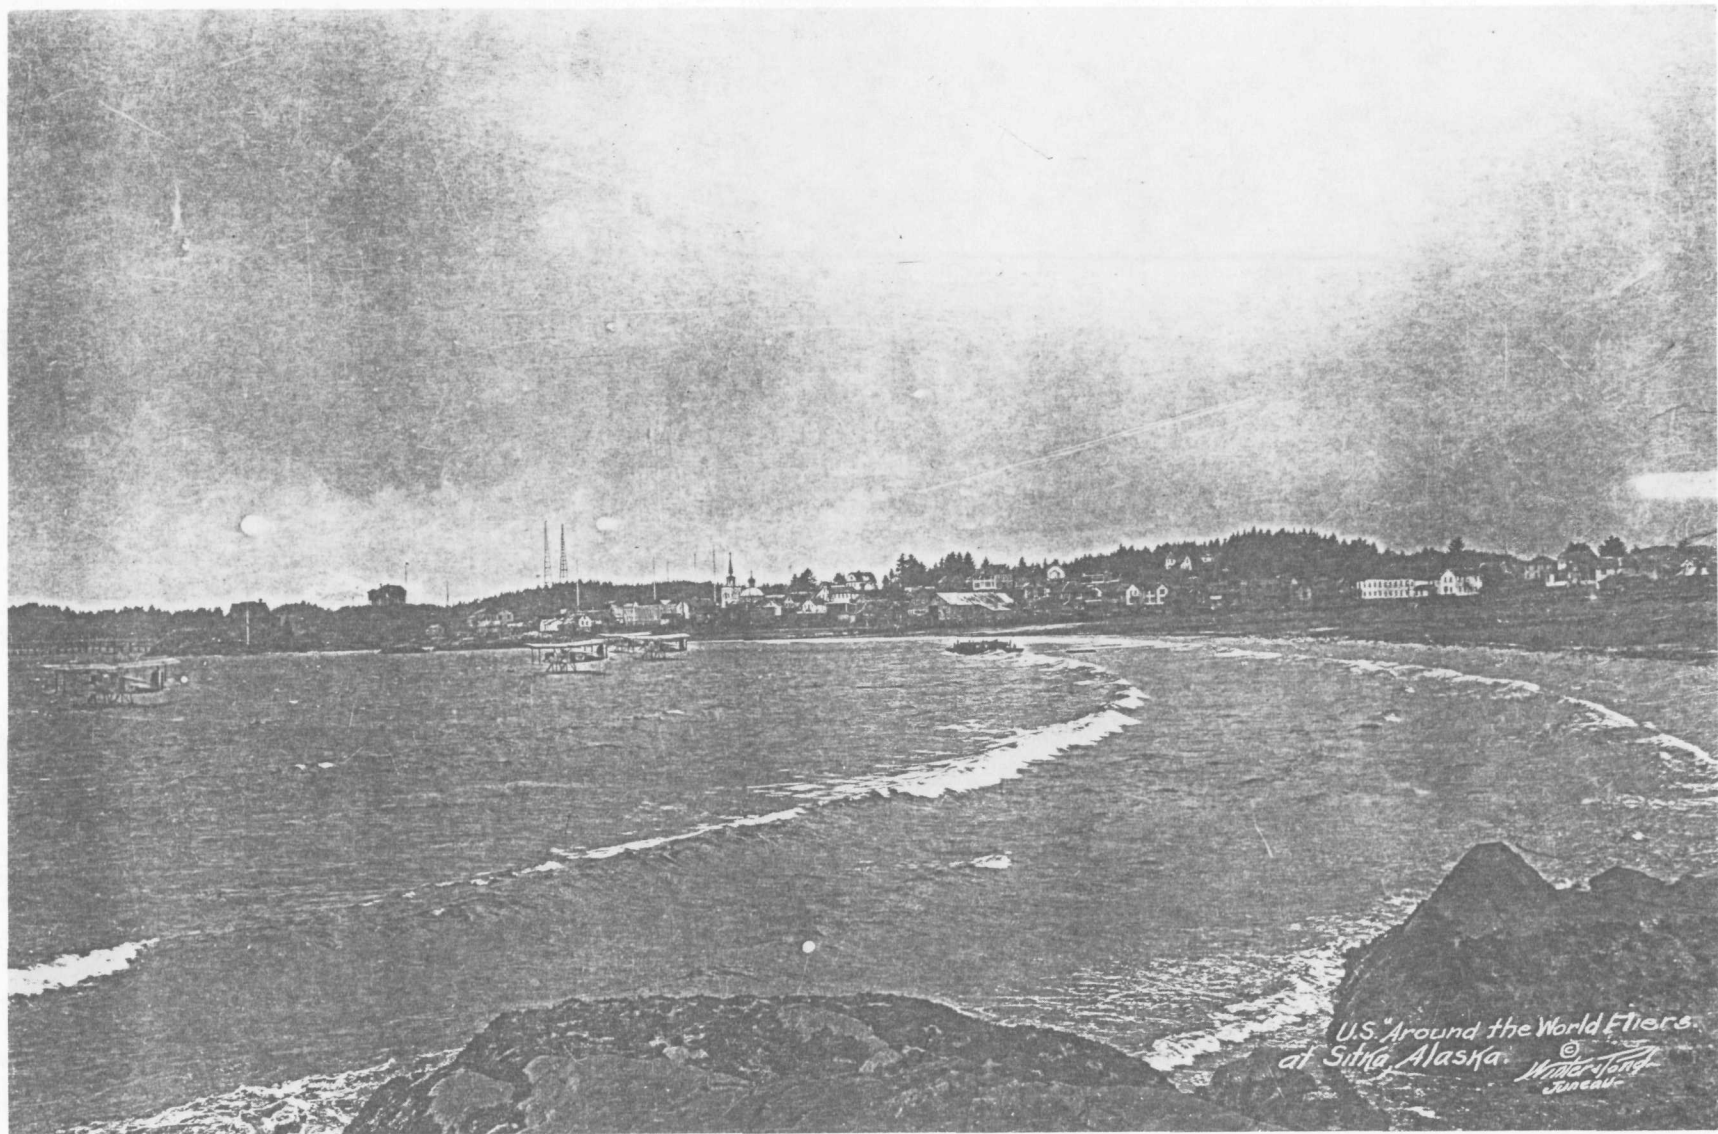
An addition to the east exterior wall appears in a 1924 photograph (Figure 7). Although the photograph is indistinct, it does appear to be an exterior stairway. Ghosting of this addition was found in July of 1981 and definitely suggests a former stairway.

FIGURE 7. May, 1924. Old School at center right.
Note stairs on east wall.
Sitka National Historical Park.

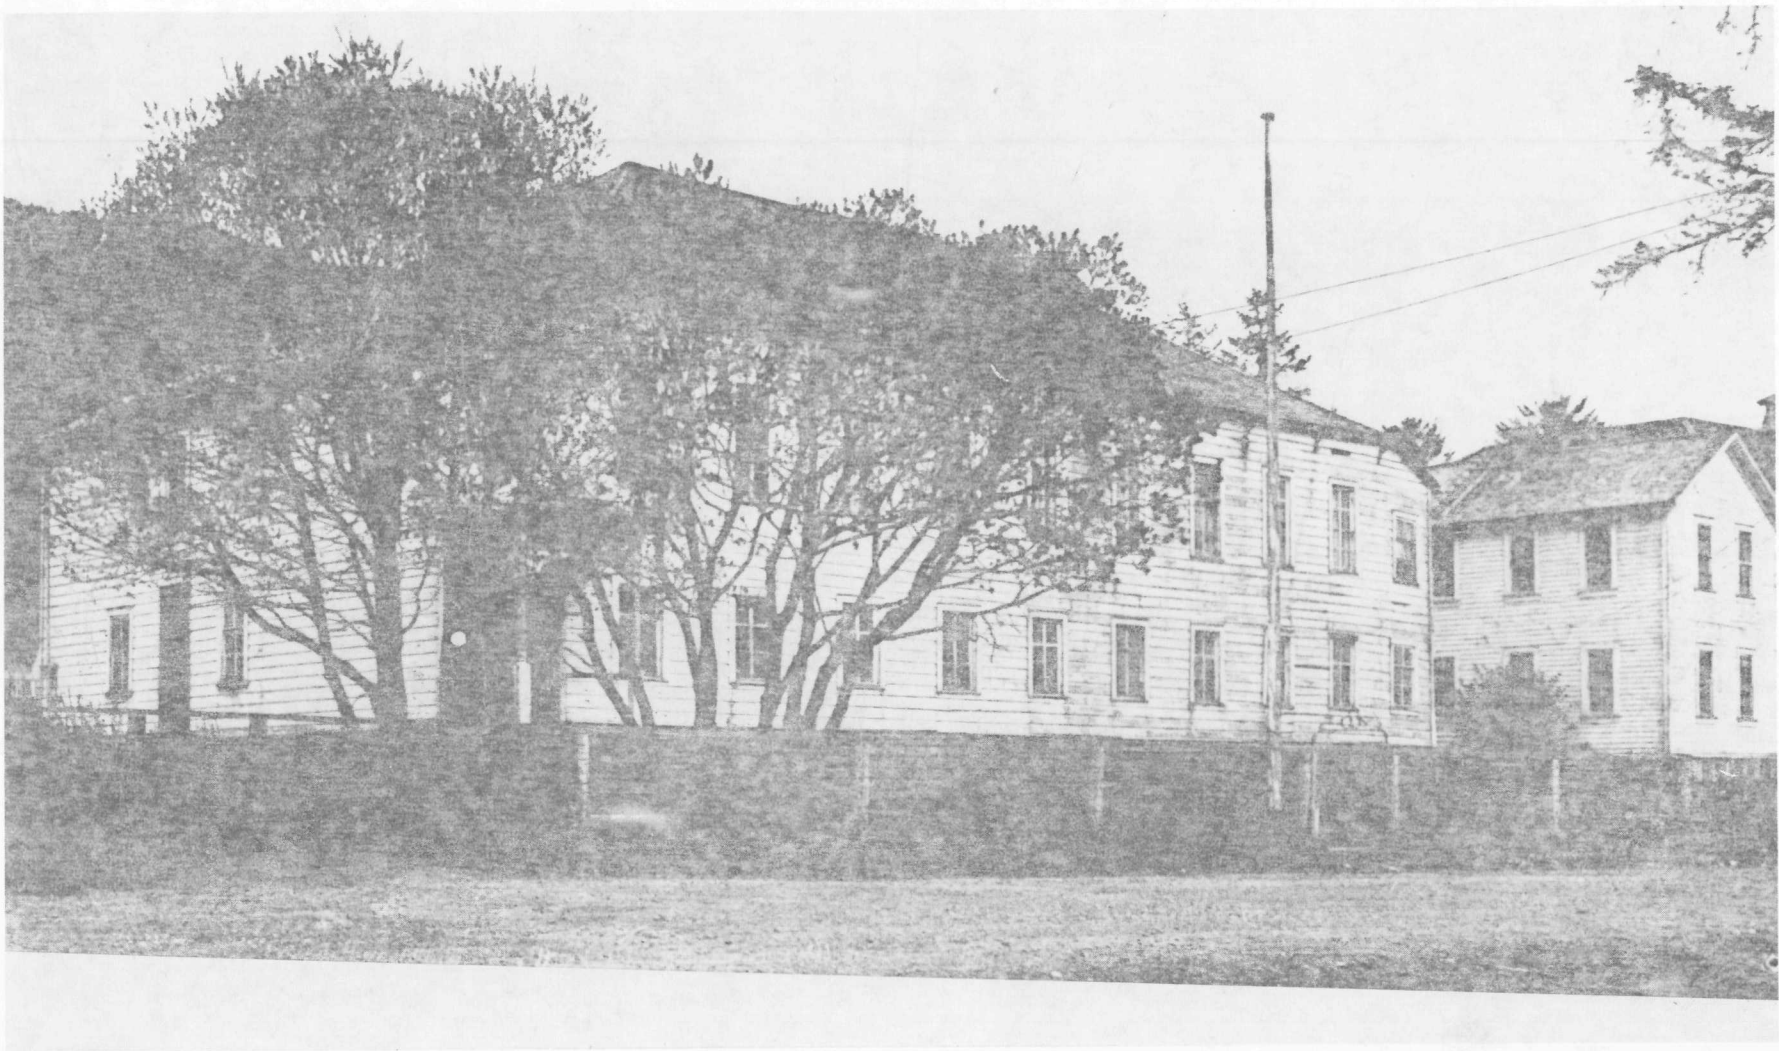
The original west entrance was consequently closed up and replaced with a double-hung window (see Figure 21).

FIGURE 8. ca. 1930s. Old School at right.
Window in place of door on west wall of school.
Vertical skirting below horizontal siding.
Sitka National Historical Park.

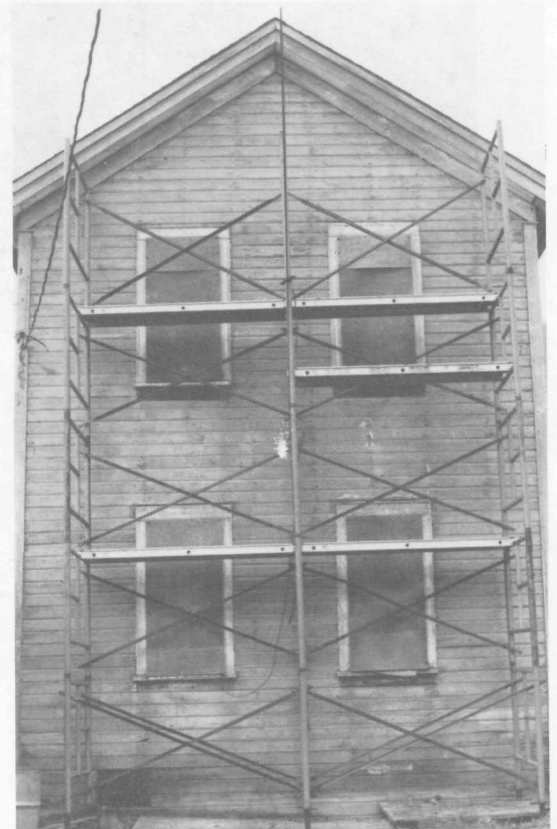
FIGURE 18.

Ghosting on siding appears to be some type of stairway. See Figure 7.

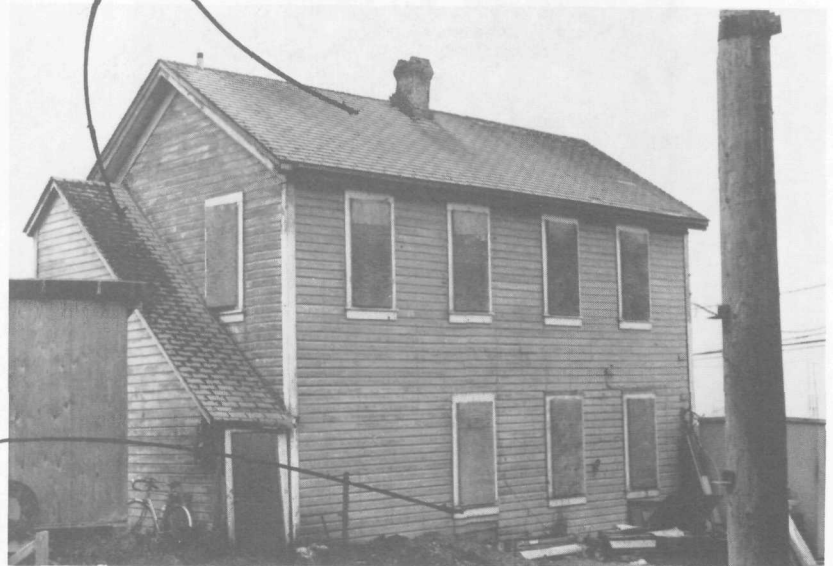
FIGURE 21. View from northwest.

Original doorway converted to window. Probably in 1922.

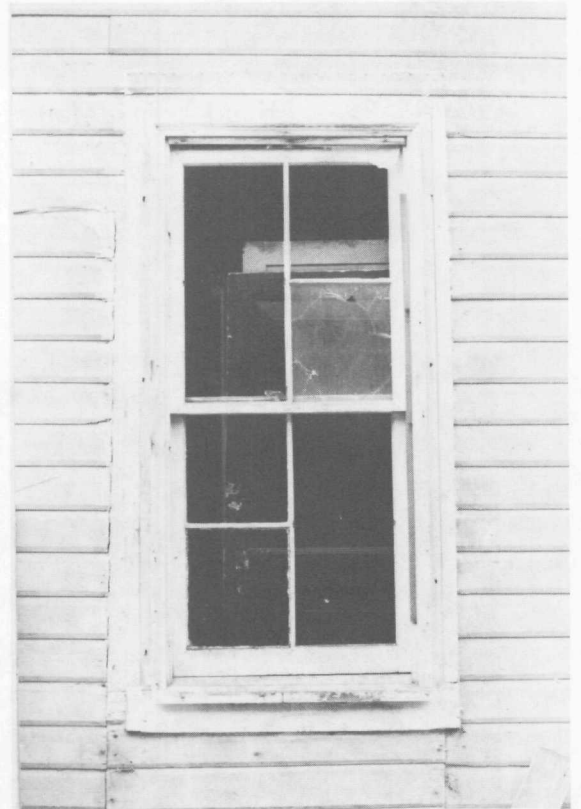
FIGURE 23.
Location of 1922 west doorway.

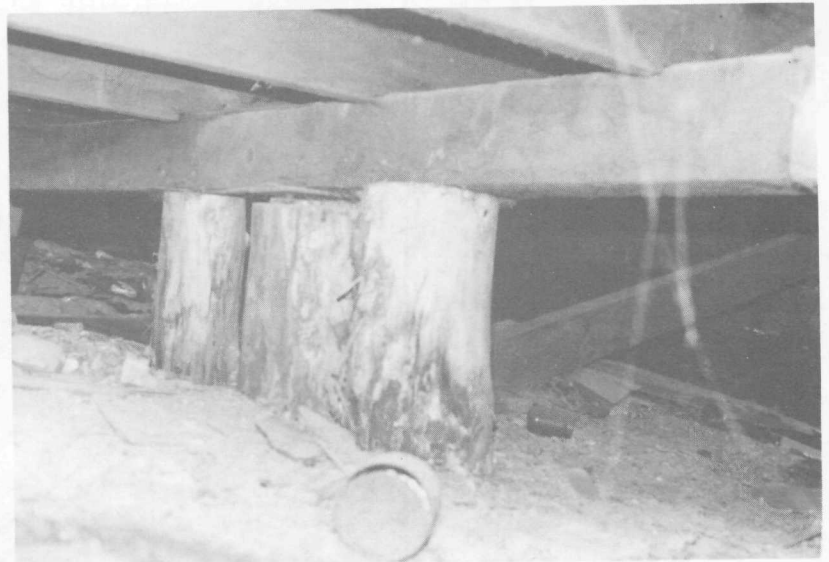
FIGURE 30. Crawl space, east side of building.

1. The existing timber pier system has deteriorated and the building has settled, its floor joists in contact with the soil. The building should be lifted, the crawl space excavated, and a reinforced concrete foundation installed with the interior support beam on piers.
