ANSLEY WILCOX HOUSE

Theodore Roosevelt Inaugural
National Historic Site
Buffalo, Erie County, New York

HISTORIC STRUCTURE REPORT

October 2006

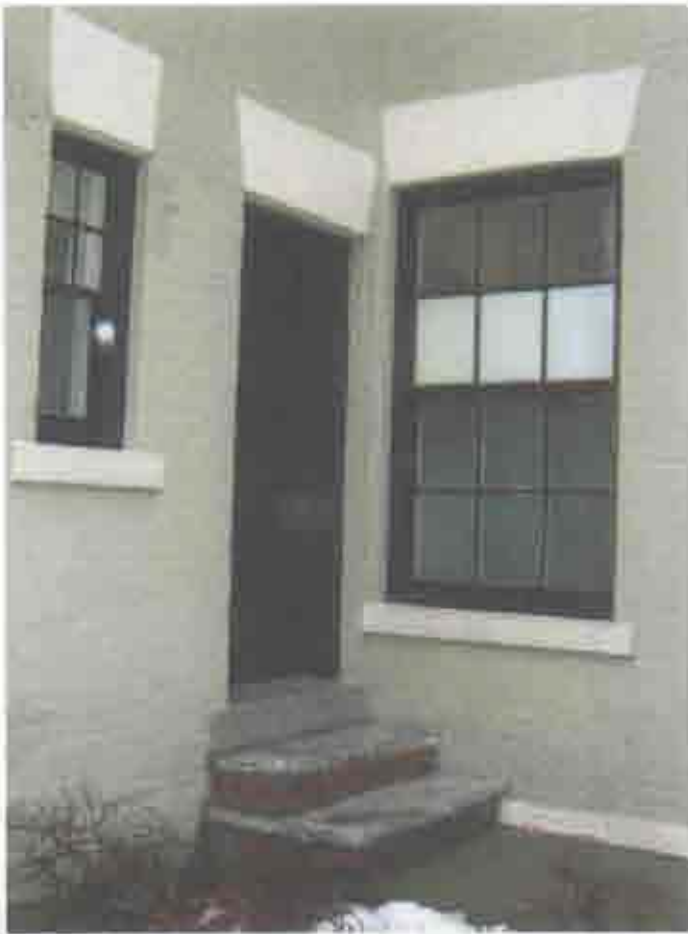
Figure 2.9. North elevation, ca.- 1971 glazing and missing basement window.

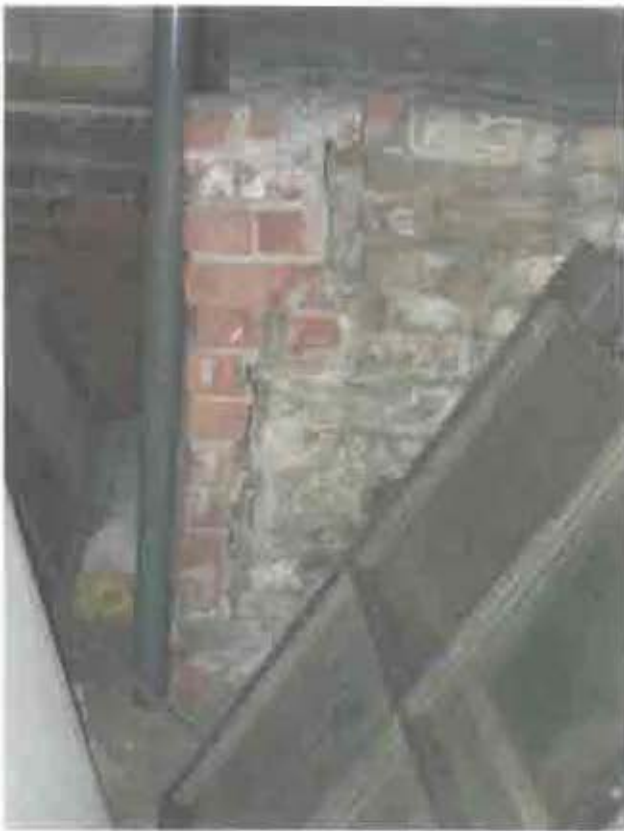
Figure 2.18. Room 001, southeast corner, damaged south retaining wall.

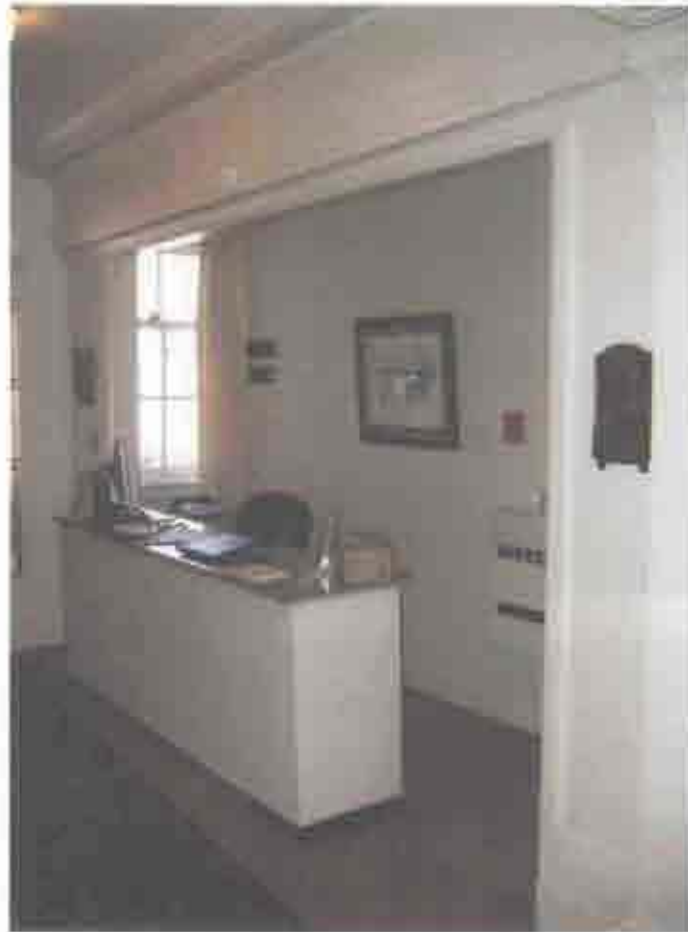
Figure 2.38 Room 106 (Side Hall), former location of missing east wall.

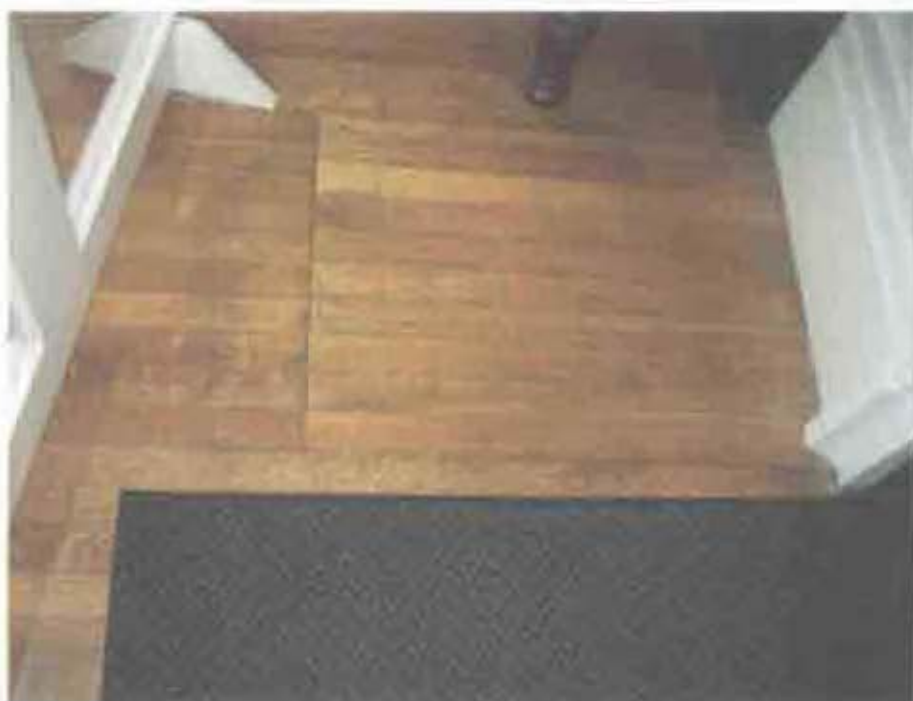
Figure 2.43. Room 108 (Dining Room), former location of missing floor register.

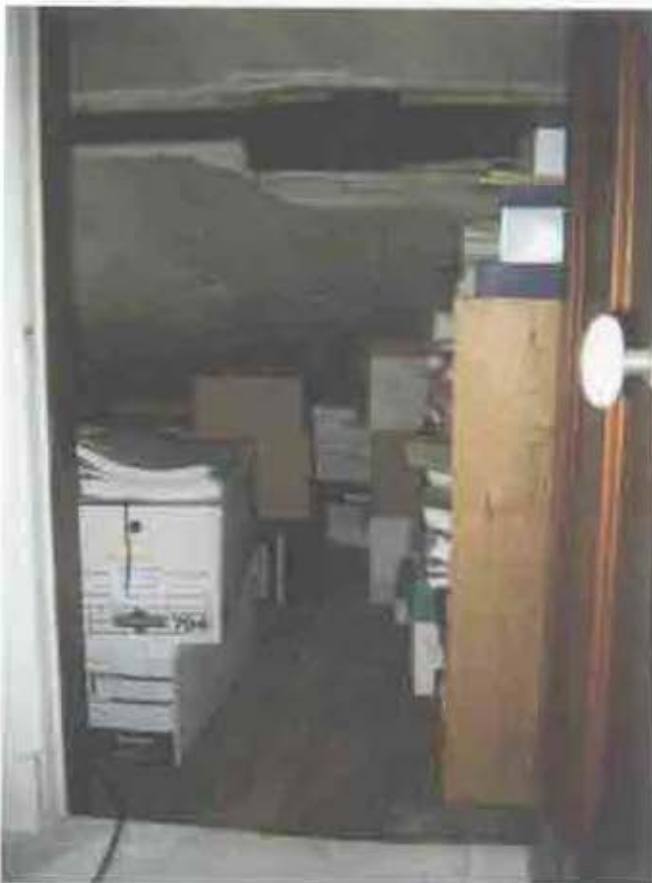
Figure 2.79. Room 305a,
deteriorated plaster ceiling.
