Indiana State Fair Collapse Incident

August 13, 2011 Collapse Incident Investigation
Report on Findings to the Indiana State Fair Commission

April 12, 2012

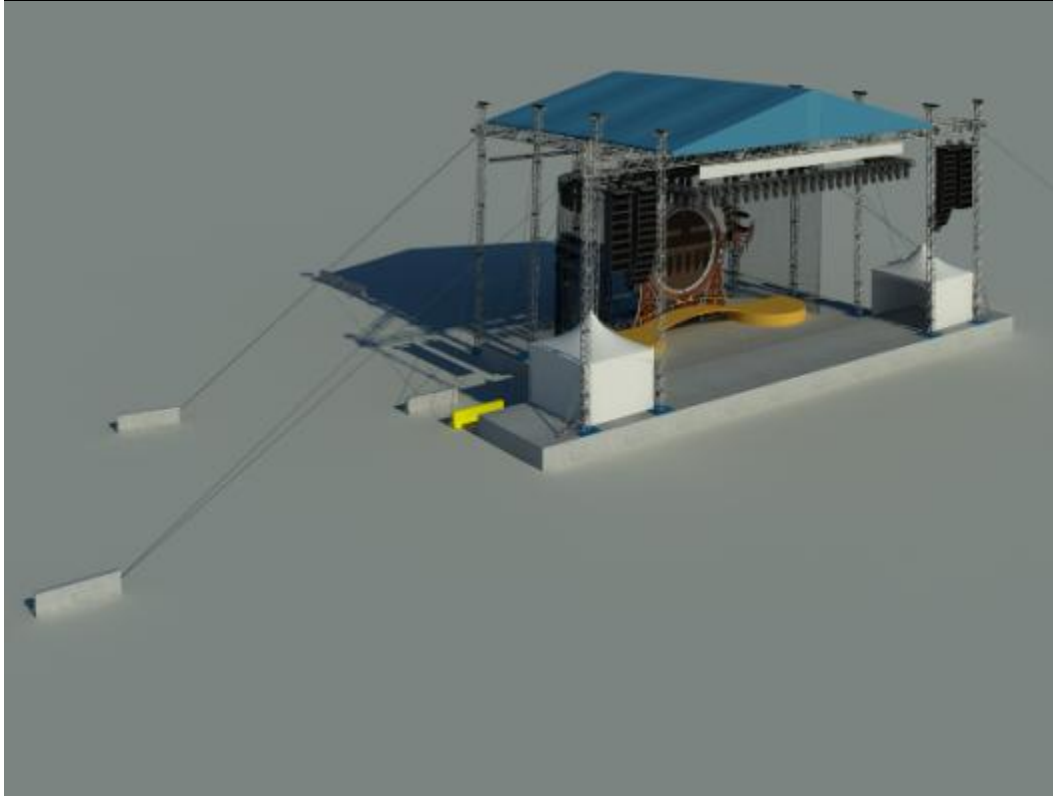
Sequence Step 1:

JBW2 Slides

33 Miles Per Hour

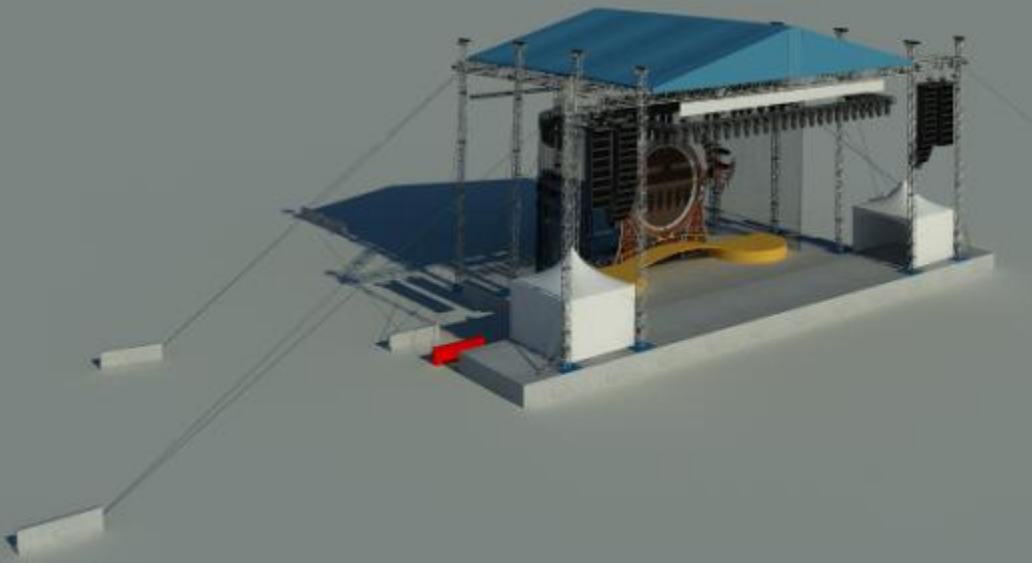
Sequence Step 2:

JBW2 Fails

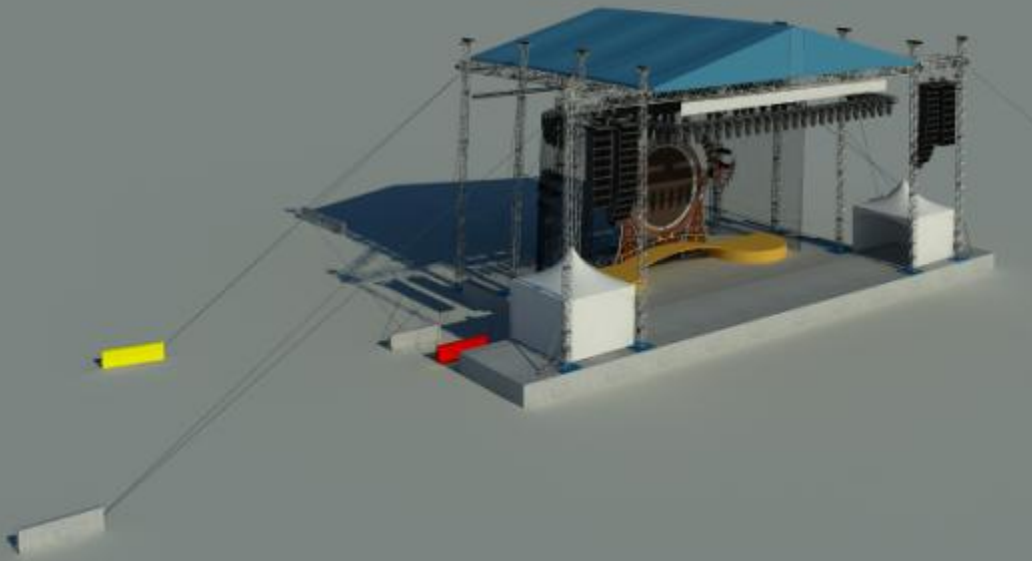
Sequence Step 3:

JBW2 Failed

JBW4 Slides

41 Miles Per Hour

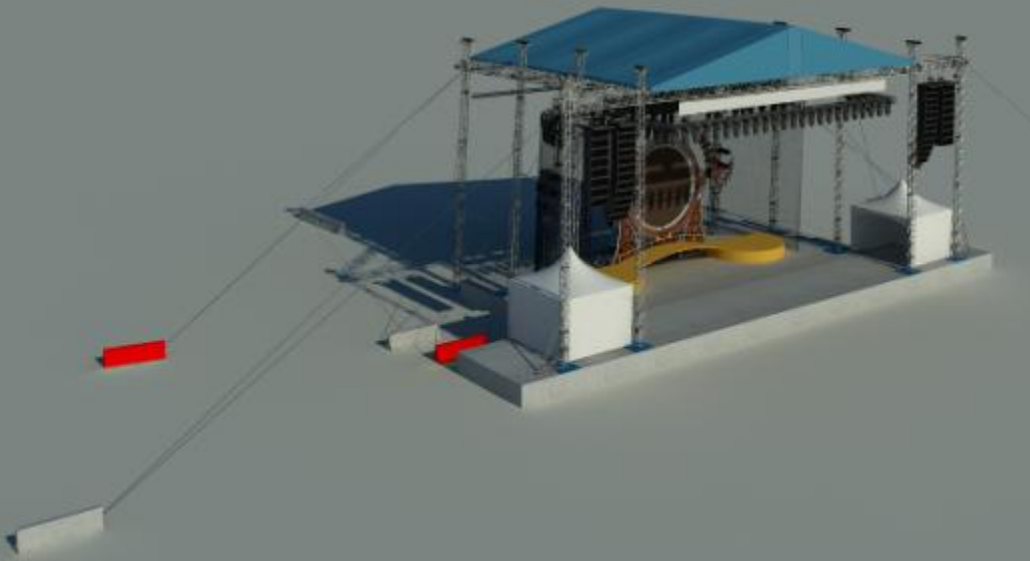
Sequence Step 4:

JBW2 Failed

JBW4 Fails

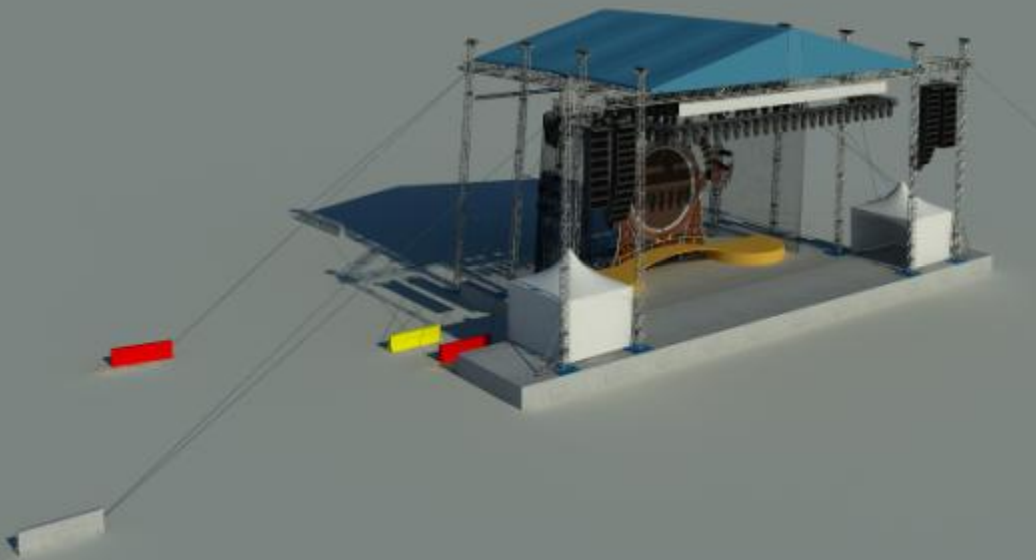
Sequence Step 5:

JBW2 Failed

JBW4 Failed

JBW3 Slides

43 Miles Per Hour

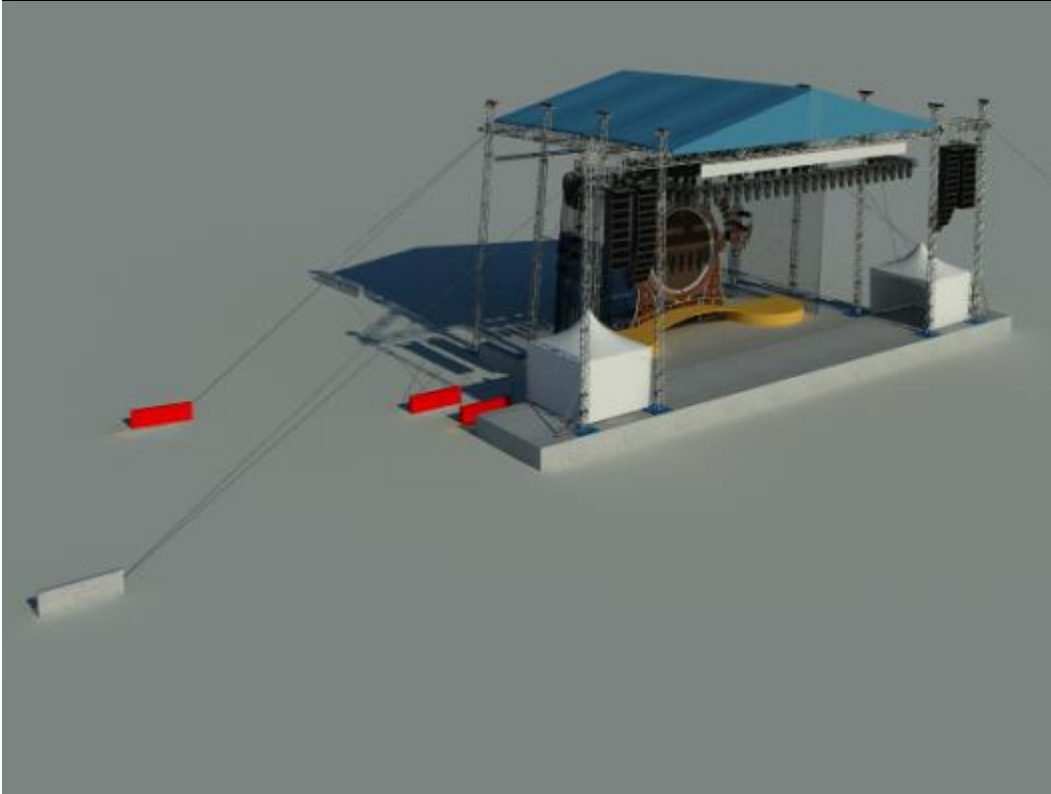
Sequence Step 6:

JBW2 Failed

JBW4 Failed

JBW3 Fails

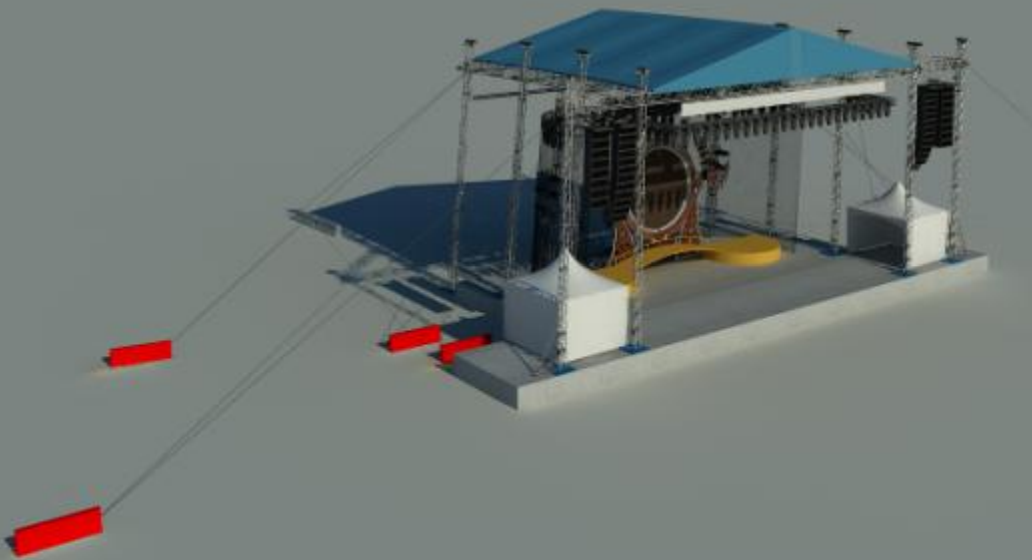
Sequence Step 7:

JBW2 Failed

JBW4 Failed

JBW3 Failed

JBW1 Fails

43 Miles Per Hour

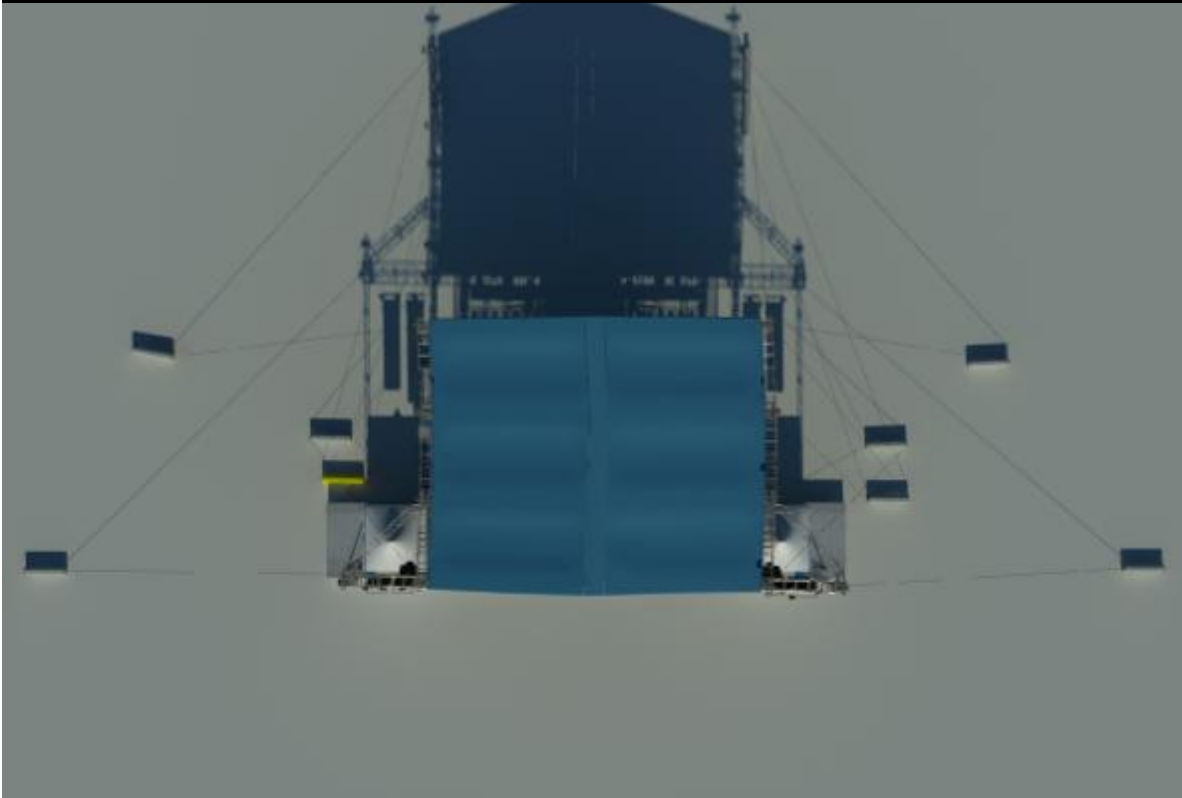
Sequence Step 1:

JBW2 Slides

33 Miles Per Hour

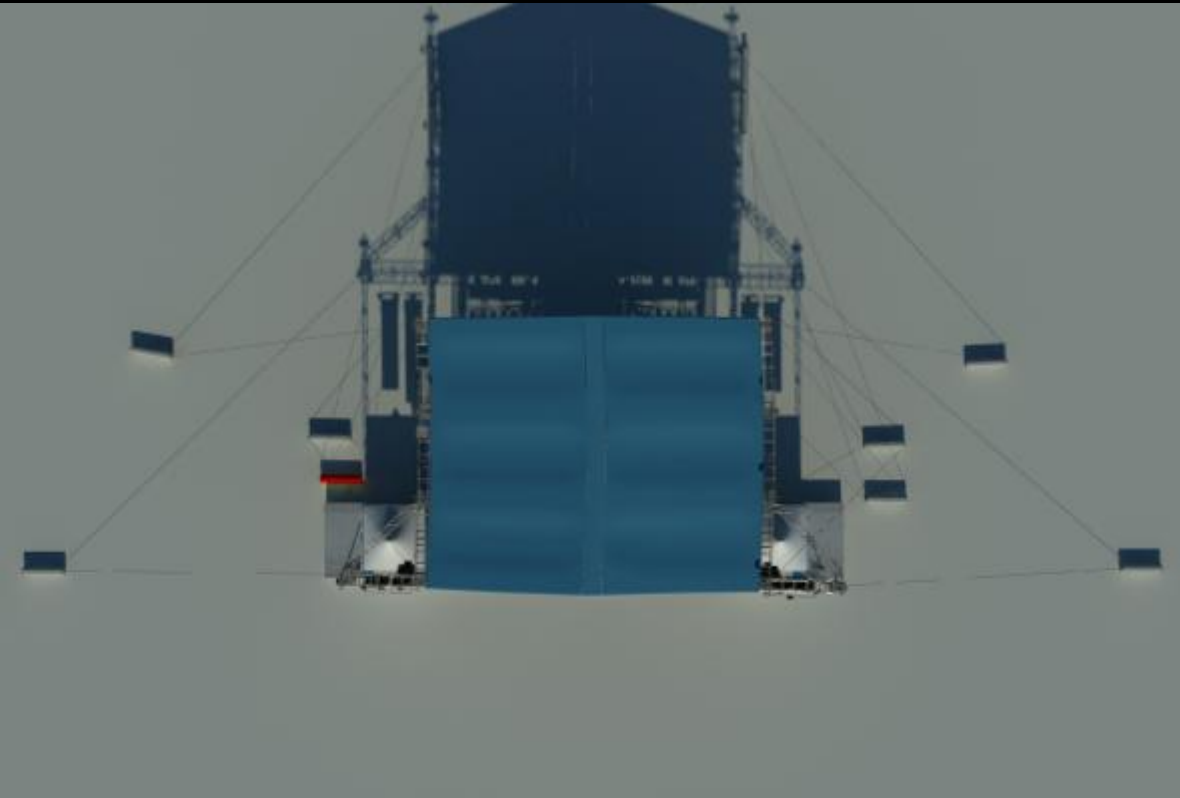
Sequence Step 2:

JBW2 Fails

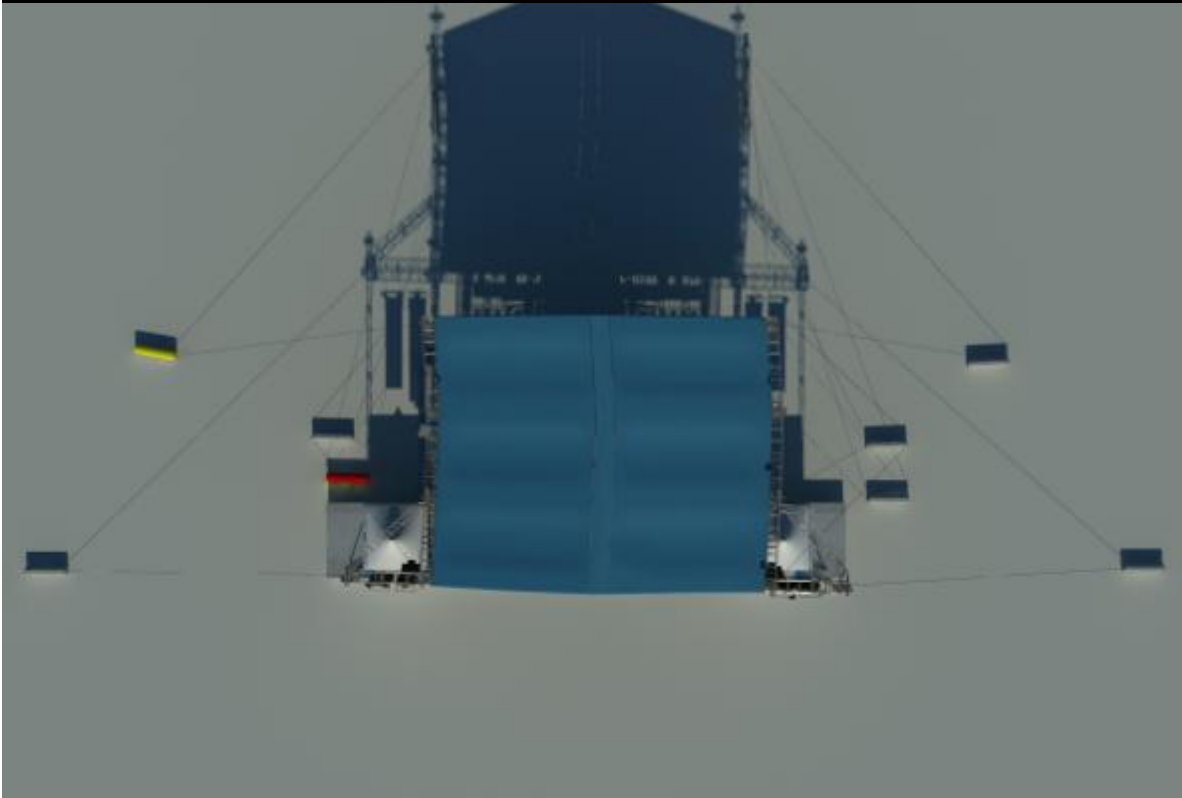
Sequence Step 3:

JBW2 Failed

JBW4 Slides

41 Miles Per Hour

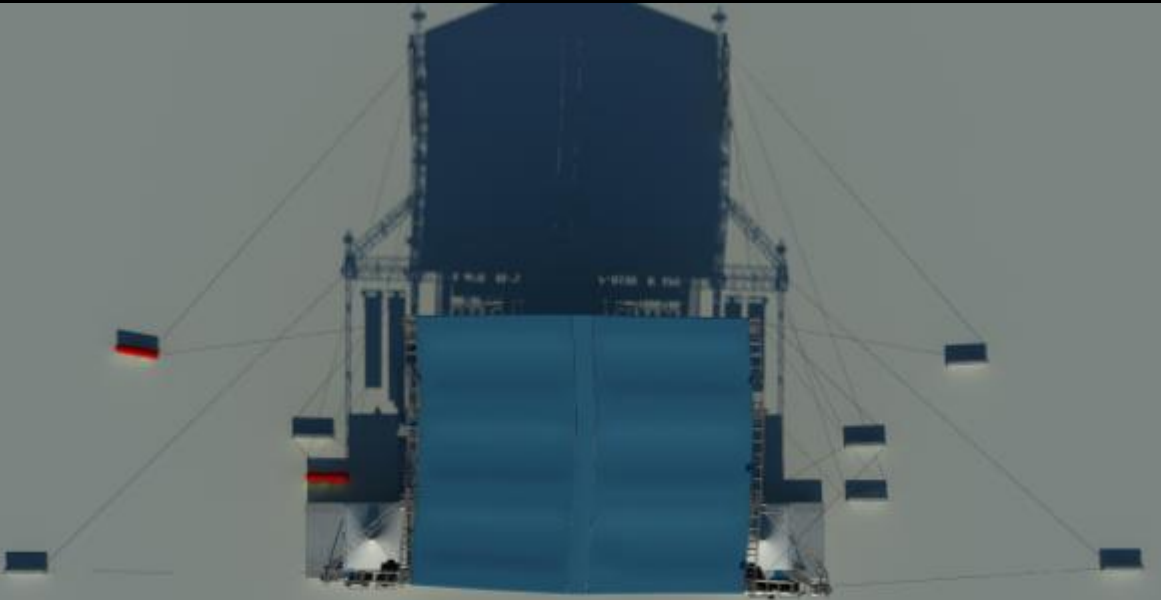
Sequence Step 4:

JBW2 Failed

JBW4 Fails

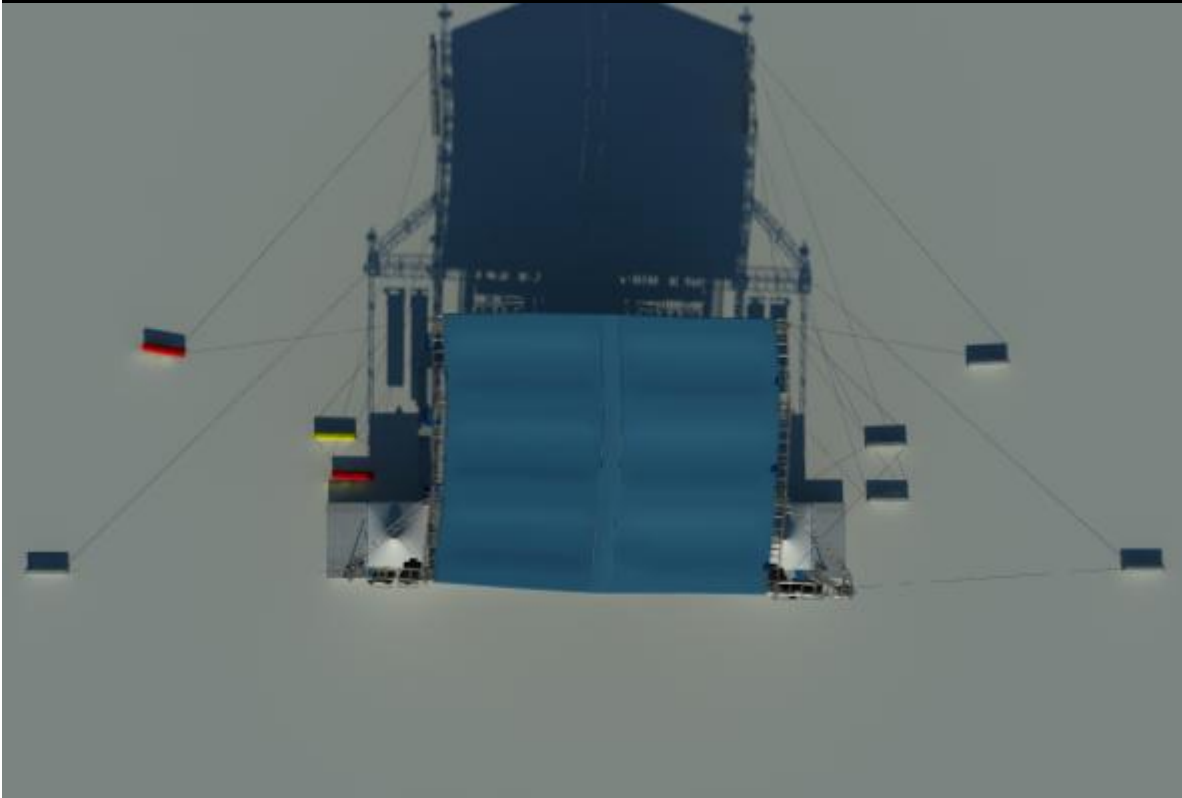
Sequence Step 5:

JBW2 Failed

JBW4 Failed

JBW3 Slides

43 Miles Per Hour

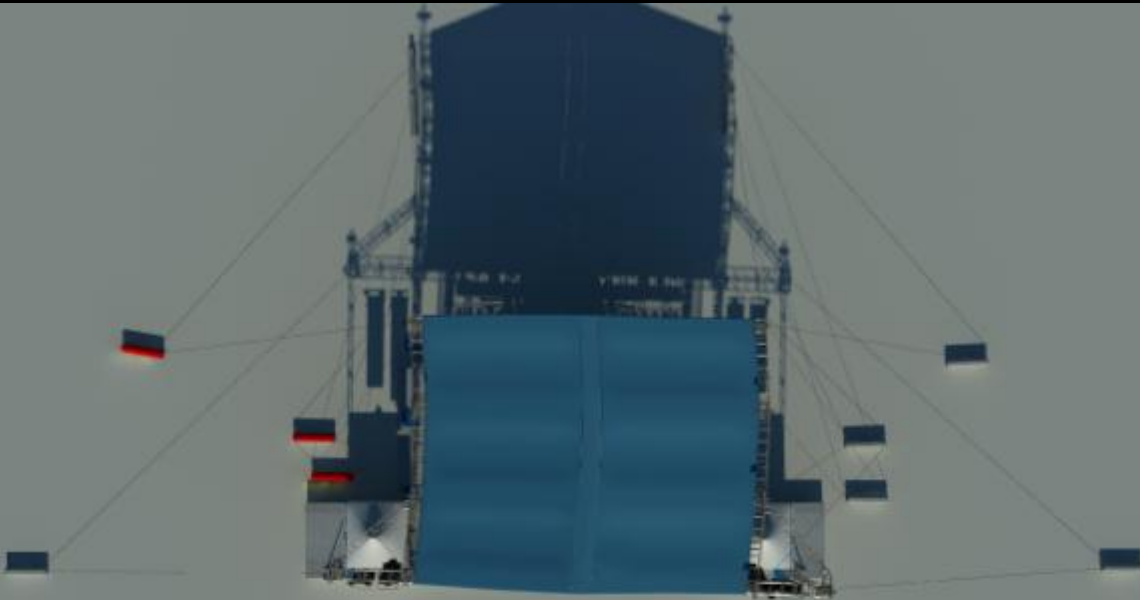
Sequence Step 6:

JBW2 Failed

JBW4 Failed

JBW3 Fails

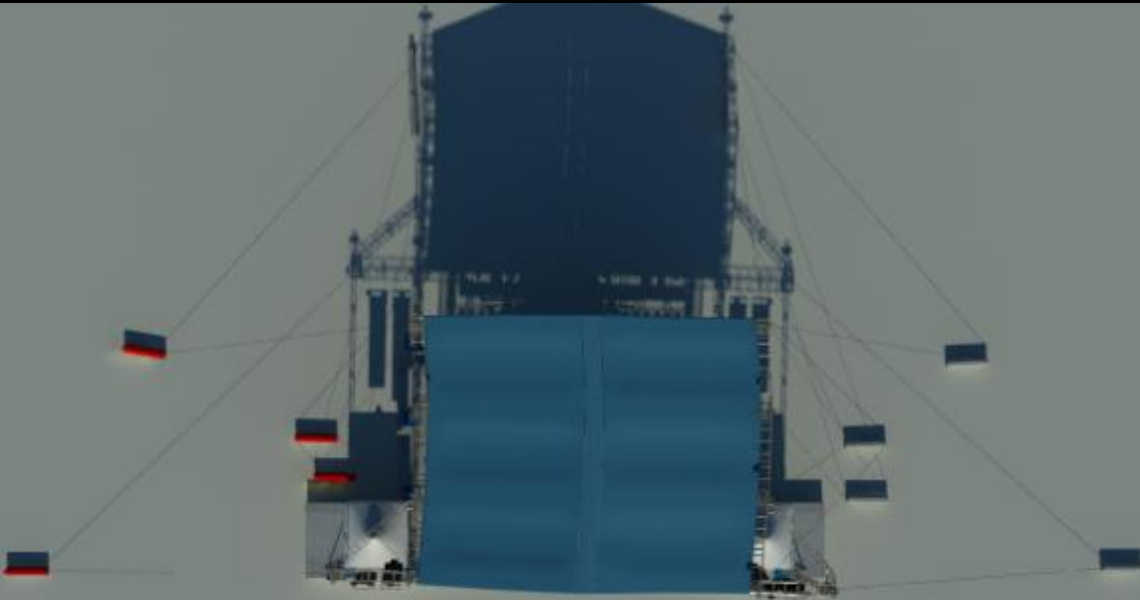
Sequence Step 7:

JBW2 Failed

JBW4 Failed

JBW3 Failed

JBW1 Fails

43 Miles Per Hour

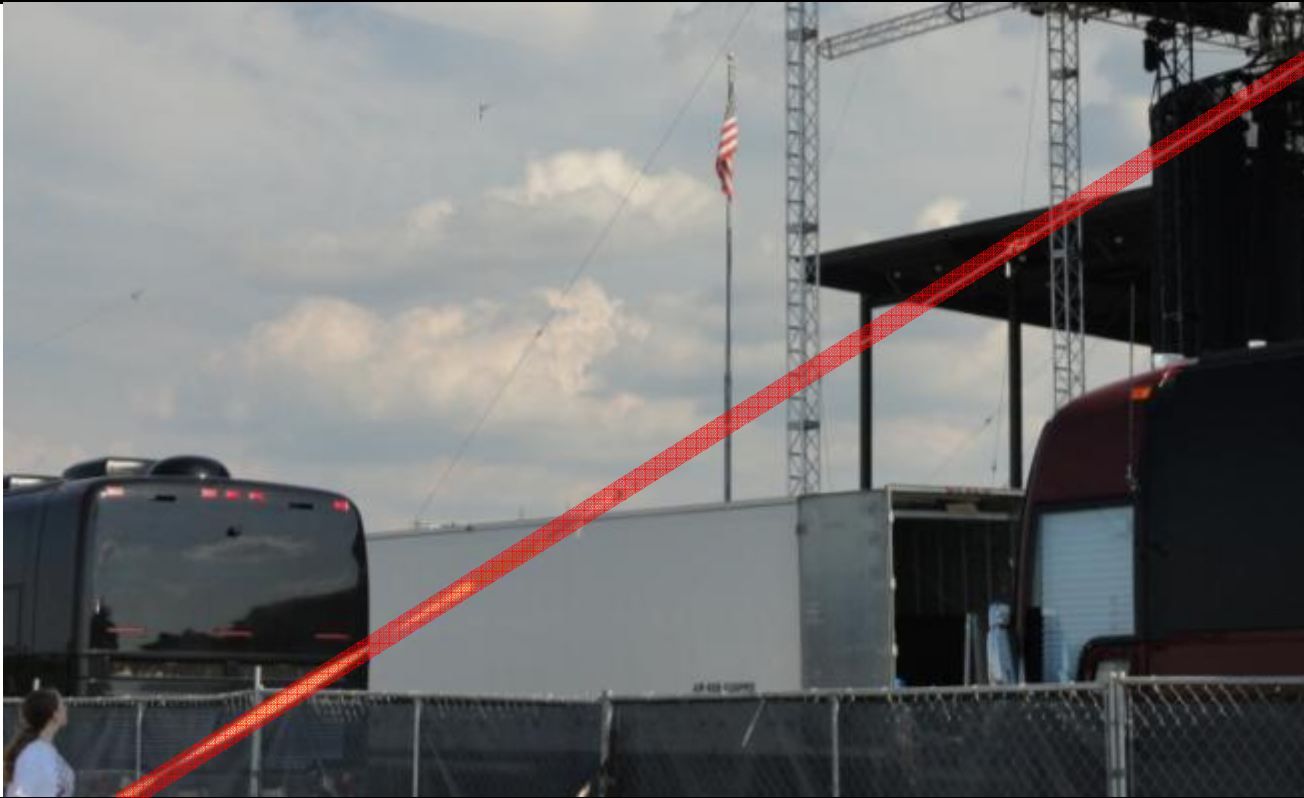
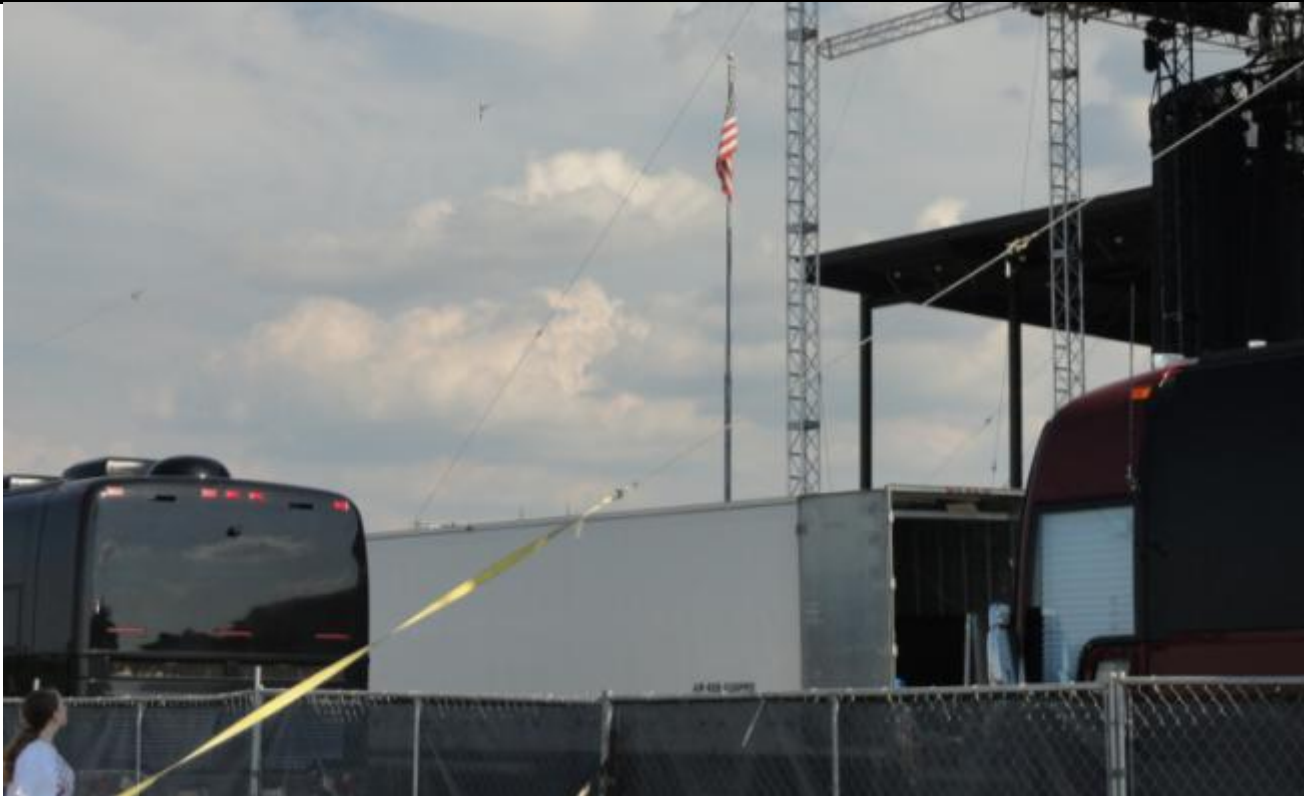
Inadequate Guy Line Capacity

- > Even if the ballast system had provided sufficient resistance, the synthetic webbing ratchet straps and wire rope guy lines used did not have sufficient strength to resist forces resulting from the North wind case under the wind loads of August 13, 2011 that were of a smaller magnitude than the code-specified requirements.
 - At 59 mph:
 - Wire Rope Capacity (13,000 lbs ultimate) exceeded at F4, B4 @ 92%
 - Ratchet Strap Capacity (10,000 lbs ultimate) exceeded at F4, B4
 - For NW wind ratchet strap capacity at F4 exceeded.
 - Note, all values are below the “allowable” capacity of components

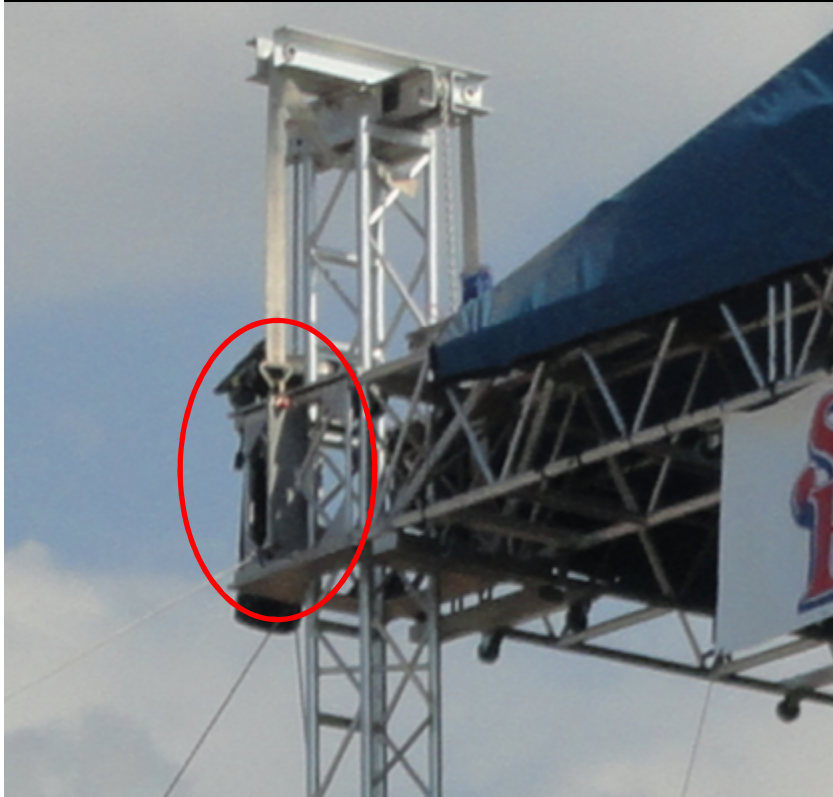
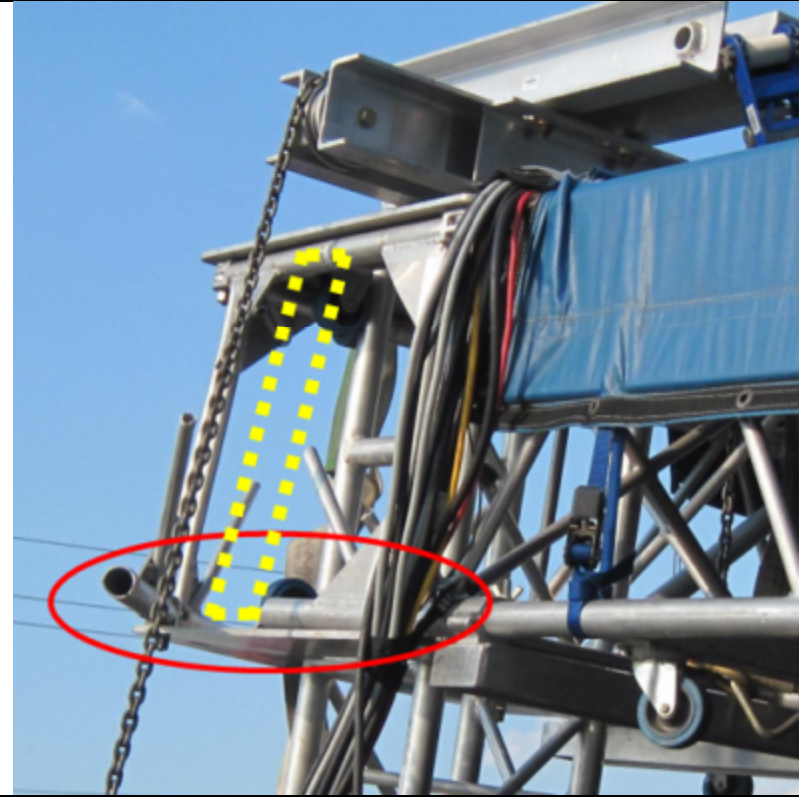
- > Even if the ballast system and guy line system had provided sufficient strength to resist the wind loads, the “fin plate” connections to the structure did not have sufficient strength to resist forces resulting from the North, West and Northwest wind cases under the wind loads of August 13, 2011 that were of a smaller magnitude than the code-specified requirements.

- > Even if the ballast system and guy line system had provided sufficient strength to resist the wind loads, the “fin plate” connections to the structure did not have sufficient strength...

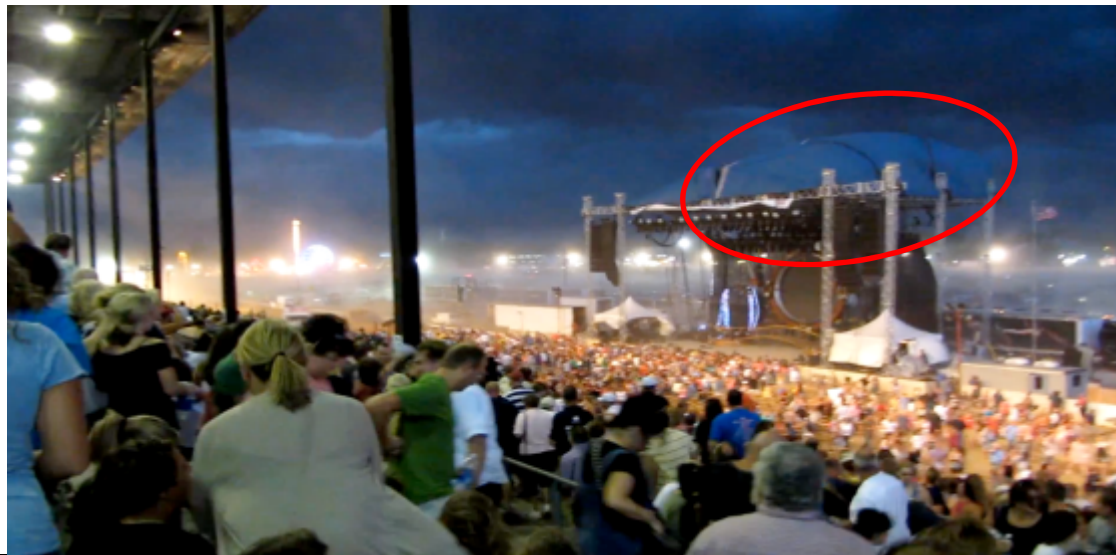
Roof Tarp Did Not Cause Failure

- > The ISF Structure was shown to fail at the August 13, 2011 wind speed without the addition of loading caused by the roof tarp displacement.

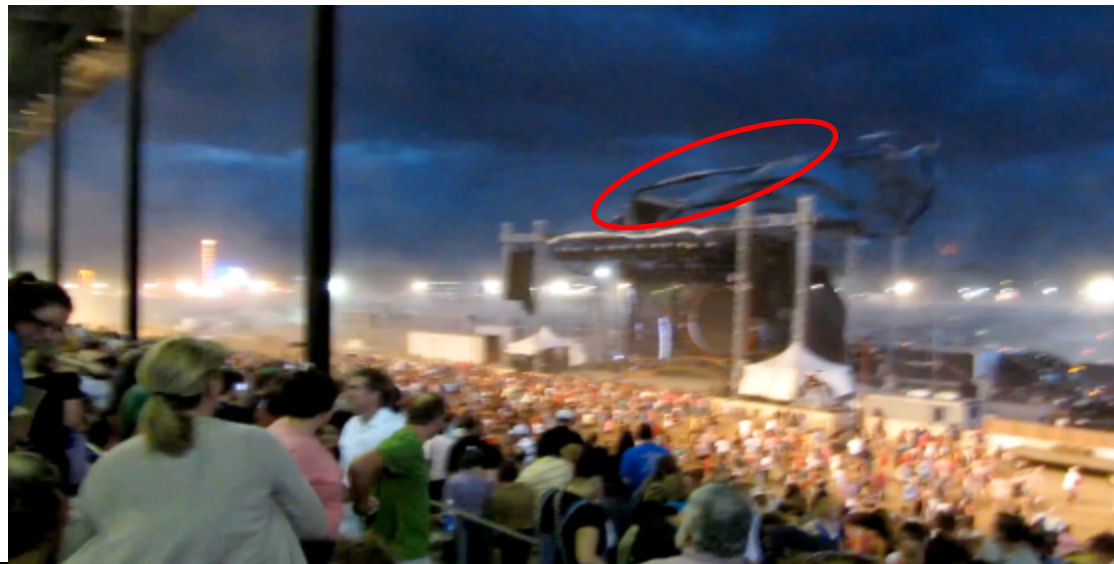
Roof Ridge Panel Release Was Insignificant

- > Timing of the roof tarp ridge panel release would not have had an effect on maintaining stability of the ISF Structure.
