## Overton Down Experimental Earthwork, Wiltshire 1968

By
K. Crabtree, B.Sc., Ph.D.
Department of Geography, University of Bristol

## GEOMORPHOLOGY OF THE DITCH SECTION

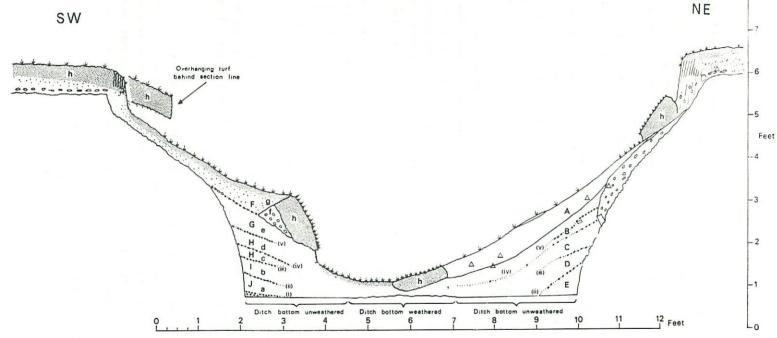
$Fig. \ 39 \\ Section through the ditch at pole VI, taken in July, 1968.$

In examination of the section, the distinct alternating layers of coarse and fine chalk rubble noted by Jewell and Dimbleby (1966) were plainly visible in the scree. Fig. 39 is based on the field drawing compiled by P. J. Fowler and the author in 1968. On the north-east facing slope, some five distinct coarser layers were discernible, separated by lines of finer

material with humus staining. Overlying all this was much finer material, humus stained throughout but still showing some signs of stratification parallel to the slope. Samples were taken from the sites marked by letters A–G on fig. 39 in 1968 in order to obtain some data on the particle sizes within the layers. Only the coarser band materials were sampled, and only small (about 1Kg) samples were taken. The normal methods of mechanical analysis were not possible because of the fragile nature of the chalk and so the material was gently hand sieved, at field moisture state. The results are given in Table 1.

The section drawing and the particle size analysis show that infilling has occurred slightly asymmetrically, that the particle size differs with the aspect, and that the rate of accumulation has varied over time. The causes of these phenomena may now be considered.

The mechanical analysis data (Table 1) and the section drawing (fig. 39) show that it is the south-west facing slope which in general has the finer material and the lower angle of rest. Samples E and J and samples D and I represent the first and second winter accumulations. In both cases the second year's material is coarser than the first year. A possible explanation for this was mentioned in connection with fig. 38. However, comparing the slopes year by year, it is the north-east facing slope which has the coarser material in the first year and the opposite slope which has the coarser material in the second year. Assuming that this really was the situation and that subsequent breakdown of the material has not occurred, then the explanation of the phenomenon may lie in one of two directions: there might be a limited amount of coarser material and that if much of this falls in the first year then finer material will fall in the second year. Alternatively the balance of processes affecting erosion of the exposed chalk face may vary from year to year.

The effect of insolation is more difficult to assess. In the case of chalk, freeze-thaw action and alternate wetting and drying are probably the two other major forms of mechanical breakdown. It is the south-west facing side which will receive the greatest insolation and hence might be expected to suffer more drying out than the north-east facing side. The result of this would be to increase the rate of supply of material to the south-west facing talus slope and to reduce the overall particle size of that material. Coupled with mechanical rainbeat, the south-west facing talus slope might be expected to be composed of finer material having a lower angle of rest and to be eroding back further into the original chalk surface compared with the north-east facing slope. The general appearance of the material in the section (fig. 39) is in keeping with this.

A feature of interest on the section (fig. 39) is the part played by fallen turves in preventing normal sequential accumulation down slope from the resting site of the turf, until the turf itself is overtopped by falling talus. Also a large chalk block weathering out of the south-west facing side, formed a similar barrier to down slope movement of angular debris.
