File OF-Surv-Inc 2008-030  
13 February 2009

**Report Issued by the National Energy Board February 2009 entitled *Investigation under the National Energy Board Act into the Death of Mr. Henri St. Pierre at the Enbridge Pipelines Inc. Kerrobert Pump Station on 24 March 2008***

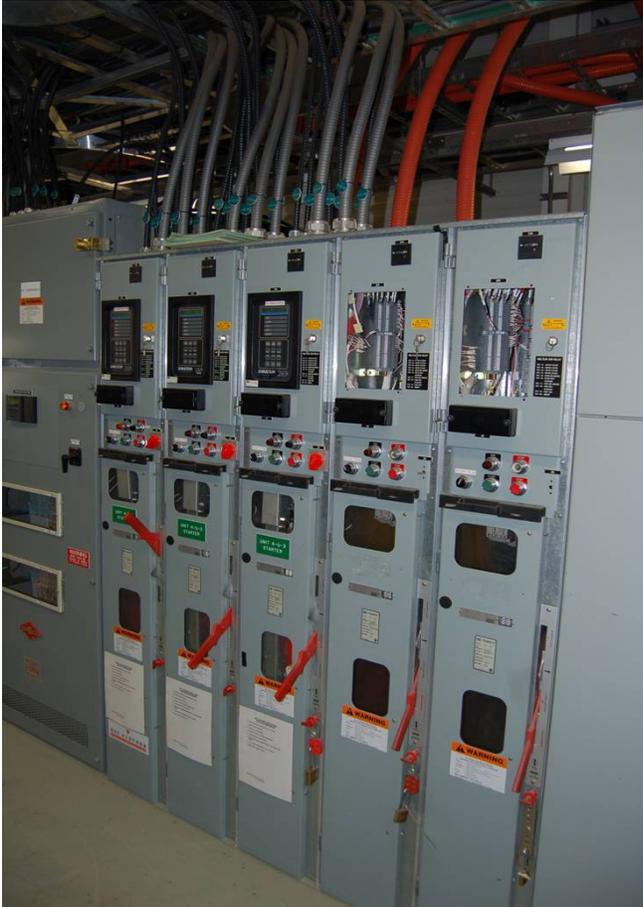
Photo 5.1 shows the bank of five unit starters left undisturbed immediately following the incident as required by section 127(1) of the CLC. The unit starters are numbered from 4-U-1 to 4-U-5 in sequence from left to right. The photo shows that starters 4-U-2 and 4-U-3 are in the racked out position (indicated by the red levers in the down position). A lock is applied to starter 4-U-3; however a lock is not applied to starter 4-U-2 due to the emergency nature of racking out this starter immediately following the incident. Starters 4-U-4 and 4-U-5 are extra starters, which were not in use and not connected to equipment at the time of the incident.

Photo 5.1: Unit starters located in 4-ESB-1 building.

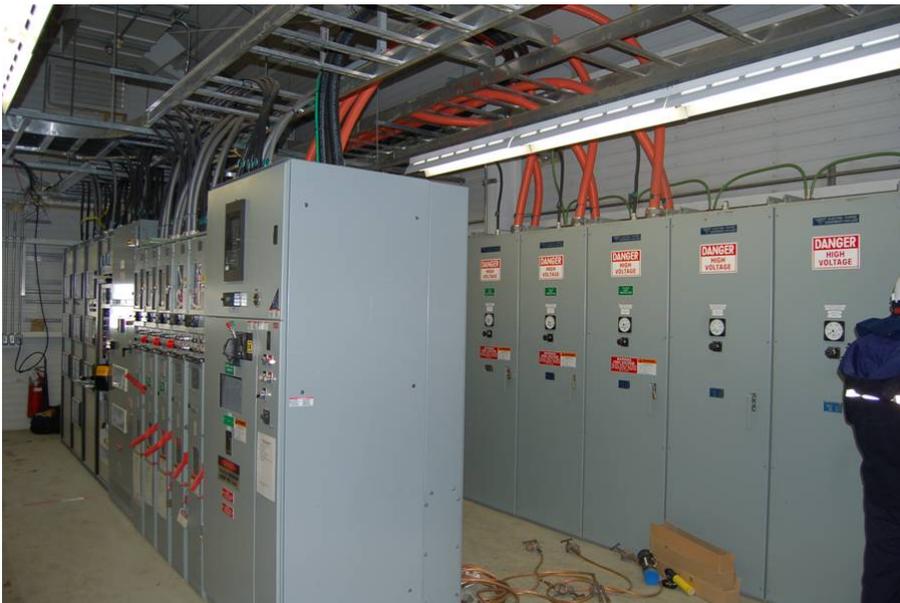
Photo 5.2 shows the relative positions of the five unit starters (left) and the five power factor capacitor cells (right). The grounding cables in use at the time of the incident can be seen lying on the floor in front of the power factor capacitor cells. Also seen in the photo is the overhead lighting that was used by Mr. Halter to test the function of the voltage probe prior to conducting a sweep inside the cell with the probe.

Photo 5.2: Unit starters and power factor capacitor cells.

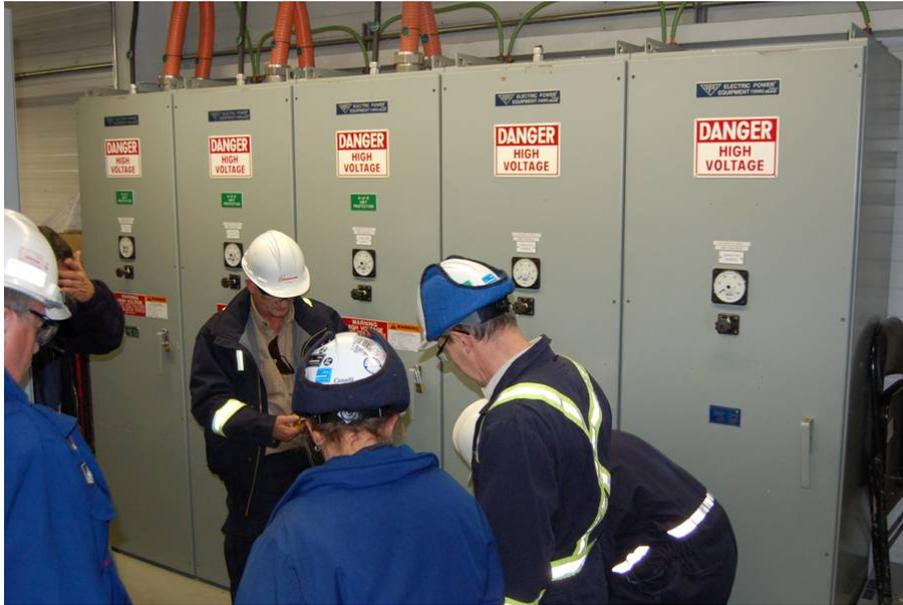
Photo 5.3 shows the bank of five power factor capacitor cells. The power factor capacitor cells are numbered from 4-U-1 to 4-U-5 in sequence from left to right.

Photo 5.3: Power factor capacitor cells.

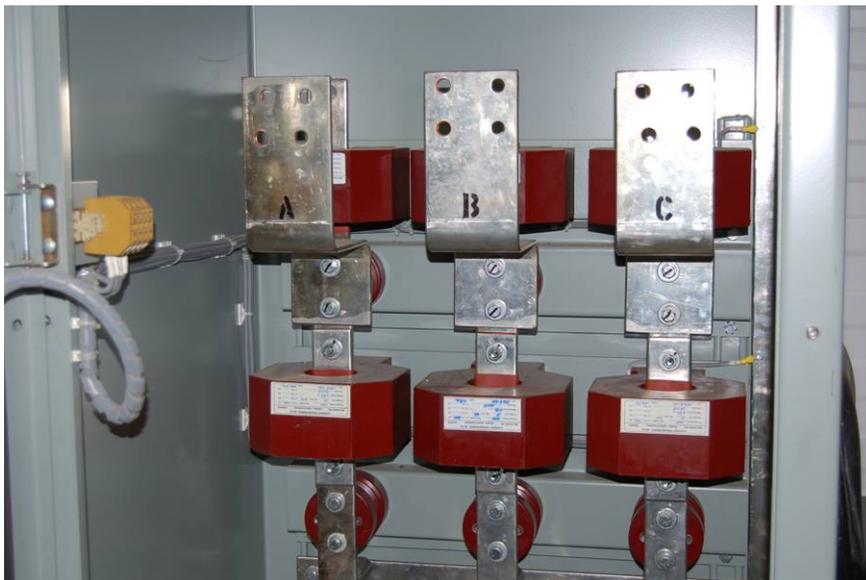
Photo 5.4 shows the inside of power factor capacitor cell 4-U-2. The metal bus bars are labeled A, B and C. After racking out the unit, grounding is accomplished by connecting the three tail ends of the grounding cables to the three bus bars and then the lead end of the grounding cables to a ground point.

Photo 5.4: inside of power factor capacitor cell 4-U-2.

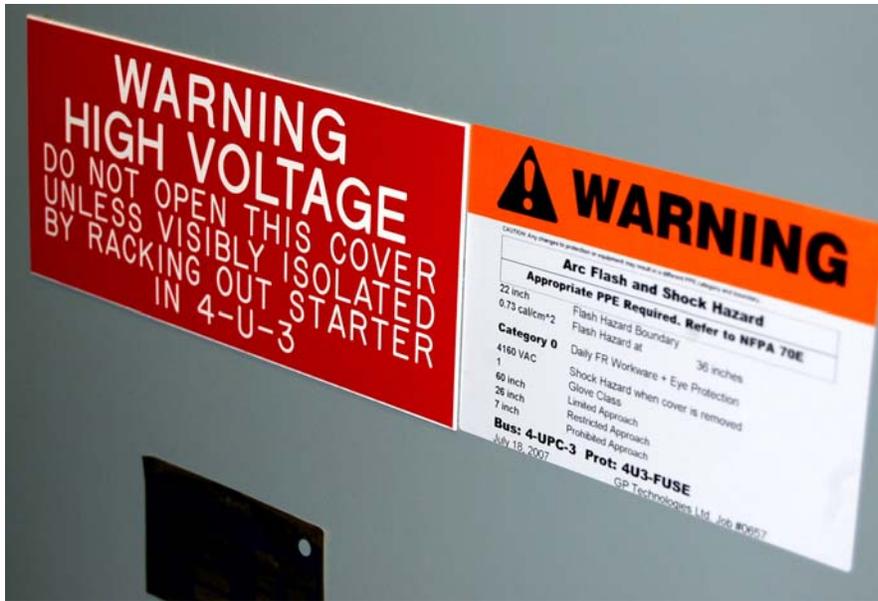
Photo 5.5: Warning labels on outside of door to power factor capacitor cell 4-U-3. The labeling is common to all power factor capacitor cells in 4-ESB-1.

The Board notes that Enbridge has assigned flash hazard number HRC-0 to the power factor capacitor cells in the Enbridge 4-ESB-1 building (photograph 5). The Board also notes the requirements of NFPA 170E to conduct a Shock Hazard Analysis, a Flash Hazard Analysis and, through calculations provided in Annex D, to determine Flash Protection Boundaries and incident energy exposure of a worker. However, these calculations do not determine a HRC number for flash protection. The standard allows for determination of the HRC number and PPE requirements using section 130.7(C)(9) in lieu of the detailed flash hazard analysis approach.

The Board notes that in addition to the HRC-0 flash hazard indicated on the warning labels to the power factor capacitor cells, there is reference to Glove Class 1. The Board interprets this sign to mean that gloves are required to be worn regardless of the PPE requirements indicated by HRC-0. The Board finds this may cause confusion for workers as the HRC-0 does not require high voltage gloves to be worn, but the Glove Class 1 is indicated. The Board also notes that the warning label warns specifically against “Arc Flash and Shock Hazard”, however, the PPE requirements of HRC-0 would not be sufficient to protect against the arc flash and shock hazard

- Demonstrate how the Hazard/Risk Category number 0 was determined for the power factor capacitor cells in 4-ESB-1.
- Re-assess the Hazard/Risk Category number assigned to the cells.
