NAVAL RESEARCH LAB WASHINGTON DC

MAR 81 H H CHASKELIS

NRL-MR-4473

ULTRASONIC INSPECTION OF A GRAPHITE/EPOXY STRUCTURAL MEMBER USING A THICKNESS-IMAGING DEVICE

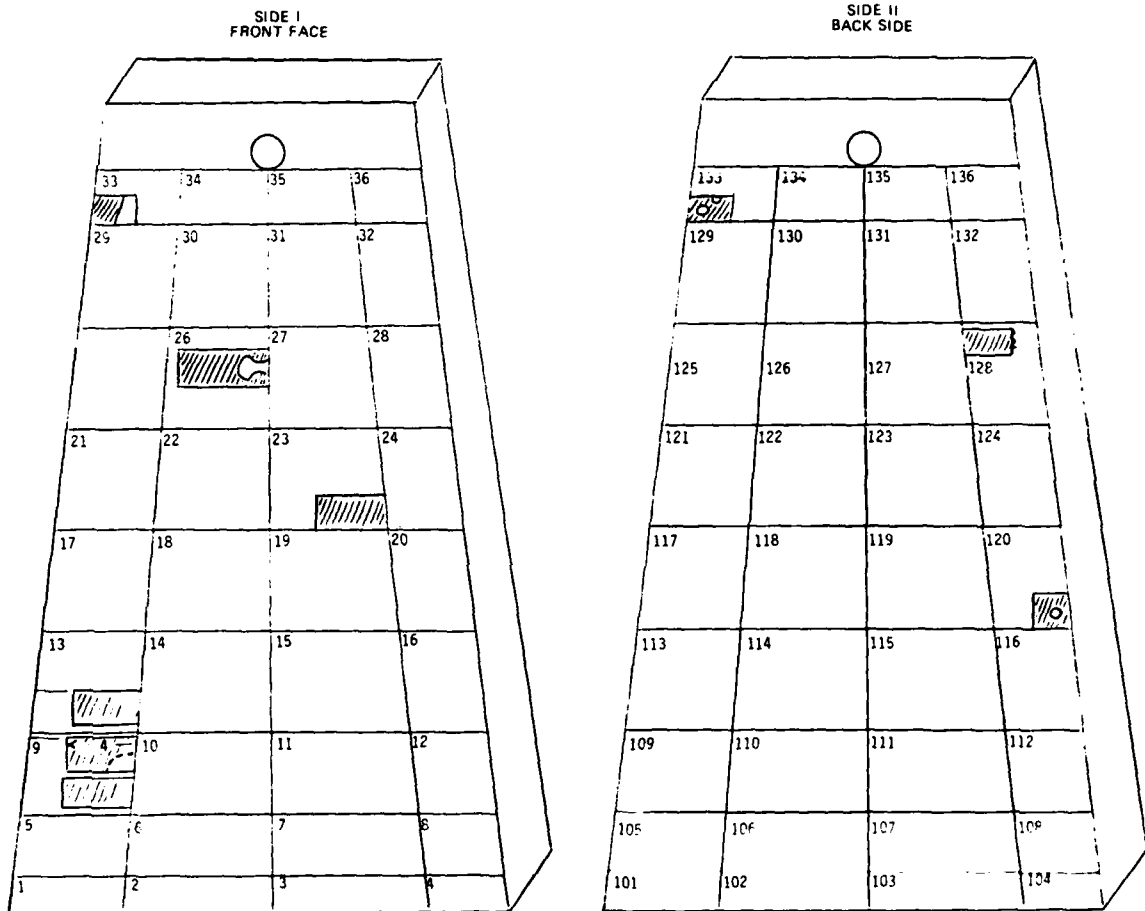
Fig. 5 — Grid sections drawn on the composite faces. The shaded areas are those sites chosen for the SCIMI inspection.

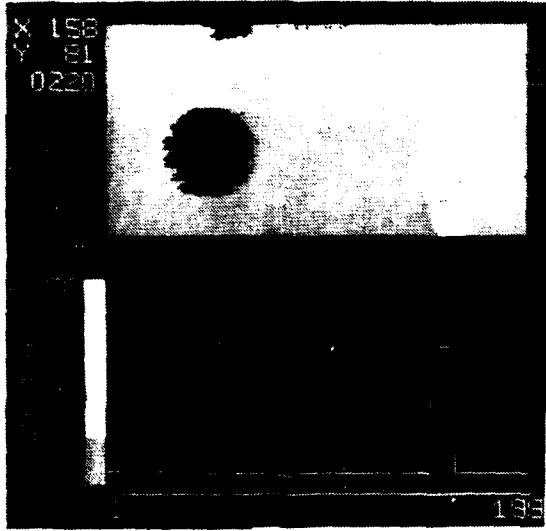
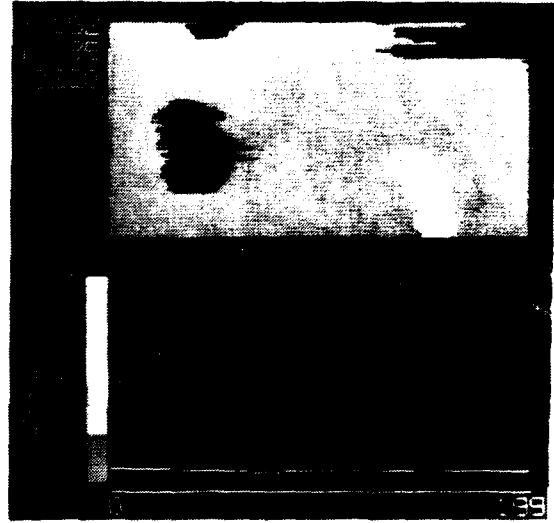
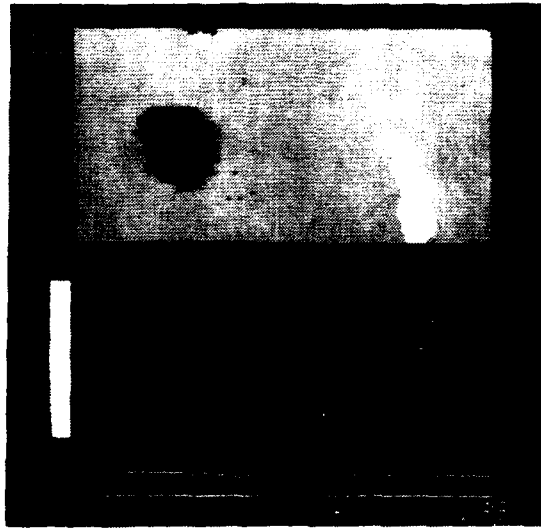
Fig. 8 — Three scans from site 133

Shown in Fig. 8 (a,b,c) are the images created by the SCIMI instrument. Information concerning the mapping parameters is shown in Table 2. The letters a, b, c, in Fig. 8 represent the three scans taken; (a) is the baseline scan and (b) and (c) are the subsequent scans after each loading cycle. A dark circle on the left side is the area where the bolt was located. The white region is the delaminated area, with a black cross marking the region where depth and location information is to be analyzed. Shown on the upper left are the x and y reference locations and the number, 0.220, is the depth of the delamination in inches. On the lower portion of the image is a depth scale along the x axis depicting the 5 scale grey levels taken from the cursor location. As can be seen, the images of the delamination are remarkably similar, even though the three scans were not physically started at identical locations.

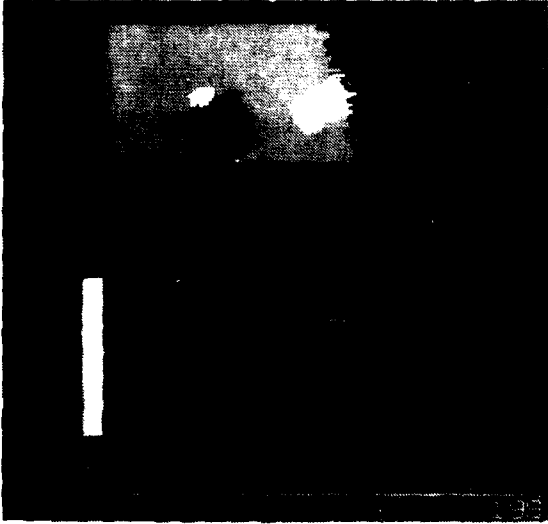
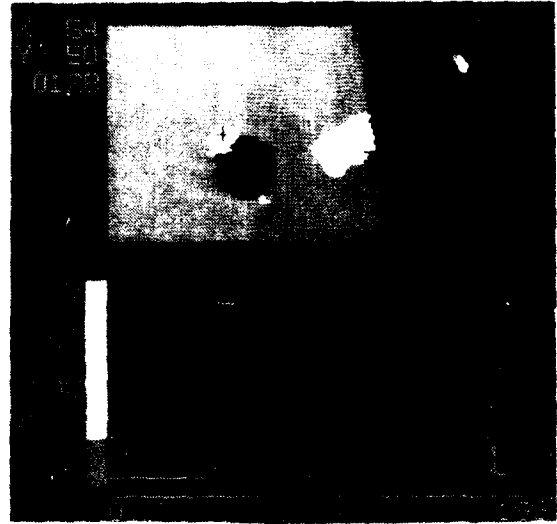
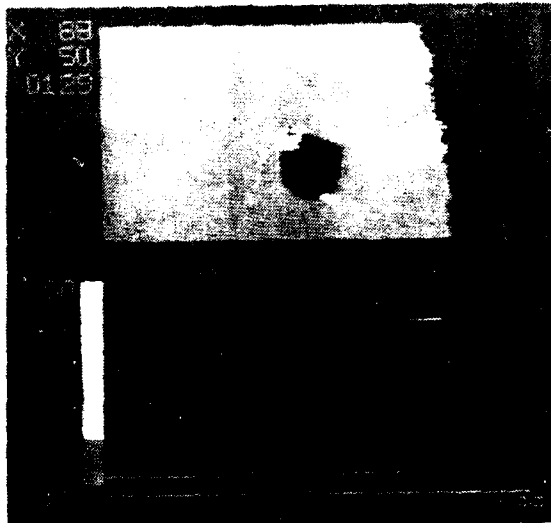
Fig. 9. Three scans from (7).

Figure 9 (a,b,c) shows the information from site 120. Not all of the 50 x 100 mm scan area was used for the image. Again a bolt hole is outlined and two delaminations are seen around it. A third larger delamination is seen at the edge of the beam. Figure 10 (a,b,c) is the image of the site just below to the scarf-joint transition. Numerous small "delaminations" can be seen, as well as several larger ones. The lower right dark area is a site not accessible for scanning. This set does not repeat as well as the previous ones. In part this is due to a small amplitude variability which exists in the instrument. Most delaminations produce a strong echo and are readily imaged. When the return signal is small, the recorded amplitude may fall on either side of the displayed threshold. For our current needs this does not appear to be a problem. The last set, Fig. 11, is the image from the bottom of area 9. Here the scan is in the scarf joint region and reflection signals from various interfaces abound. Figs. 11a and 11b represent two scans taken at slightly different gain settings. Fig. 11c is a repeat of 11b but

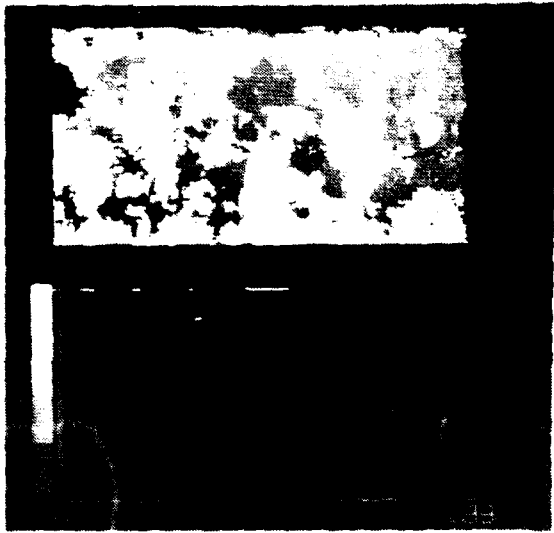
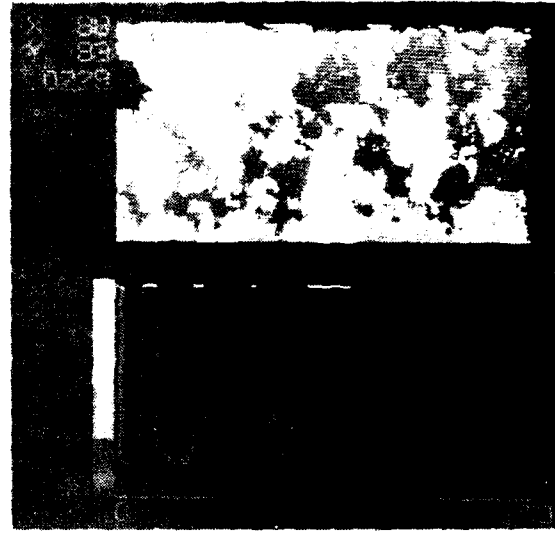
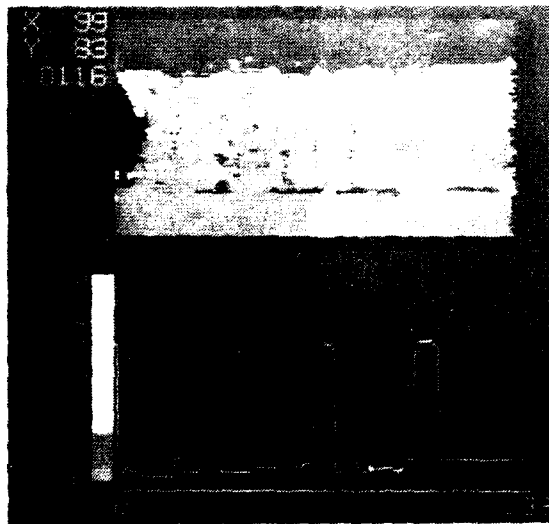
Fig. 11 - Three scans from site 9B

displayed using a different threshold and grey scale. Viewed under these conditions, the horizontal line near the top of the scan represents the transition at the scarf joint.
