DELAWARE RIVER BASIN,
Tributary of Mill Creek, Berks County,
Pennsylvania. Phase I Inspection Report,
SCS PA 476
BERKS COUNTY, PENNSYLVANIA

NDS I.D. NO. PA 00719
DER I.D. NO. 6-456

PHASE I INSPECTION REPORT
NATIONAL DAM INSPECTION PROGRAM

JANUARY 1980

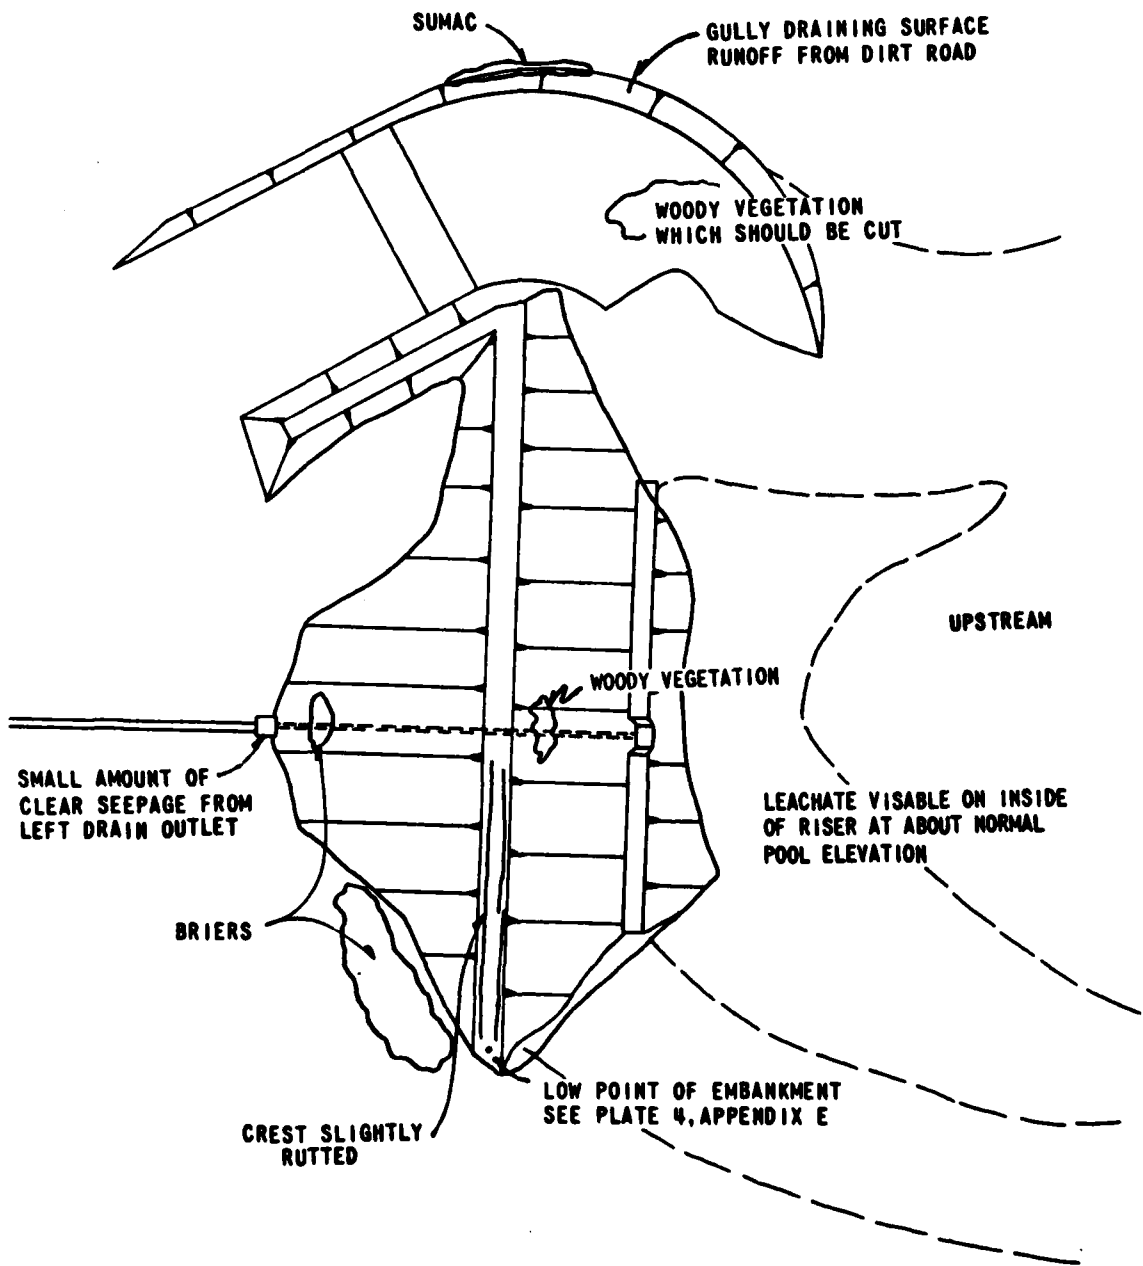
FIELD OBSERVATION PLAN
 SCS PA 476
 SHEET 5A OF 11

2. Emergency Spillway. The grass-lined emergency spillway at the right abutment, shown in Photographs No. 4 through 6, Appendix C, was inspected and found to be stable and in good condition. The emergency spillway has a very good vegetation cover, but with some year-old woody vegetation that should be cut. The right spillway slope has older Sumac which should be cut annually. Gullies have been cut through the right slope to facilitate surface drainage from the adjacent dirt road, as shown in Photograph No. 9, Appendix C, and Sheet 5a, Appendix A.

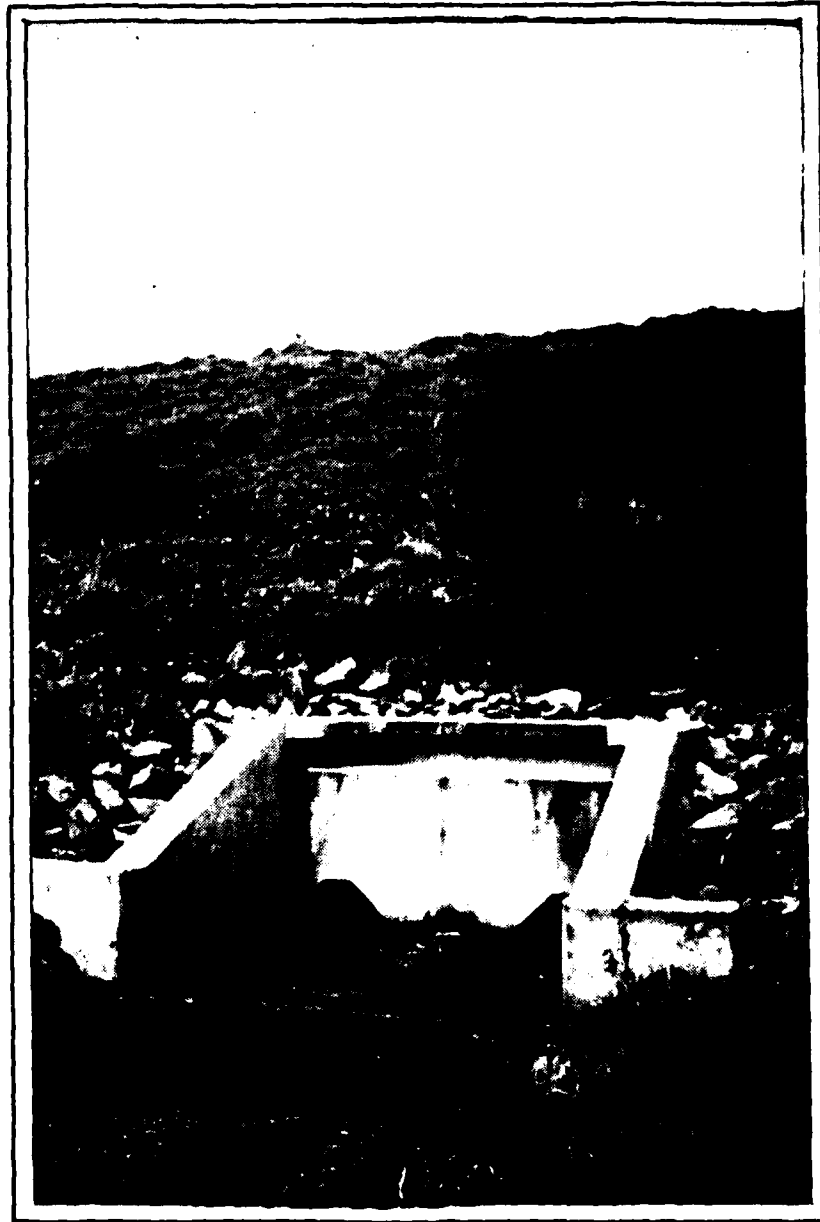
PHOTOGRAPH NO. 3

excessive concrete deterioration, spalling or other structural deficiencies or defects. Inspection of the inside of the riser from the top of the riser through the access gate door disclosed a small amount of leachate visible on the inside of the riser at about normal pool elevation. The pond drain sluice gate located on the outside of the riser operates easily. The outlet channel was inspected and observed to be in good condition with no excessive erosion or bank undercutting. The impact basin, Photograph No. 3 in Appendix C, was found to be in good condition.

IMPACT BASIN AT DOWNSTREAM TOE. NOTE
WEEDS AND BRIERS ON DOWNSTREAM SLOPE.

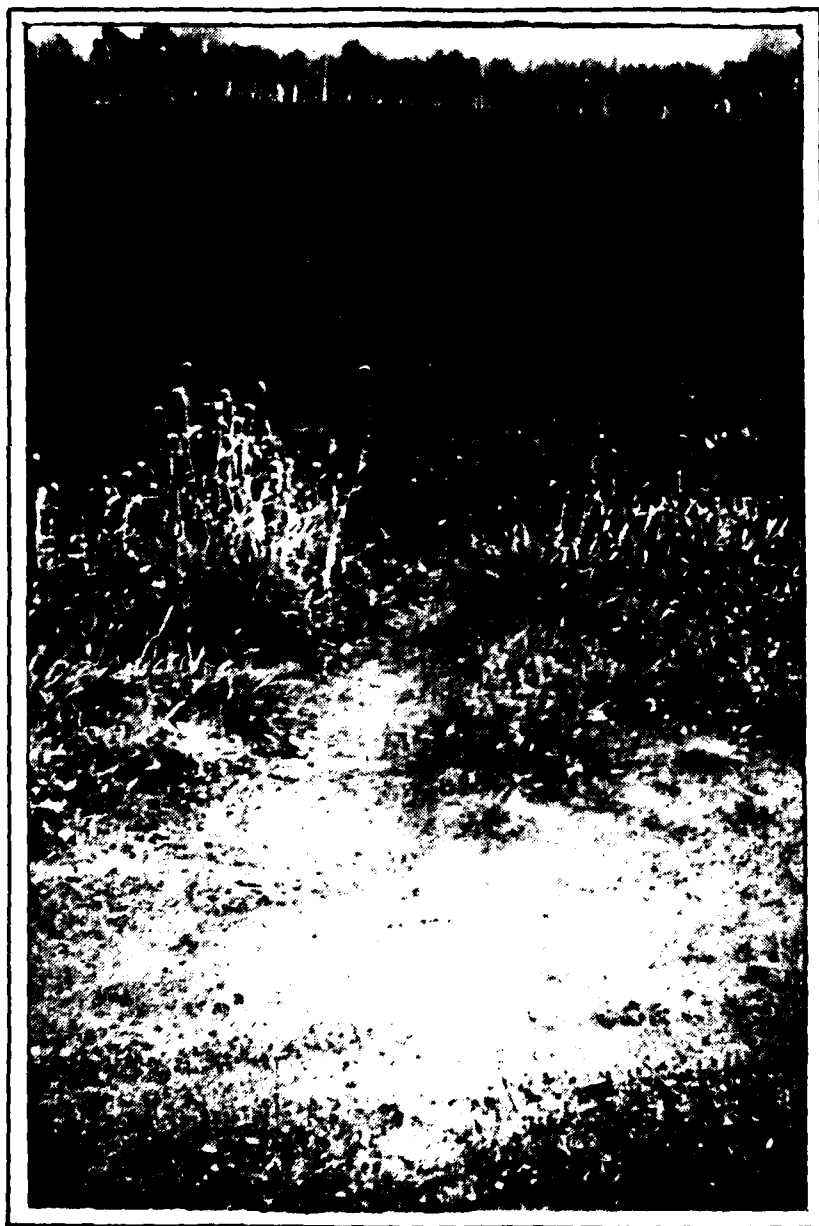
PHOTOGRAPH NO. 10

VIEW OF GULLY DRAINING SURFACE
RUNOFF FROM DIRT ROAD INTO
EMERGENCY SPILLWAY.

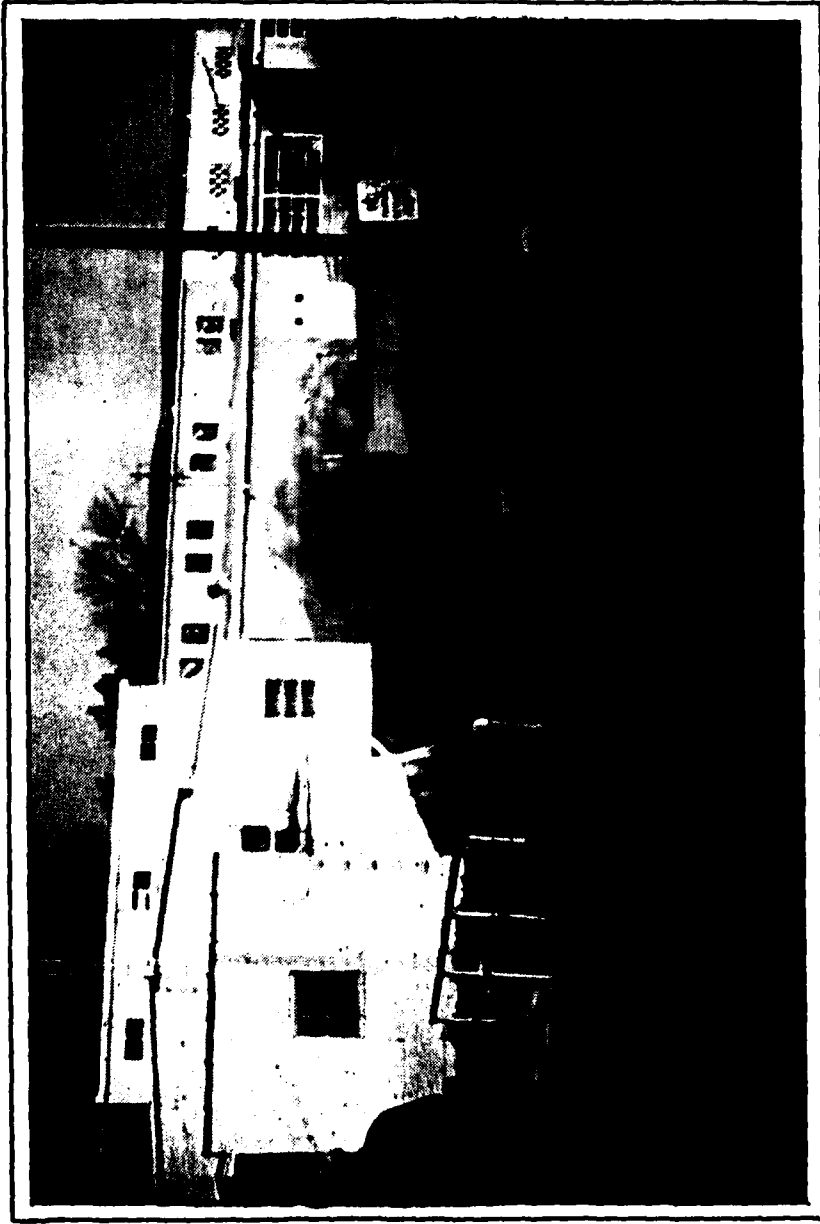
PHOTOGRAPH NO. 13

e. Downstream Conditions. About 800 feet below the dam are two houses subject to damage in the event of dam failure. In the next 500 feet the stream passes under Route 22 and joins with the outflow from SCS PA 477, a flood control dam in the adjacent watershed. In the next 1.25 miles is a pumping station and wastewater treatment plant built adjacent to the stream and subject to damage in the event of dam failure. In Hamburg, the stream flows under houses and businesses; see Photograph No. 11, Appendix C. It is apparent, merely by comparing the relative sizes of the stream channel through Hamburg and the emergency spillway, that property damage would occur during an extreme event, and it is judged that failure during the PMF would significantly increase property damage and loss of life.

TYPICAL VIEW OF DOWNSTREAM DAMAGE
CENTER IN HAMBURG, PENNSYLVANIA.
