AEFA Project No. 88-06

ARTIFICIAL AND NATURAL ICING TESTS OF THE EH-60A QUICK FIX HELICOPTER

June 1988

Final Report

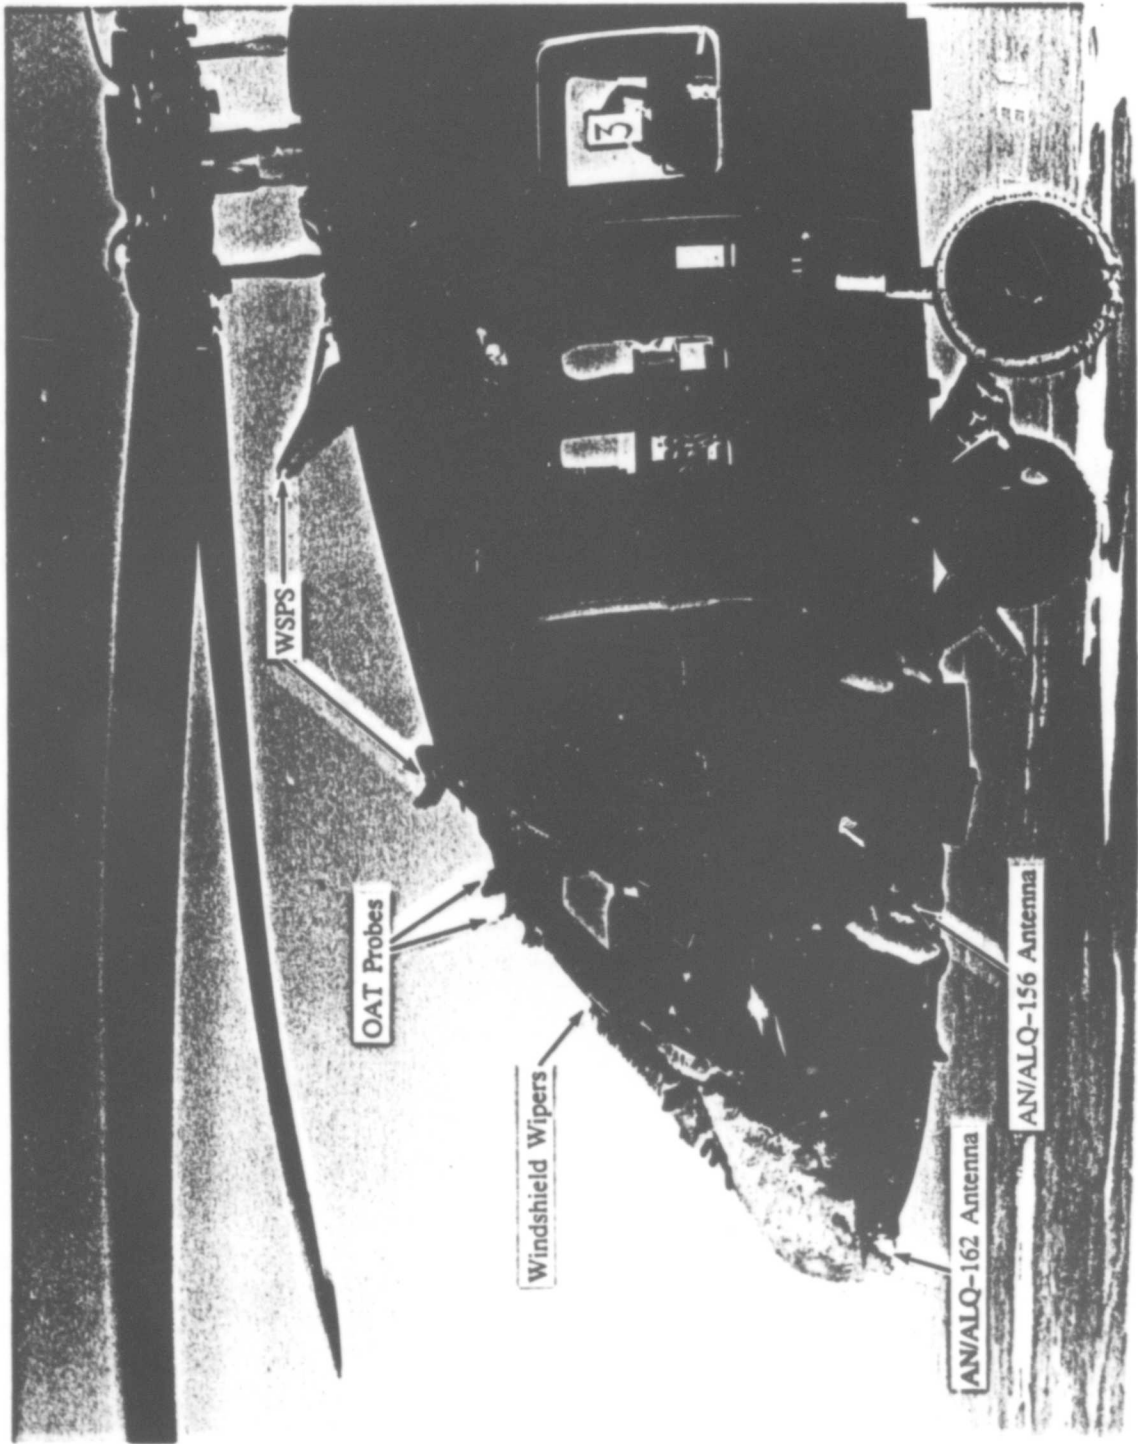
12. The airframe ice accretion and shedding characteristics of the EH-60A Quick Fix helicopter were evaluated throughout these tests. Specific test conditions are presented in table F-1. In-flight photographic documentation was utilized from chase aircraft, the HISS and onboard photography. A photograph of the helicopter with typical ice accretions is shown in figure H-2. Specific conditions of this photo were 57 minutes of exposure at -5.1°C and LWC of 0.95 gm/m^3 . Ice formed on all stagnation areas and sharp protrusions from the airframe. One deficiency associated with the airframe ice accretion and shedding characteristics was the excessive DF dipole antenna element oscillation induced by ice accumulation resulting in damage to the DF dipole antenna element mounts and phenolic blocks.

Figure H-2. Airframe Ice Accumulation
Artificial Icing - .95 gm/m³ LWC, -5.1°C OAT, 57 min

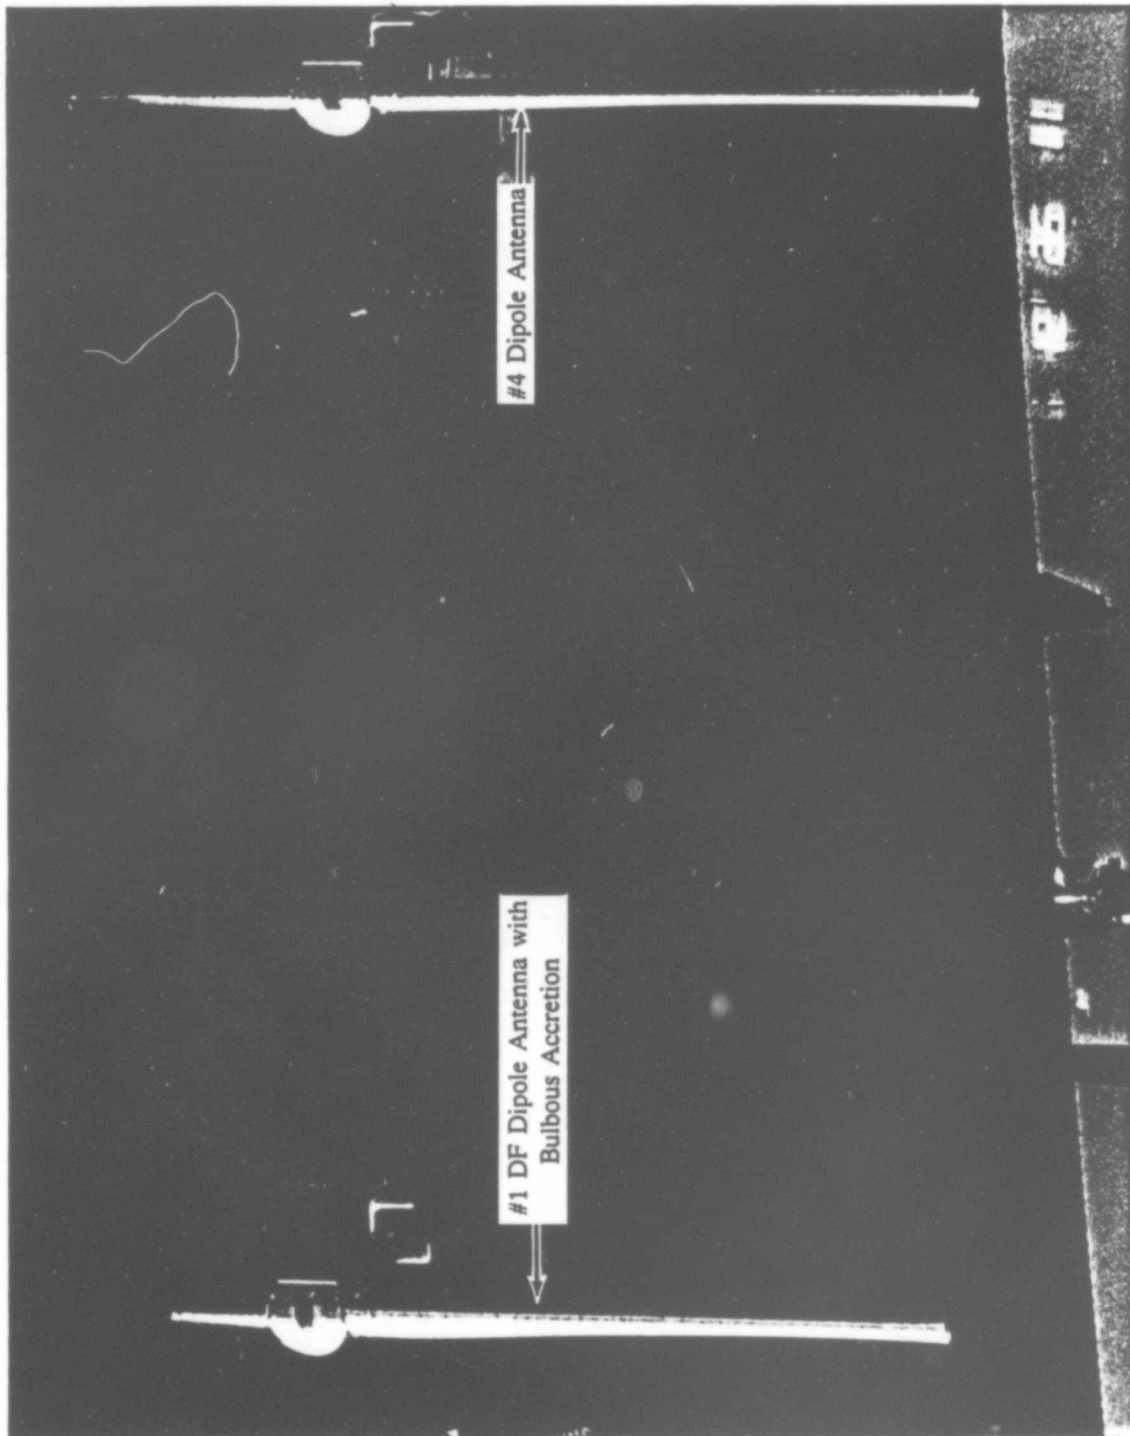
13. The ice accretion characteristics of the DF dipole antennas were evaluated throughout these tests. Ice accumulation varied with antenna location (fig. H-3). The number three antenna accreted less ice than the other three throughout the tests. The upper elements of the DF antennas accreted ice from the phenolic blocks upward to approximately 20% of the element length and did not shed during flight. The lower elements accreted ice the full length of the element with a bulbous accretion just below the phenolic block (fig. H-3). Ice accumulation caused the DF antennas to oscillate. During oscillation, the upper 50 to 60% of the lower elements would self shed leaving the remaining accumulated ice near the tip (fig. H-4). Following the self shed, the amplitude of the oscillation would increase. Post flight inspection revealed loose DF element retaining screws. Flight in artificial icing conditions resulted in a high frequency vibration of the lower element of the number two DF antenna with tip amplitudes of ± 4 inches. At forty four minutes into an artificial icing immersion at -15.0°C and LWC of 0.52 gm/m^3 , the upper left screw on the number two lower DF antenna mount sheared just below the screw head (fig. H-5). At 21 minutes into a natural icing immersion at -9.3°C and LWC of 0.20 gm/m^3 , the upper right screw on the number two lower DF antenna mount sheared approximately 0.2 inch below the screw head (fig. H-6). Post flight measurement recorded 1.25 inches of ice accumulation on portions of the DF antenna elements (fig. H-7). No damage to the DF antennas or their mounts was noted. At 30 minutes into a natural icing immersion at -13.0°C and LWC of 0.55 gm/m^3 , a ± 4 inch tip amplitude vibration of the lower element of the number two DF antenna element was observed and abruptly stopped with a simultaneous shed of ice from the element. Post flight inspection of the DF antennas revealed a cracked phenolic support block of the front right DF antenna (#2) (figs. H-8 and H-9). The Test Incident Reports (TIR) submitted by AEFA on these incidents are included in appendix G. The effect of ice accumulation on the proper function of the DF system was not tested. The excessive DF dipole antenna element oscillation induced by ice accumulation resulting in damage to

the DF dipole antenna element mounts and phenolic blocks is a deficiency. Further testing to determine the effect of ice accumulation on the proper function of the DF system should be accomplished.

Figure H-3. Dipole Antenna Ice Accumulation
Artificial Icing - .99 gm/m³ LWC, -9.9°C OAT, 38 min

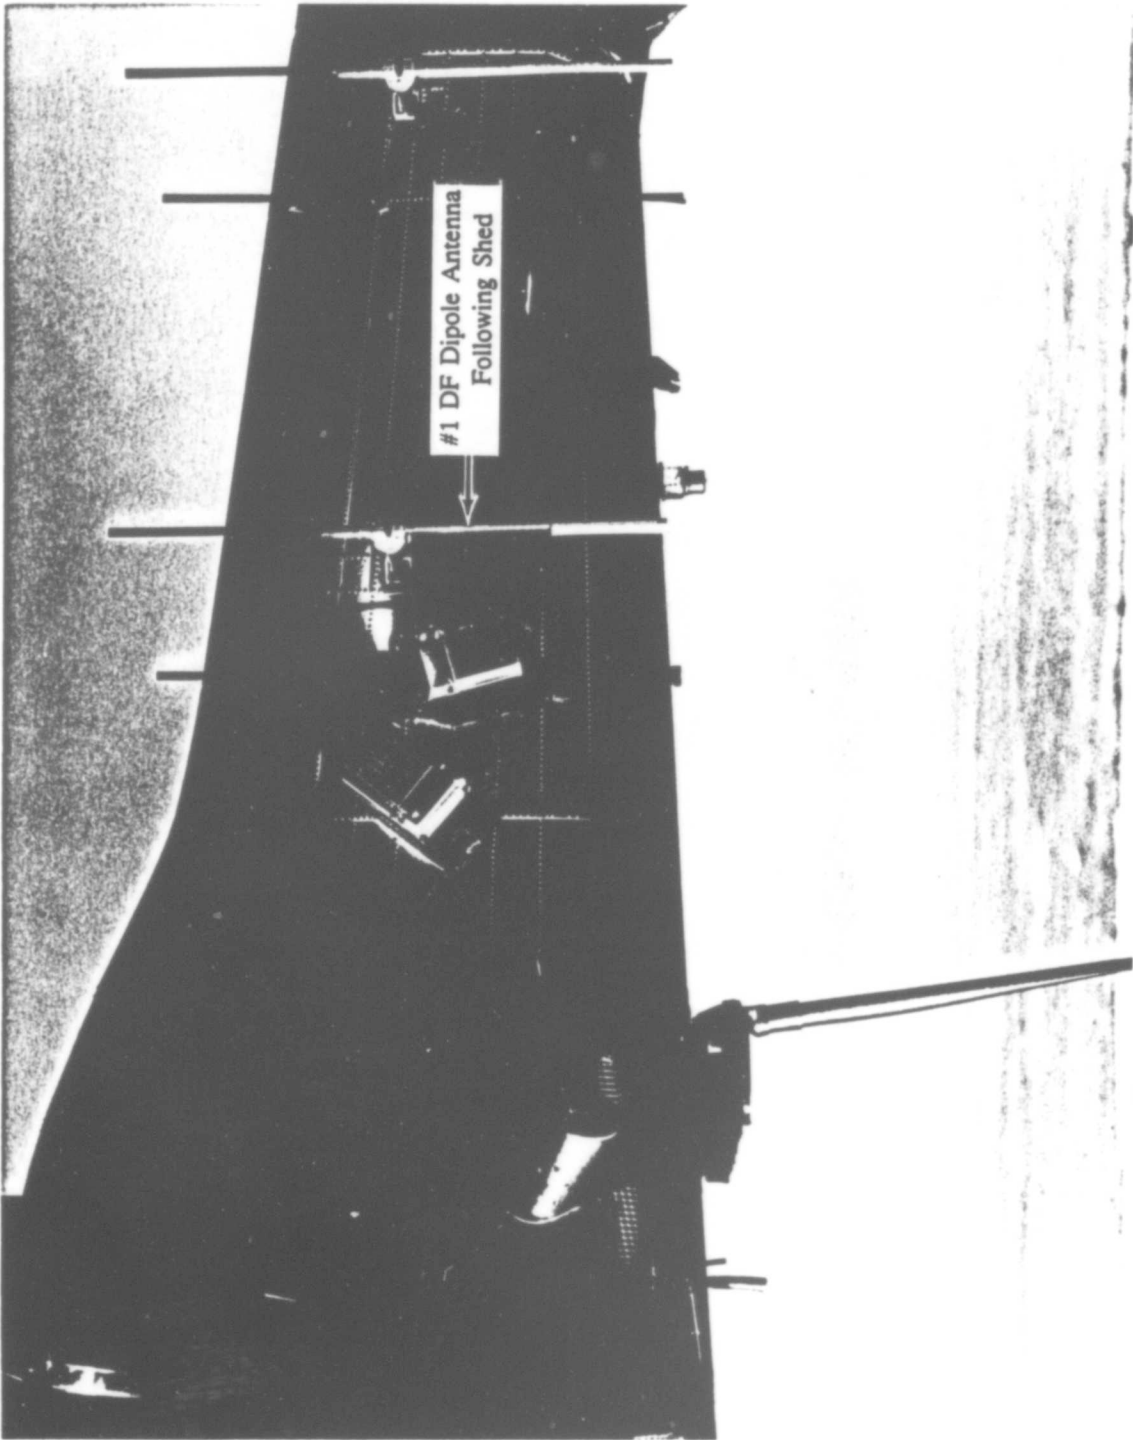
Figure H-4. Self Shed Pattern of Dipole Antennas
Artificial Icing - .99 gm/m³ LWC, -9.9°C OAT, 38 min

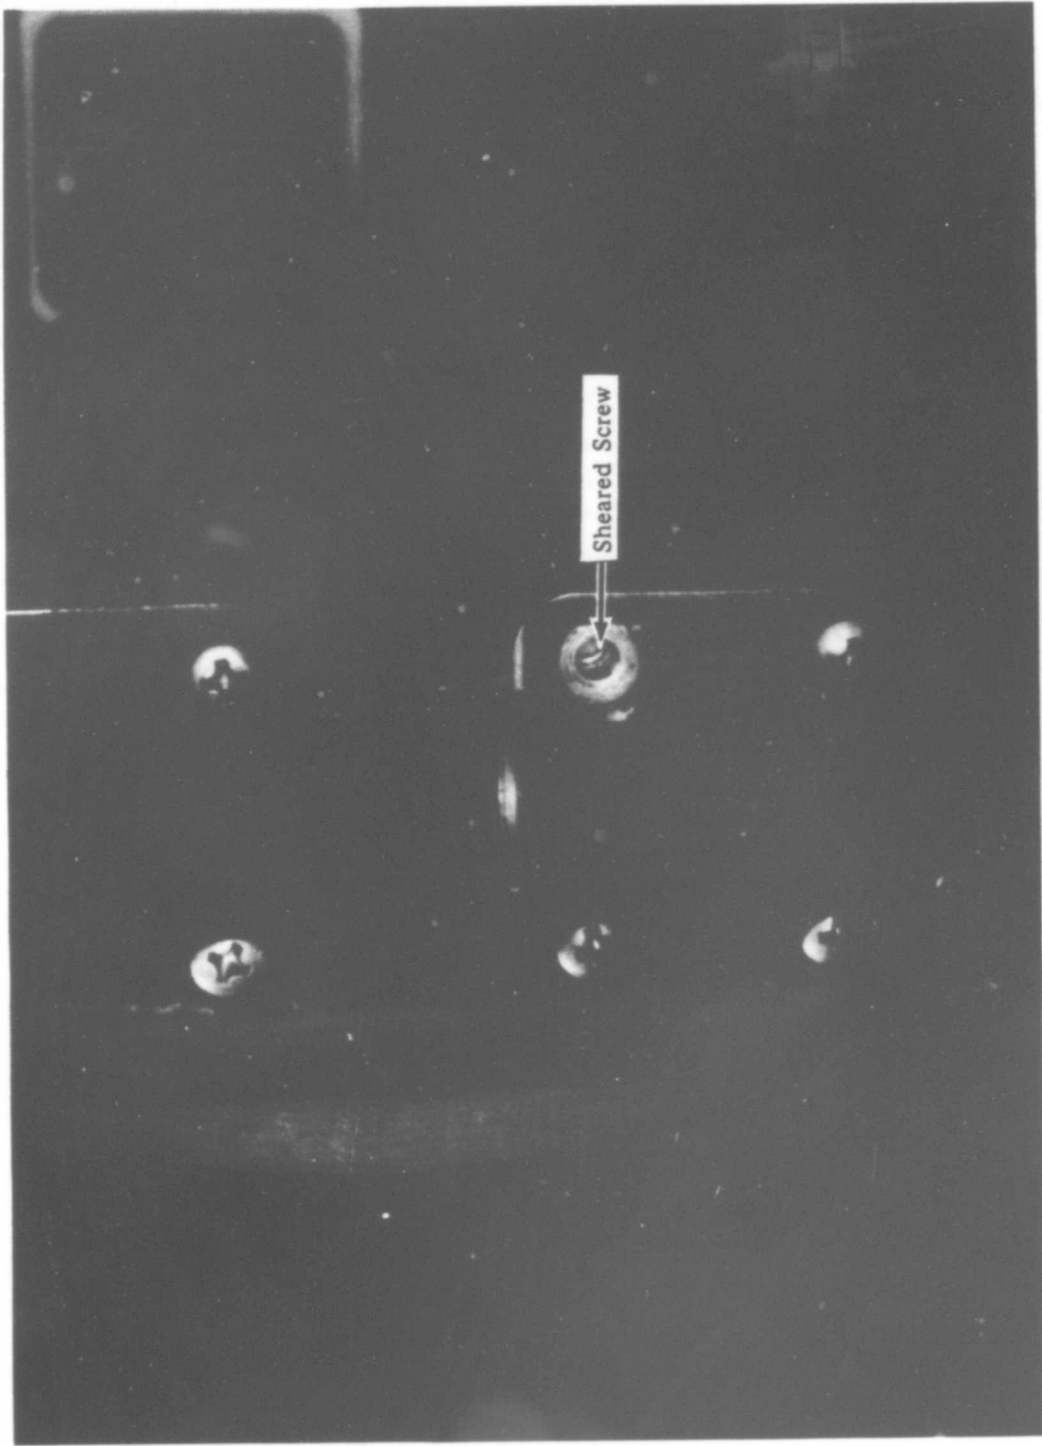
Figure H-6. Sheared Dipole Retaining Screw
Natural Icing - .20 gm/m³ LWC, -9.3°C OAT, 21 min

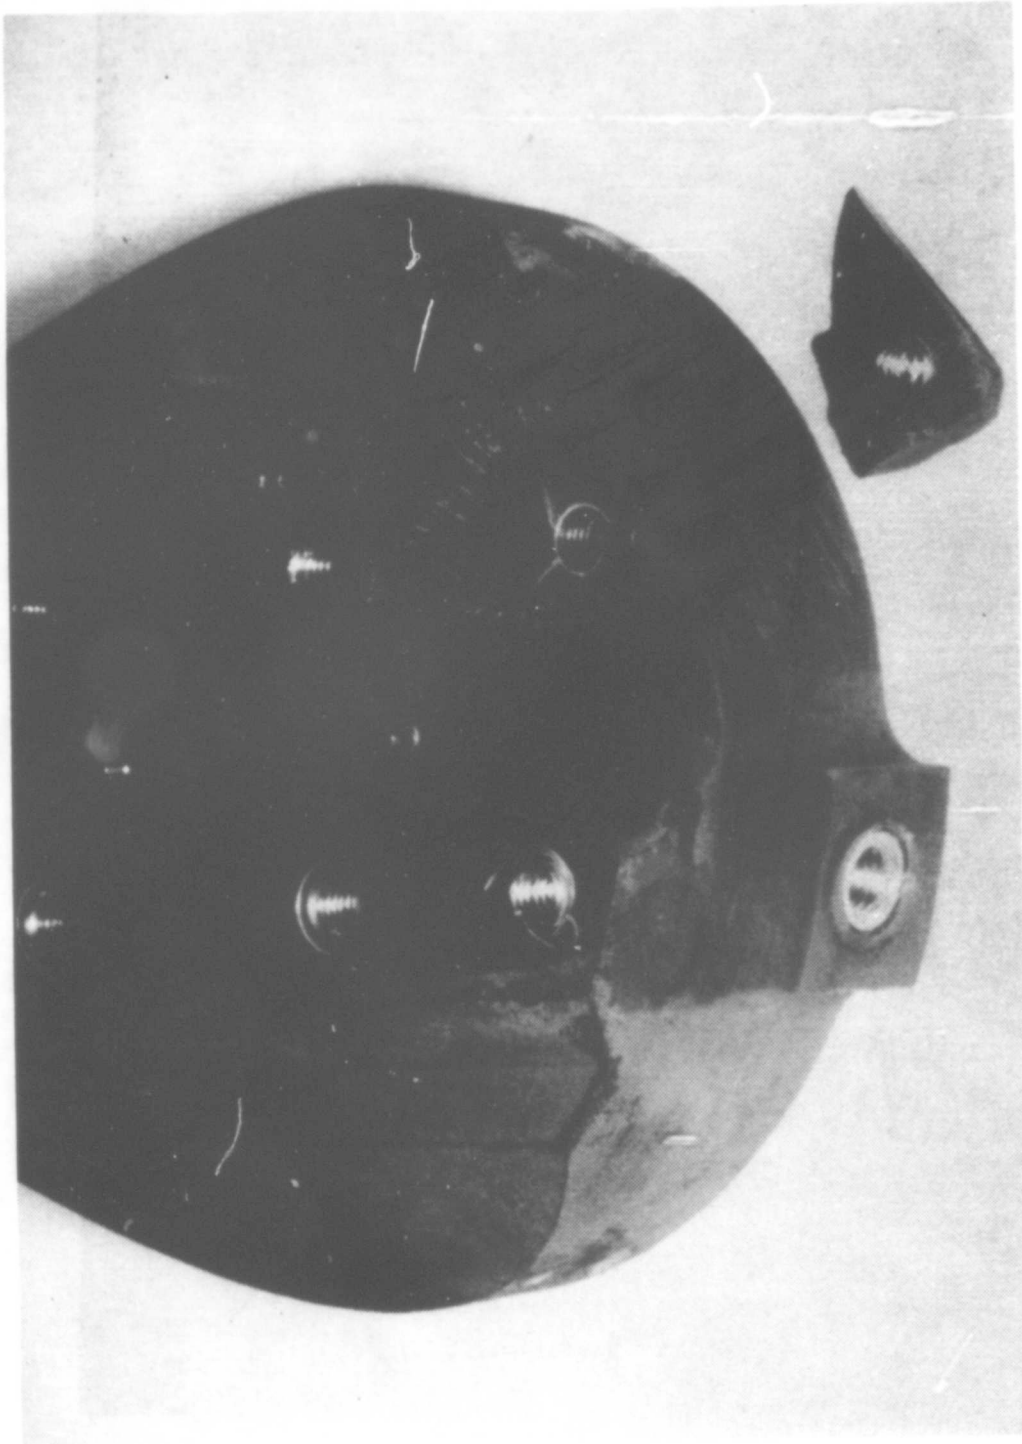
Figure H-9. Cracked Phenolic Block
Natural Icing - .55 gm/m³, -13.0°C OAT, 21 min

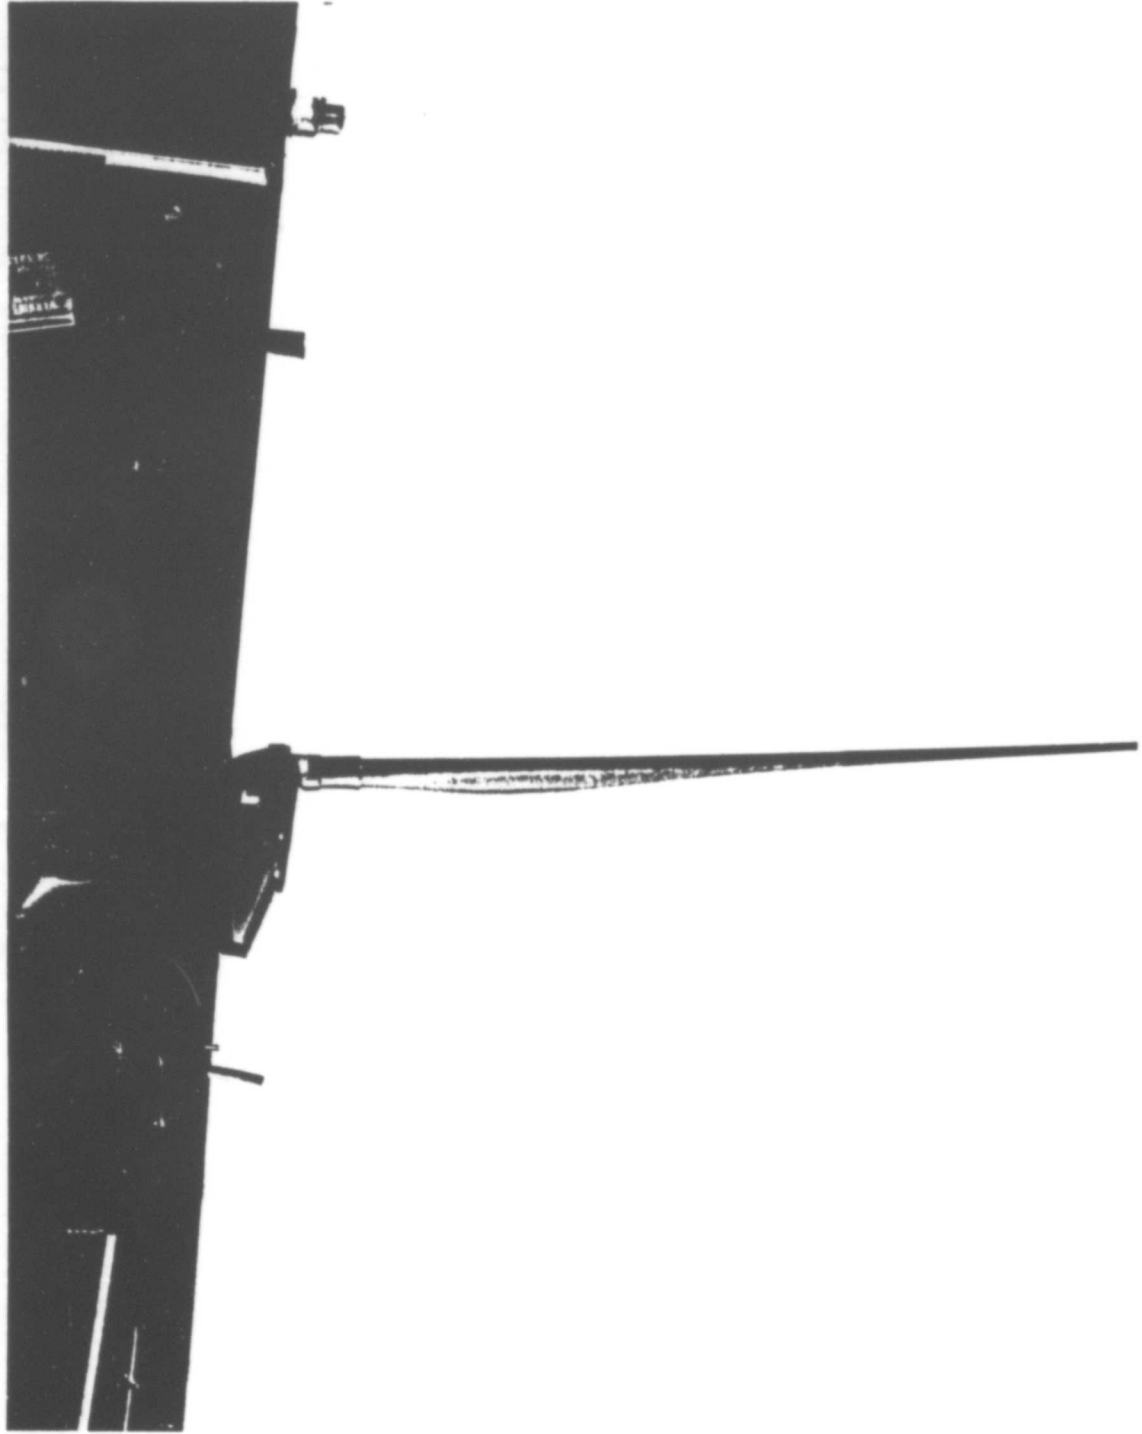
Figure H-10. ECM Antenna: Artificial Icing
Artificial Icing - .95 gm/m³ LWC, -5.1°C OAT, 57 min

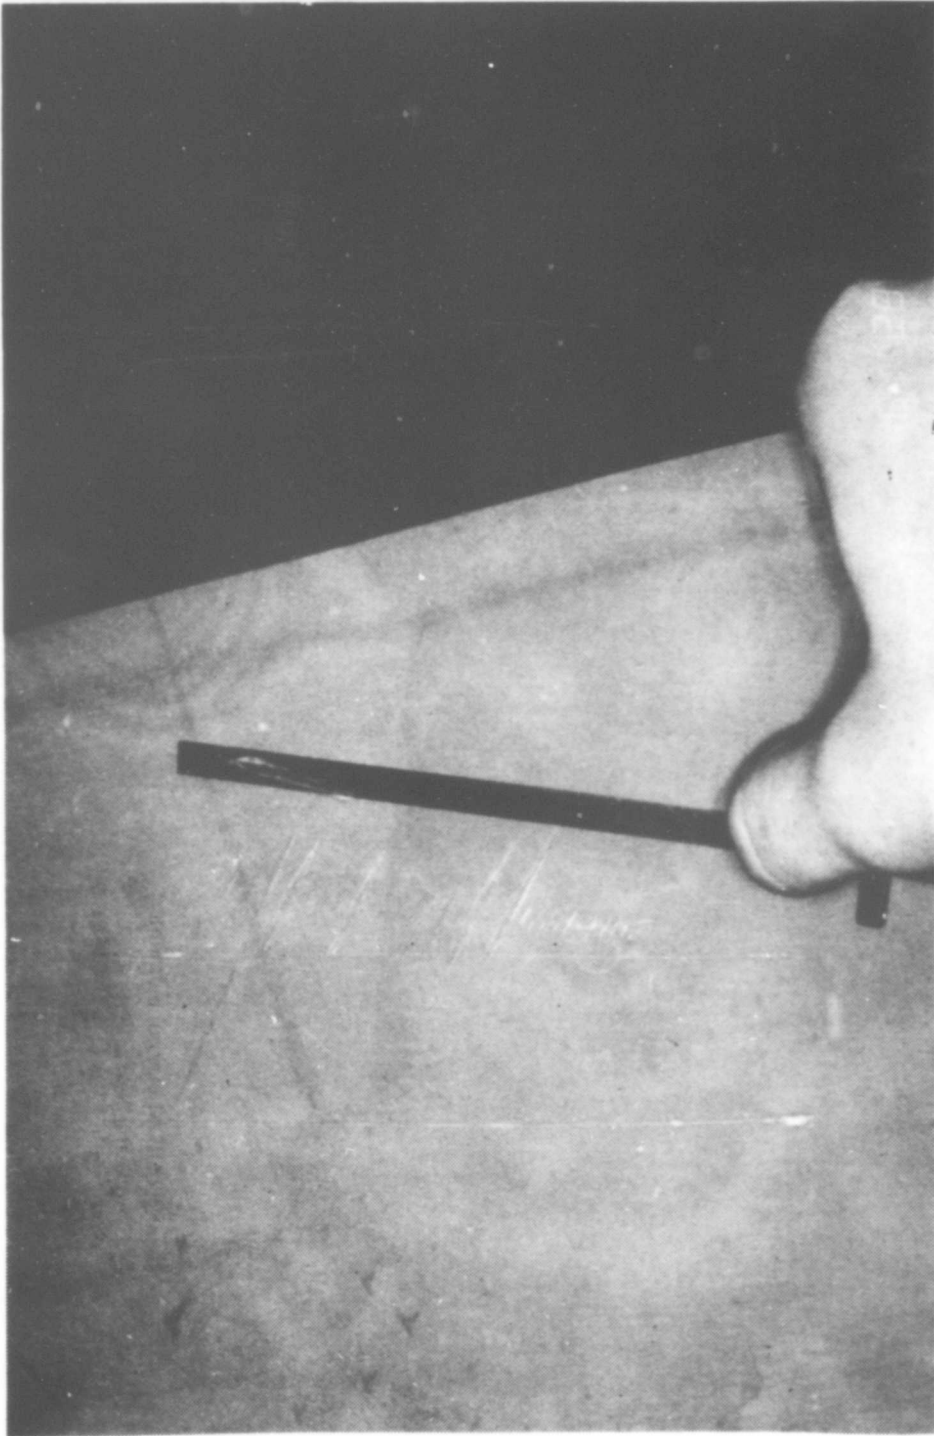
22. The tail rotor was damaged during an artificial icing flight of one hour duration at -19.6°C and a LWC of 0.45 gm/m^3 . Post flight inspection revealed a cut and dented area on the tail rotor blade which required replacement (fig. H-19). The damage caused no unusual vibration or change in aircraft handling characteristics. The TIR submitted by AEFA is presented in appendix G. Ice impact damage to the tail rotor paddle from uncontrolled shedding is a shortcoming.

Figure H-19. Damaged Tail Rotor Paddle
Natural Icing - .45 gm/m³ LWC, -19.6°C OAT, 60 min

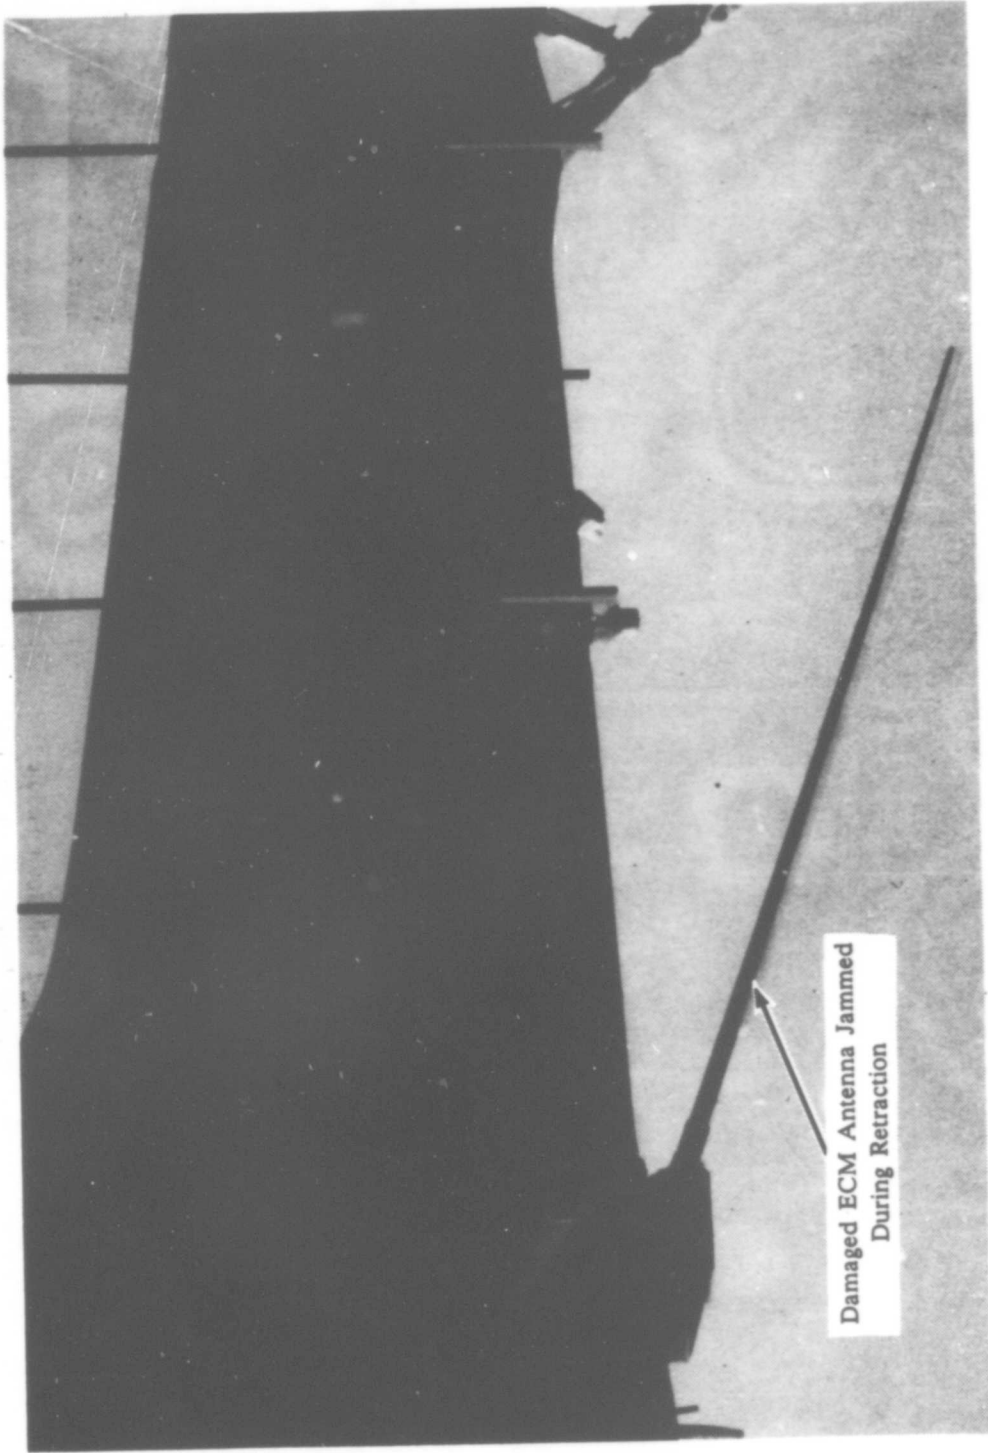
23. Following a natural icing flight of 1.5 hours duration at -9.3°C with a LWC of 0.2 gm/m^3 , the ECM antenna failed to fully retract to the stowed position (fig. H-20). The aircraft was brought to a hover and the ECM antenna removed from the antenna mount. Post flight inspection revealed the right pivot stud on the antenna mount had sheared (fig. H-21). The sheared pivot stud permitted the antenna mount to skew in the housing during retraction resulting in the antenna mount being jammed against the housing. The left pivot stud was bent and the actuator connecting point to the stud arm subassembly would not rotate due to torsion damage (fig. H-22). The ECM antenna was removed for the remainder of the tests. The TIR submitted by AEFA is presented in

appendix G. The damage to the pivot stud of the ECM antenna mount following an icing encounter, preventing full retraction of the ECM antenna, is a shortcoming.

Figure H-20. Jammed ECM Antenna
Natural Icing - .20 gm/m³ LWC, -9.3°C OAT, 92 min

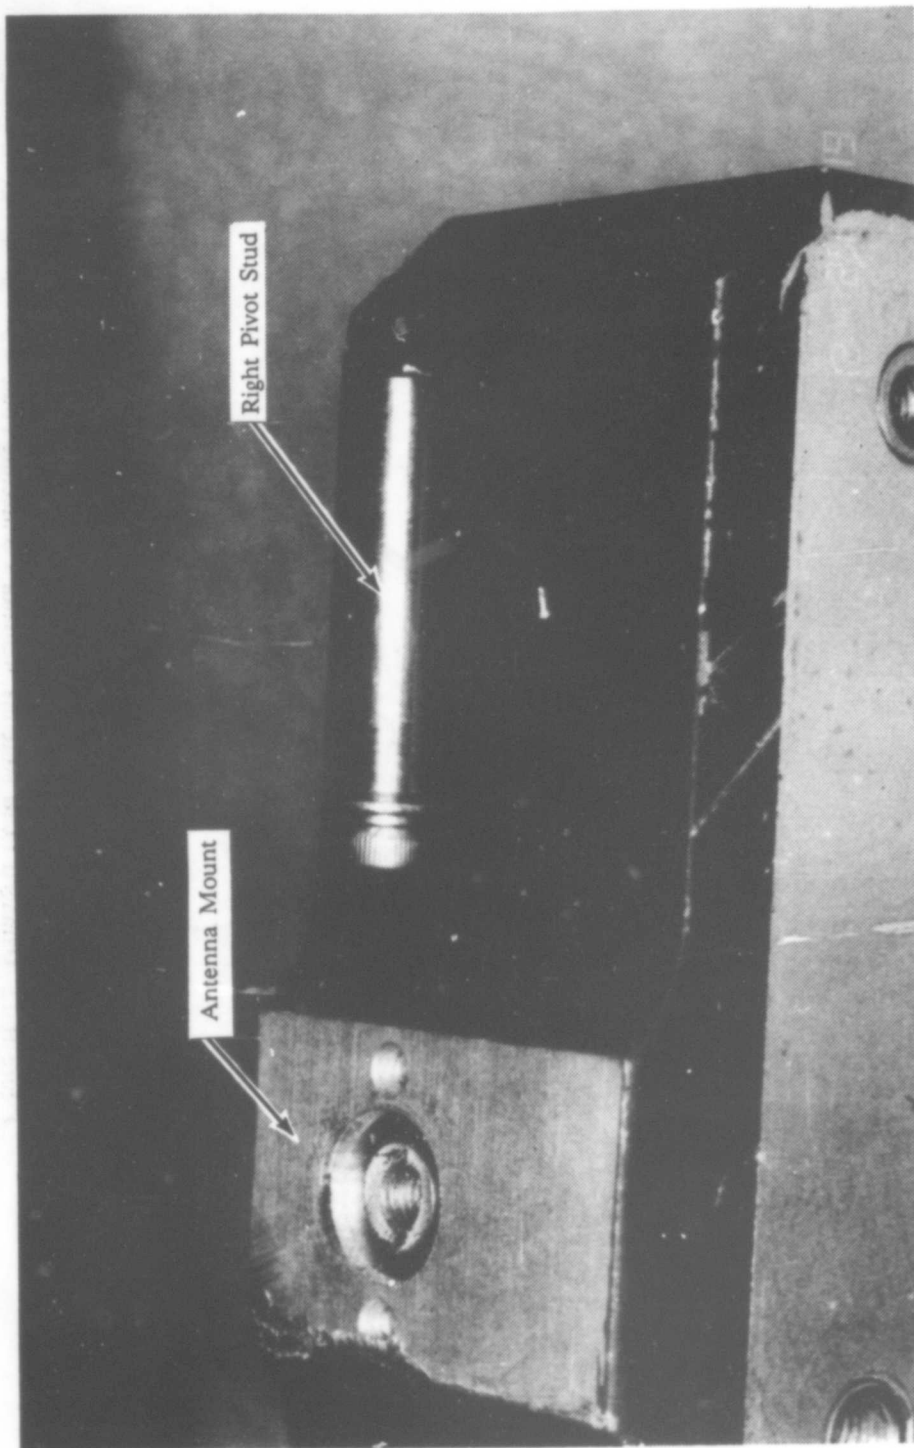
Figure H-21. ECM Antenna Mount and Sheared Pivot Stud
Natural Icing - .20 gm/m³ LWC, -9.3°C OAT, 92 min

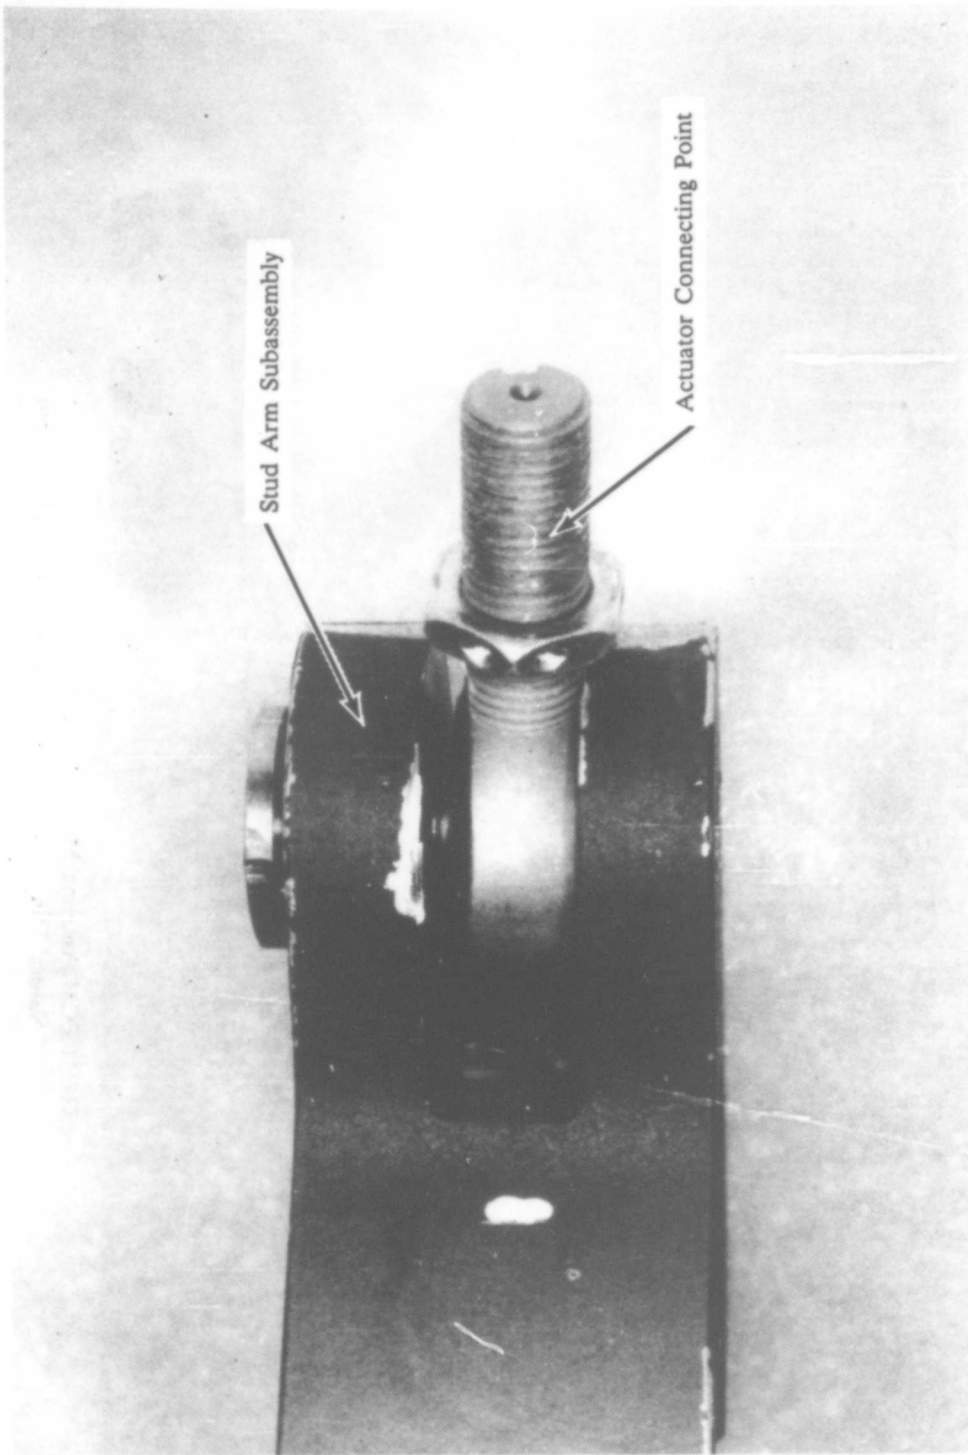
Figure H-22. Damaged ECM Antenna Actuator Connecting Point
Natural Icing - .20 gm/m³ LWC, -9.3°C OAT, 92 min
