US Army Corps
of Engineers
Seattle District

Construction Foundation Report

Mud Mountain Dam Seepage Control Cutoff Wall

CONSTRUCTION FOUNDATION REPORT
 SEEPAGE CONTROL WALL
 CONTRACT NO. DACW67-83-C-0047

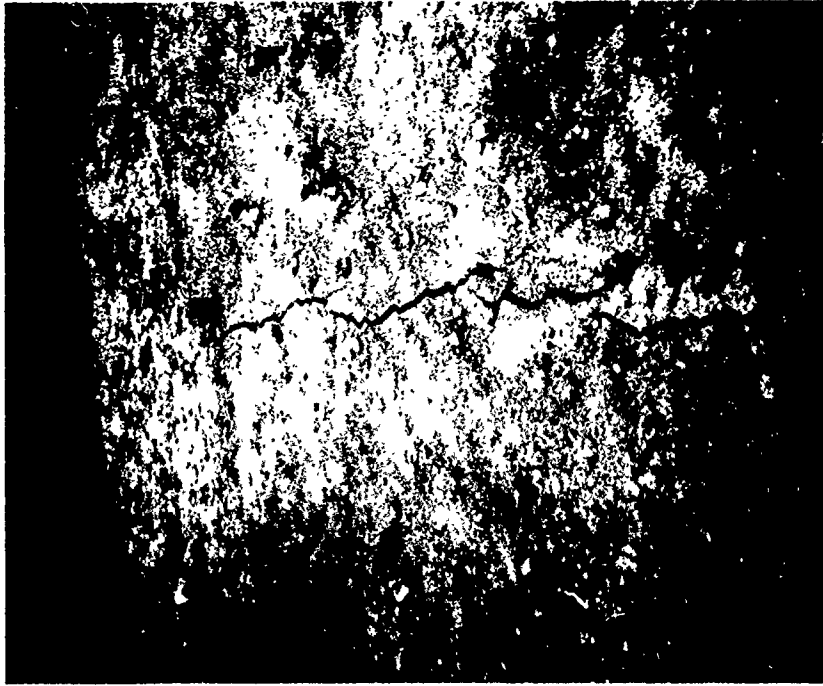
First indication of hydrofracture in Panel 35. Originally thought to be deeper expression of weathered surface cracks noted on surface during dam lowering. 200,000 gallons of slurry were lost before stabilizing panel. Panel is 40 inches wide. Looking at left wall. Upstream guidewall to left.

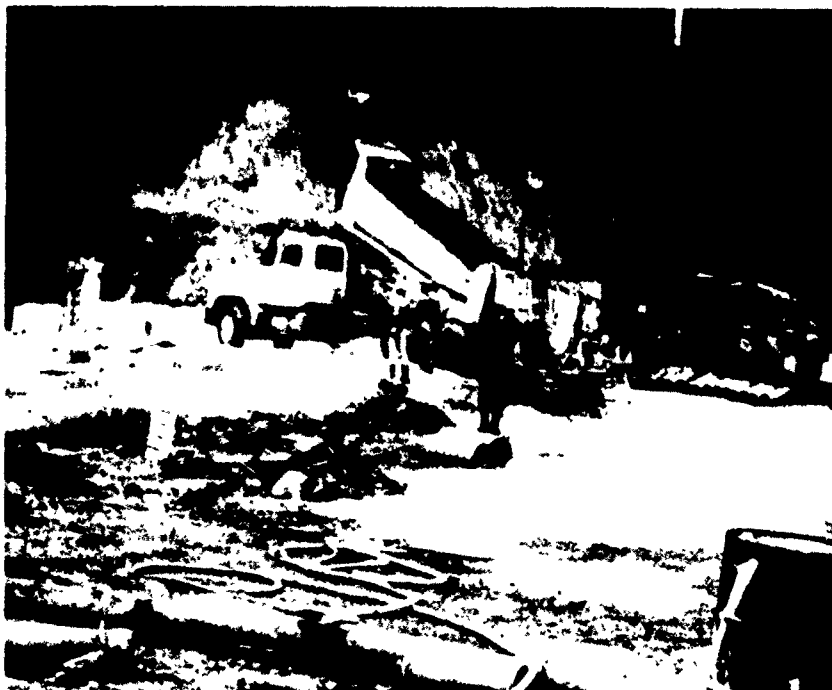
Hydrofracture in Panel 145 (?). Looking at left wall.

Emergency measures for uncontrolled slurry loss being implemented. Contractor is dumping wasted sand/silt mix from desander back into panel to help seal cracks.
