# EXAMINATION OF CORRODED TUBES FROM THE BOILERS OF THE USS EDWARDS (DD-950)

METALLURGY DIVISION

August 1959

NRL MEMORANDUM REPORT 964

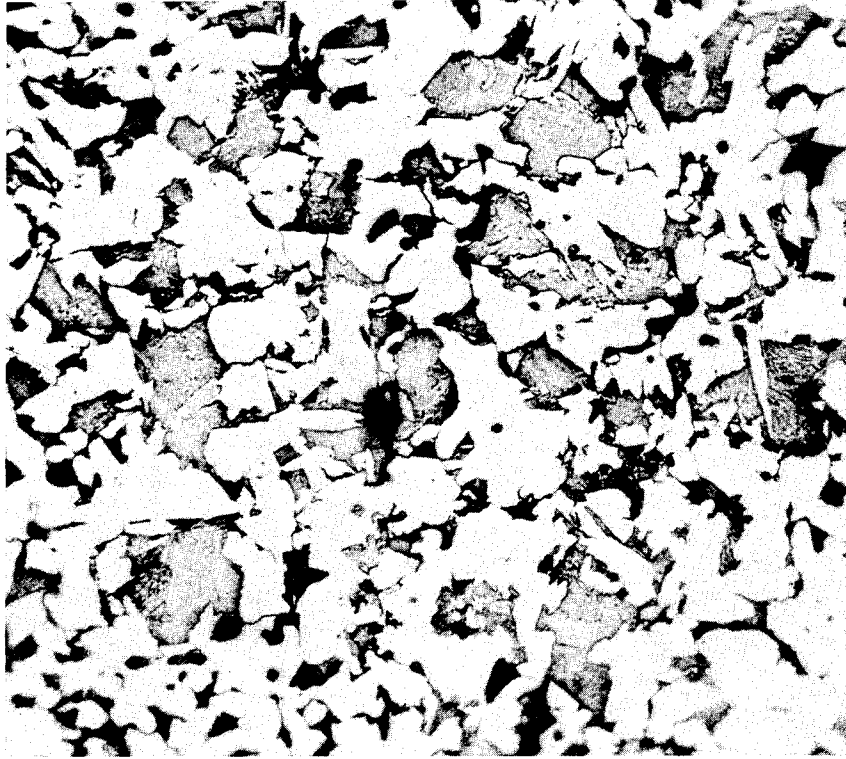
- Fig. 2 - 1B Boiler - RW No. 21 (Section through bulge that had cracked). Notice structure indicating that metal was rapidly cooled from temperature above 1335°F when the tube failed. Etchant: 1% Nital. 1000X.

Fig. 2 - 1B Boiler - RW No.21 (Section through bulge that had cracked). Notice structure indicating that metal was rapidly cooled from temperature above 1335<sup>o</sup> F when the tube failed. Etchant: 1% Nital. 1000X.

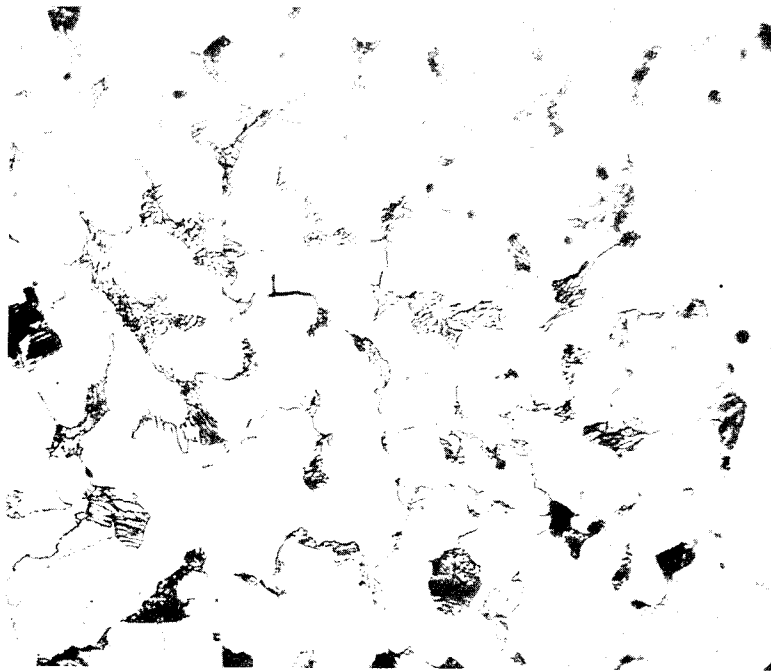
- Fig. 3 - 1B Boiler - RW No. 18 (Section through bulge that had not cracked). Note lamellar (new) pearlite which indicates that service temperature exceeded 1335°F. Etchant: 1% Nital plus 2% Picral. 1000X.

Fig. 3 - 1B Boiler - RW No.18 (Section through bulge that had not cracked). Note lamellar (new) pearlite which indicates that service temperature exceeded 1335<sup>0</sup>F. Etchant: 1% Nital plus 2% Picral. 1000X.

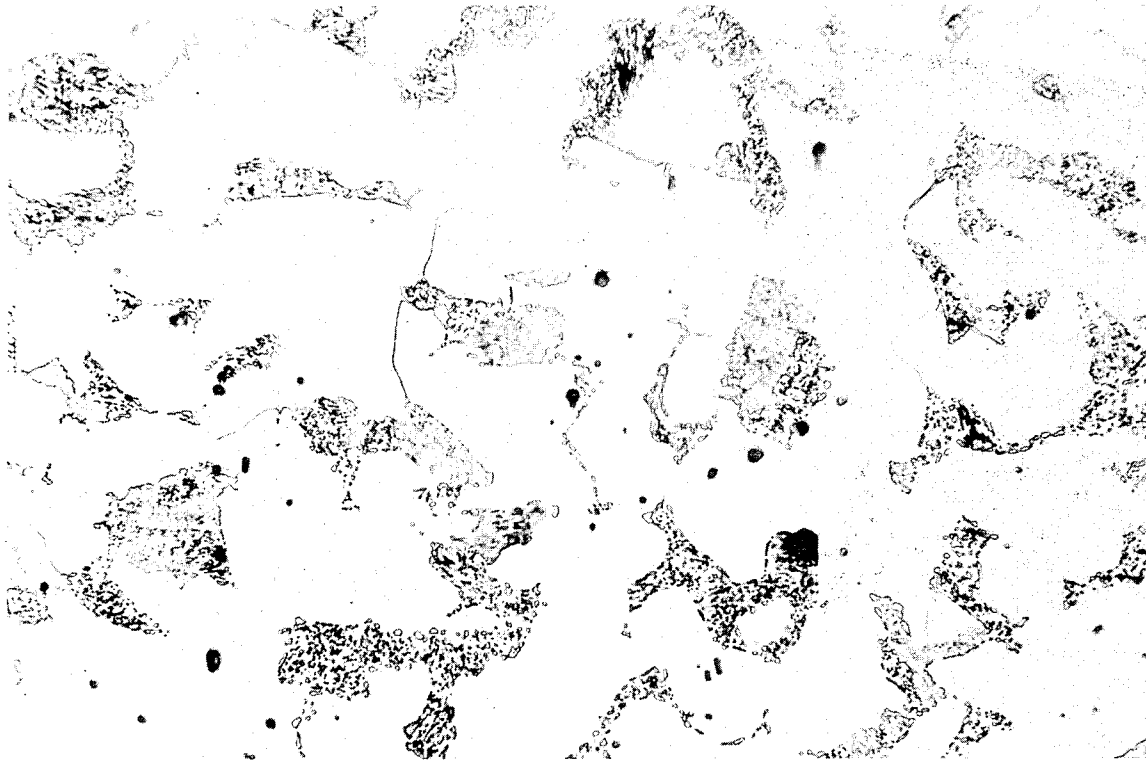
- Fig. 4 - 1B Boiler - RW No. 18 (Section adjacent to bulge). Note coarse carbides; no evidence of partial austenitization is present. Etchant: 1% Nital plus 2% Picral. 1000X.

Fig. 4 - 1B Boiler - RW No. 18 (Section adjacent to bulge). Note coarse carbides; no evidence of partial austenitization is present. Etchant: 1% Nital plus 2% Picral. 1000X.
