PB99-910401
NTSB/AAR-99/01
DCA94MA076

AIRCRAFT ACCIDENT REPORT

UNCONTROLLED DESCENT AND COLLISION WITH TERRAIN
USAIR FLIGHT 427
BOEING 737-300, N513AU
NEAR ALIQUIPPA, PENNSYLVANIA
SEPTEMBER 8, 1994

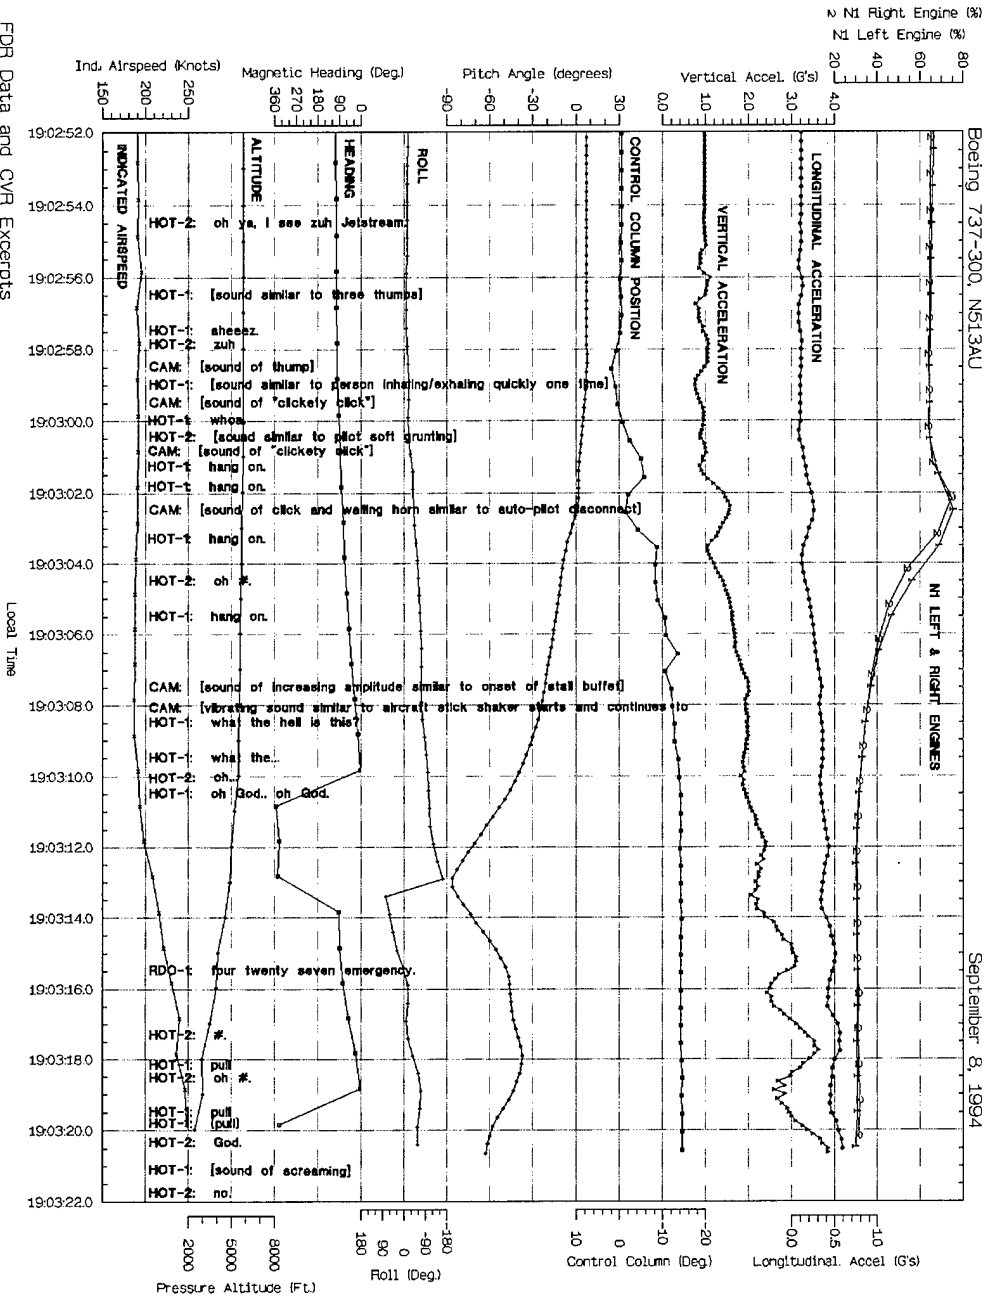
Figure 1. FDR data during the final 30 seconds of USAir flight 427.

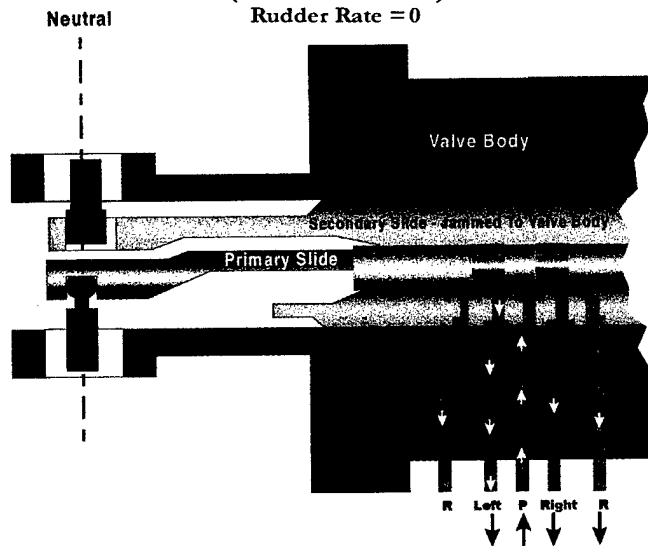
**Intended Operation:
Secondary Slide Jammed Full Open, Primary Slide Opposing
(Full Cross Flow)
Rudder Rate = 0**

Figure 16. PCU servo valve intended operation with the secondary slide jammed to the servo valve housing and primary slide opposing.

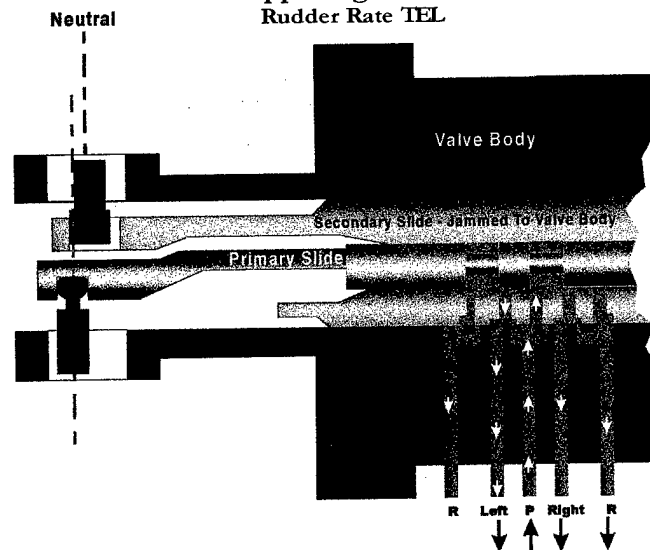
**Newly Discovered Failure Effect:
Secondary Slide Jammed Full Open, Primary Slide Over-Stroke
In Opposing Direction
Rudder Rate TEL**

Figure 17. PCU servo valve with the secondary slide jammed to the servo valve housing and the primary slide in the overtravel condition.

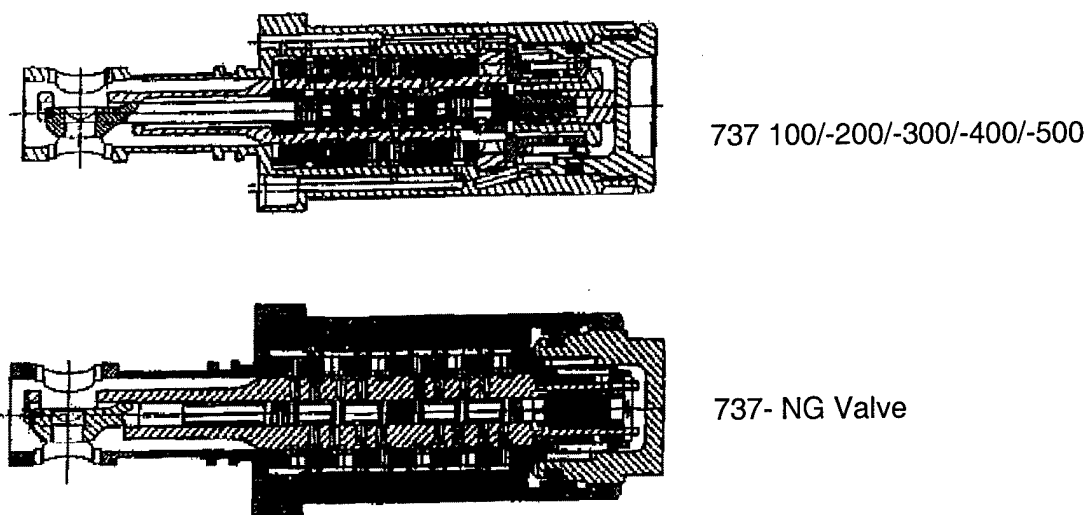
single piece rather than built up by a group of smaller parts. Figure 31 shows the 1998 redesigned servo valve for both the earlier 737 series airplanes and the 737-NG airplanes.

Figure 31. Parker's 1998 redesigned servo valve for 737 airplanes.
