NATIONAL TRANSPORTATION SAFETY BOARD

SAFETY STUDY

Emergency Evacuation
of Commercial Airplanes

**NTSB/SS-00/01
PB2000-917002
Notation 7266
Adopted June 27, 2000**

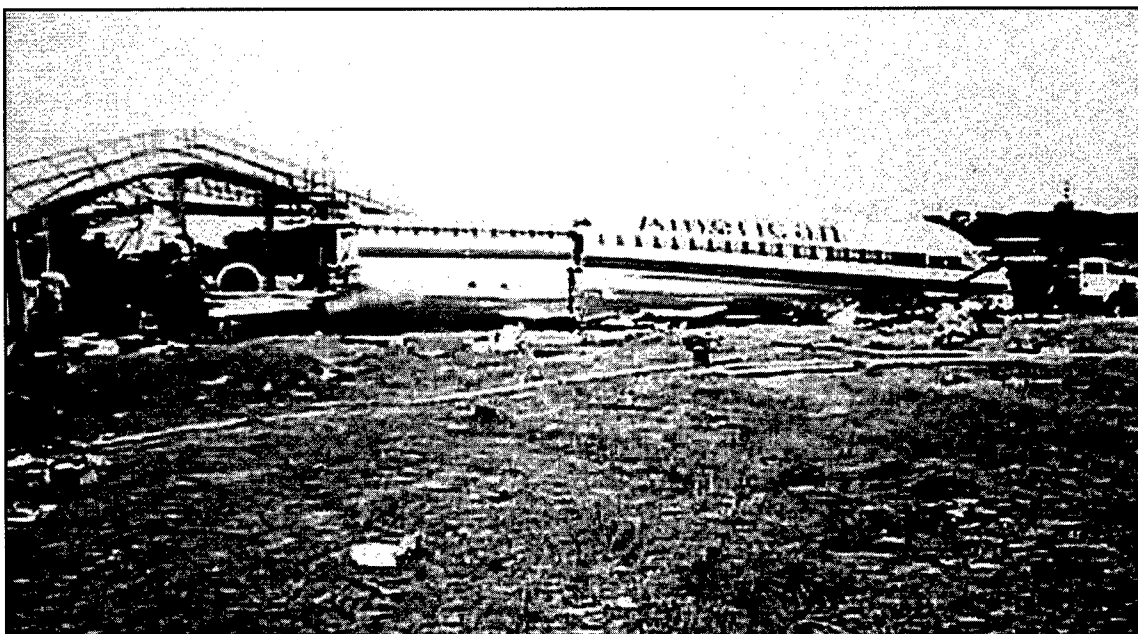
In the MD-82 accident in Little Rock, Arkansas (case 45), the crash forces caused seats to break free from their seat tracks and block aisles. In the forward portion of the cabin, passengers had to navigate around fallen overhead bins and across a severely deformed floor. Fortunately, the crash caused several gaps in the fuselage that passengers were able to use for egress. As seen in figure 5–3, the crash forces split the cabin in two separate sections divided at the wing.

Figure 5–3. View of the McDonnell Douglas MD-82 accident scene that involved evacuation on June 1, 1999, Little Rock, Arkansas (case 45).

Based on the circumstances of the evacuation in this accident, the Safety Board recommended that the FAA

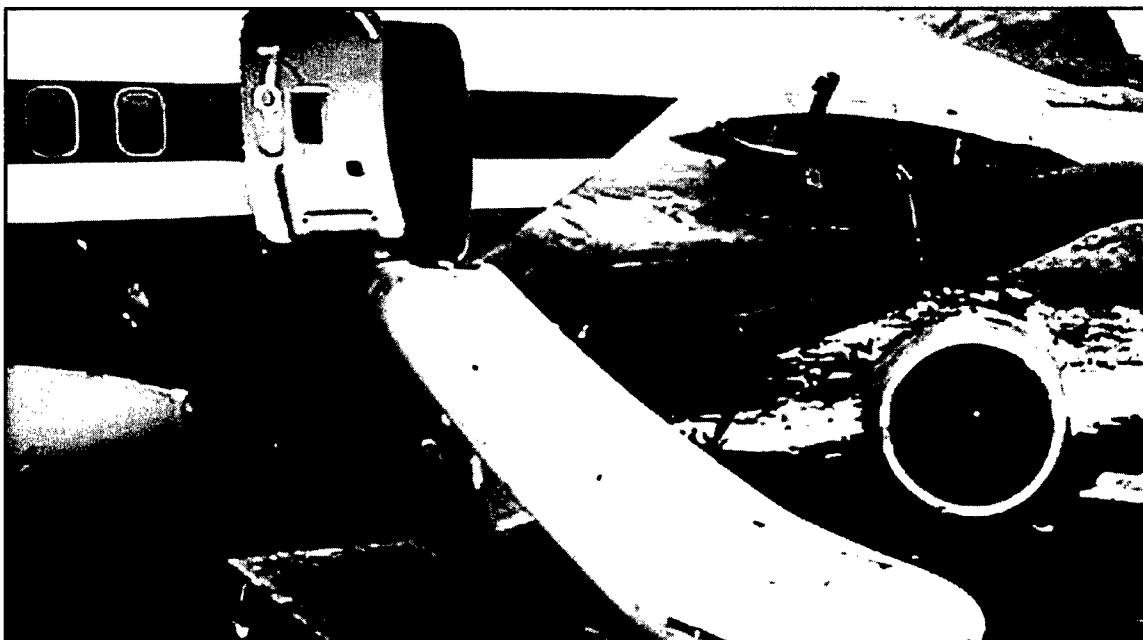
In the 727 accident in Chicago (case 9), the aircraft landed short of the runway, striking a light structure and the runway threshold. A liferaft ceiling panel door⁵³ fell open, blocking the main aisle to the L1 exit.⁵⁴ The flight attendant assigned to the L1 exit decided not to use the exit because the ceiling panel blocked access to the exit. Passengers evacuated through the R1, overwing, and L2 exits (figure 5–4).

Figure 5-4. View of a slide used in the Boeing 727 evacuation on February 9, 1998, Chicago, Illinois (case 9).

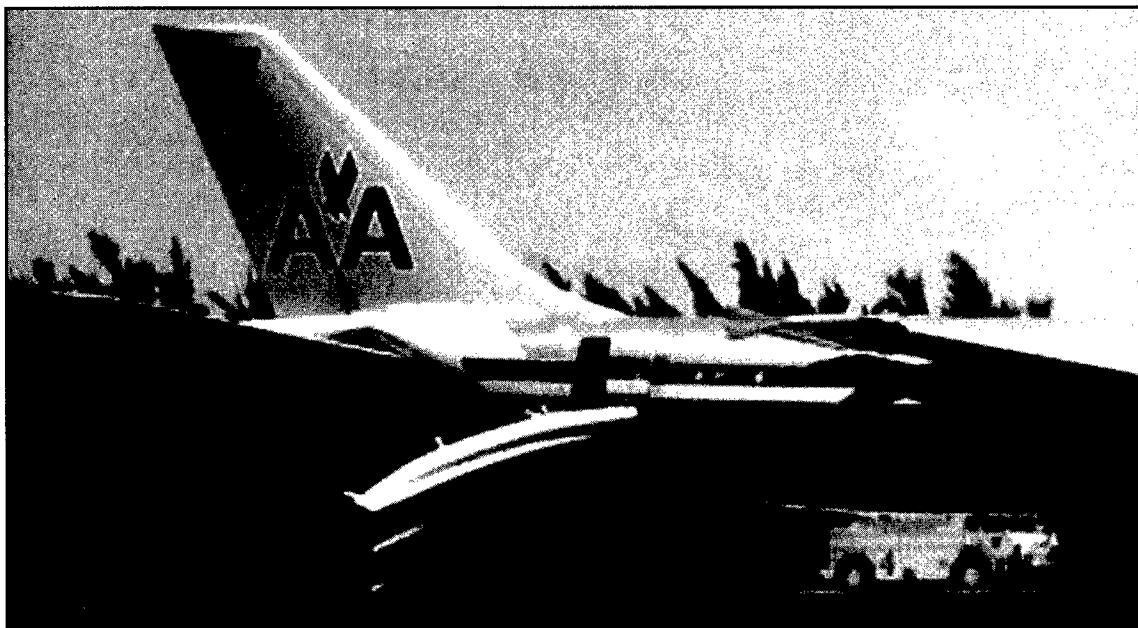
deploy the slides at R1, R2, and R4. However, there was a delay in deploying the R1 slide because of a failure of the power assist in the door. Also, the R3 door partially opened before jamming. The flight attendant tried repeatedly to open the door, but reported that he “knew [the slide] was caught up” in the pack. Postincident testing conducted by the Safety Board indicated that the malfunction might have been caused by a Velcro® fastener that became hooked on a clip on the inside of the decorative cover. In addition, the slide deployed at R4 was unusable for a period of time because winds were blowing the slide against the airplane (figure 5–9). During this time, the 234 passengers were exiting from only two of the eight exits on the A300.

Figure 5–9. View of the wind’s effect (25-knot gusts) on the evacuation slide used following the Airbus 300 accident on July 9, 1998, in San Juan, Puerto Rico (case 24). Passengers were able to use this exit after a person on the ground held the slide in place.
