Considerations for Determining Safe Separation Distances from Mass Fires: a Literature Search

Thomas L. Boggs
Jacobs Naval Systems Group, Ridgecrest, CA 93555

Josephine Covino
*Policy Development Division
Department of Defense Explosives Safety Board, Alexandria, VA*

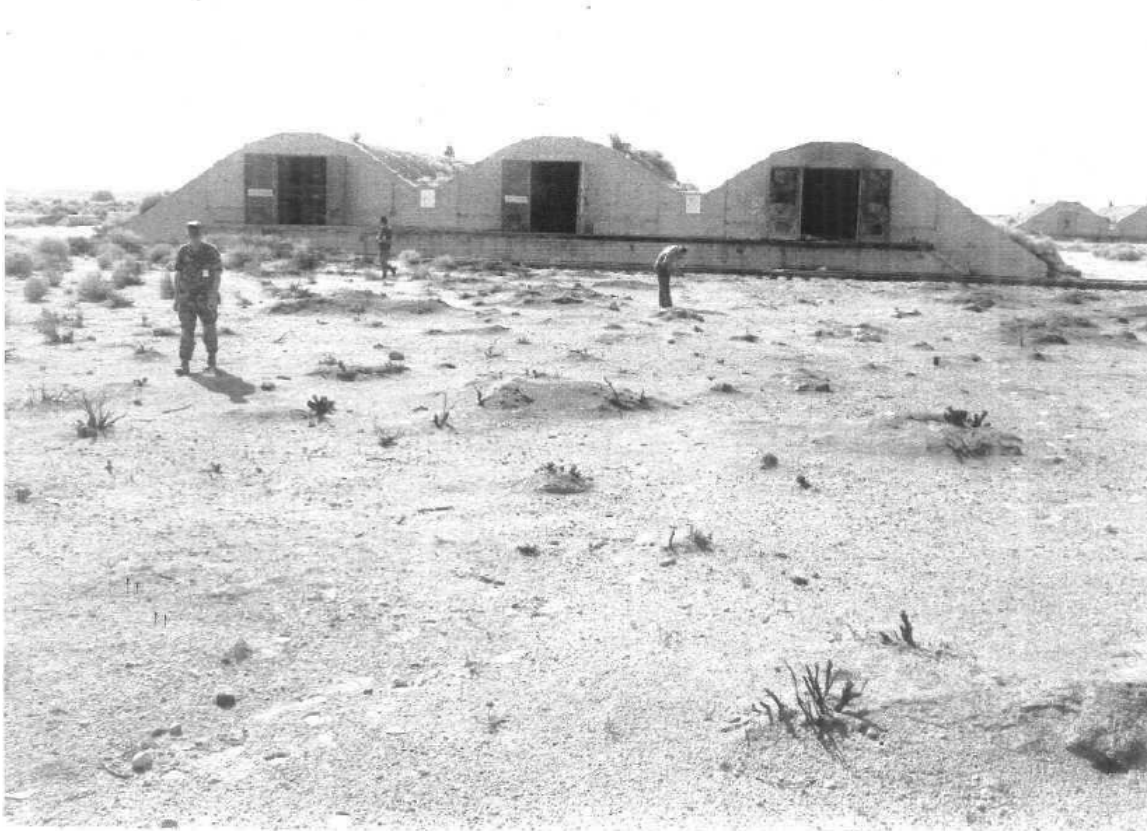
A fire occurred in one of the arches of a 3-arch earth-covered magazine (Figure 1).

FIGURE 1. Three Arch Earth-Covered Magazine at Hawthorne Army Ammunition Plant.
Fire occurred in unit on the right.

The magazine contained 30,715 pounds of Hazard Division (HD) 1.3 Navy propelling charges. Many of the lots had low stabilizer levels, and Hawthorne had requested permission to dispose of the items by open burning. Unfortunately, the State of Nevada denied their request. Fire occurred and blew open the doors. Flames extended out 100 to 150 feet. The very intense burning continued for about 3 minutes and then decreased significantly. During the period of decreased burning, several “pops” attributed to deflagration occurred, but there was no detonation. The fire was allowed to burn itself out. Cartridge cases, unburned propellant grains, and pieces of cork were expelled through the doors and found scattered on the ground directly in front of the magazine; in addition, several cartridge cases were found several hundred feet from the magazine. The fire was attributed to stabilizer depletion in single-base propelling charges.

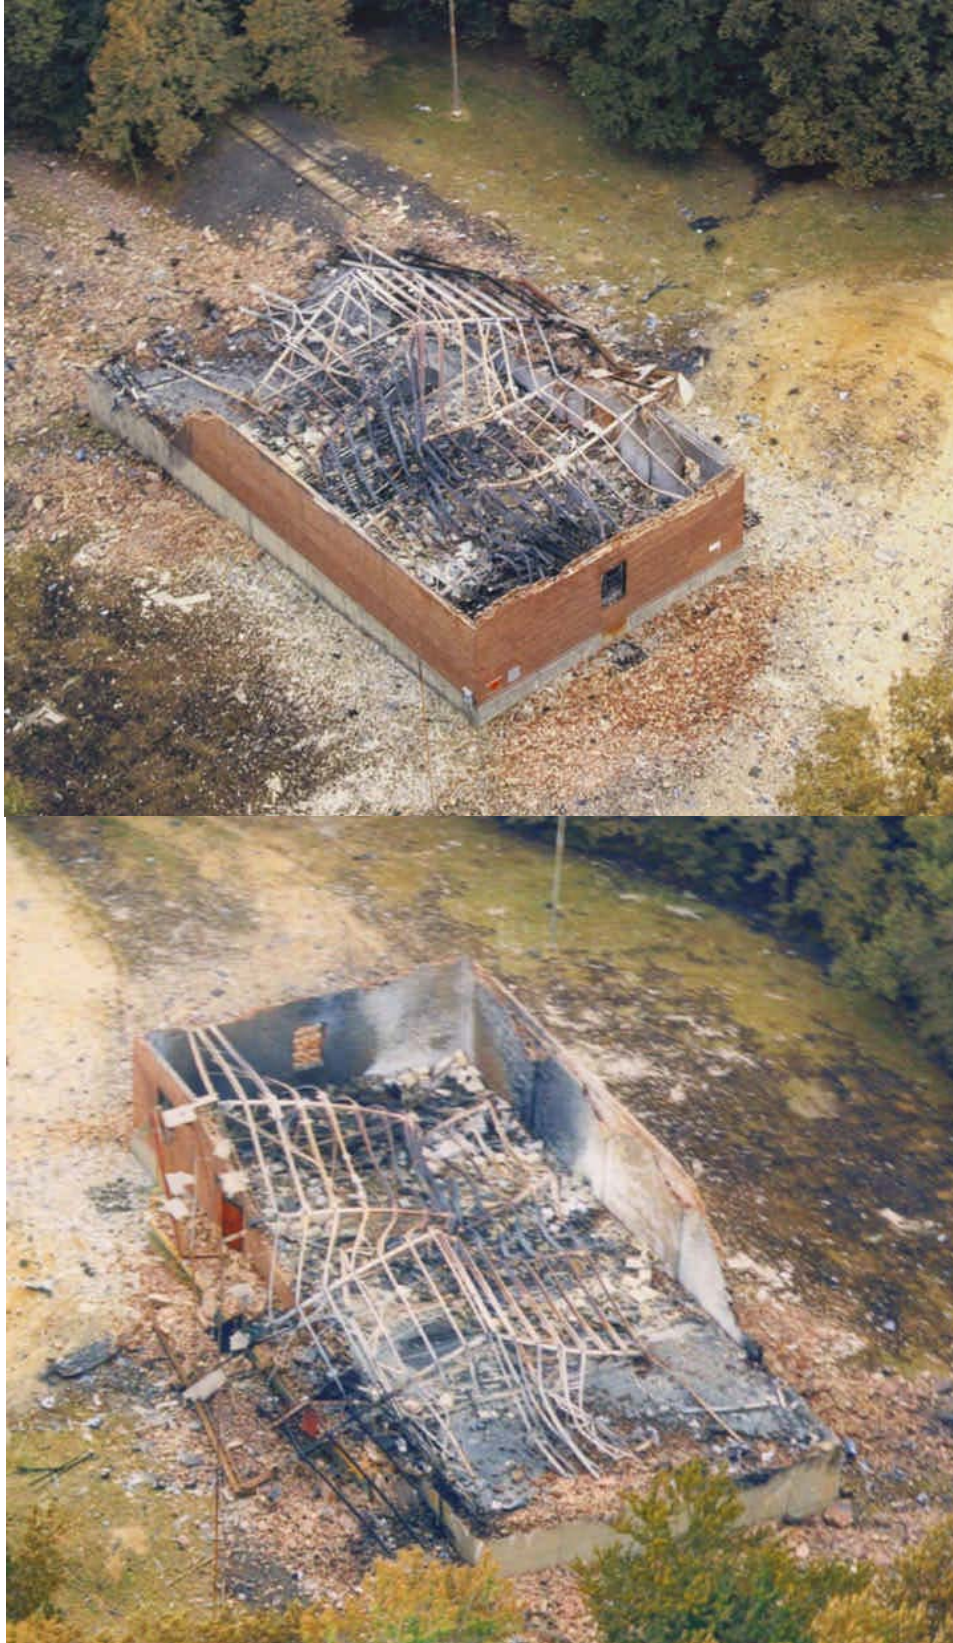
The surmised sequence of events started with auto-ignition of nitrocellulose gun propellant. The fire spread and involved a relatively large quantity of magnesium-teflon-viton flare material, which provided an intense boost to the fire. This in turn led to the first and largest detonation followed by a series of smaller detonations.

FIGURE 5. Magazine 518 after the Fires and Detonations.

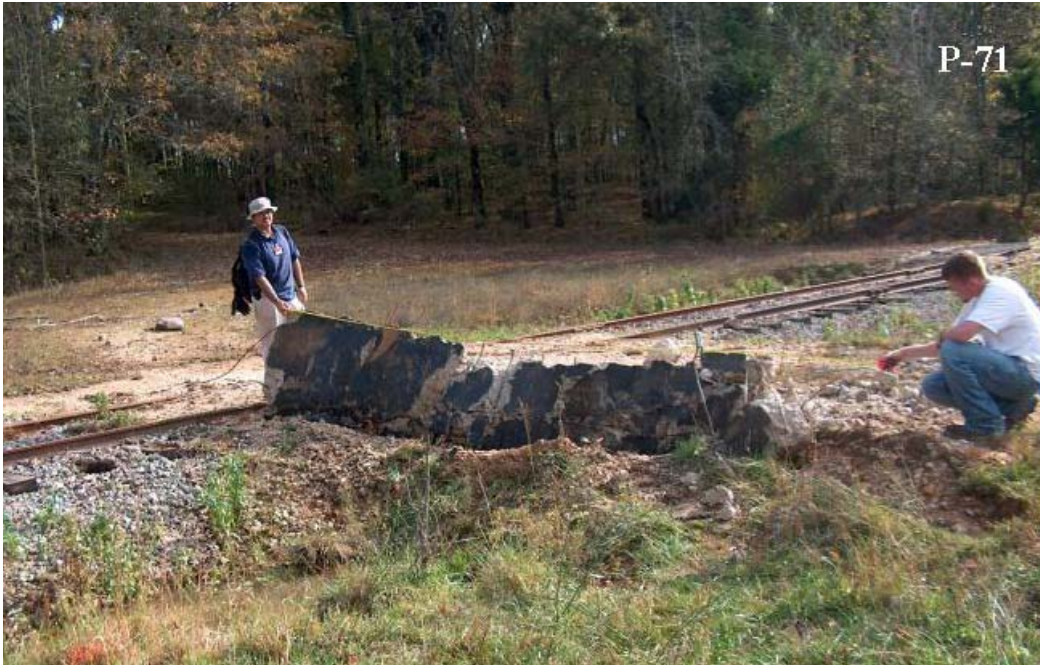
Witnesses reported hearing two blasts in rapid succession, with the second blast being more powerful than the first. Of particular interest was the size of some of the debris and the distances it was thrown. For example, one fragment was steel reinforced concrete 16 feet in length and 3 to 4 feet in width (Figure 6).

FIGURE 6. Large Fragment that Landed Between Magazines P-70 and P-71.

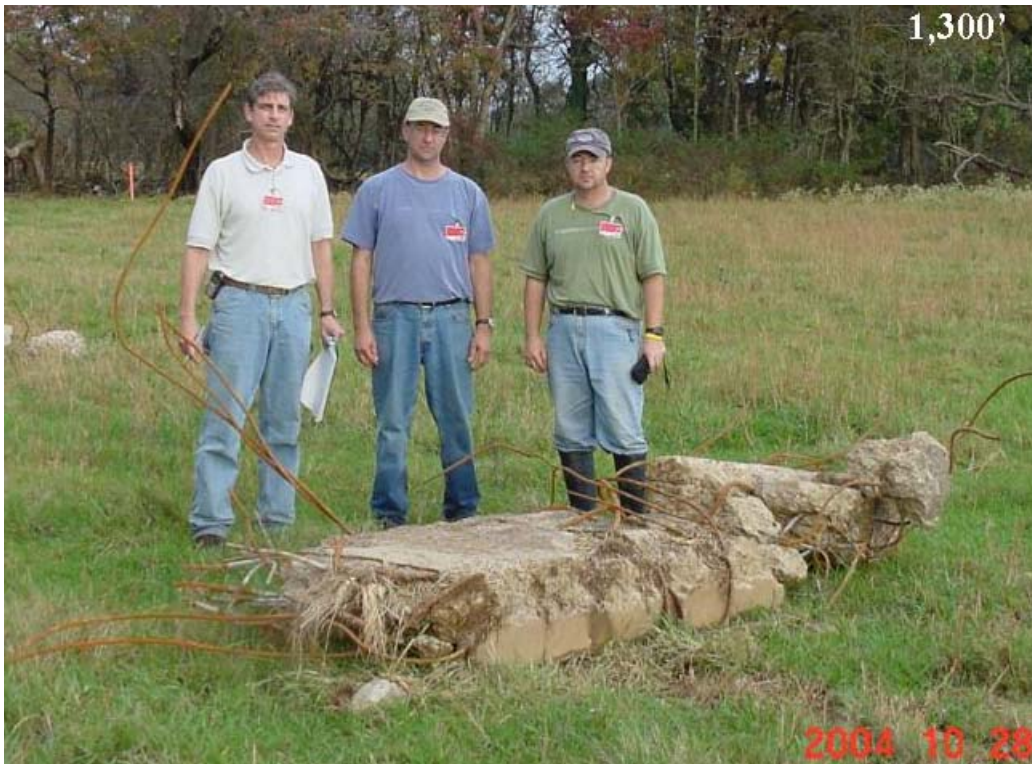
Figure 7 shows a large fragment that had been part of the headwall found at approximately 1,300 feet.

FIGURE 7. Large Fragment that had Been Part of the Headwall Found at Approximately 1,300 Feet from the Magazine.

The large fragment shown above traveled beyond the 1,250 foot radius for inhabited building distance (IBD) arc. Other large fragments were found significantly further than the 1,250 foot IBD arc. For example, there was significant damage to a tree located 2,100 feet in front of the magazine caused by a large fragment impact. Other debris estimated to have been a 6- by 8-foot section from the head wall significantly damaged a tree 3,100 feet from the magazine.

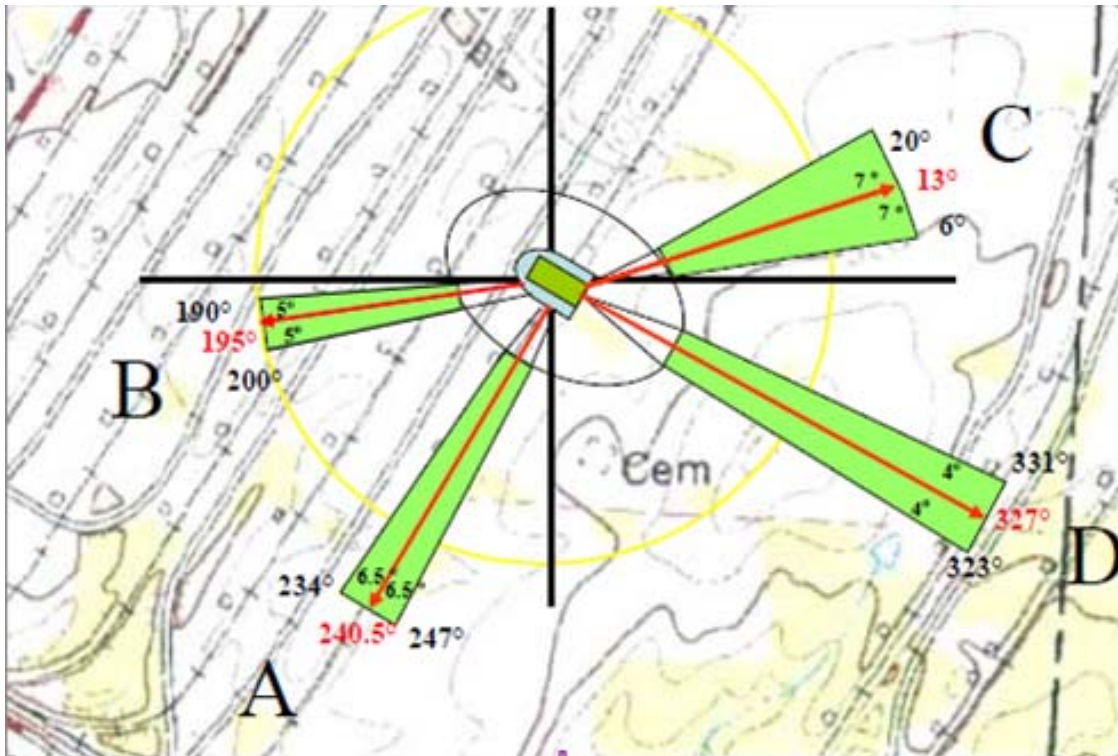
Subsequent debris mapping was conducted. All of the debris was from the structure of the earth-covered magazine. Four sectors were defined and the debris within each of the sectors was mapped. The four sectors are shown in Figure 8.

FIGURE 8. Search Sectors, Milan Accident 2004.

Most of the fragments were concrete, rebar, or a combination of both. Emphasis was placed on hazardous fragments having an impact energy of 58 ft-lb or greater and/or a weight greater than 6.17 ounces (175.5 grams). The vast majority of the fragments were hazardous. The fragments were addressed in the following two fashions: one was simply a unit count, each fragment counted as one item, and the other was a weight-equivalent count where each fragment's weight was divided by the minimum weight of a hazardous fragment (6.17 ounce). The results show the following in terms of less than one hazardous fragment per 600 square foot area:

- Sector A. For the unit count method, there is a problem (more than one hazardous fragment/600 ft²) from 1,250 to 1,300 foot radius, and no problem out to 1,750 feet. However, for the weight-based count, there is a problem from 1,250 to 1,350 feet and again at about 1,550 feet.
- Sector B. There are essentially no problems for either the unit- or weight-based count from 1,250 to 2,400 feet radius.

- The use of unit count indicates excessive hazardous fragment density beyond the 1,250 IBD arc in one sector (A).
- The use of weight-equivalent count indicates excessive hazardous fragment density beyond the 1,250 IBD arc in three sectors (A, C, and D).

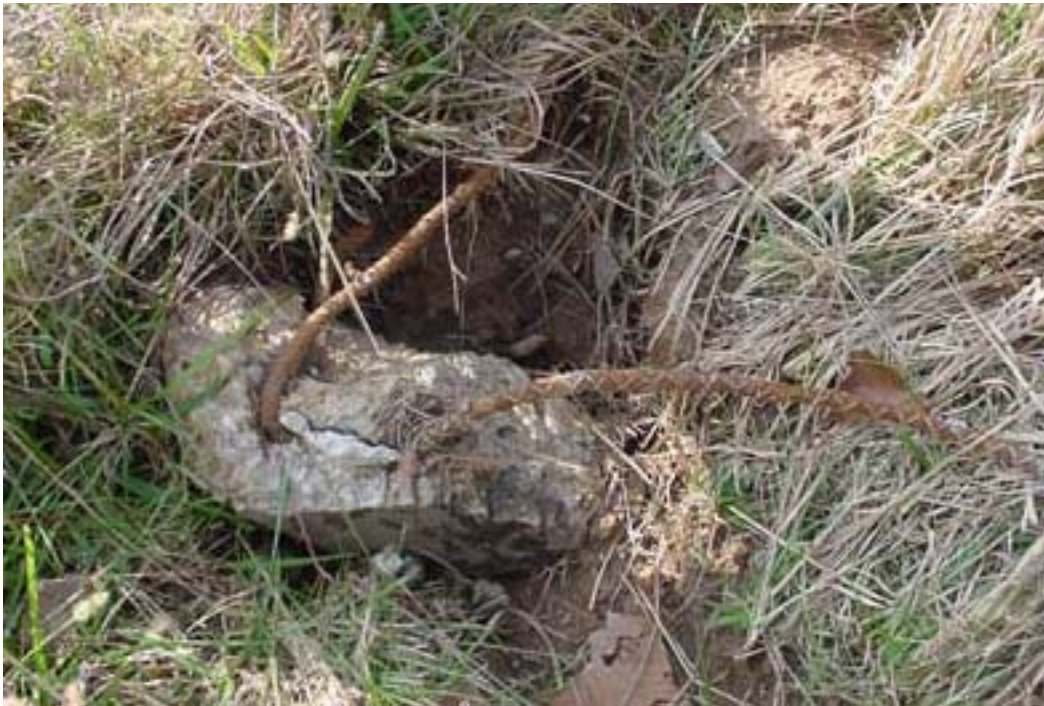
In addition to the sectors described above, the investigators recorded notable fragments outside of the search sectors. These included especially large fragments and/or fragments that traveled unexpectedly long distances. For example, significant debris was found on top of and in front of magazine P-6, which is approximately 2,050 feet away from P-69 (Figure 9).

FIGURE 9 Fragment Found in Close Proximity to ECM P-6,
Approximately 2,050 Feet Away from ECM P-69.

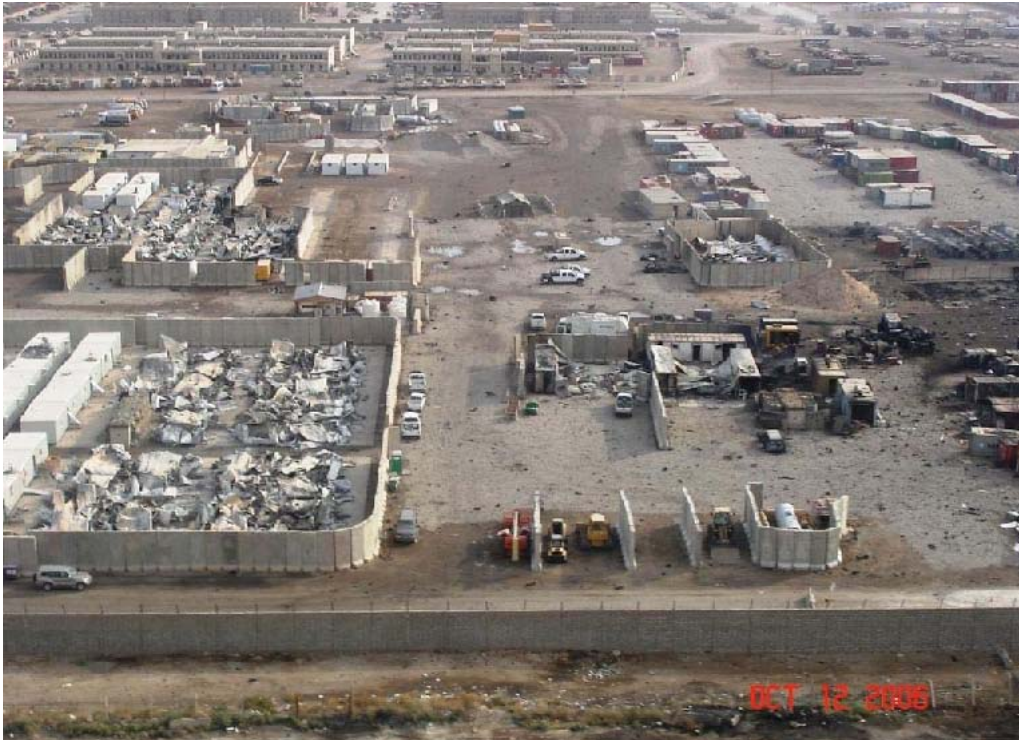
An incoming 82-mm mortar round started a fire at Forward Operating Base Falcon located in a former commercial trucking depot near the southern entrance to Baghdad. There were no injuries reported, but the fire spread and caused fires and explosions in surrounding tank and artillery ordnance and small arms ammunition. The fires and explosions went on for over 12 hours after the original fire. There was significant damage as shown in Figures 10 and 11.

FIGURE 10. Damage at FOB Falcon near Baghdad, Iraq, 10 October 2006.

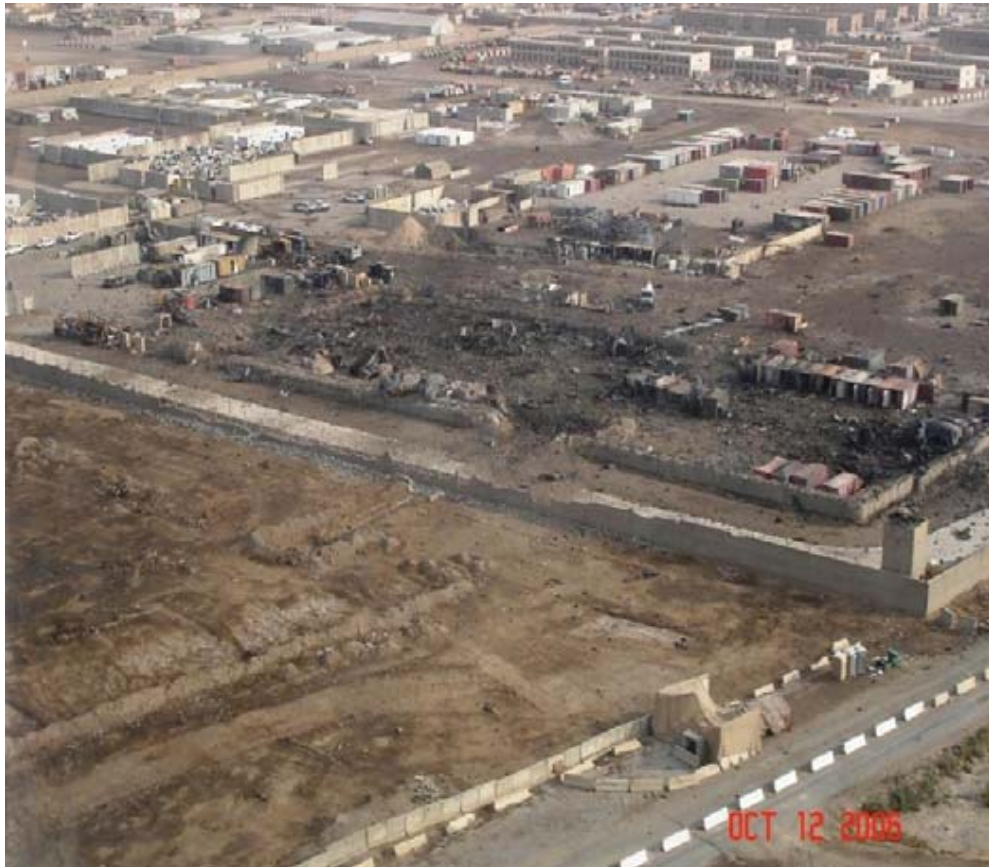
FIGURE 11. Damage at FOB Falcon near Baghdad, Iraq, 10 October 2006.

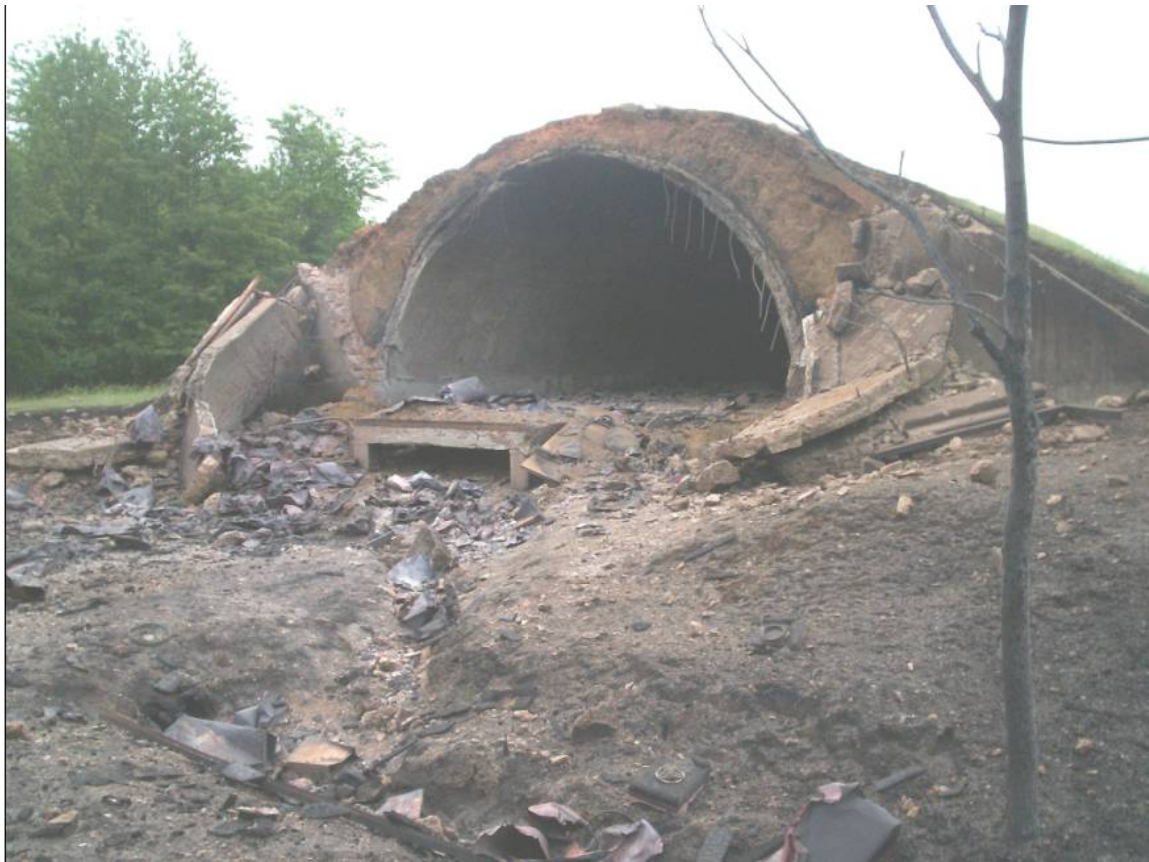
The post-mortem photographs clearly show that the fire blew out the headwall and scattered debris over an area as shown in Figures 12 through 14.

FIGURE 12. Earth-covered Magazine with Headwall Blown Out.

The cause of the accident was likely due to auto-ignition of the M-10 propellant as a result of stabilizer depletion.

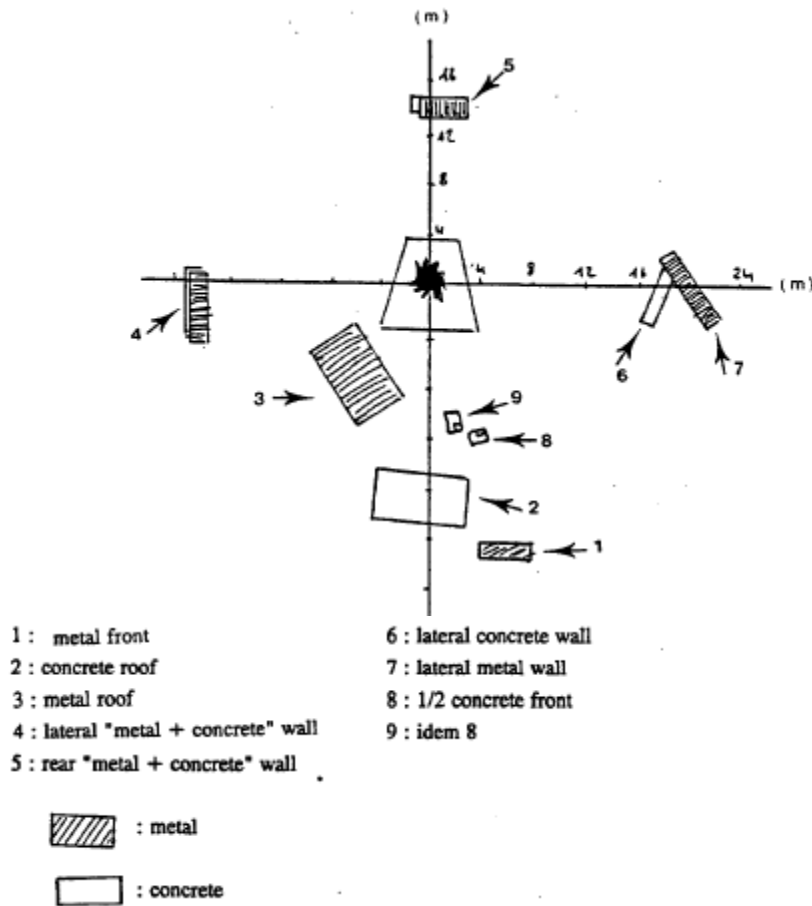
Test 4 resulted in the igloo bursting 1 second after ignition, releasing a fireball. At ground level, no trace of a plume was observed. The igloo separated along its structural lines or corners. It separated into five main parts, each comprising two pieces—one concrete and one steel as shown in Figure 21.

FIGURE 21. Location of Debris.

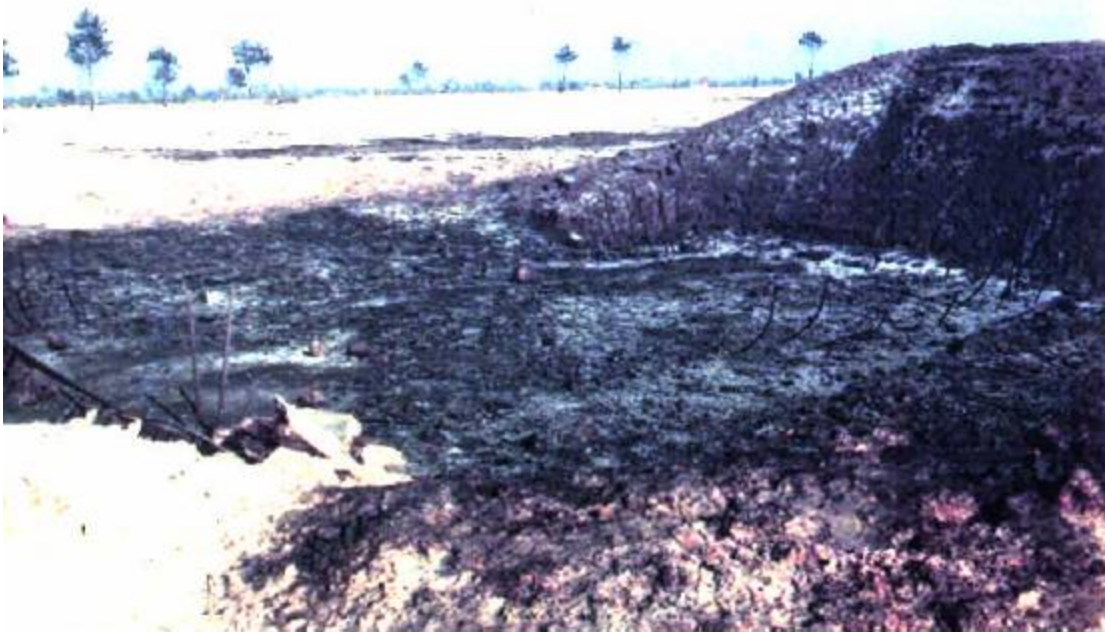
Interestingly, none of the overpressure gauges recorded any signal, nor was any crater formed, indicating neither a strong explosion nor a detonation occurred (Figure 22b). One of the internal overpressure gauges recorded an overpressure of 7 bars before saturating. The authors estimated that the maximum internal overpressure before rupture at 10 to 12 bars.

FIGURE 22. Captieux Trial Shot 4 (a) Before and (b) After.

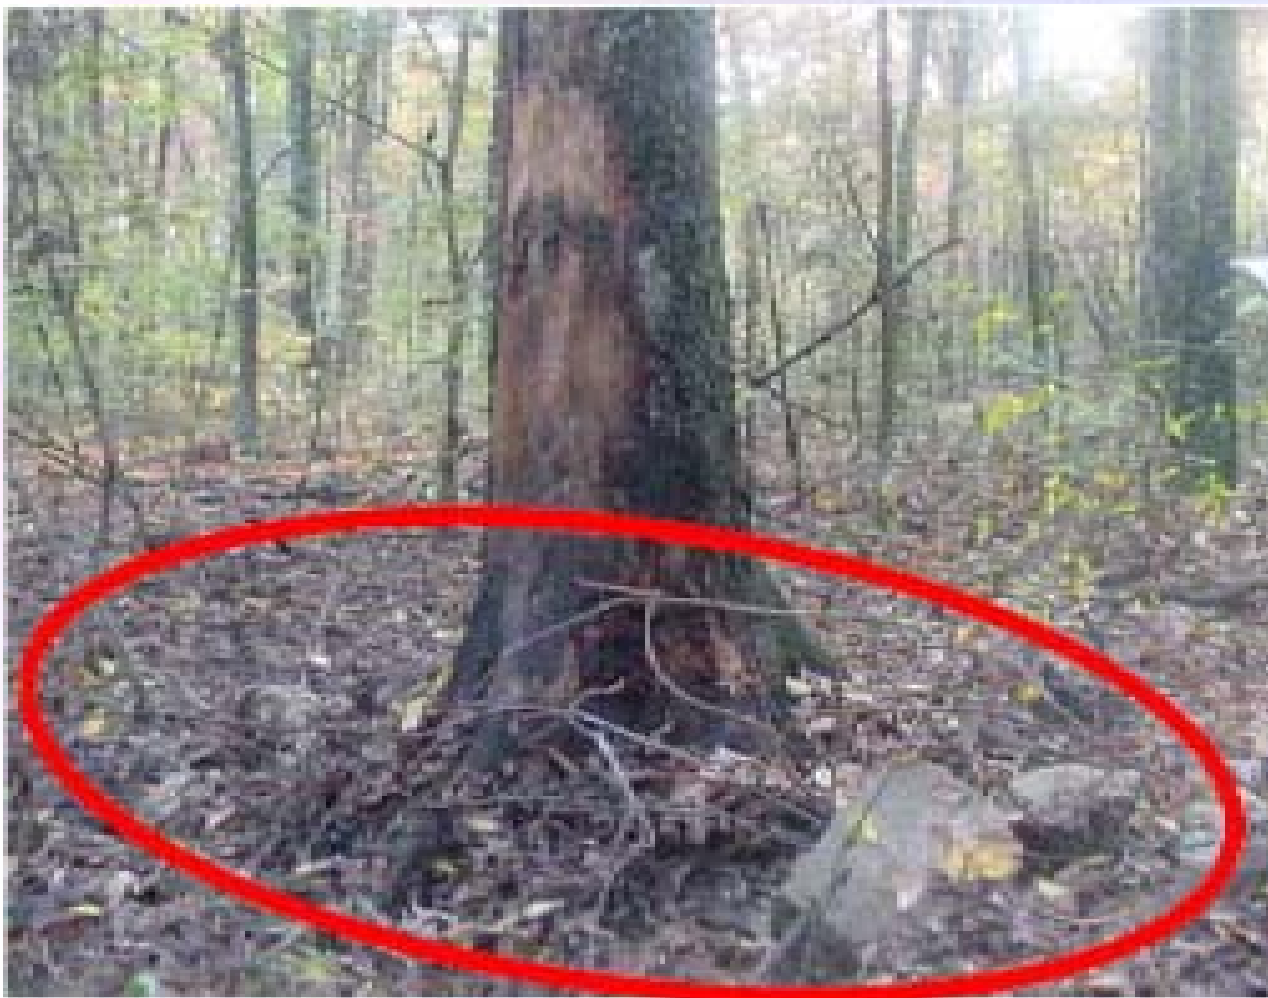
Milan 2004

Tree at 3100' from magazine impacted by 6' x 8' piece of headwall that shattered on impact with tree

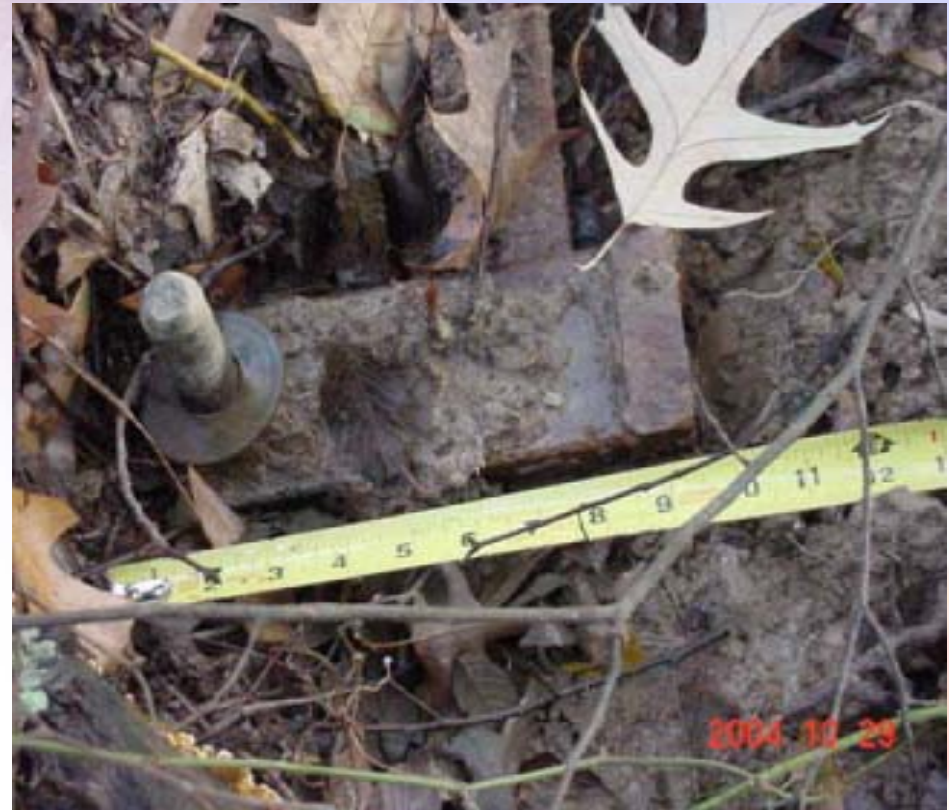
Milan 2004

Tree at 2100' impacted by large piece of headwall. Piece of hinge found at base of tree. Rebar and angle iron also found at base of tree. Concrete shattered on impact, concrete debris found beyond tree.

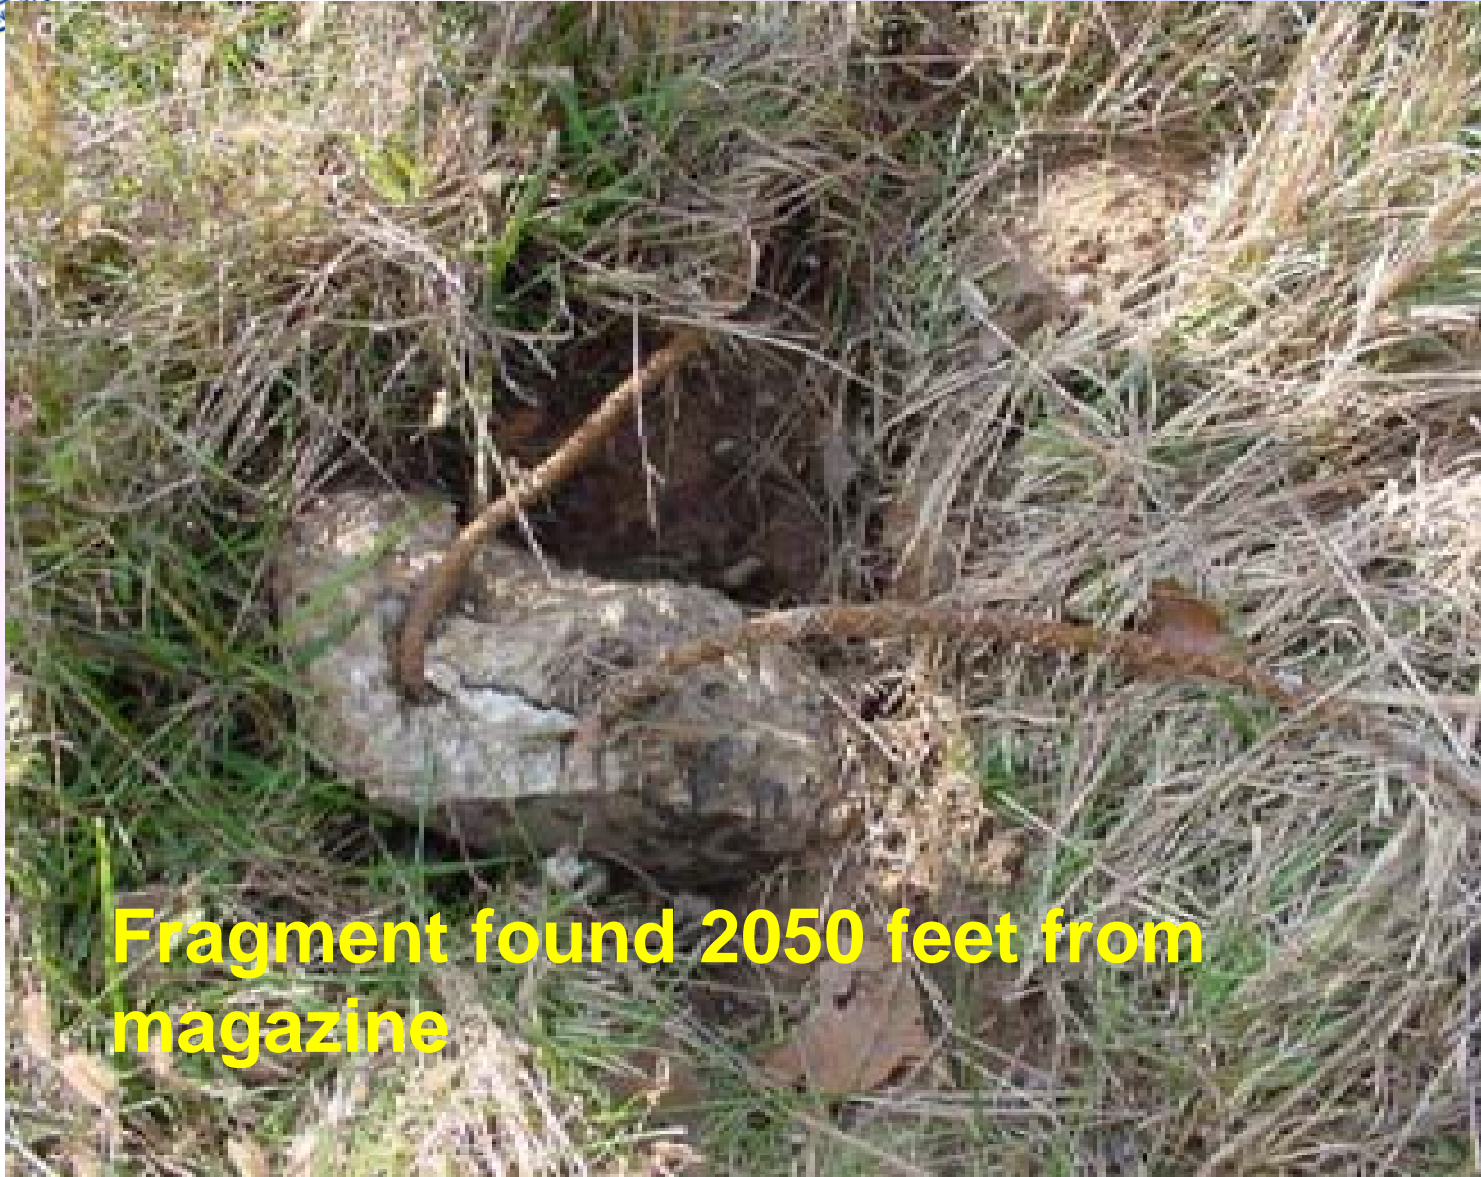
Milan 2004

Fragment found 2050 feet from magazine
