Appendix A – Program Area Responses

Mine Safety and Health Administration
1100 Wilson Boulevard
Arlington, Virginia 22209-3939

Corrective Actions Response to Recommendations of the
Internal Review Report

Please find attached the corrective actions that address the recommendations from the Mine Safety and Health Administration's (MSHA) internal review of the April 5, 2010 Upper Big Branch (UBB) mine disaster. They are from the Administrators of Coal Mine Health and Safety and Metal Nonmetal Health of Safety, and the Directors of Education and Policy Development, Technical Support, Program Evaluation and Information Resources, and the Office of Assessments, Accountability, Special Enforcement and Investigations. These are in addition to several actions already taken by MSHA following the UBB tragedy. Some recommendations directed to the Office of Assistant Secretary are addressed below.

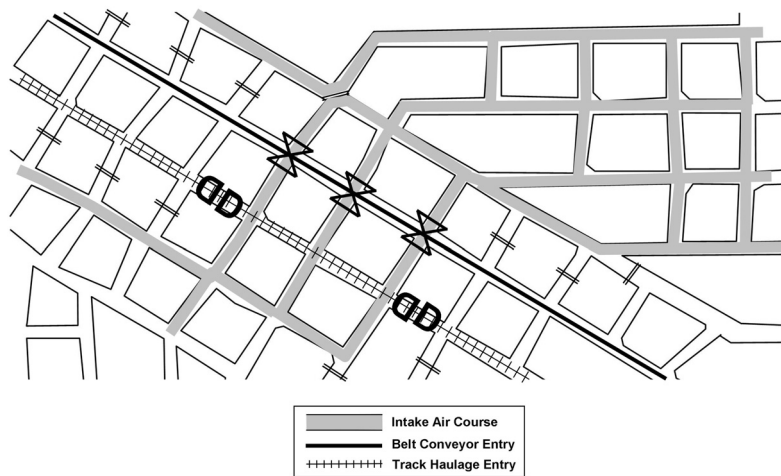
Figure 19 - Depiction of actual installation of equipment doors in the North Glory Mains

In some locations, the Operator installed two pairs of equipment doors to allow the track haulage road to pass through another air course, rather than building overcasts to permit uninterrupted travel. Airlock doors do not provide the same function as overcasts, but can be used to reduce the number of overcasts needed to isolate air courses. Although installing airlock doors in this manner complies with 30 CFR Part 75, miners may be tempted to leave both doors open for convenience, particularly when multiple vehicles pass through them, such as during shift change. Keeping both doors open, even for short durations, does not comply with 30 CFR 75.333.

Figure 19 shows one such installation in the main track haulage road of the North Glory Mains. At the time of the explosion, miners accessed the 1 North Longwall and two development sections (Headgate #22 and Tailgate #22) using this roadway. Coal was transported in the adjacent belt conveyor entry. The two entries containing the track and belt conveyor were ventilated by a common air split along much of their length. However, where a separate intake air course crossed the belt conveyor air course, the Operator installed two sets of equipment doors. Miners drove track equipment through one set of doors, into the separate intake air split, then through a second set of doors, back into the air course containing the belt conveyor system. The belt conveyor air course was reduced from two entries to one where it crossed a set of overcasts that permitted the two air splits to cross without mixing. These air courses could not mix at this location since they isolated primary and alternate escapeways and the intake split (shown in gray) that ventilated the working sections.

District 4 personnel indicated during interviews that safety standards did not prohibit the use of equipment doors in this manner. However, 30 CFR 75.333(d)(1) does not provide guidance to operators or inspectors regarding the evaluation of equipment door installations, and MSHA policy has never been developed to address enforcement of this standard.

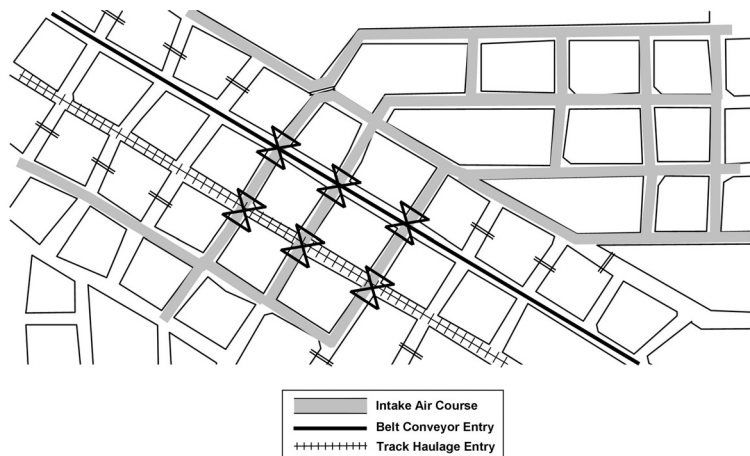
Figure 20 - Six Overcast Alternative to Eliminate Equipment Doors

Figure 20 shows how the separation of the two air courses could have been maintained using two sets of overcasts and no equipment doors. This method would have provided access to the track haulage entry without the need to open and close doors. Overcasts would have maintained separation of these air courses with less risk to the ventilation system because equipment doors are more prone to damage and excessive leakage. Therefore, the method illustrated in Figure 20 has historically been the preferred industry practice in areas of high traffic, such as in main haulage roads.

Another advantage to the use of overcasts is that the common air split is maintained in two entries rather than one in the area of the air lock, which reduces ventilating pressure losses when overcasts are properly installed. Vehicular access between air courses still can be accomplished by installing equipment doors to replace stoppings in crosscuts between the air courses.

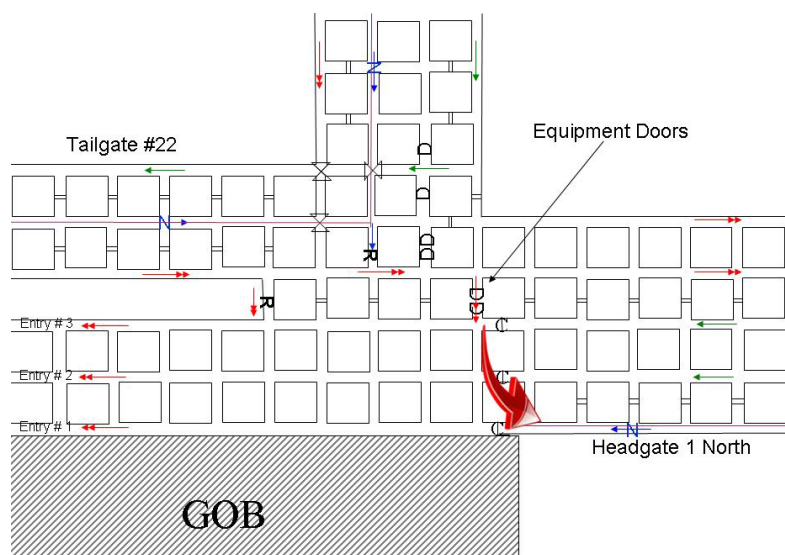
Figure 21 - Latest Headgate Ventilation Design

The MSHA Accident Investigation team found that open equipment doors at key locations would not have caused a dramatic decrease in the intake air quantity for the 1 North Longwall. However, some reductions on the Headgate #22 and Tailgate #22 development sections were possible when equipment doors installed on the longwall intake were opened. The Accident Investigation team also found that return air from the development sections could be routed to the longwall face when equipment doors between the No. 3 entry of the longwall headgate and the No. 1 entry of Tailgate #22 were left open (see Figure 21). The Accident Investigation team determined through interviews with miners that there was at least one occasion when this occurred.

Conclusion: Mine design and plans incorporating equipment doors in critical areas often create a ventilation system too fragile to maintain an acceptable degree of safety for miners. Currently, regulations address the use of equipment doors to separate air courses in lieu of stoppings. However, the proper installation, operation, and maintenance of equipment doors are critical for maintaining a safe and effectively ventilated mine.

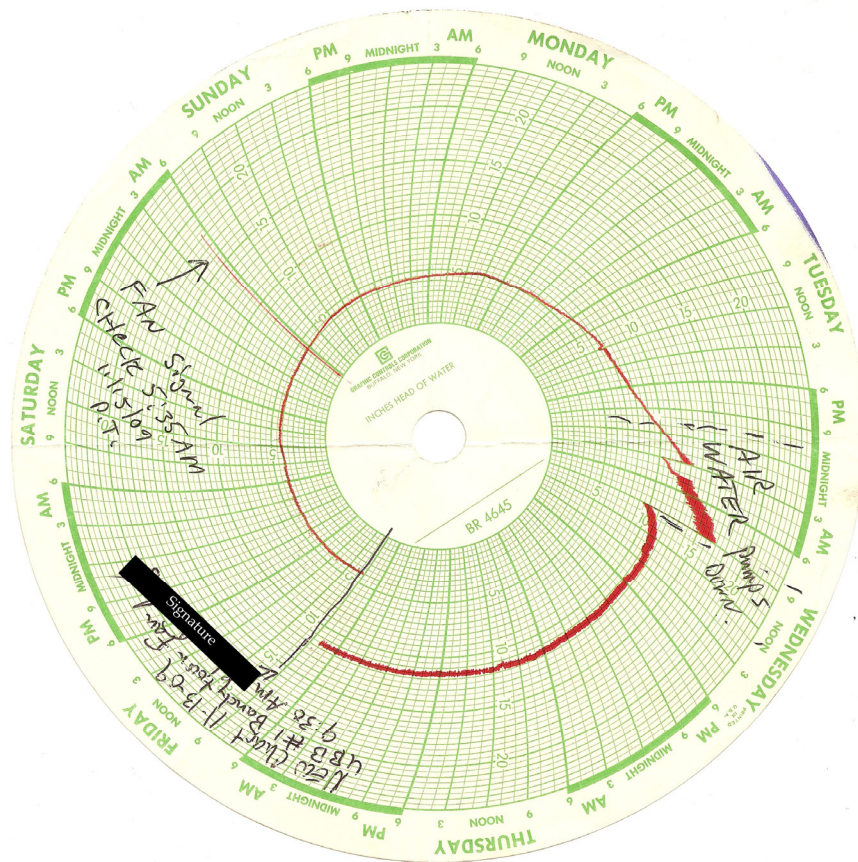
Figure 22 - Bandytown Fan Chart from November 2009

The MSHA Accident Investigation team concluded from inspector notes and witness testimony that a water inundation occurred on November 16, 2009. Further, the Accident Investigation report stated: “Thus, it is plausible that differential subsidence above the 1 North panel occurred beneath the barrier, causing joints or fractures to open sufficiently to allow water and air communication between the Eagle and Powellton seams.” The water flooded the bleeder and return entries in Headgate 1 North in by the longwall face. As the water accumulated in the bleeder system, it increasingly restricted air flow, which also caused the fan pressure to increase.

On November 13, 2009, the fan pressure recorded at the Bandytown Fan was approximately -4.0 inches of water.⁷³ On Monday, November 16, the fan pressure began to gradually increase. By Wednesday, November 18, a fan pressure of -17.0 inches of water was recorded. During this time period, a handwritten notation on the Bandytown Fan pressure chart indicated “pumps down.” The fan pressure chart is shown in Figure 22.

On November 19, 2009, a District 4 ventilation specialist examined the longwall headgate entries and observed an accumulation of water 12 to 15 inches in depth in the No. 3 entry extending a distance of 300 feet from crosscut 55 to 58. At that time according to production reports, the longwall face was at crosscut 54 on Headgate 1 North. The specialist issued a section 104(a) citation (No. 6612944) for this violation of 30 CFR 75.364(b)(2). During his interview with the Internal Review team, the specialist stated that the water level was not increasing. At that time, the fan pressure on the Bandytown Fan chart was reduced to approximately -11.5 inches of water as a result of pumping.

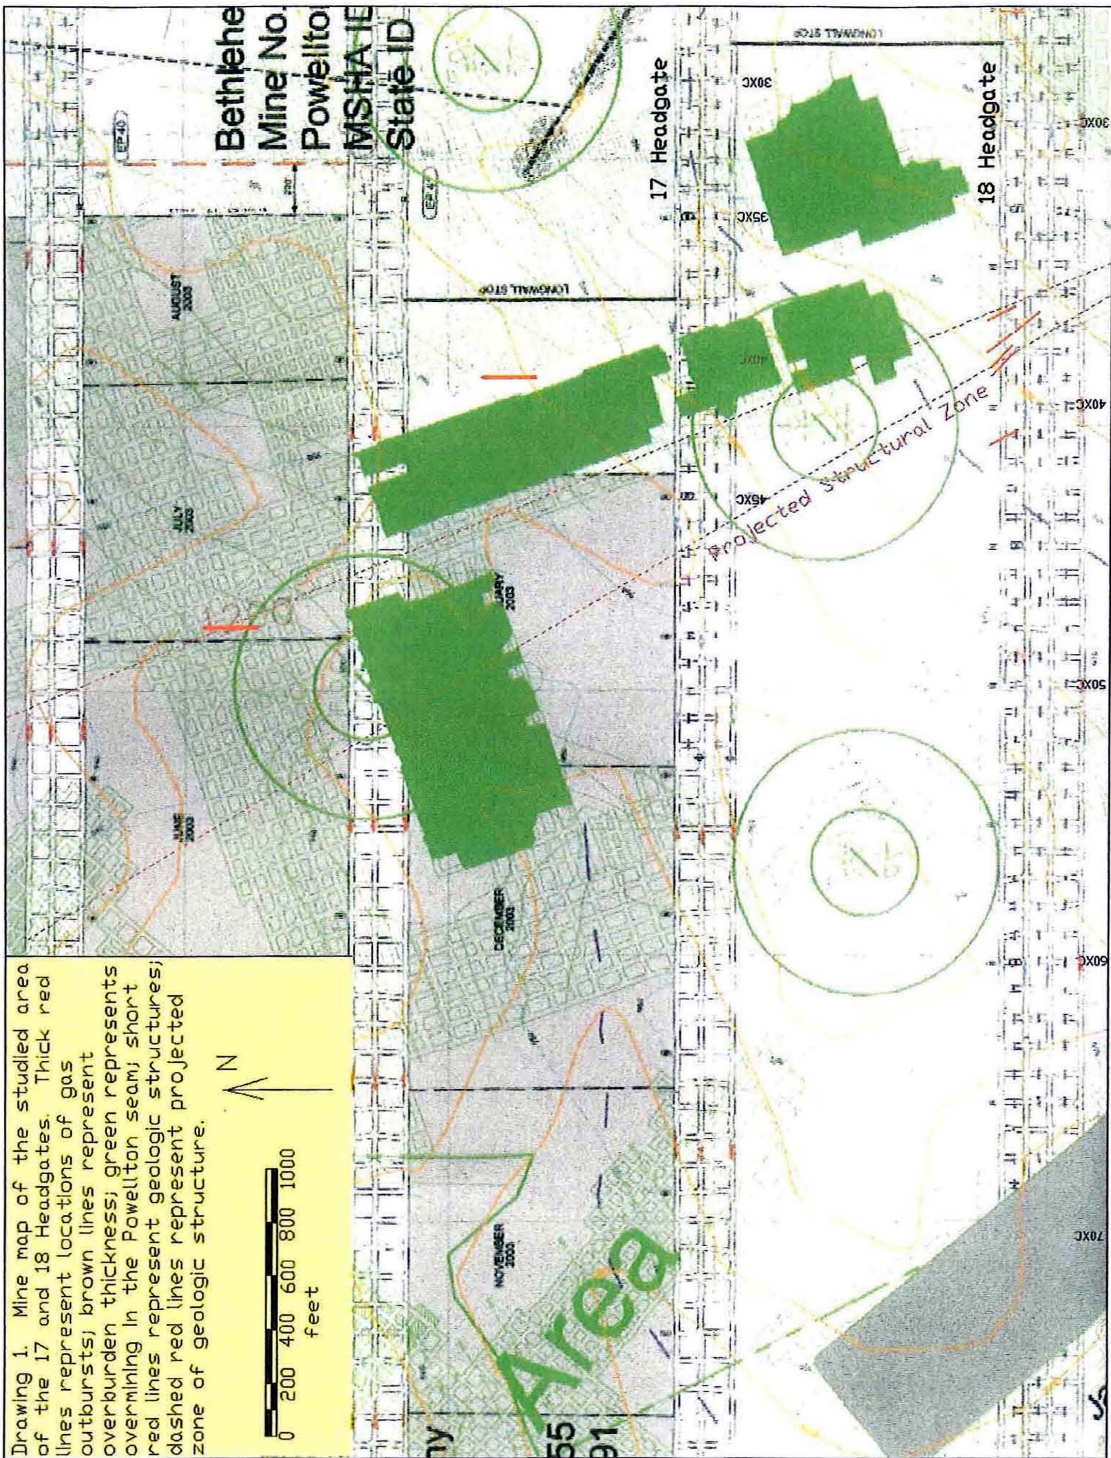
Drawing 1. Mine map of the studied area of the 17 and 18 Headgates. Thick red lines represent locations of gas outbursts; brown lines represent overburden thickness; green represents overlying in the Powellton seam; short red lines represent geologic structures; dashed red lines represent projected zone of geologic structure.

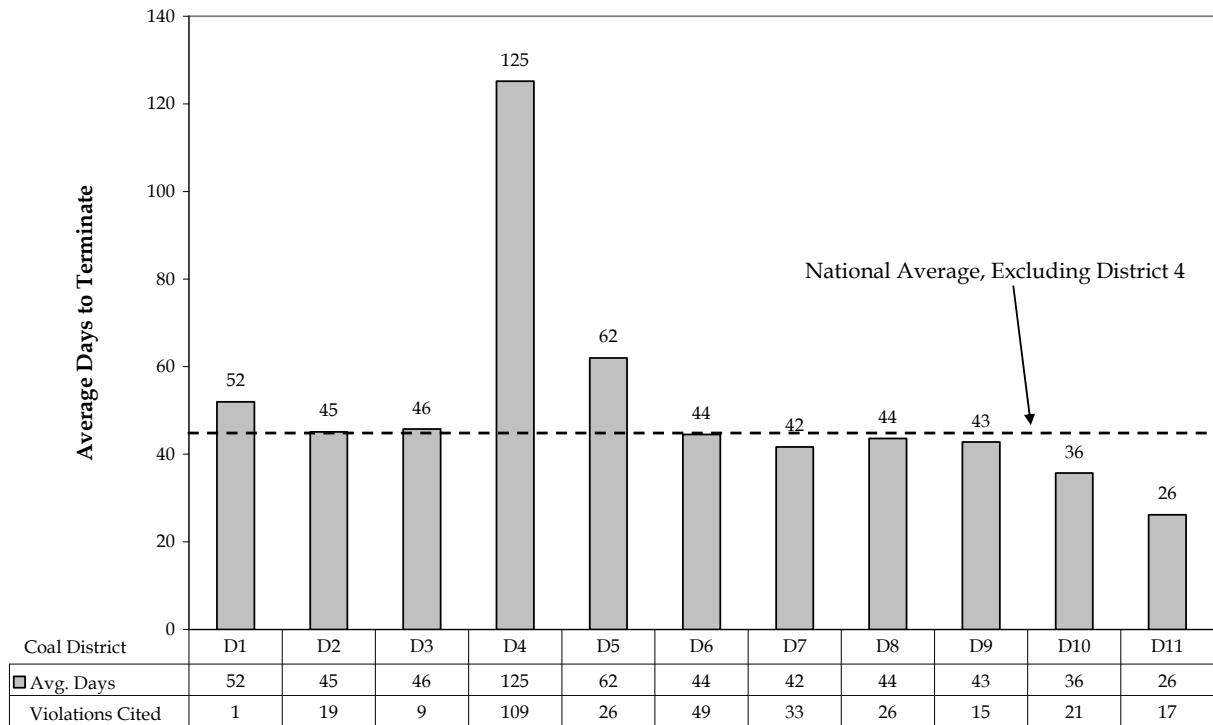
Figure 23 - Average Days to Terminate Violations for Exceeding Respirable Dust Standards.

Figure 23 shows the average number of days in each Coal district to terminate citations issued for violations of 30 CFR 70.100(a) or 30 CFR 70.101 when miners’ exposures exceeded the applicable respirable dust standard during the review period. The average time to abate violations of 30 CFR 70.100(a) and 30 CFR 70.101 at UBB was consistent with the average time to abate similar violations at other mines in District 4. However, the average time to abate violations of these respirable dust standards in District 4 was almost three times the average for all other districts.

The District 4 Health Department supervisor stated in an interview that, when a mine operator was cited for an overexposure under 30 CFR 70.100(a) or 30 CFR 70.101, the district required an upgrade to the existing plan to enhance dust controls. If noncompliance continued, a section 104(b) order was issued and the MMU was shut down until “meaningful” changes to the plan were made and additional dust control measures were implemented. During the review period, District 4 inspectors and specialists issued nine section 104(b) orders, including the aforementioned order at UBB.
