COAL MINE SAFETY AND HEALTH
REPORT OF INVESTIGATION

Fatal Machinery Accident
July 2, 2003

Highland 9 Mine
Highland Mining Company
Waverly, Union County, Kentucky
I.D. No. 15-02709

Release Date: October 30, 2003

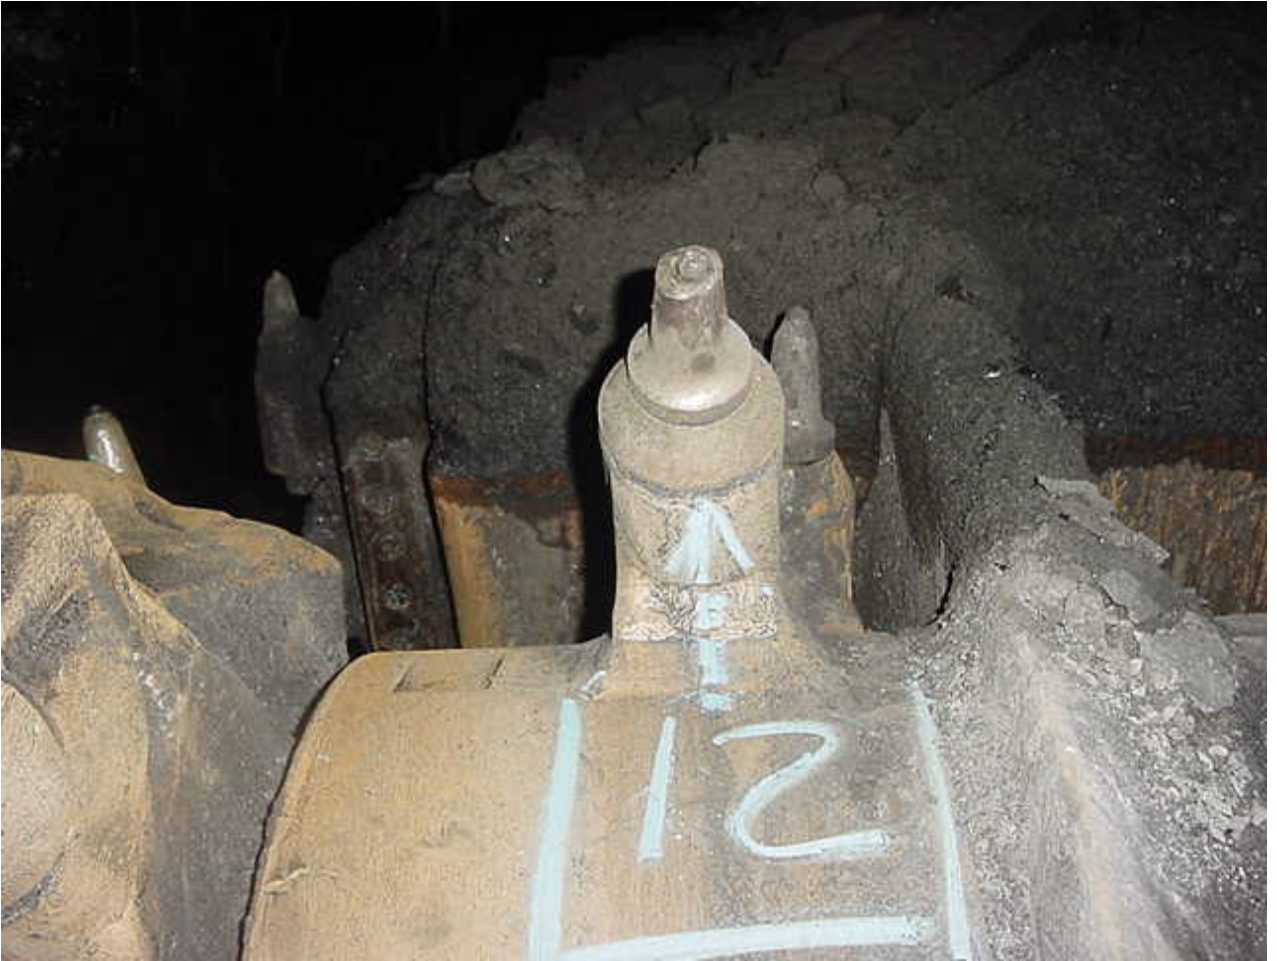
Appendix E

Causal Factor: The bit lost its tungsten carbide tip causing the steel bit body to come in contact with a carbonate nodule. The cutting bit body repeatedly impacted the carbonate nodule resulting in the shrapnel being generated.

The direct cause of the accident was breakage and fragmentation of the No.12 bit on the continuous mining machine's cutting drum as it impacted a carbonate nodule. Bits are not to be used when the tip (insert) is missing. The root cause of the accident was lacking or missing procedures for safely mining when carbonate nodules are encountered. These include the following when such conditions are present: undermining where possible; locating the operator farther from the machine; examining for and replacing broken bits more frequently; using personal protective equipment; ensuring the machine configuration is appropriate for the conditions.

No. 12 Bit Located on Cutter Head

Corrective Actions: When adverse roof conditions of this nature are encountered, cutting bits should be visually examined prior to and frequently during the operation and replaced as necessary.

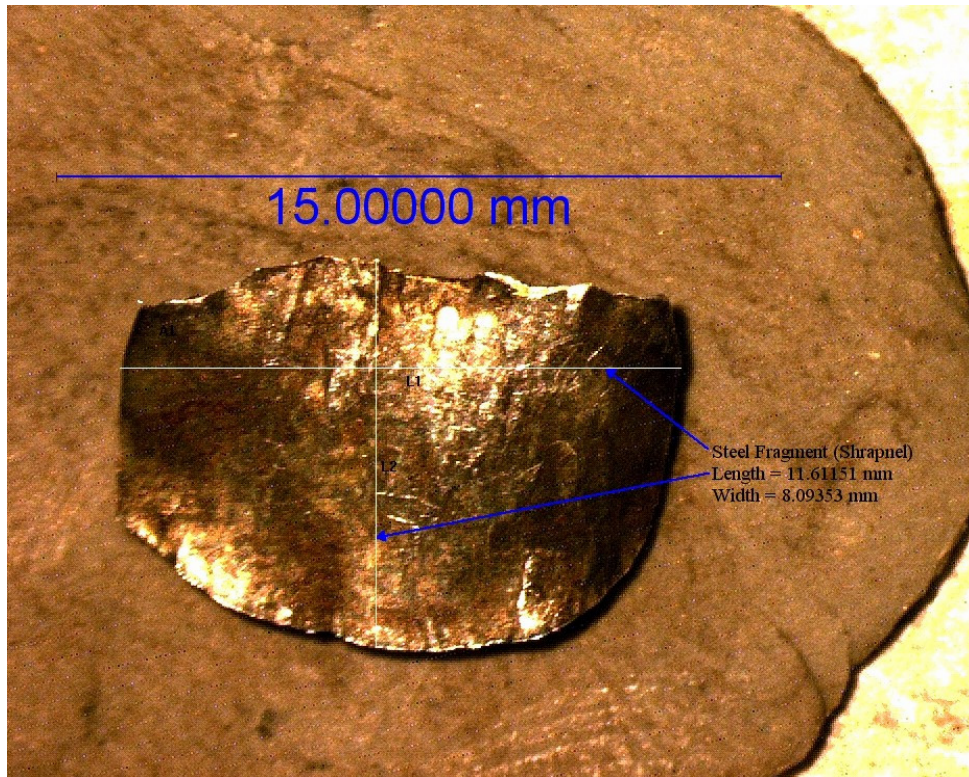
Appendix F

The piece of material recovered from the victim’s body was wedge-shaped, measuring 0.46” long x 0.32” wide x 0.27” thick at the base tapering to a sharp edge (see Appendix F). The material weighed 1.5236 grams and was approximately 0.18 cubic centimeters in volume. The material was determined to be steel. The material was found through microscopic evaluation to be from the body of the No.12 bit, located on the end drum approximately 20 inches from the right side of the continuous mining machine (see Appendix E). The bit had lost its carbide tip during or prior to cutting through the large carbonate nodule on the right side. The bit continued to hammer into the face at a rate of approximately 59 times a minute. At some point in time, a piece of the bit base separated and struck the victim in the neck.

Microscopic Photo of Metal Shrapnel

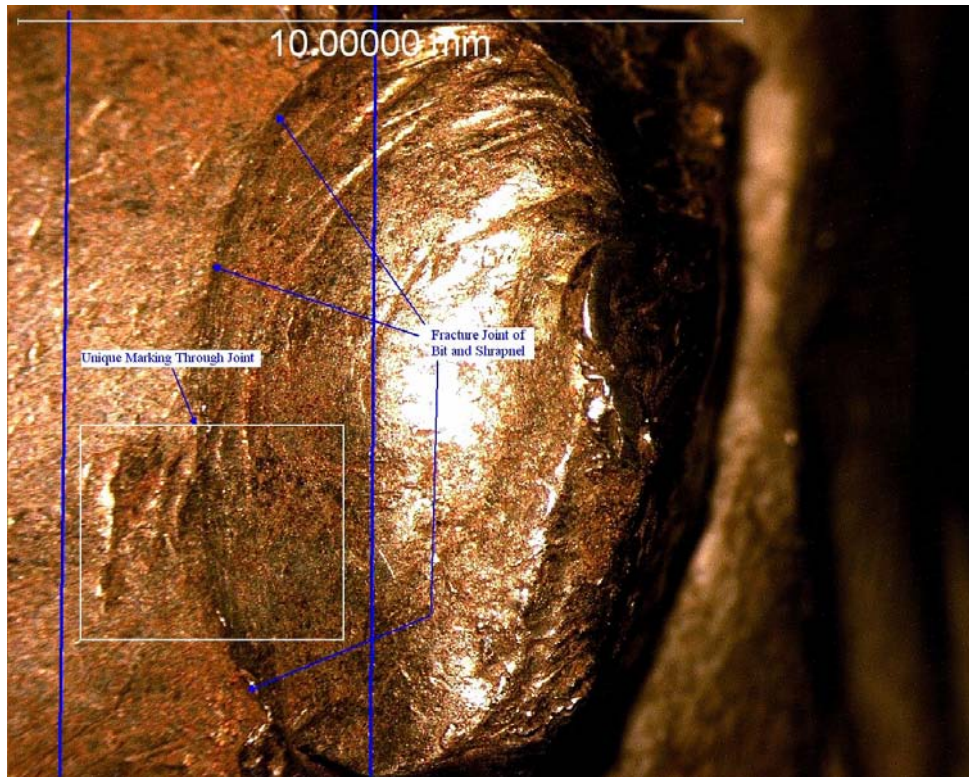
Appendix G

Microscopic Photo of Bit and Shrapnel Match

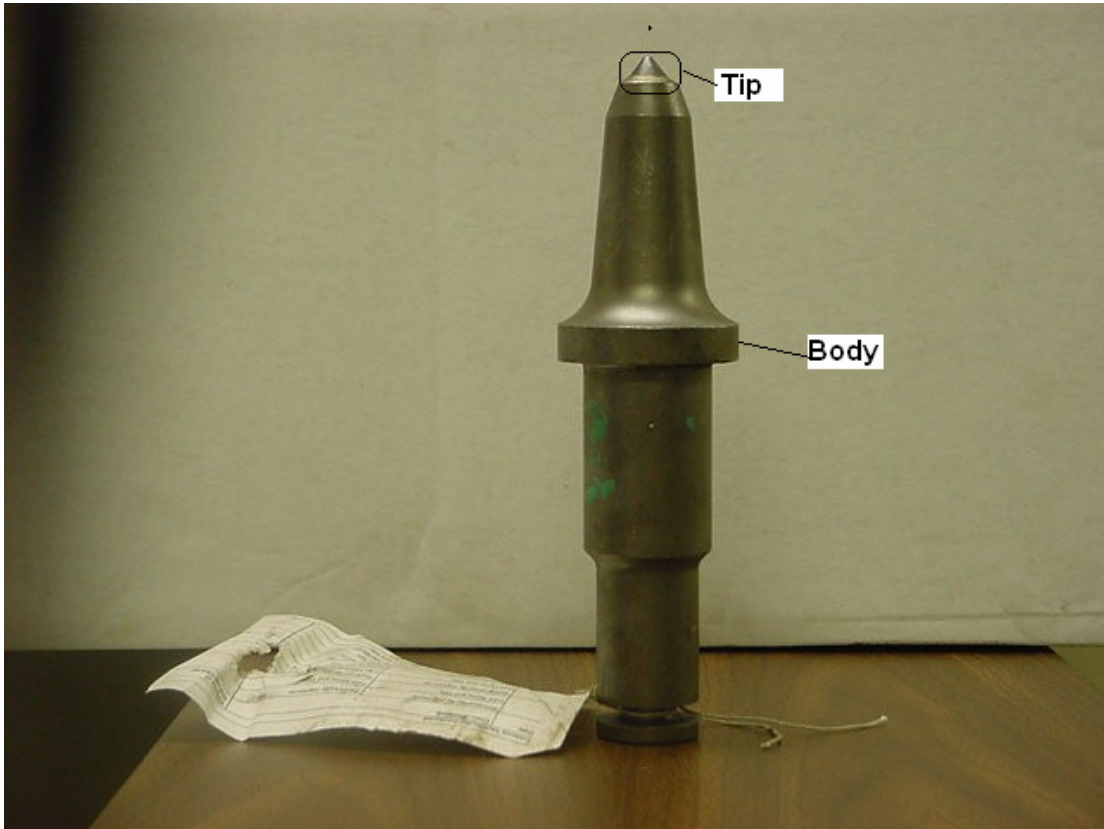
Appendix H

The continuous mining machine was fitted with Kennametal U170 4.0 16s conical cutting bits commonly called miner bits (see appendix H). Kennametal reported the bit body is made of 4140 steel heat treated and tempered to a 40-45 Rockwell "C" hardness, with an approximate density of 7.85 grams/cubic centimeter (g/cc). The 16 mm diameter cutting bit tip is made of Kennametal Grade K3560 tungsten carbide with a density of 14.35(g/cc). A notice is attached to the bit container warning of the safety risk in using dull bits. In May 2003, the mine changed to the U170 4.0 16s bit to reduce respirable dust generation. Kennametal reported that Highland 9 Mine is the only operation utilizing this bit.

Kennametal U170 4.0 16s Conical Bit

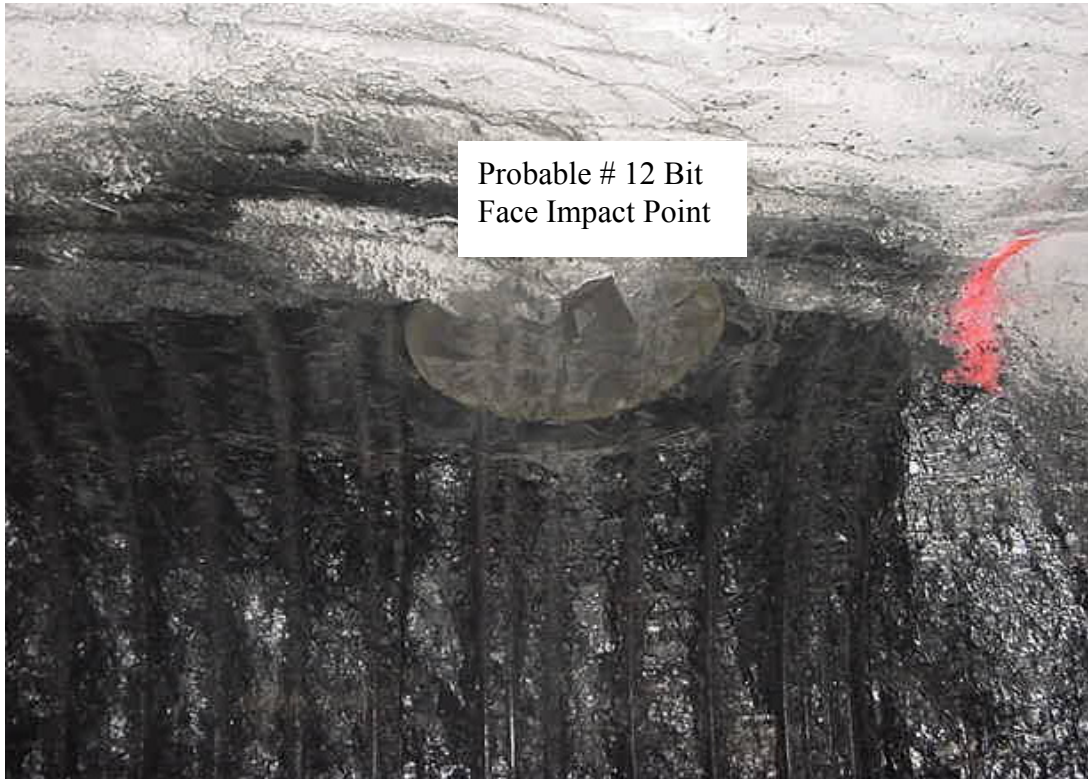
Appendix I

At the time of the accident the bits on the cutter head encountered a carbonate nodule in the mine roof measuring roughly 14” in length by 12” in depth (see Appendix I). The bits contacting the carbonate nodules were generating a significant amount of sparks.

Causal Factor: The presence of a carbonate nodule in the mine roof measuring roughly 14” in length by 12” in depth and numerous other small carbonate nodules with extensive pyritic dissemination were encountered in the mine roof. The carbonate nodules are conducive to sparking when struck with the cutting bits due to the density of the limestone and the presence of pyrite.

Carbonate Nodule

Corrective Actions: When carbonate nodules with extensive pyritic deposits are encountered in the mine roof the operator should first mine directly under the deposits to create a free face in attempt to jar the nodules loose. These nodules are extremely hard to cut due to the density of their carbonate makeup. The shale that surrounds the nodules increases the propensity of the nodules to drop out especially when they are hit with the continuous mining machine cutter head.
