# LOCAL ROAD SAFETY PLAN

**BOONE COUNTY**  
KENTUCKY

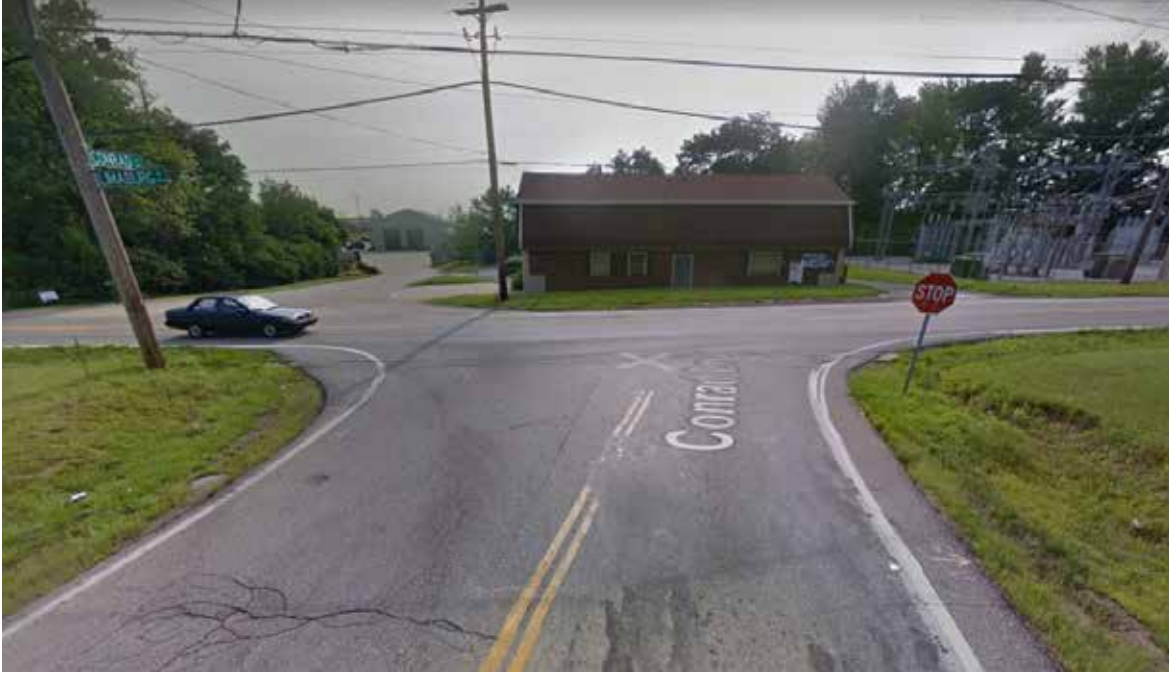
Figure 17: 'T' Intersection Conrad Lane at Limaburg Road

Some roadways were observed to have minimally placed traffic control at intersections, particularly at 'T' intersections. These intersections typically only had a single stop sign (Figure 17).

At 'T' intersections, especially in unlit areas, the presence of the intersection may be even more difficult to discern for some drivers. In addition to the risk associated with entering the intersection, fixed object crashes if a driver proceeds through a 'T' intersection are also common. A Two Direction Large Arrow signs (W1-7; see figure) is another low-cost method to reinforce stop control at T- intersections. It is proposed that Boone County adopt the use of the Two Direction Large Arrow (W1-7) sign at all 'T' intersections on rural roads as shown in Figure 18.

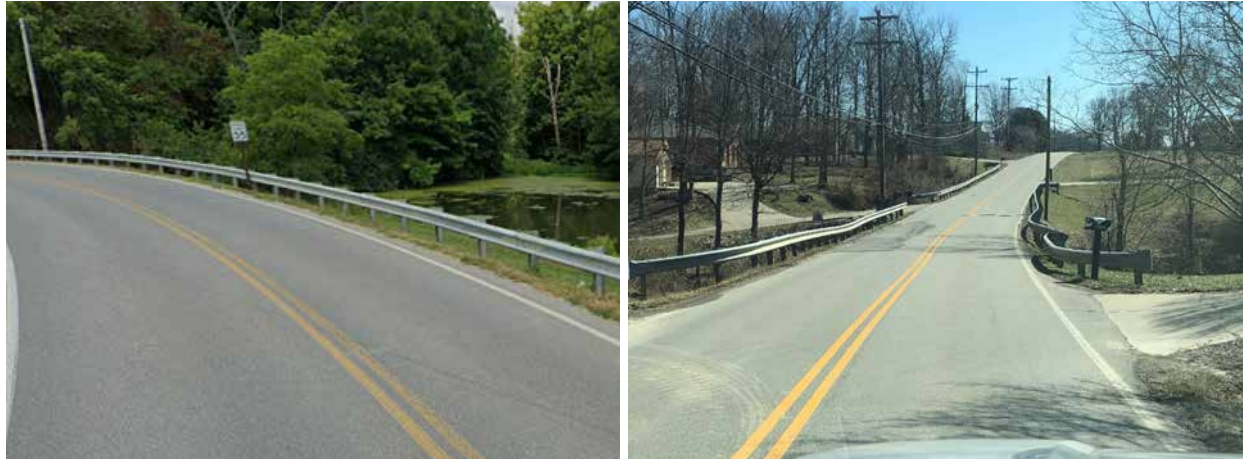
**Figure 20: Existing Guardrail Installations (Hicks Pike and Bullitsville Road)**

On several roadways within the county, the need for guardrail to protect against critical slopes and/or fixed objects was observed. In some cases guardrail was present, but required adjustment or replacement to meet current standards (**Figure 20**); while in other areas guardrail was absent or required extension of the length of need to adequately protect errant vehicles. In most cases, guardrail end treatments were noted to not meet current design and crashworthy standards. Select guidance based on KYTC standards for guardrail installation is provided below. Additional guidance can be found in KYTC Standard Roadway Drawings and the AASHTO Roadside Design Guide.

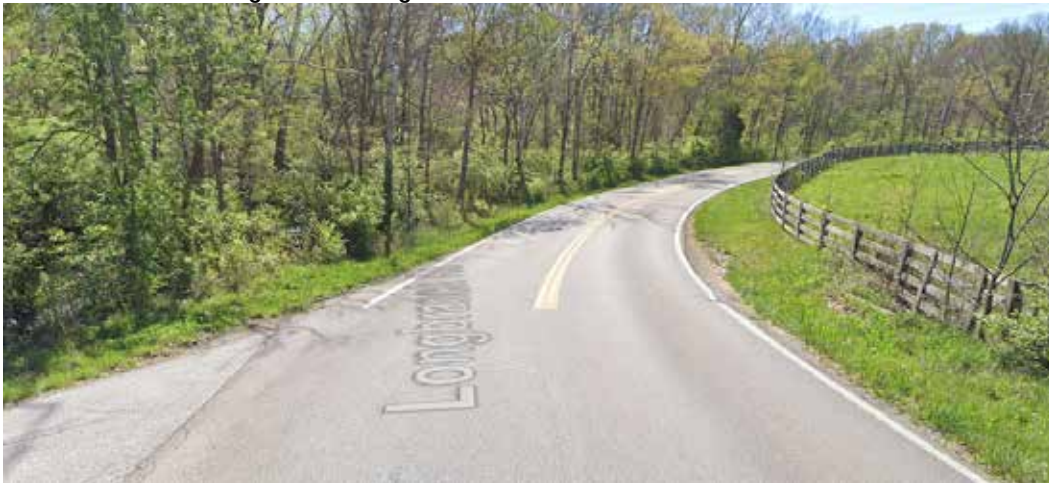
**Figure 26: Longbranch Road at Fowler Creek Road**

**Figure 25** shows one of these locations on Longbranch Road near the intersection with Fowler Creek Road where 9 of the 11 crashes involved wet pavement conditions. Several similar locations have been previously identified and mitigated by the Boone County Road Department through the installation of High Friction Surface Treatment (HFST) which increases surface friction during wet weather events.

It is recommended that areas identified as having a higher concentration of wet weather crashes be observed during significant rain events to identify areas of ponding and/or excessive sheet flow. If no drainage issues are identified, friction testing is recommended to determine if HFST would be a suitable mitigation measure.

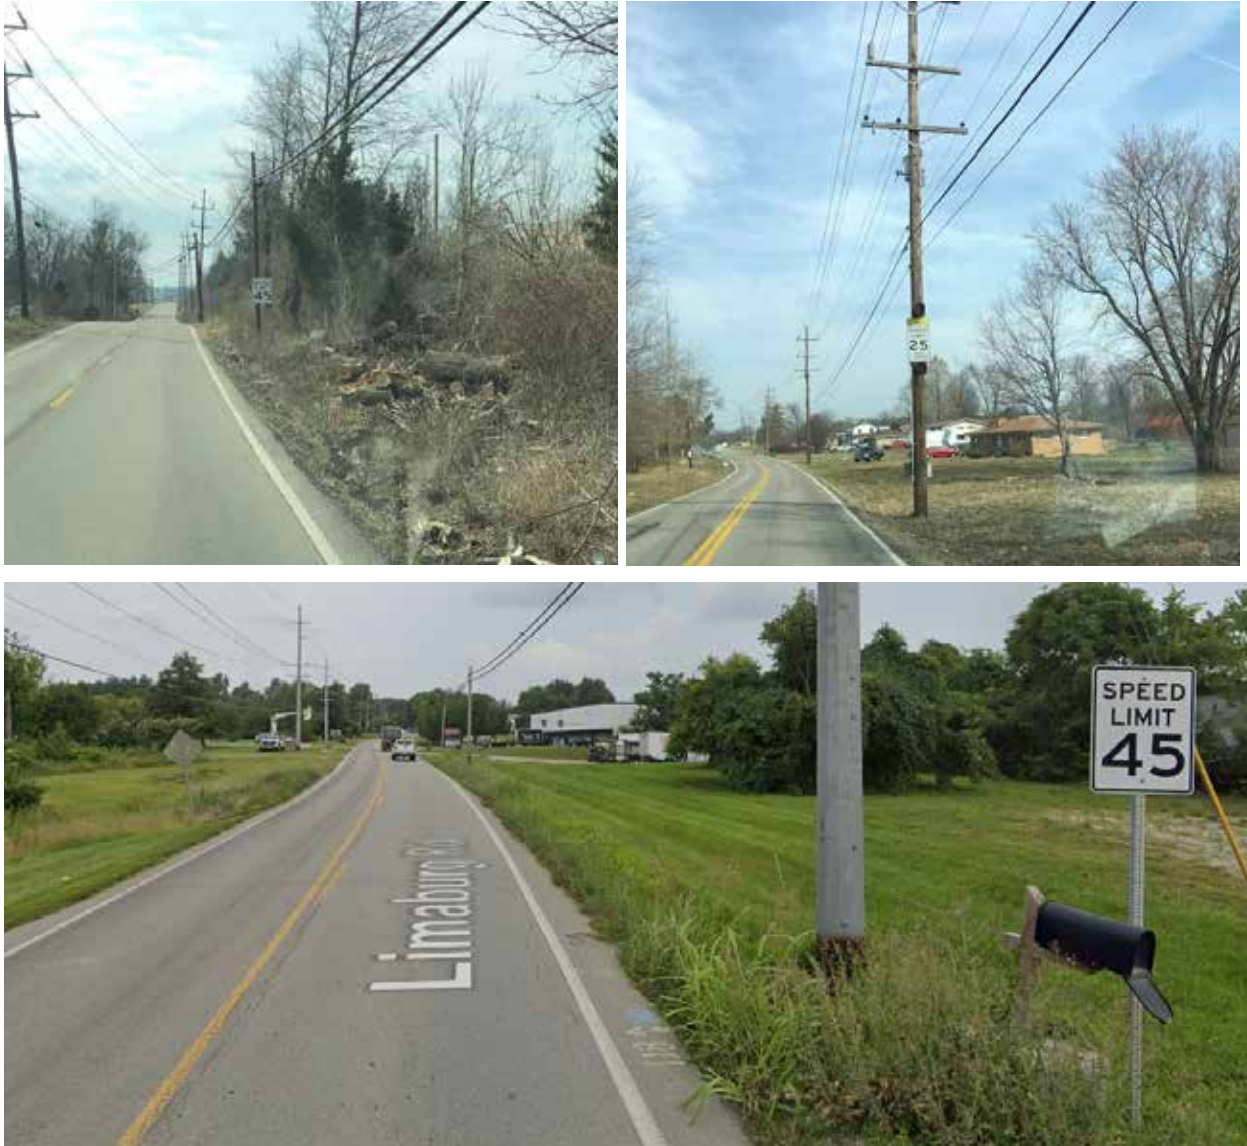
Figure A1-3: Fixed Objects (Limaburg Road)

The northern half of the corridor has a high frequency of fixed objects, as shown in Figure A1-3 and A1-4. Utility poles are located close to the road edge presenting a hazard as well as other fixed objects and debris, such as the logs shown in Figure A1-3. The proximity of these obstacles to the roadway increase the likelihood of crashes as is evidenced by the crash analysis above and shown in Figure A1-1. It is recommended that utility poles close to the roadway be demarcated with Type 2 object markers. Debris and vegetation within the right-of-way that can be removed should be removed.

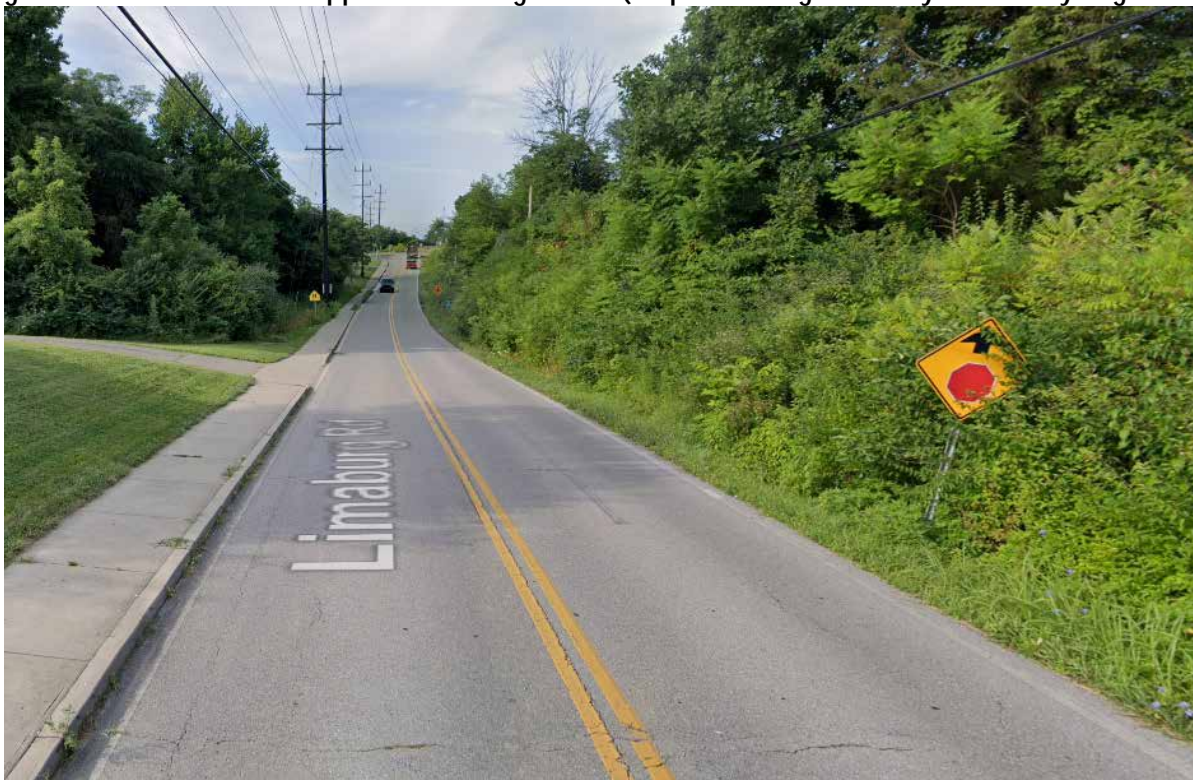
Figure A1-16: Southbound Approach to Cougar Path (Stop Ahead Sign Partially blocked by Vegetation)

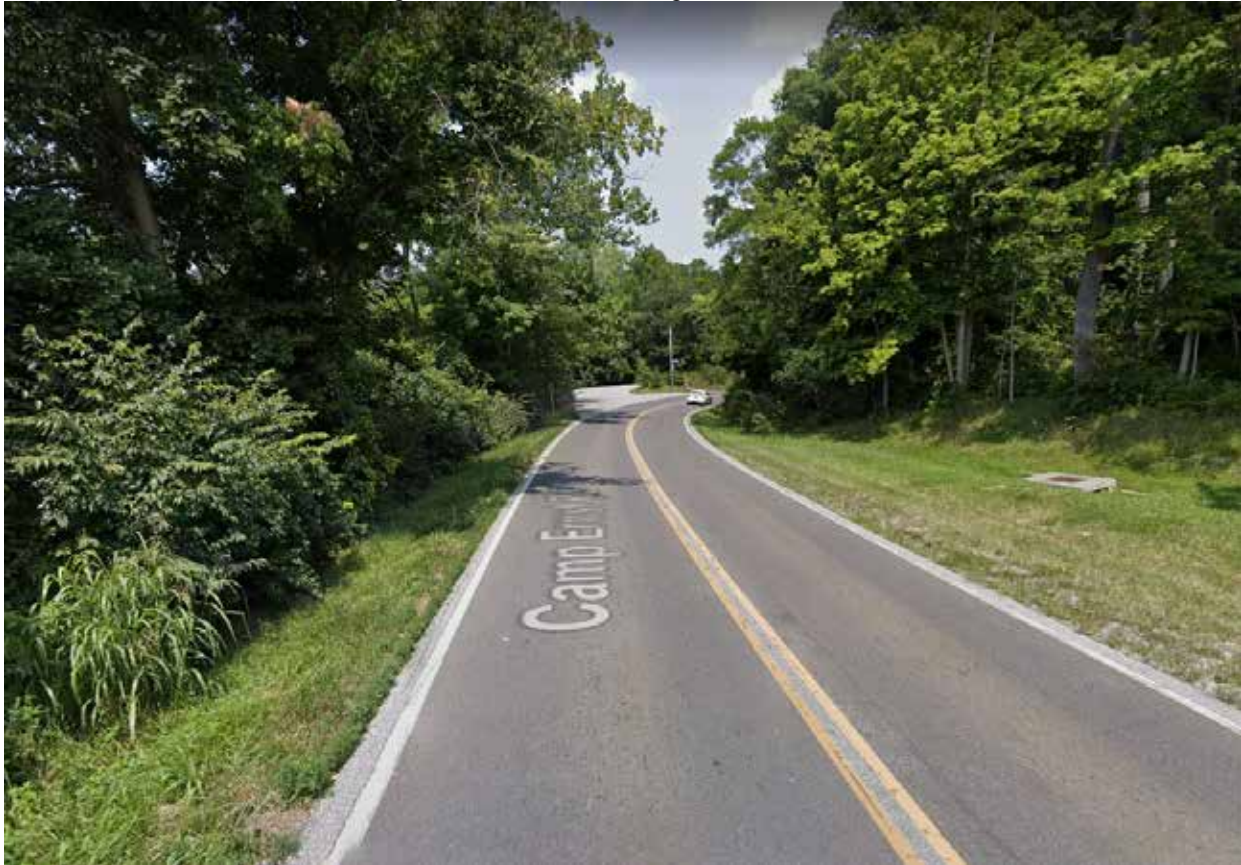
**Figure A2-4: Northern High Crash Location**

**Wet Crash Location No. 1.** The northern location near the intersection of Camp Ernst Lane experience 56 crashes within the 5-year study period, 41 of which involved a wet pavement condition. The curve has a radius of approximately 400 feet and proper superelevation, though it is located on a downward grade from the south as it approaches Gunpowder Creek. The intersection of Camp Ernst Lane near the apex of the curve, further complicates the negotiation of the curve as it can cause a visual trap as to the intended path of the curve.

1. Continue to monitor crash history at the northern high crash curve, recently improved with the HFST to ensure that crashes have been sufficiently addressed by the improvement.
2. Evaluate drainage at the southern high crash curve location near the Boone County Knothole Baseball Complex to ensure that standing or sheeting water on the roadway is not the primary cause of the high wet pavement crash frequency. If drainage is deemed sufficient, consider a similar HFST application as was installed for the northern curve.
3. Provide improved ditching and shouldering throughout the corridor to relocate drainage ditches away from roadway to increase recovery area for vehicles. This may require relocation of driveway crossdrains to provide adequate slope within the ditch. A similar project was recently completed by a home owner along Camp Ernst Road as shown below.

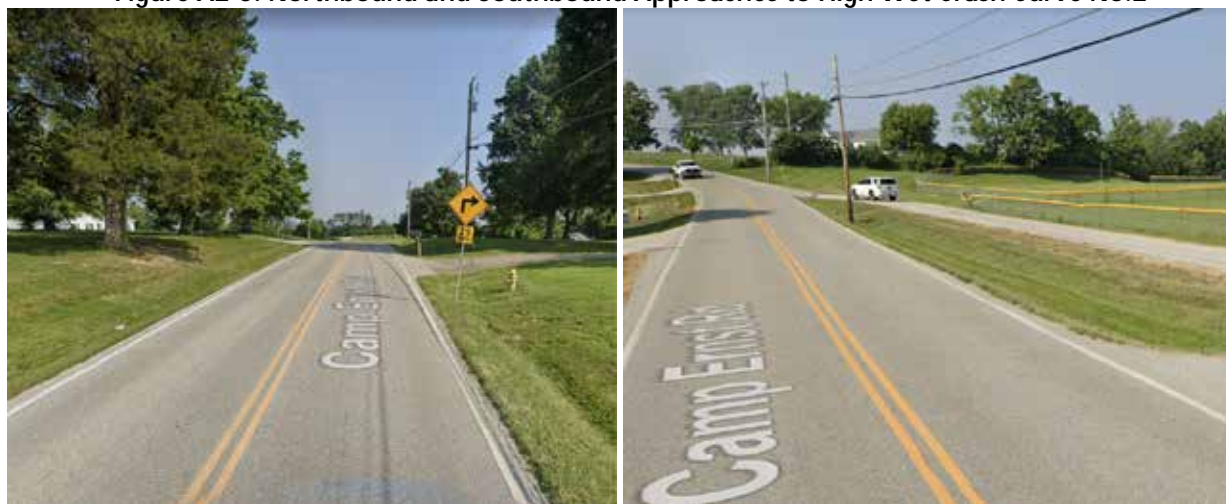
Figure A2-5: Northbound and Southbound Approaches to High Wet Crash Curve No.2

**Wet Crash Location No. 2.** The southern location, shown in Inset No. 2 experienced 15 crashes over the 5-year study period with 13 involving wet pavement conditions. The curve has a radius of approximately 400 feet with proper superelevation. Curve warning signs are present from the south, as the curve develops after a vertical crest. Advanced curve signs are not present from the north (**Figure A2-5a**). Chevrons are located throughout the curve. A secondary entrance to the Boone County Knothole Baseball complex is located at the north PC of the curve (**Figure A2-5b**). The road appears to have good drainage ditches on both sides with the water flowing off the roadway (**Figure A2-6**). Approximately 400 feet to the north, ditches are not as prominent as through the curve, but any flow from this area is not anticipated to impact the operations of the curve itself where crashes are occurring. If drainage is not an issue as it appears, a lack of pavement friction may be contributing to the high number of wet weather crashes.

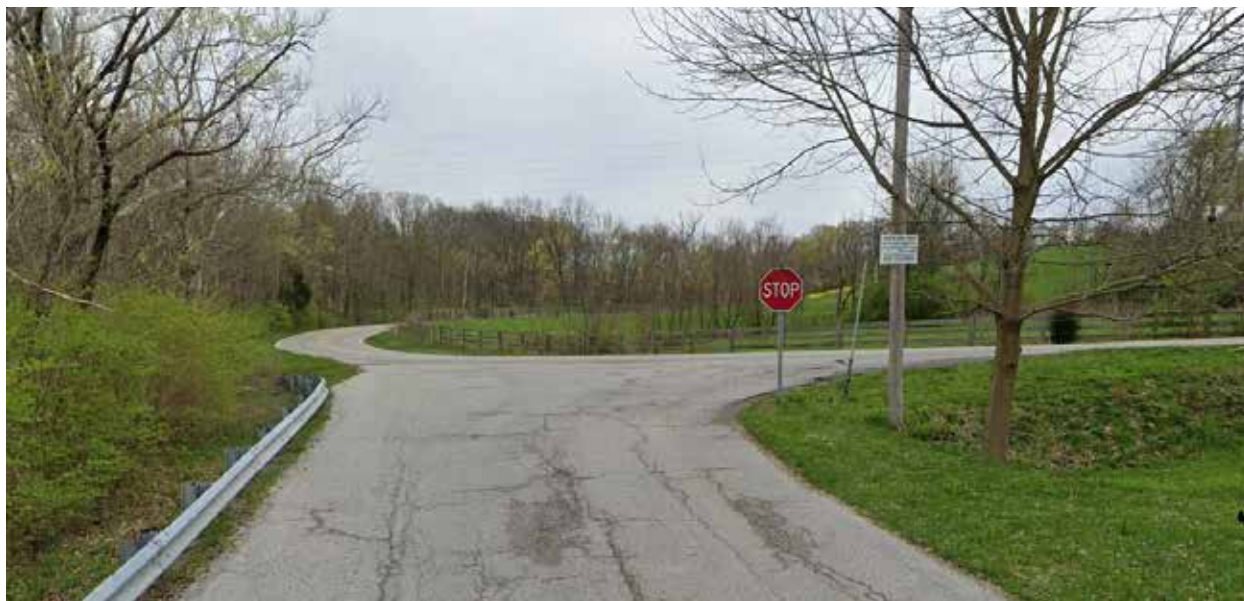
Figure A4-10: Fowler Creek Road at Longbranch Road (looking left)

The intersection of Fowler Creek Road which is located in a curve (Figure A4-10), can also present issues as to the appropriate stop location, as well as cause issues for drivers on Longbranch road, understanding the intended vehicle path.

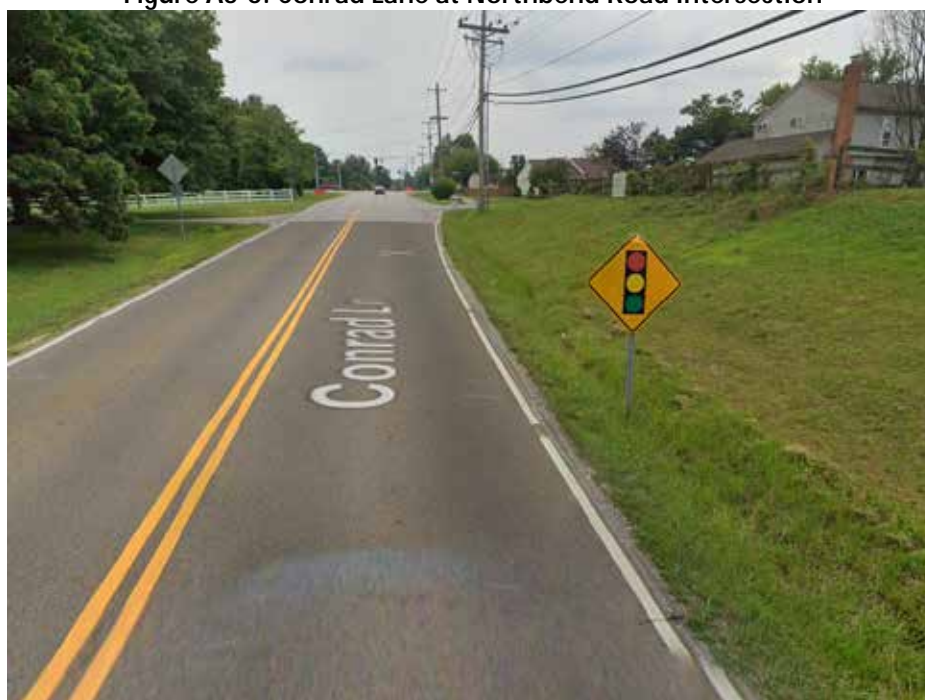
Figure A5-6: Conrad Lane at Northbend Road Intersection

The signal ahead sign on the eastbound approach to Northbend Road is located over 400 feet from the intersection and appears to be placed below the 5 foot minimum height recommended by the MUTCD (Figure A5-6). Minimum distance for advance warning signs for traffic signal control is 100 feet, though the presence of stopped queues may require additional distance.

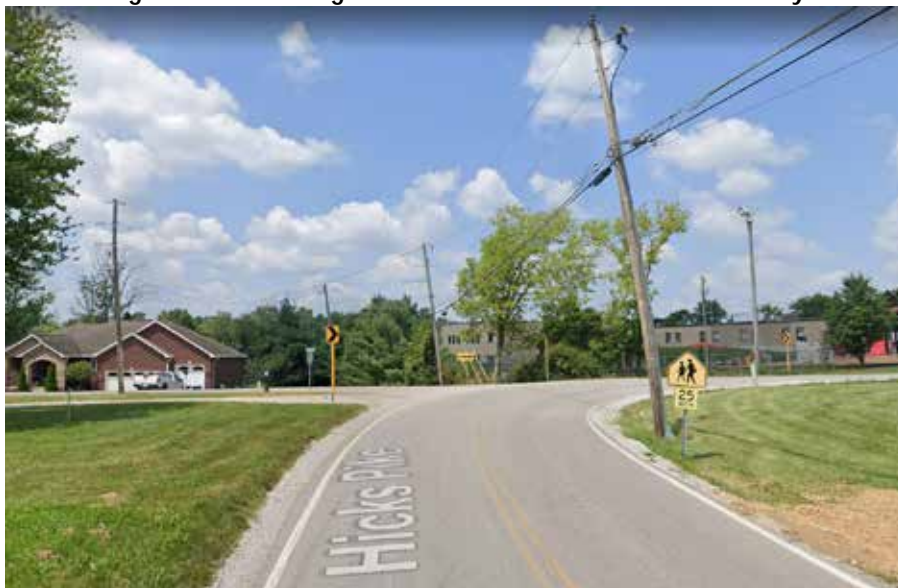
**Figure A6-4: 90 Degree Turn Near New Haven Elementary**

A pedestrian crossing sign is also present at the apex of the curve adjacent to a utility pole (**Figure A6-4**). Several signs, including the Large Arrow Sign at the turn also appear to be undersized (**Figure A6-4**). Additionally, The intersection of Huey Place and a residential driveway at this location further complicate the signing and geometrics of the curve. From the north only two chevrons are present at the turn, primarily oriented towards the tangent of the roadway. It is also noted that gravel from one of the driveways is present on the roadway which could contribute to loss of control crashes (**Figure A6-5**).
