# St. Michaels Church, Trefeglwys, Powys

Archaeological Watching Brief

By Chris E Smith BA (Hons) MA MIFA Report No. 602

Date: January 2010

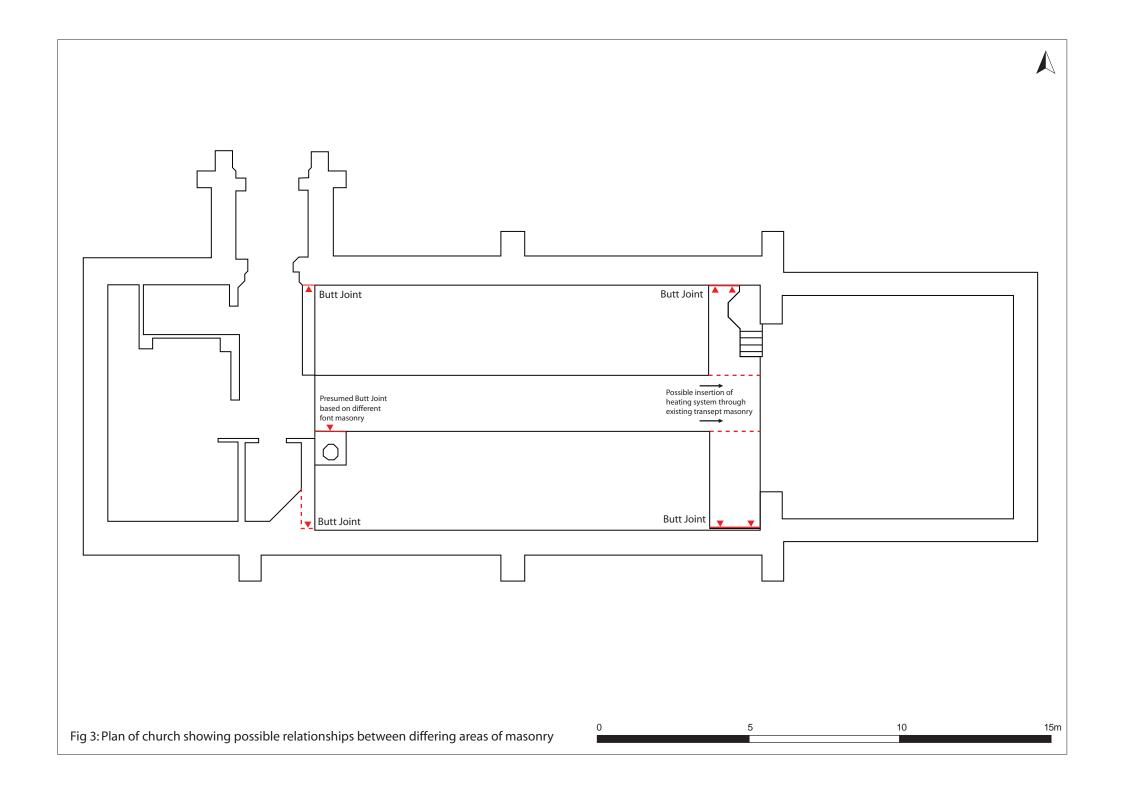
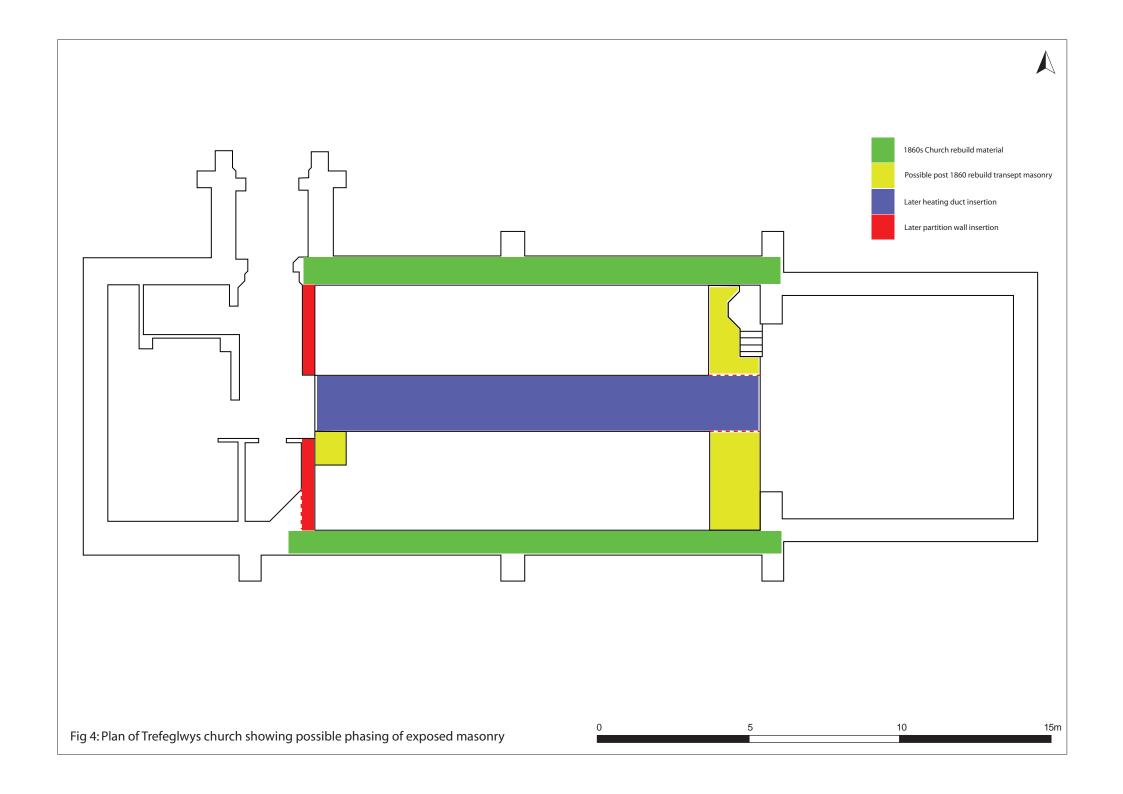
- 4.3.6 Areas exposed during the watching brief showed various types of masonry in different areas of the church (Plates 1-6) (Figs 3-4). The masonry of the central aisle, for example, was of a different finish to that of the church wall foundations. The masonry beneath the font looks very similar in its make up to the masonry of the transept either side of where it joins the central aisle. Masonry in the centre of the transept appears to be the same as that of the central aisle. It is possible therefore that

- the central aisle, which houses the old heating ducts, was inserted through the transept sometime after its construction in the nineteenth century.
- 4.3.7 This would mean that the central aisle, or at least the heating aspect of it, post dates the 1860s rebuilding.
- 4.3.8 The wall at the west end of the nave was also finished in bricks and clearly butted against the load bearing outer walls. The lower courses of this wall were constructed in stone and appear tied into, and thus contemporary with, the outer walls of the church. The addition of bricks over this stone course may hint at a later addition. The bricks also appear to butt against the masonry beneath the font.
- 4.3.9 Aside from the previous heating system, clear evidence of phasing within the exposed masonry and occasional disarticulated human bone, nothing of archaeological significance was discovered.

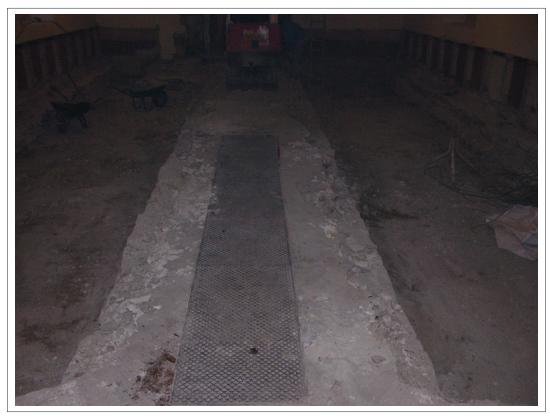
- 4.3.1 Removal of the floorboards and joists beneath the pews on either side of the central aisle revealed the large open areas into which warm air was carried via a flue beneath the central aisle. These open areas measured approximately 10m in length by 3m in width. Removal of rubble and debris from these revealed a compacted, level, soil horizon at approximately 0.5m below the original floor level of the church. Mixed within the rubble and debris above the compacted soil horizon was a small amount of disarticulated human bone.

Plate 1: View of hollow areas (cavities) in nave located either side of the central aisle. Note heating grills in foreground located directly above flu in central aisle. Scale 1x1m

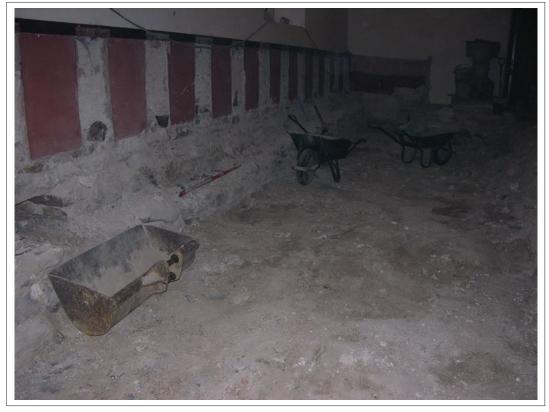
- 4.3.2 Removal of the rubble and debris from the sub-floor cavities either side of the central aisle revealed the interior of the church wall foundations (Plates 1-6).

Plate 2: View of church wall foundation level, exposed after removal of floorboards, joists and rubble fill from hollow area. Scale 1x1m

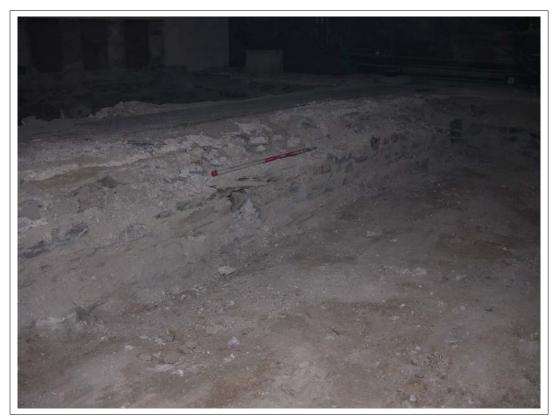
- 4.3.3 The level of the central aisle was reduced in height by approximately 0.3m in order to accommodate the new heating ducts. Removal of overburden composed of stone rubble and concrete/cement, via mechanical excavator revealed the top of the previous heating system. This consisted of a long brick flue running beneath the central aisle. Branches off the flue diverted hot air into the cavities either side of the central aisle. Towards the transept end of the central aisle, the brick flue terminated and joined a cast iron pipe.

- 4.3.4 Within the rubble and concrete/cement overburden of the central aisle a moderate amount of disarticulated human bone was located. This consisted primarily of long bones and skull fragments with no smaller bones apparently being present. Given the presence of the bones directly above a nineteenth or twentieth century heating system, and their entirely disarticulated nature, they are likely to have been redeposited during a construction phase within the church.

Plate 3: View of central aisle containing heating flue, Scale 1x1m

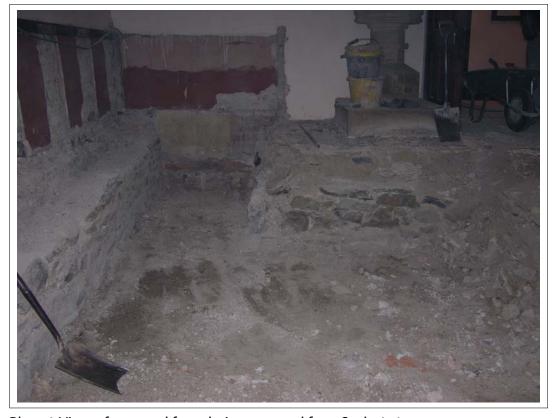
Plate 4: View of exposed foundations around font. Scale 1x1m

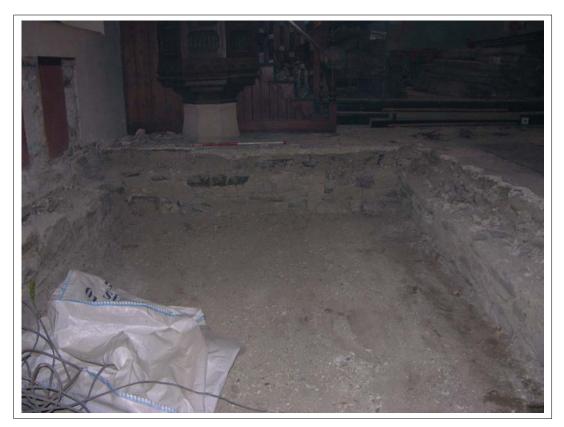
Plate 5: View of exposed foundation masonry below pulpit. Scale 1x1m

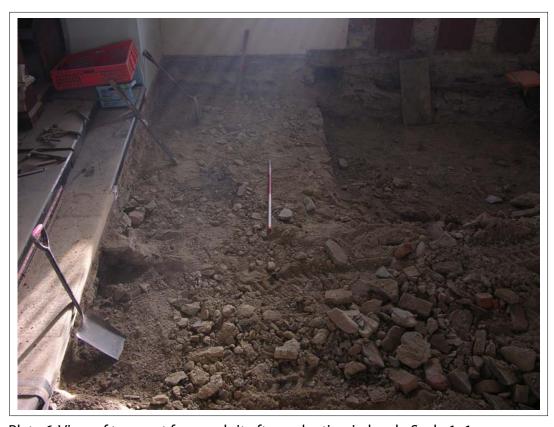
- 4.3.5 Reduction in the floor level in the transept revealed a yellow, sandy, rubble deposit beneath the cement. The base of the deposit was not revealed as it continued below the depth of the excavation (0.3m). No human bone, disarticulated or otherwise, was located within the overburden on the transept.

Plate 6: View of transept from pulpit after reduction in levels. Scale 1x1m
