**PHASE I ENVIRONMENTAL SITE ASSESSMENT
TRACT 1B, MAUI INDUSTRIAL PARK SUBDIVISION**

360 East 100th Avenue
Anchorage, Alaska

ESL Project Number: 8009

PHASE I ENVIRONMENTAL SITE ASSESSMENT

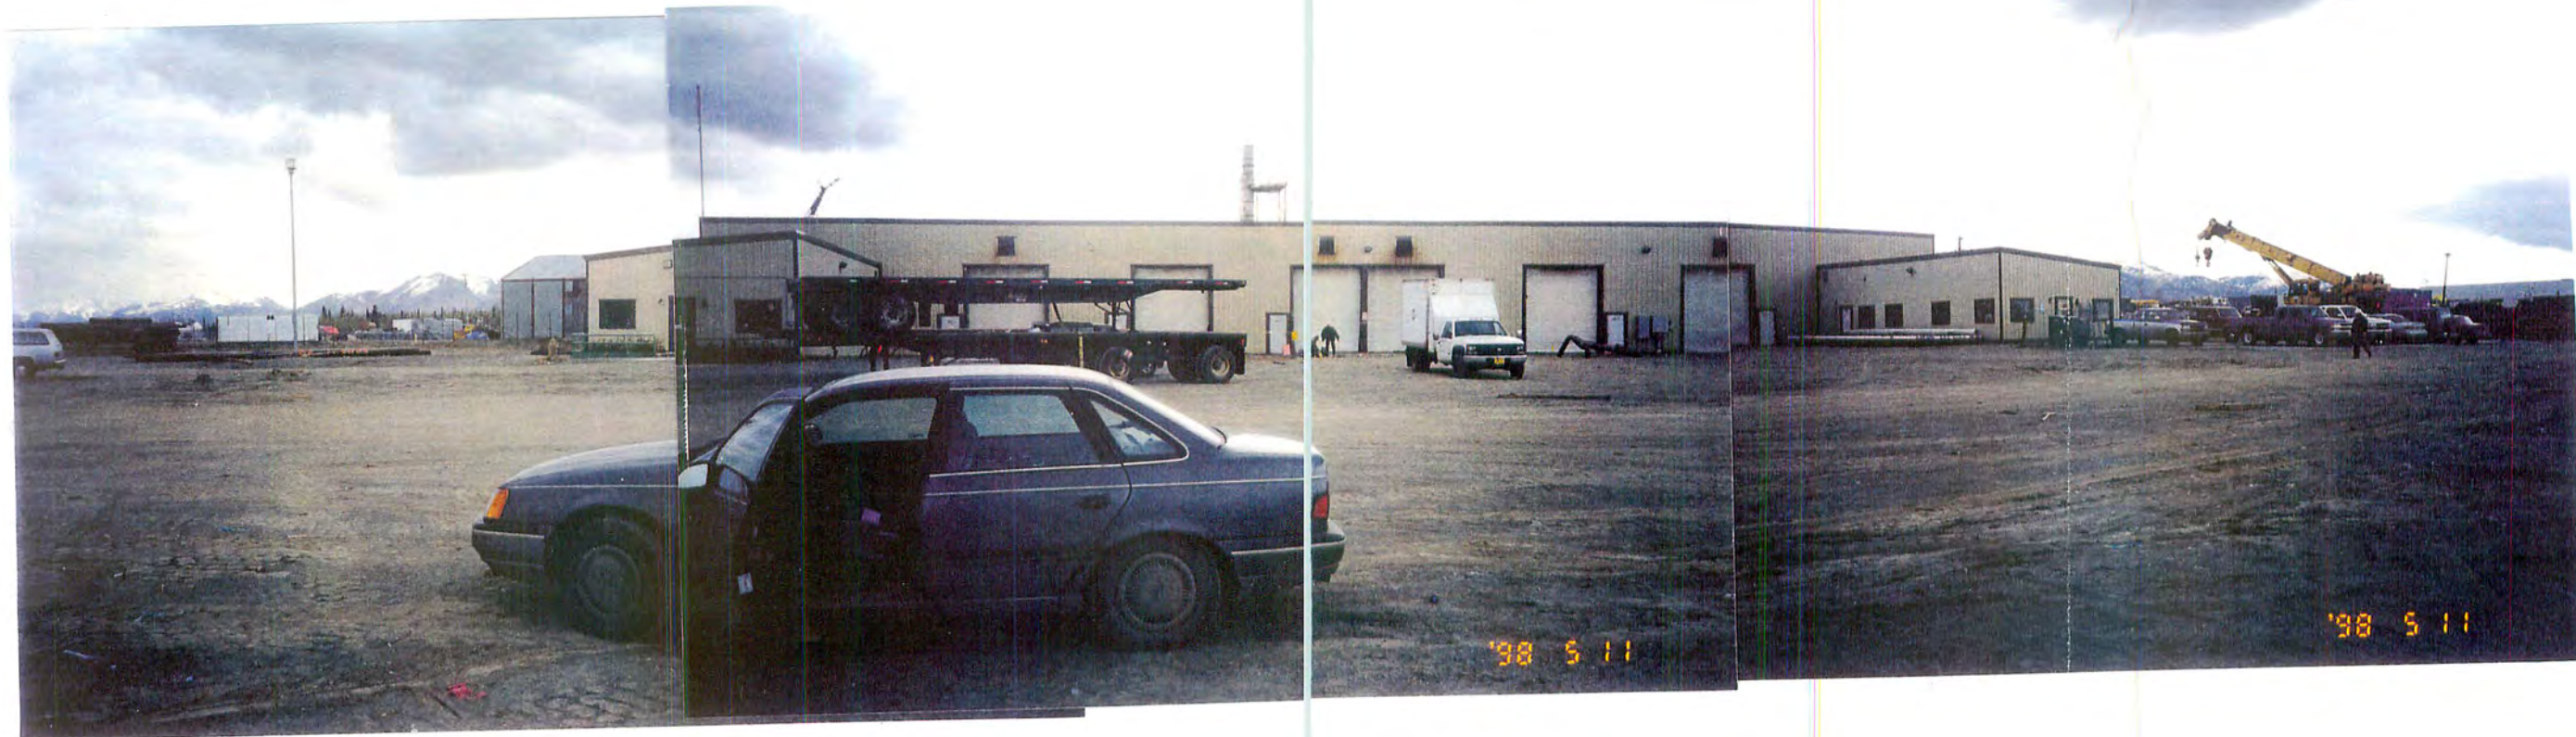
FIGURE 1:
EASTERN PERSPECTIVE OF SUBJECT FACILITY.

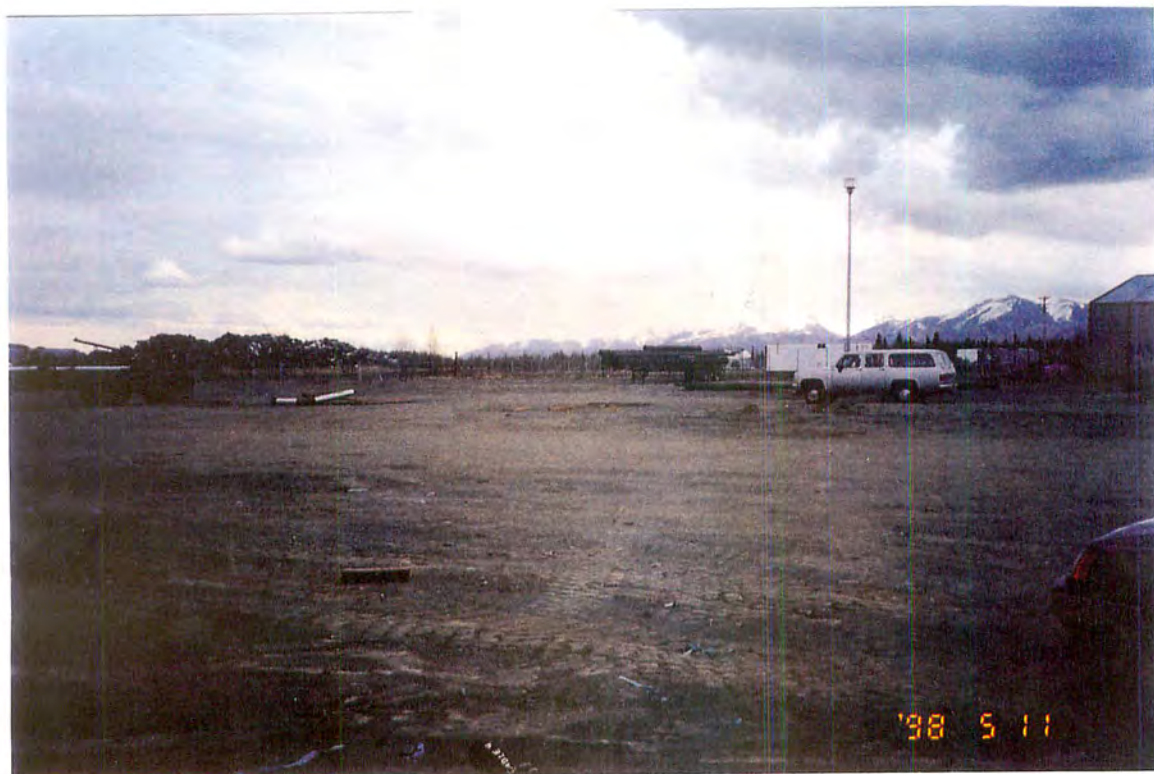
FIGURE 2:
EASTERN PROPERTY LINE OF
SUBJECT FACILITY AND
GENERATOR AT ADJACENT
EITECH COMPLEX.

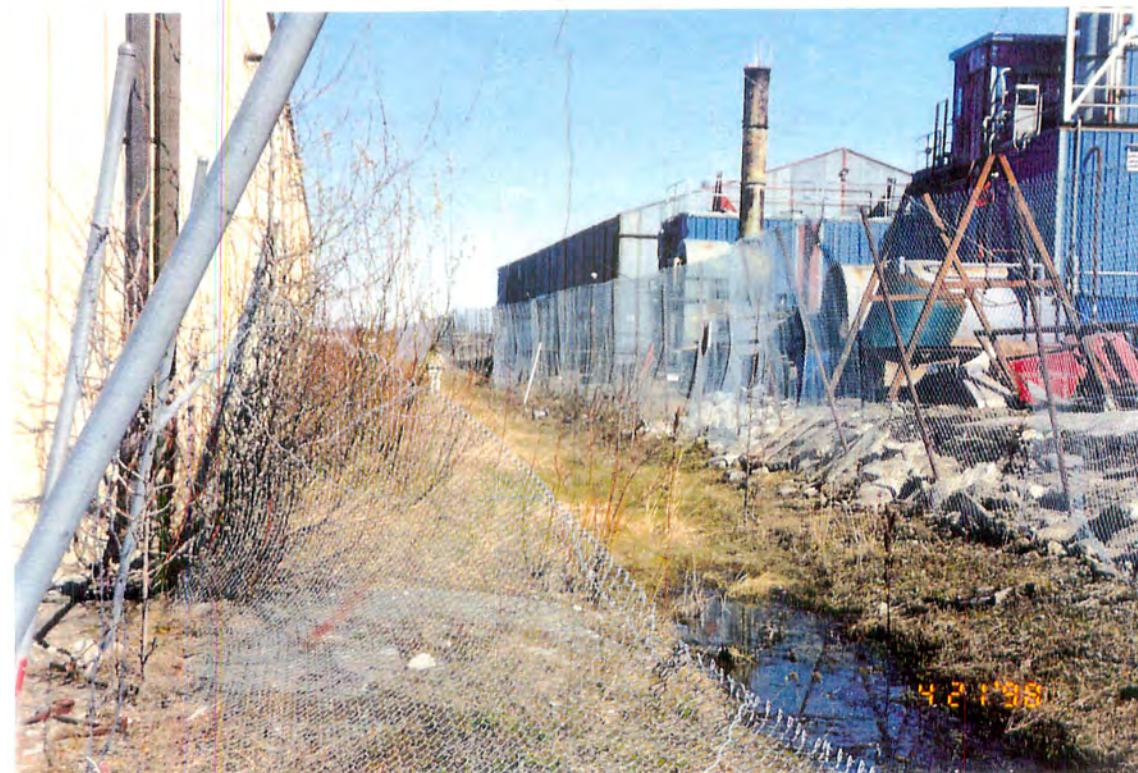
FIGURE 3:
NORTHERN PORTION OF
FACILITY FRONTING ON EAST
100th AVENUE.

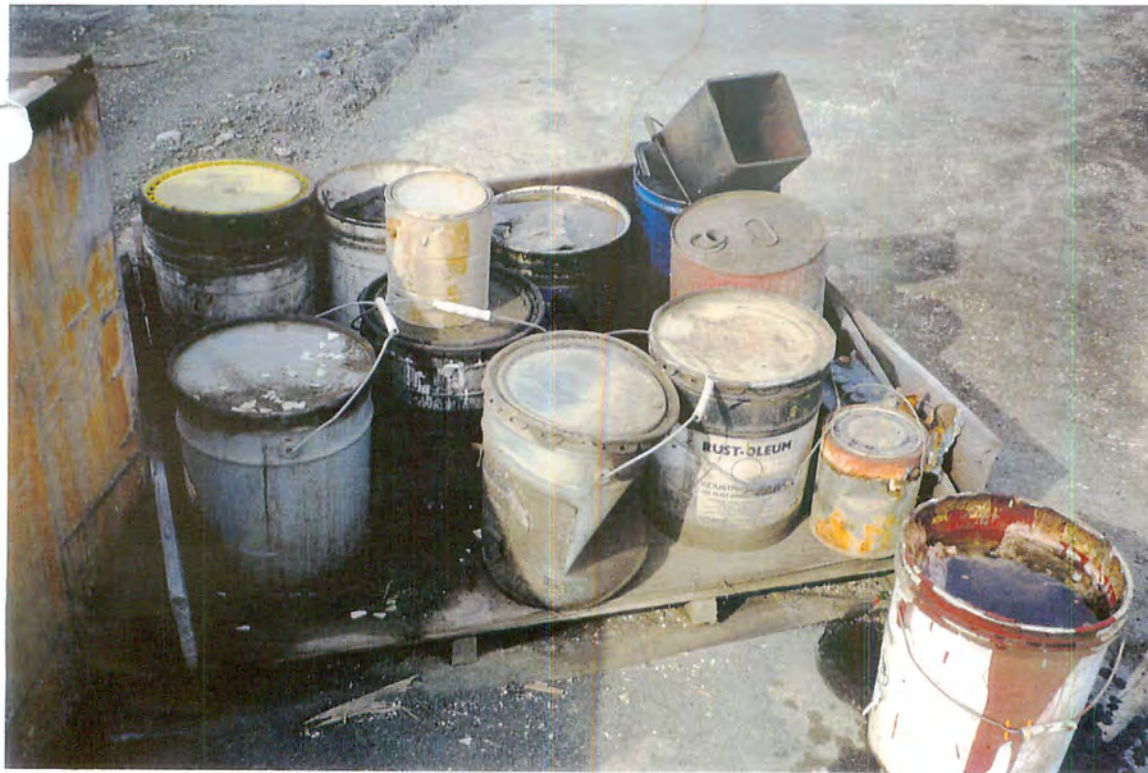
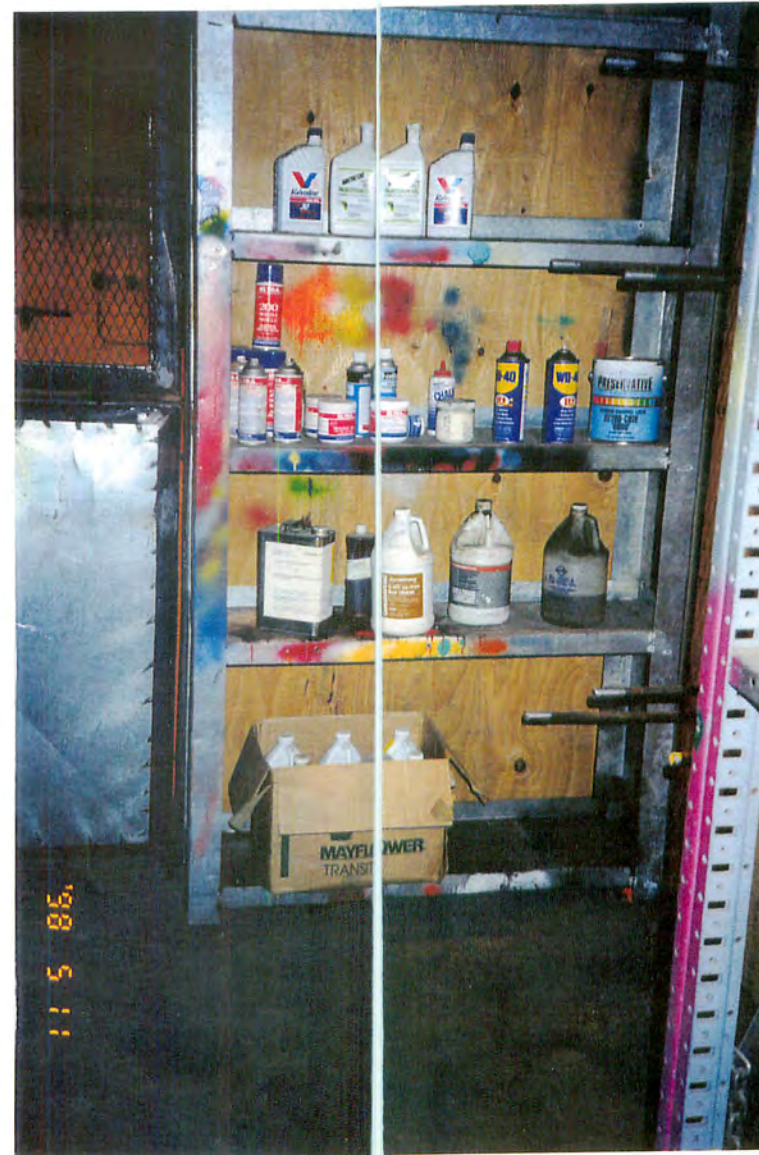
1. Approximately 50-100 gallons of oily wastes, hydraulic oil, and abandoned paint-related products were found onsite (see appended inventory), as well as discarded lead-acid batteries;
2. Approximately 1000-1200 gallons of oily or paint-waste contaminated water and sludges are found in the blind sumps in the warehouse floor;
3. Approximately 125 to 150 tons of oil or fuel contaminated soil is found immediately south of the south end of the building in an approximately 1900 SF area. This constitutes a reportable spill under ADEC regulations.

FIGURES 4 & 5:
ABANDONED CHEMICAL PRODUCTS AND WASTE MATERIALS
(INCLUDES OILY SORBENTS, NEW PAINT / COATINGS AND
RELATED WASTES, WELDING SUPPLIES, ETC).

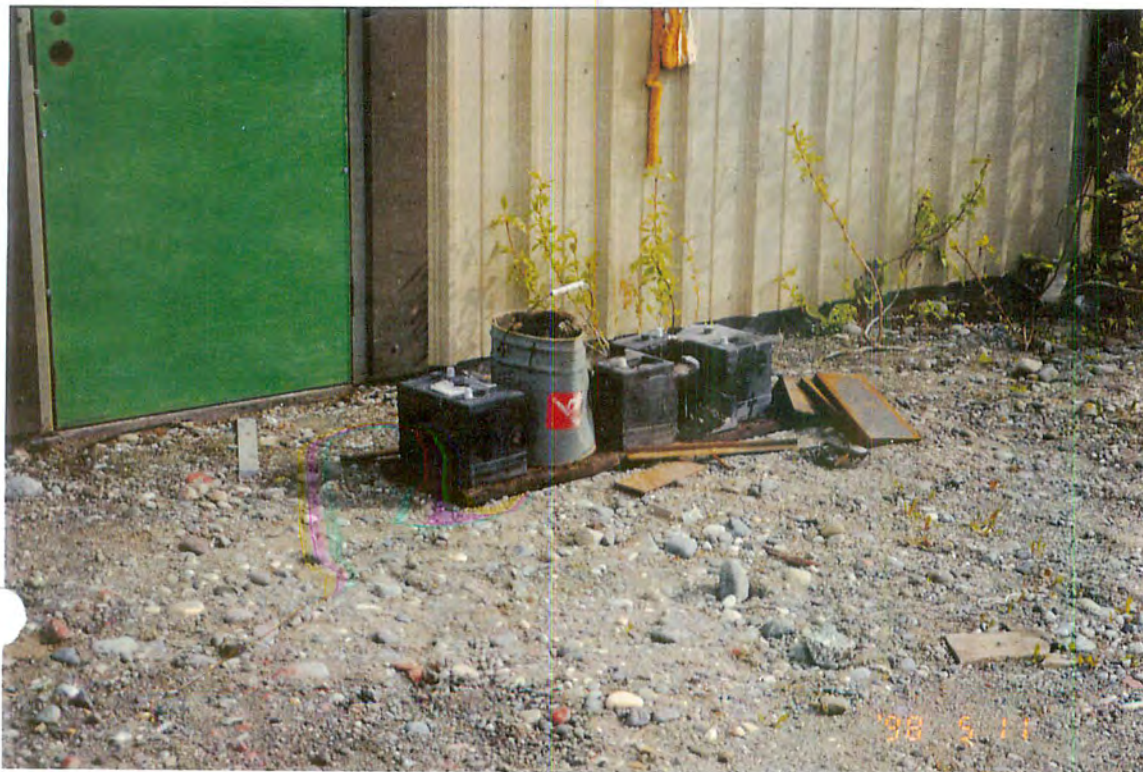
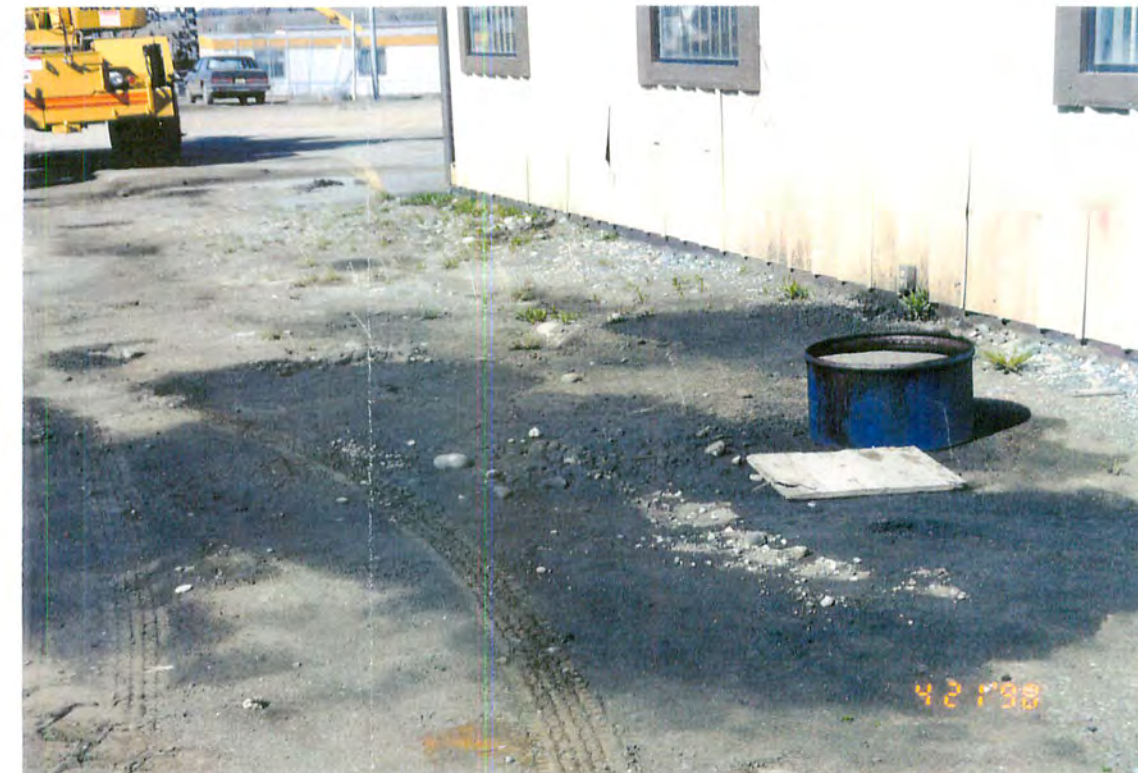
Immediately south of the southern office wing (see Sheet 3), lubricating oil and fuel stains can be seen on the ground surface. Within this stained area, approximately 250 SF of extensively oil and fuel-contaminated soil was found; this constitutes a reportable spill under ADEC guidelines. Field observations indicate that approximately 150 cubic yards of contaminated soil must be addressed. This material must be excavated and treated according to State regulations as specified by the plan and oversight requirements of ADEC's Contaminated Sites Program.

FIGURES 7 & 8:
VIEWS OF A USED OIL SPILL NEAR THE SOUTHERN END
OF THE FACILITY. THE MOST HEAVILY STAINED
PORTIONS COMPRISE AN AREA EXCEEDING 250 SF,
WITHIN A STAINED AREA APPROXIMATING 1900 SF.

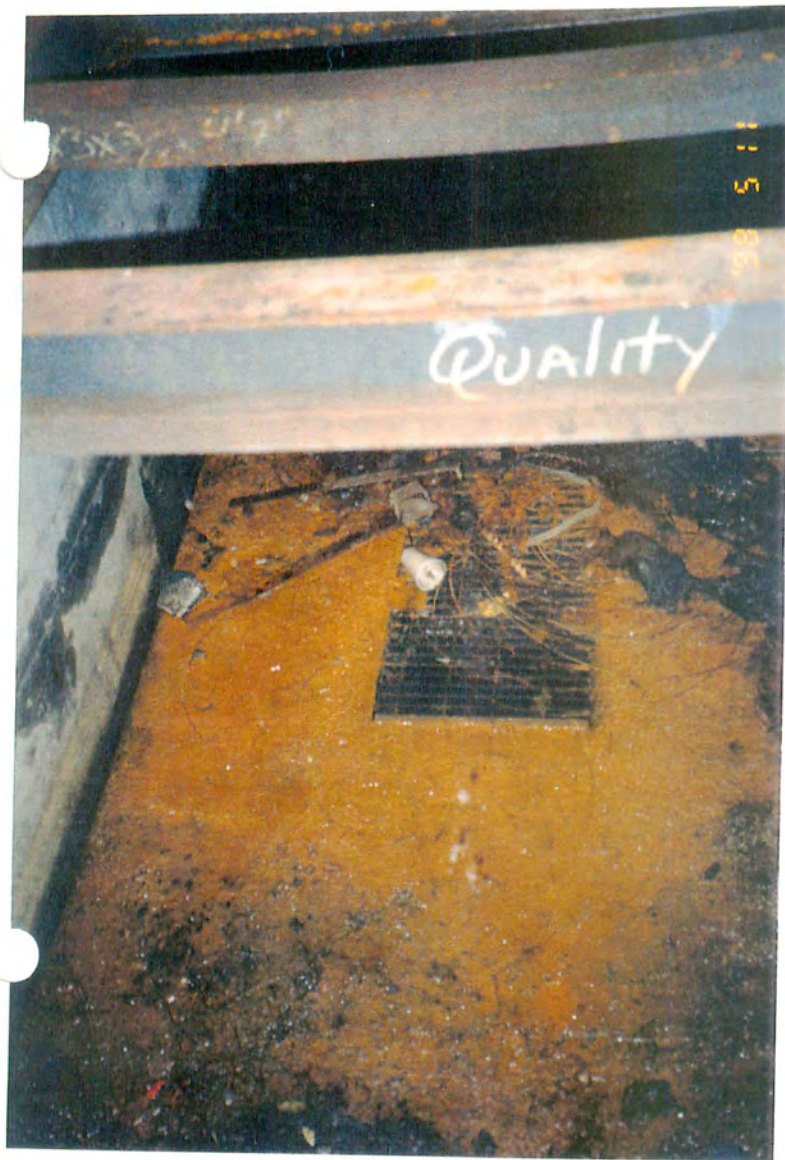
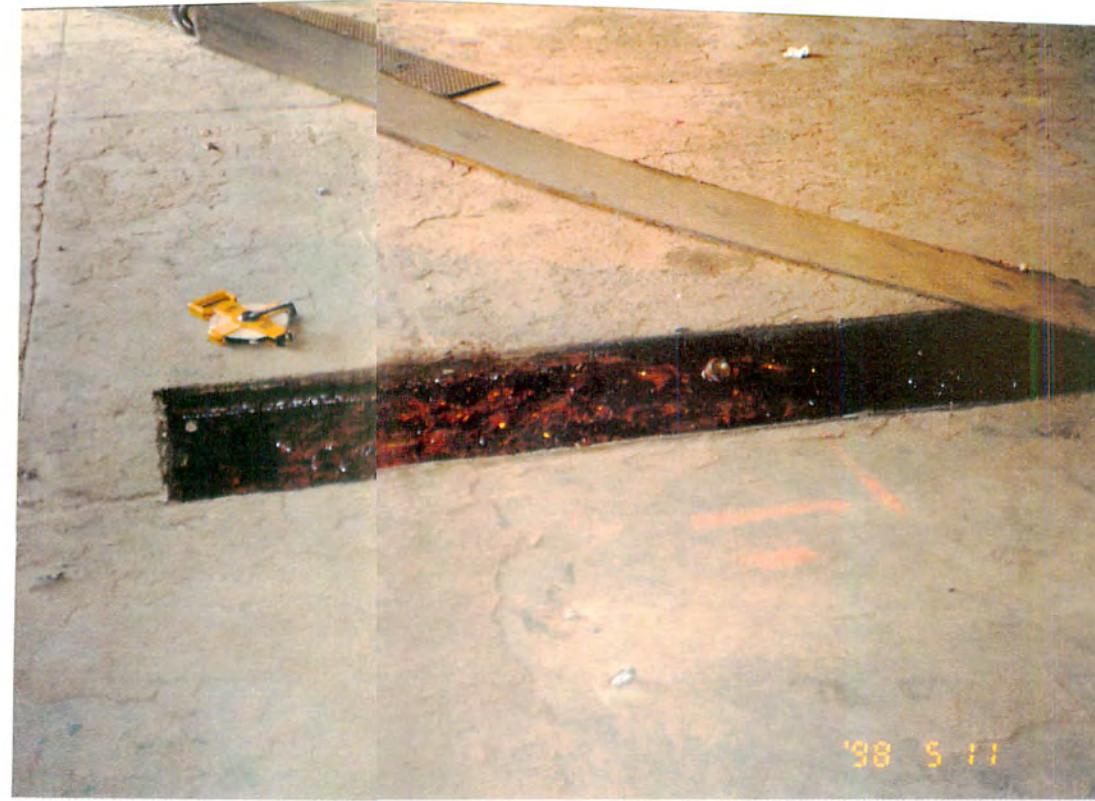
Septic Tankage:	None observed
Leaching System:	None observed
Note:	Possible discharge pipe out of grease pits

FIGURES 9 & 10:
 NORTH GREASE PIT
 (DESIGNATED "B-1" BY JMM).
 NOTE SUMP IN FLOOR OF PIT
 (PHOTO 9). 5 IN CAST IRON
 PIPE EXITS THIS PIT FROM
 WEST WALL, TERMINUS
 UNKNOWN.

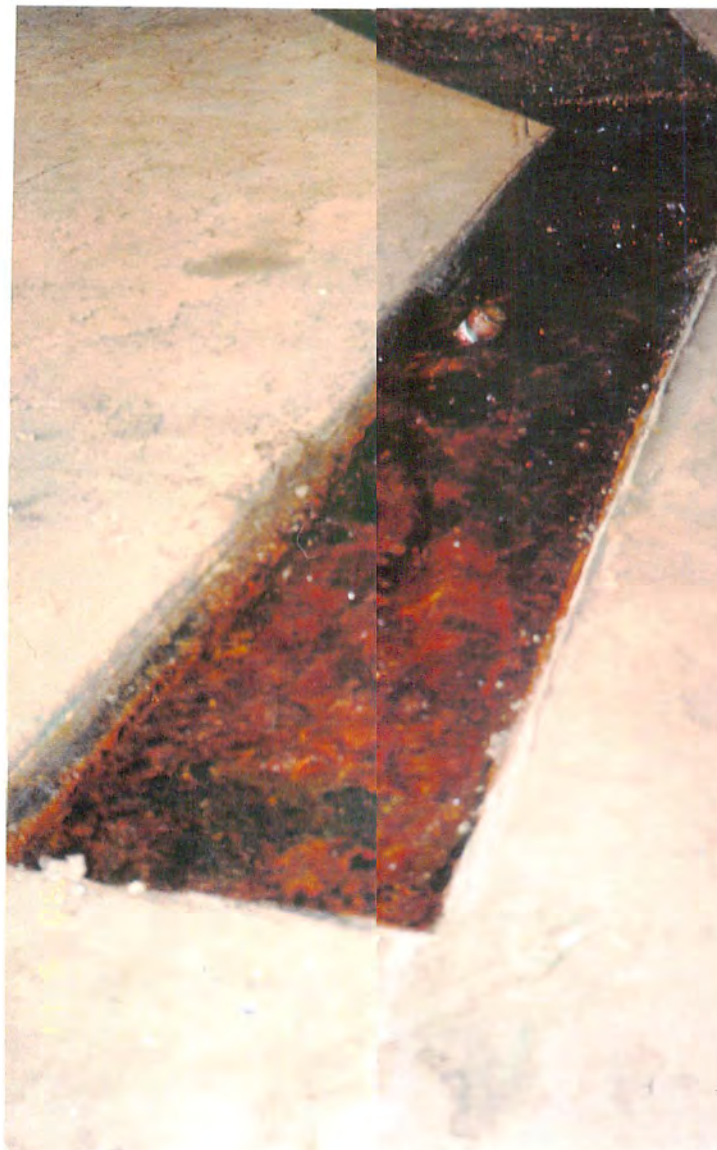
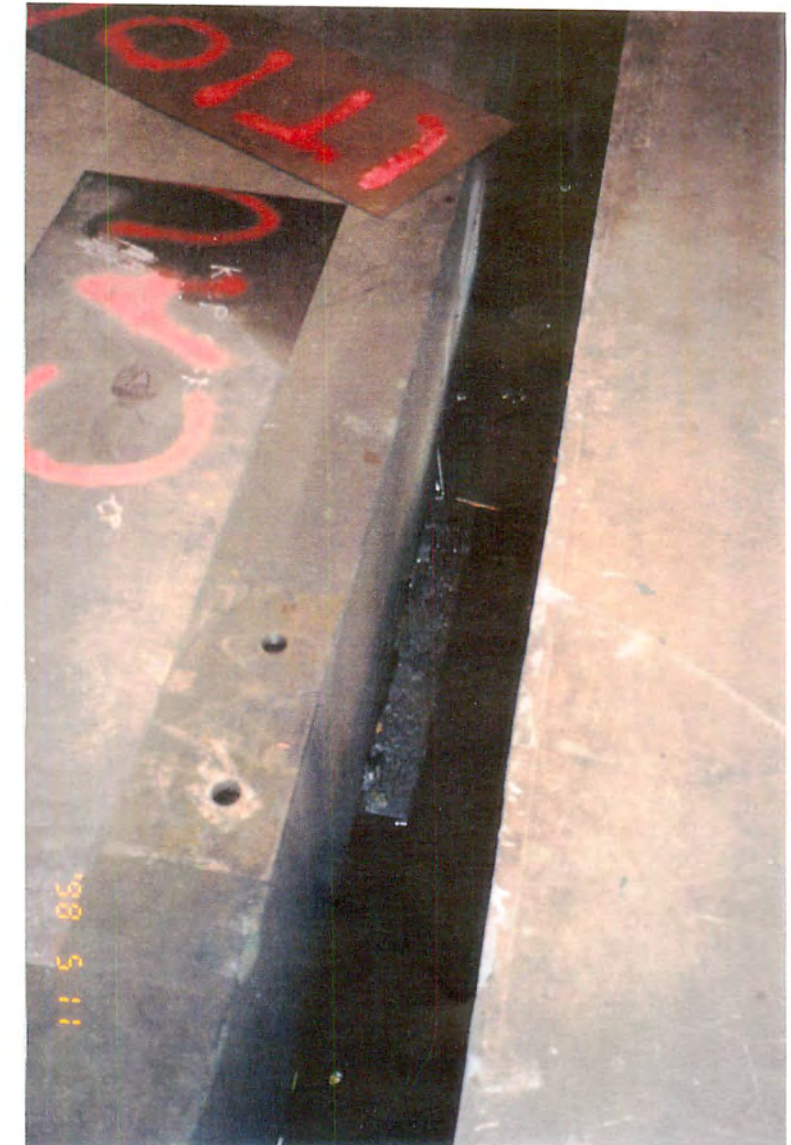
FIGURES 11 & 12:
 DRAINAGE SUMP B-5 IN
 SOUTH BAY (FORMER PAINT
 SHOP). PAINT WASTE
 EVIDENT IN SUMP CONTENTS;
 JMM VERIFIED HAZARDOUS
 LEVELS OF HEAVY METALS IN
 SUMP SLUDGES.

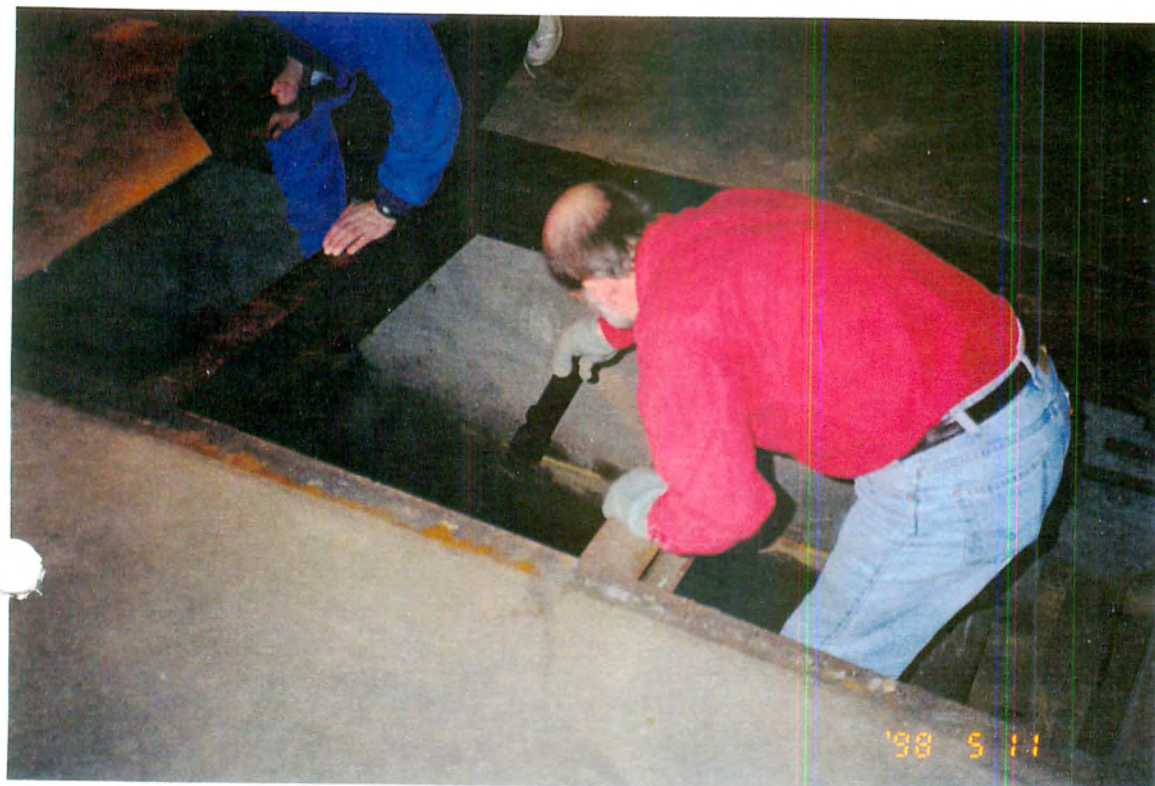
FIGURE 13:
 1 x 15 FT PIT IN NORTH MIDDLE BAY, PROBABLY PART
 OF A REMOVED HOIST ASSEMBLY. PIT CONTAINS
 APPROXIMATELY 30-50 GALLONS OF HYDRAULIC OIL.
