Report of Investigation 2021-3 Stebbins

EROSION EXPOSURE ASSESSMENT—STEBBINS

Richard M. Buzard, Mark M. Turner, Katie Y. Miller, Donald C. Antrobus, and Jacquelyn R. Overbeck

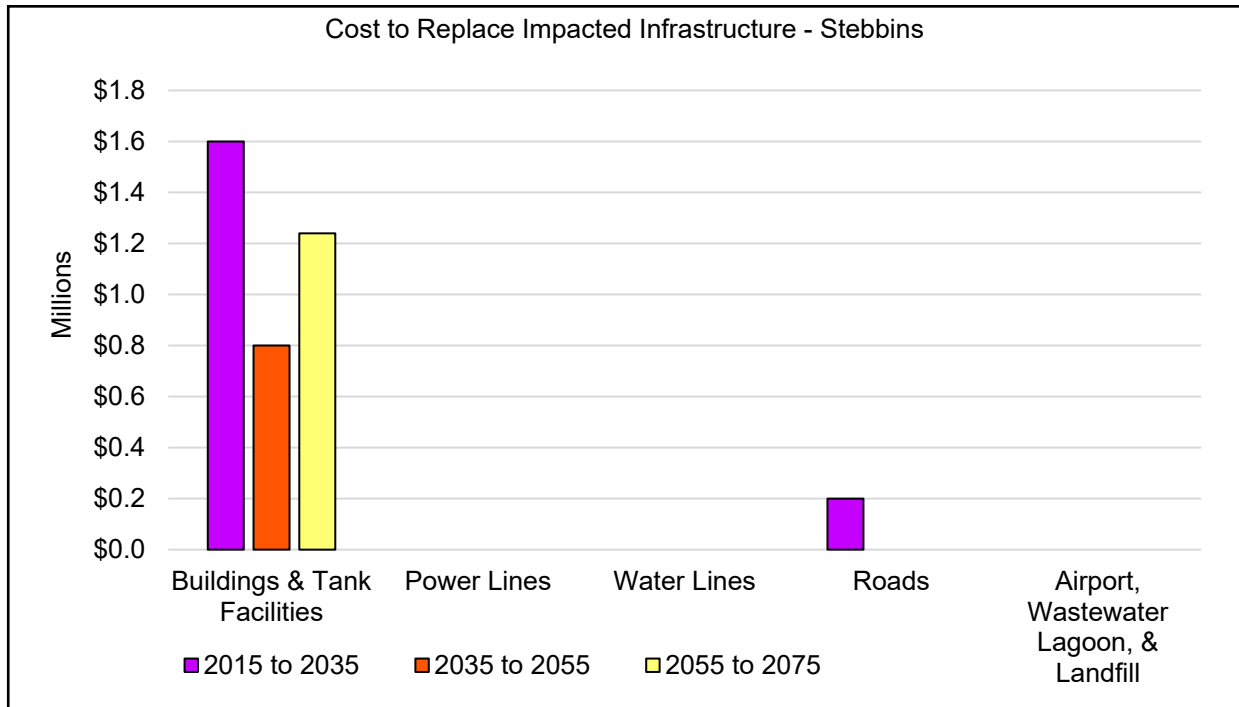
Figure 1. This figure summarizes the replacement cost of all infrastructure in the erosion forecast area. Twenty-year intervals are symbolized by color: purple represents the time interval 2015 to 2035, orange represents 2035 to 2055, and yellow represents 2055 to 2075. The bulk of costs are buildings across all periods.

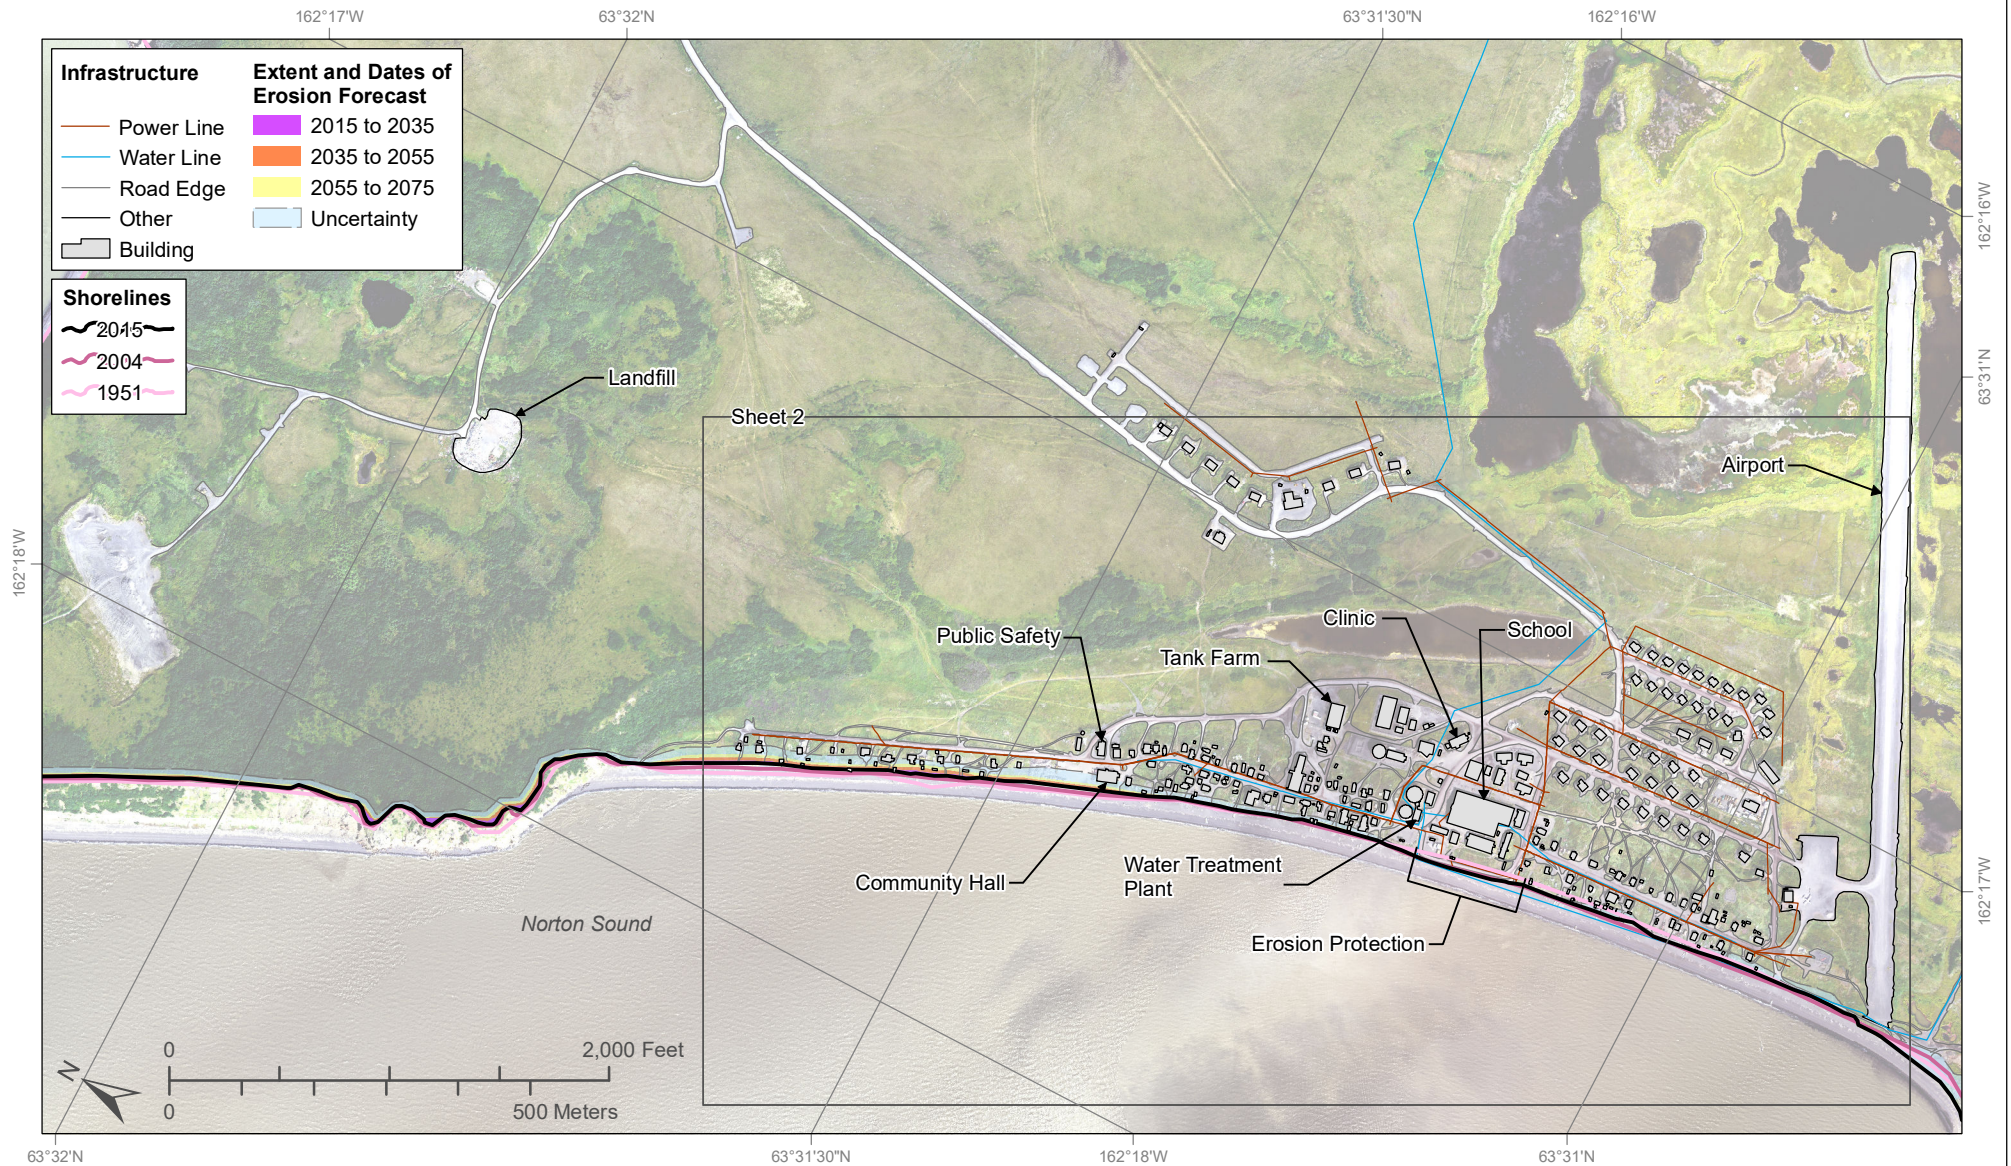
Erosion Forecast Stebbins, Alaska

Erosion and accretion of coasts and rivers result in shoreline change. These rates of shoreline change at Alaska communities are calculated from historical and modern shorelines (shorelines shown as lines in pink scale and labeled by year). The long-term (1951 to 2015) shoreline change rate is used to forecast where erosion could impact community infrastructure. Erosion is forecast to reach the colored areas by specified time intervals: 2015 to 2035 (purple), 2035 to 2055 (orange), and 2055 to 2075 (yellow). The area of uncertainty of the 2075 shoreline at a 90 percent confidence interval is light blue. Areas that are not colored by time interval are not forecast to erode by 2075 based on the historical shoreline change rate. For more detailed information about the impacts to infrastructure from erosion at Stebbins, refer to the Stebbins erosion exposure assessment report.

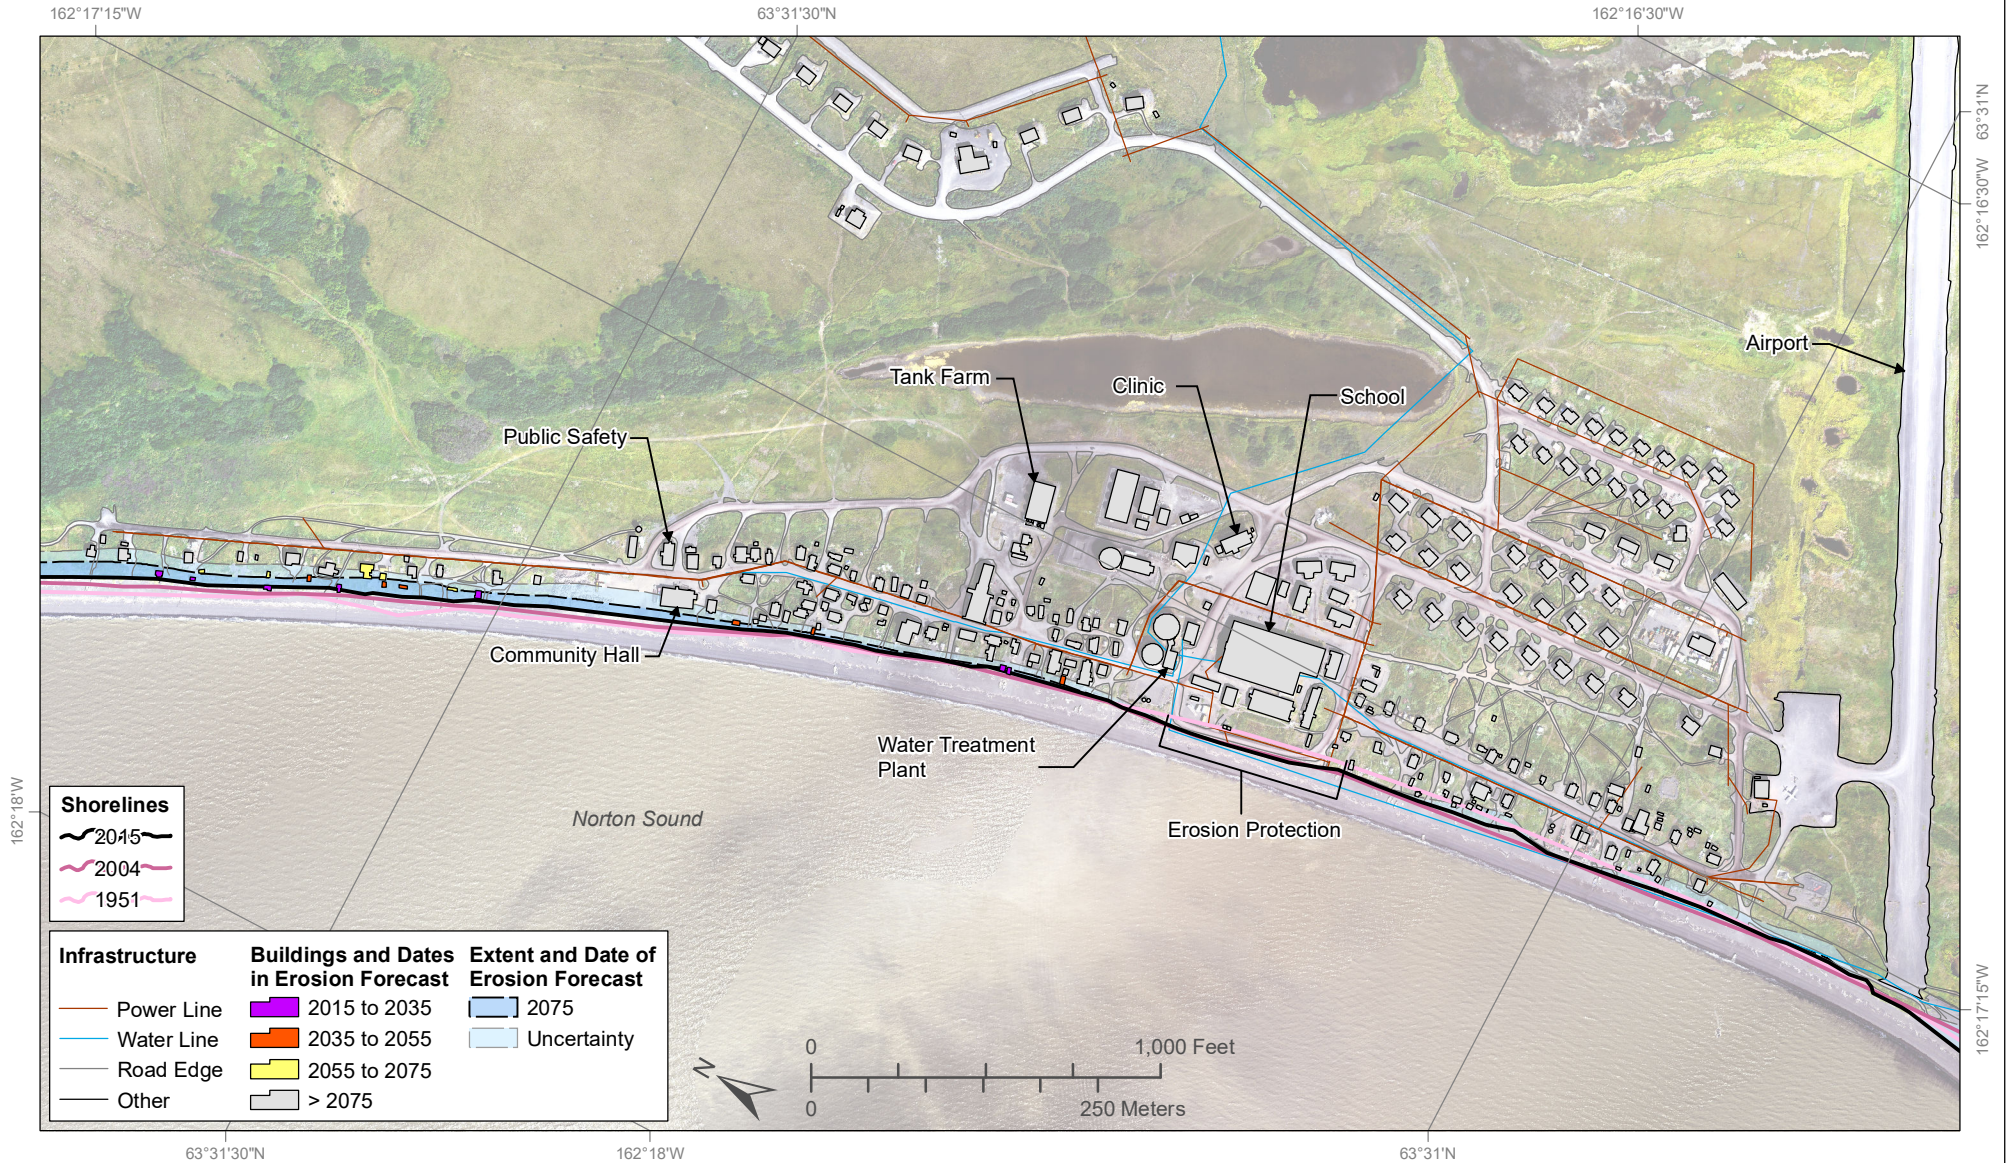
Erosion Exposure Stebbins, Alaska

Erosion and accretion of coasts and rivers result in shoreline change. These rates of shoreline change at Alaska communities are calculated from historical and modern shorelines (shorelines shown as lines in pink scale and labeled by year). The long-term (1951 to 2015) shoreline change rate is used to forecast where erosion could impact community infrastructure. Erosion is forecast to year 2075 (dark blue) with a 90 percent confidence interval area of uncertainty (light blue). Buildings forecast to be impacted by erosion are colored by the range of years when the impact is forecast to occur: 2015 to 2035 (purple), 2035 to 2055 (orange), 2055 to 2075 (yellow), and no impacts expected by 2075 (gray). For more detailed information about the impacts to infrastructure from erosion at Stebbins, refer to the Stebbins erosion exposure assessment report.
