Number: 737-25-1728
Original Issue: October 10, 2016
Revision 1: November 26, 2019
ATA System: 2523

SUBJECT: EQUIPMENT/FURNISHINGS - Passenger Compartment - Service Units - Passenger Service Unit (PSU) and Life Vest Panel Modification

BOEING SERVICE BULLETIN 737-25-1728

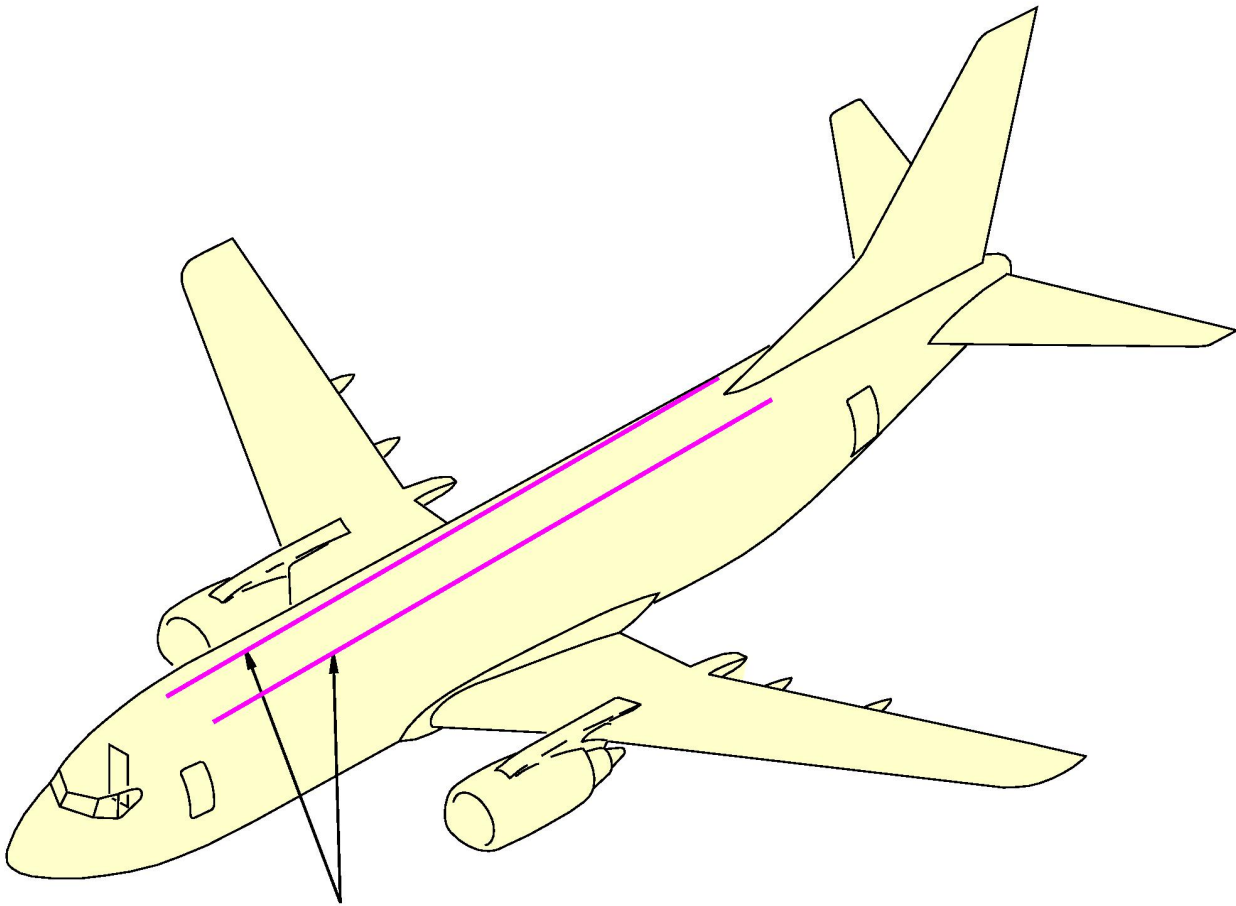
GROUP 1:
LOWER PSU. INSTALL LANYARD ASSEMBLIES. CLOSE PSU.

GROUP 2:
LOWER PSU. INSTALL LANYARD ASSEMBLIES. CLOSE PSU.
LOWER LIFE VEST PANEL. INSTALL LANYARD ASSEMBLIES.
CLOSE LIFE VEST PANEL.

GROUP 3:
LOWER PSU. INSTALL LANYARD ASSEMBLIES. CLOSE PSU.
LOWER LIFE VEST PANEL. INSTALL LANYARD ASSEMBLIES.
CLOSE LIFE VEST PANEL.
