REPORT ON THE UPPER BIG BRANCH MINE DISASTER

HOMICIDE

UNITED MINE WORKERS OF AMERICA

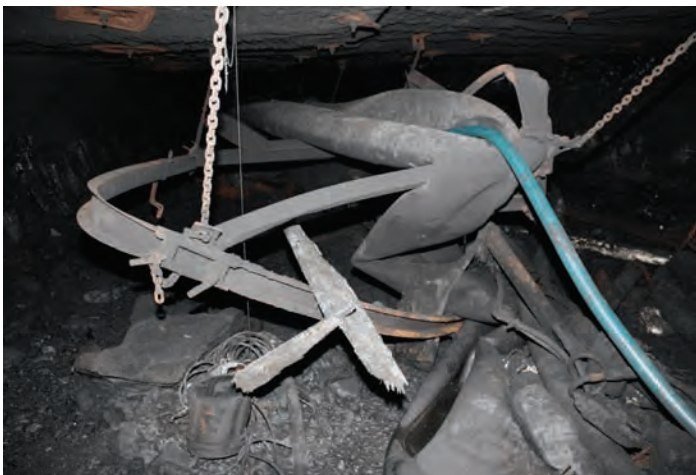
Tailgate 22 section belt and belt structure bent, twisted from forces of explosion.

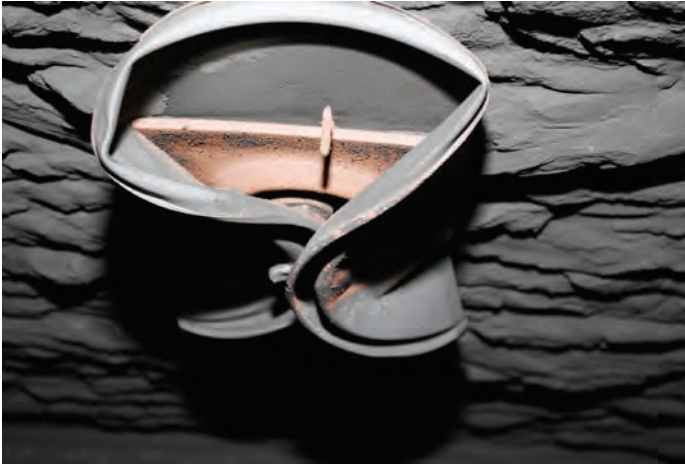
Roof bolt plate bent from initial path (left side) and secondary path (right side) of explosion.

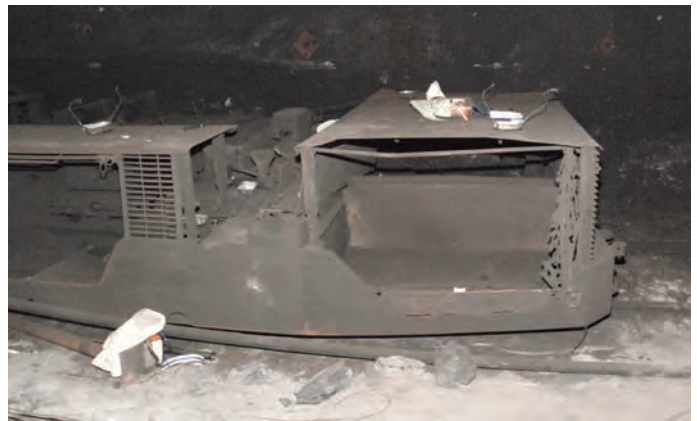
Deployed SCSRs on top of mantrip and on ground at 1 North 21 Longwall track.

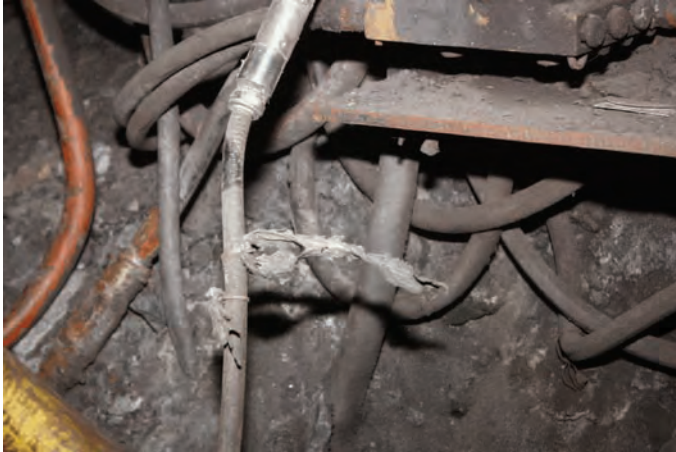
The investigation showed that poor ventilation must have been a common problem on the longwall. The investigation revealed a burnt remnant of a brattice cloth hanging from shield 173 towards the tailgate drive where a methane sensor was mounted. The curtain o-rings and tie wires indicate it was hung from the shield towards the face to a point just inby the tailgate methane sensor. This would direct all the airflow towards the sensor, diluting the methane at that point and eliminating its ability to detect the actual amount of methane on the face.

Melted canvas and plastic ties on air hose where canvas was used to direct airflow onto methane sensor on the longwall.

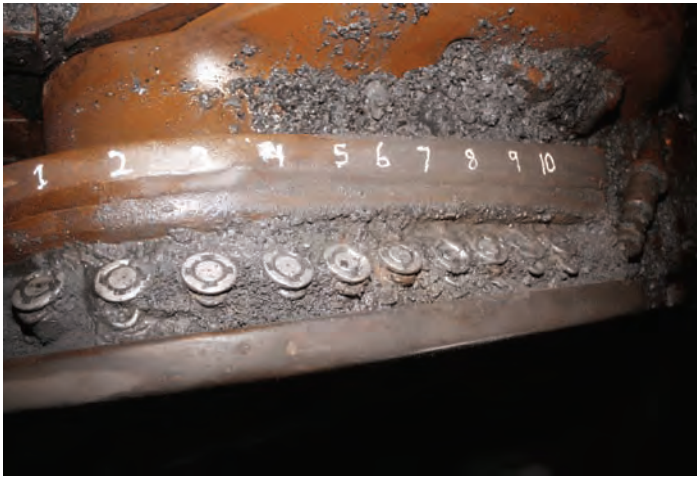
- Headgate drum - of the twenty-eight sprays visible, nineteen were operating and nine were plugged.
- Headgate ranging arm - of the ten sprays visible, five were plugged.
- Tailgate drum - of the forty-two sprays visible, twenty-seven were operating, eight were plugged and seven were missing.
- Tailgate ranging arm - of the ten sprays visible, five were plugged.

Headgate ranging arm sprays on the UBB longwall. Five of the ten sprays were plugged and did not work.

With almost forty percent of the visible water sprays plugged or missing, the spray system was unable to function as designed. The fact that thirty-four of the sprays were plugged is problematic and should be cited by the Agencies. However, in this particular case, the Union believes none of the sprays on the shearer drums were working properly, because the missing sprays reduced the water pressure significantly, thus rendering the system useless for purposes of safety.

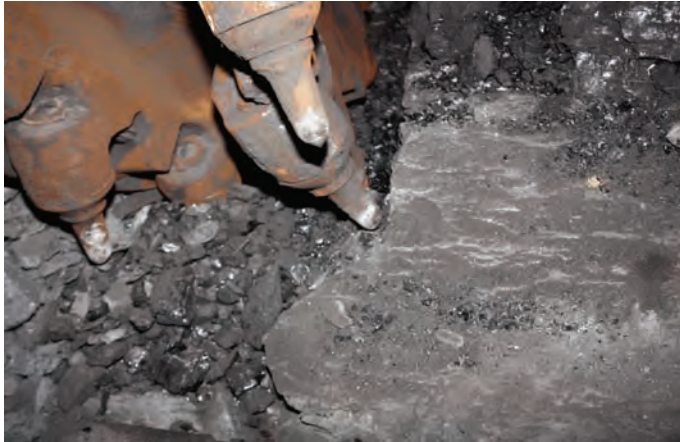
Photo 1. The longwall taildrum bits in a cut-out at the tail. The UMWA believes sparking from this area caused an initial methane ignition, which then grew into a coal dust explosion.

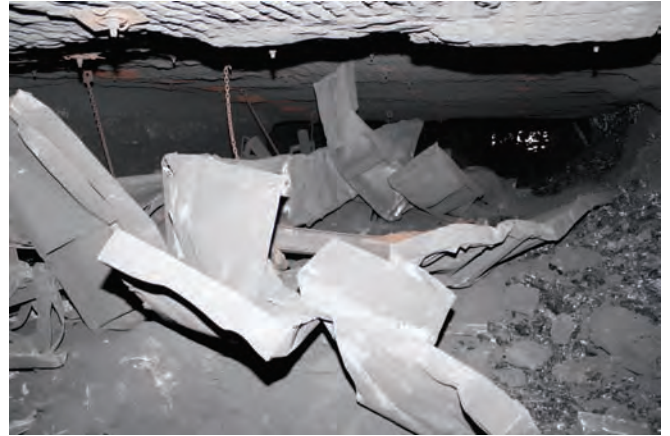
Photo 2. Steel overcast cover panels twisted and crumpled at #1 Crosscut in the Tailgate 22 Section.

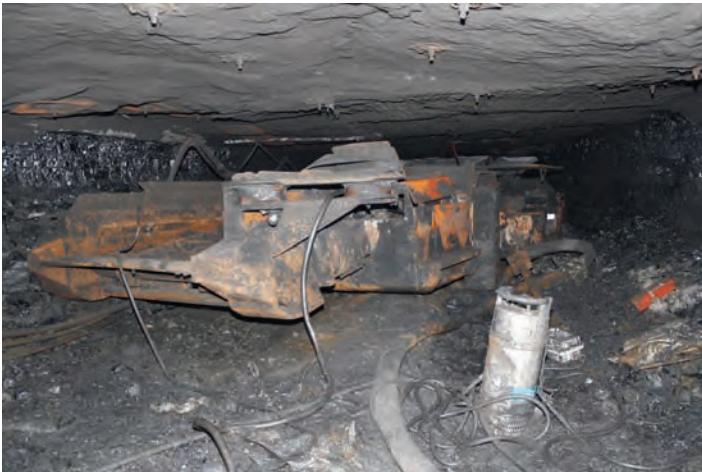
Photo 3. A shuttle car inby the belt dump point in the Tailgate 22 Section shows evidence of the flames and forces of the explosion.

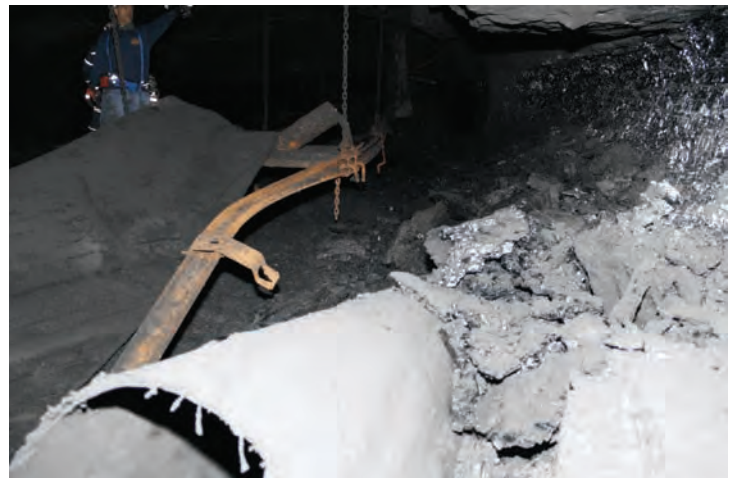
Photo 4. Bent and twisted steel belt structure at #4 crosscut of Tailgate 22 Section shows evidence from the forces of the explosion.

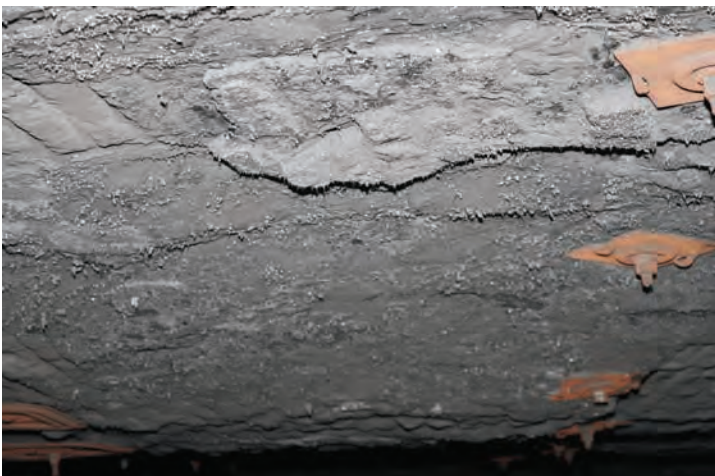
Photo 5. Evidence of coking on mine roof inby the first open crosscut in the #1 Entry. This type of coking is a residue of a coal dust explosion.

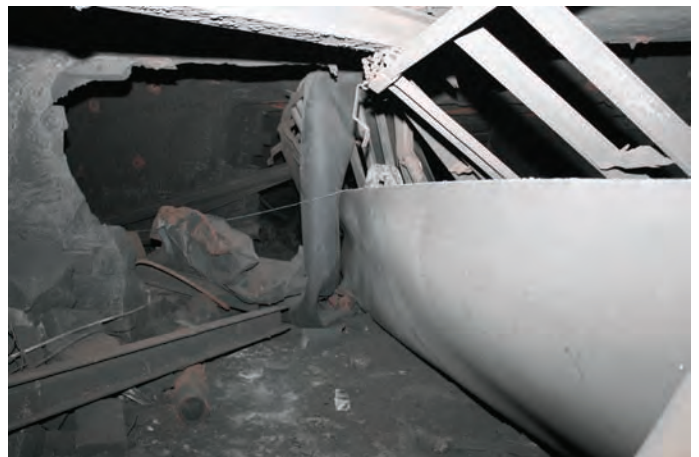
Photo 6. 1 North Longwall belt structure at a blown-out overcast. The belt structure has been completely overturned.

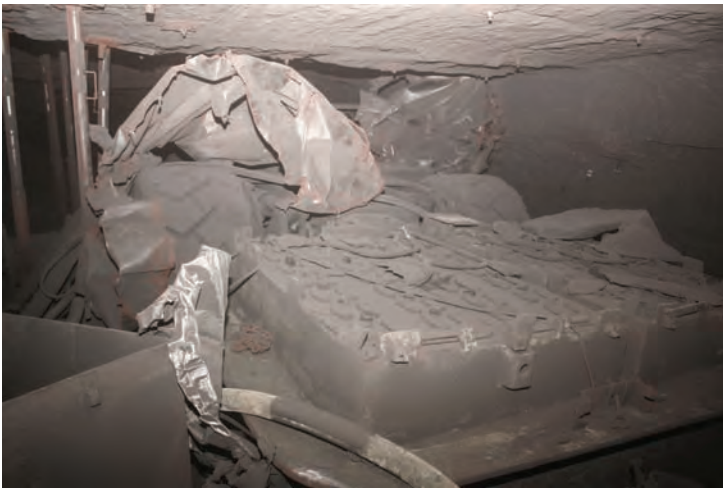
Photo 7. Shield hauler with a steel ventilation door wrapped around the top, found at Headgate 22.

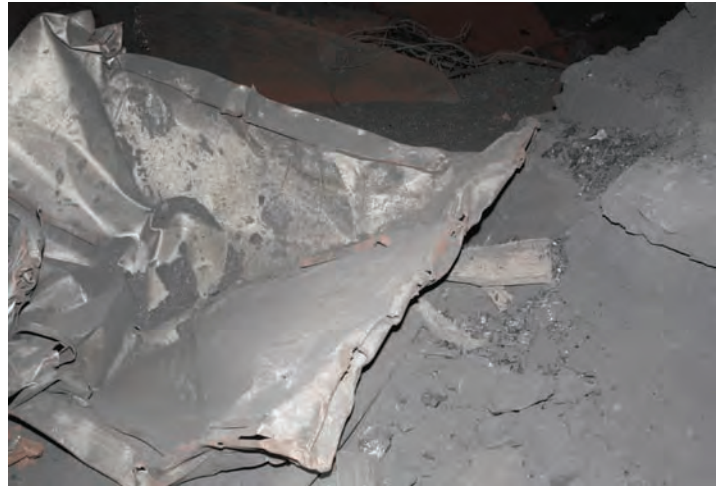
Photo 8. Airlock door blown from hinges and twisted, one block outby Tailgate 22 belt dump.

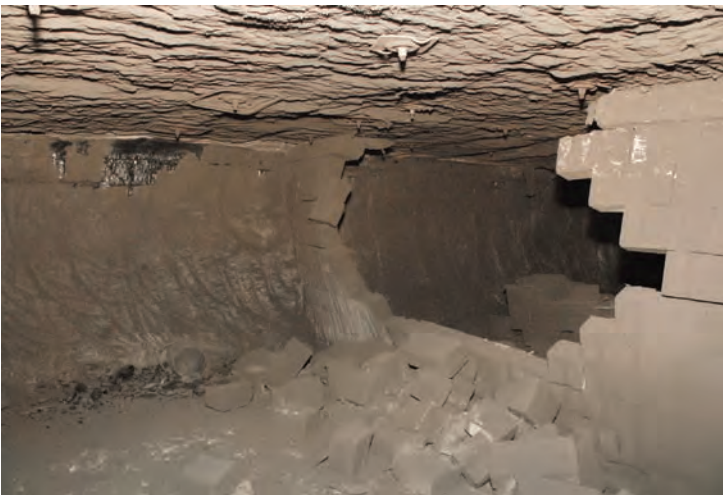
Photo 9. Stopping blown out toward the north as a result of the initial path of forces, at 73 crosscut, northeast of 78 switch.

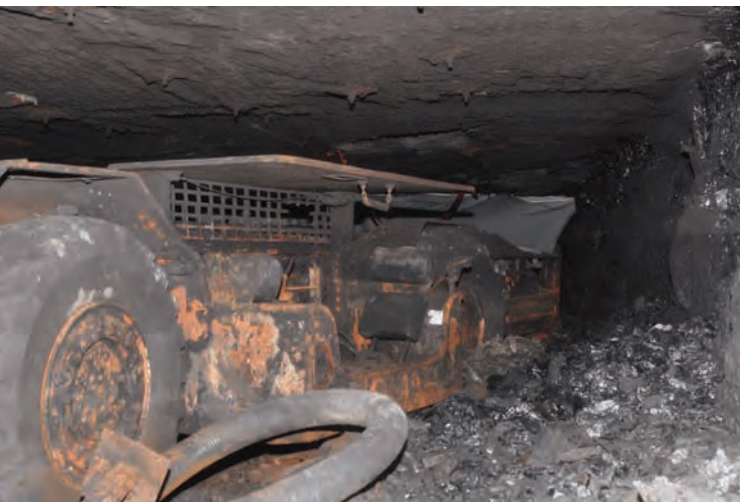
Photo 11. Shuttle car showing heat damage from the flames and forces, in the Tailgate 22 Section.

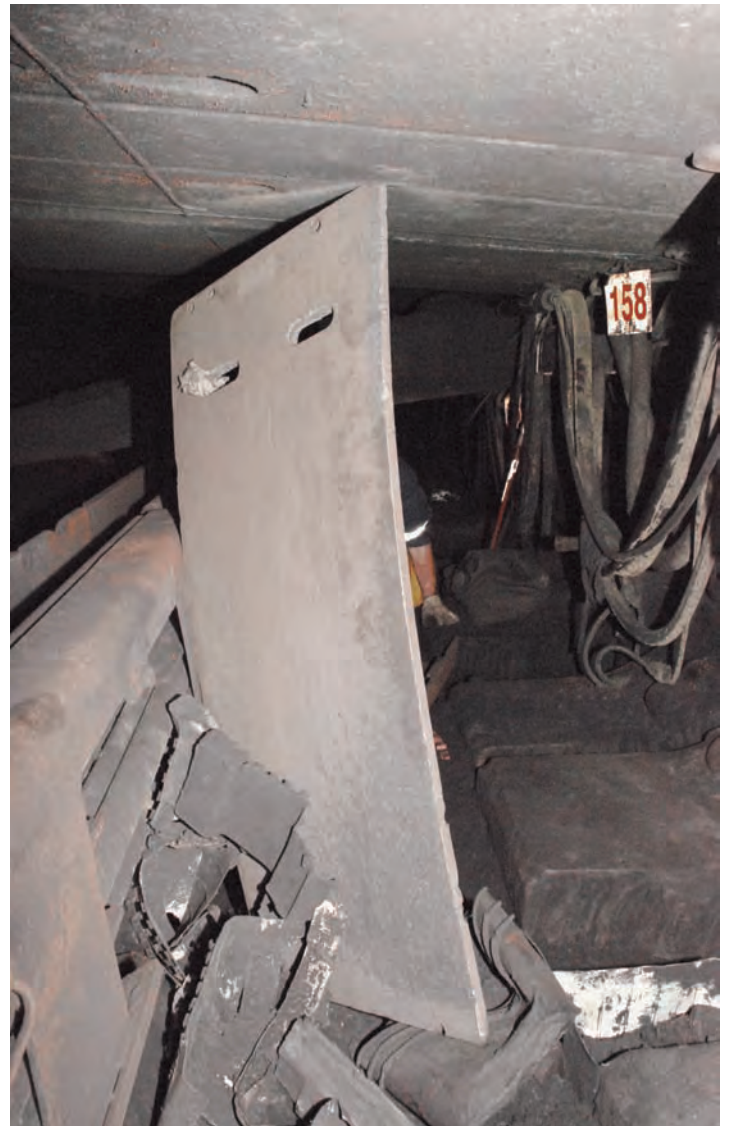
Photo 10. Tail drive assembly lid wedged between top of longwall shield and toes of shield at Shield #158.
