Historical Review

Of Selected Mining Sites In The Silver Trail Region

Prepared for
Waste Management Program
Indian and Northern Affairs Canada

March 2004

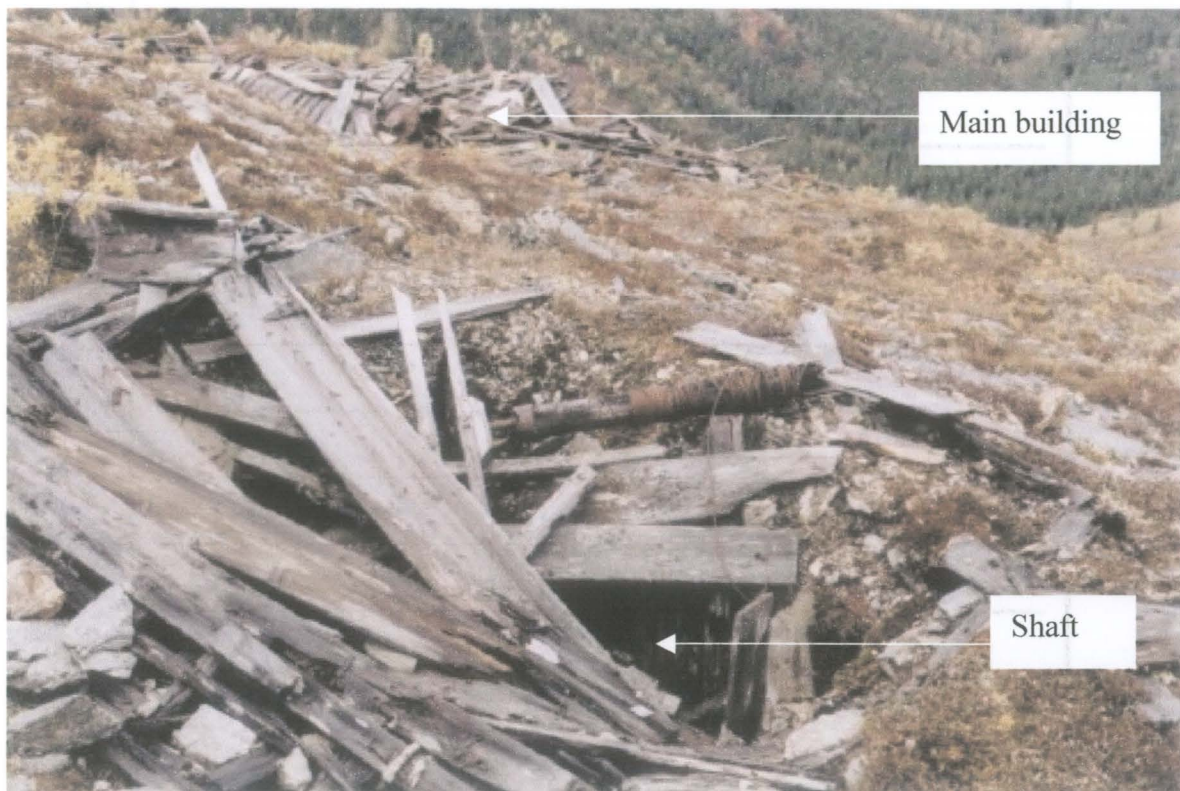
The site has deteriorated since the last inspection was done, the building that served as a residence has collapsed further, with some of the material sloughing down the hillside.

The shaft condition has not changed considerably; it is approximately four by four with wooden cribbing in a state of decay. The shaft has collapsed to within four feet of the surface topography, the last four feet are filled with wood, debris, and some metal refuse.

Once all debris is burnt and waste cable and metal removed, we feel that what remains of the shaft could be hand filled with the local rock.

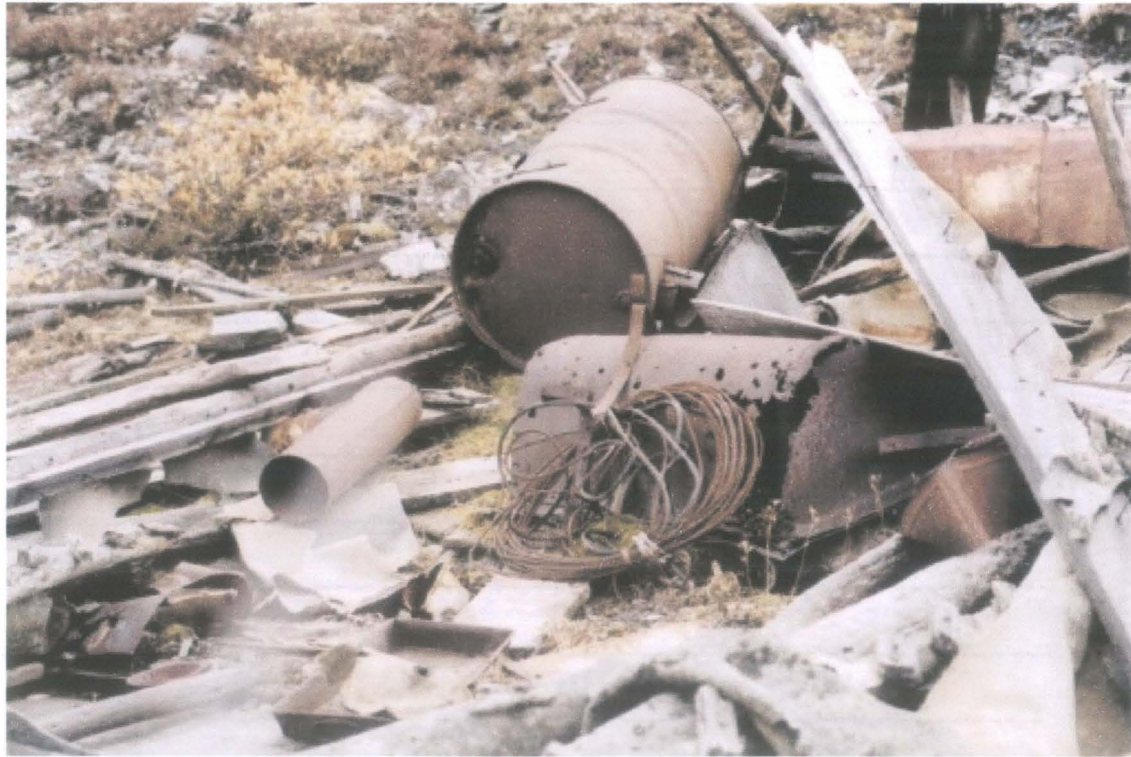
The shaft is a major public safety issue. The photos below show a fair amount of metal debris, wire, cable and exposed nails in the lumber. There is always the possibility that someone could be hurt during investigation of the site.

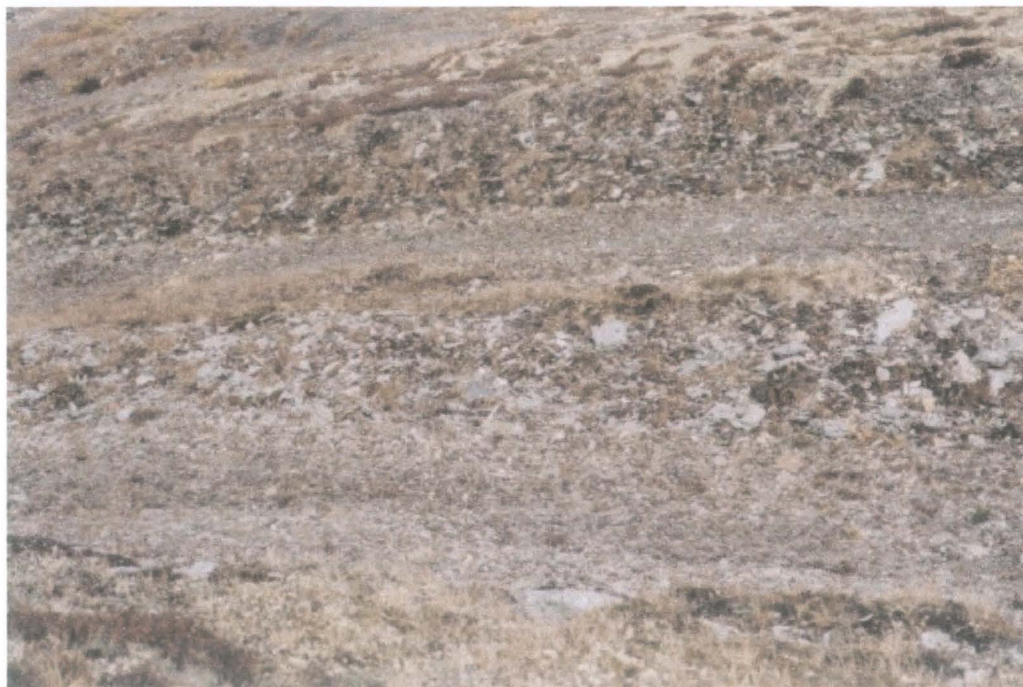
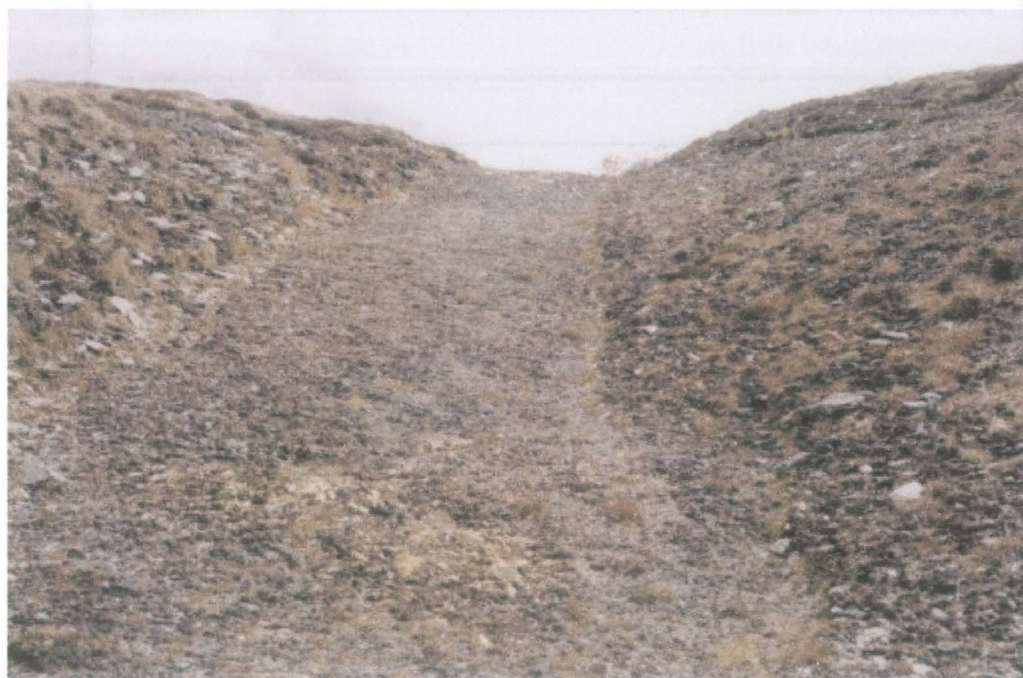
Photos: above, The trenches at the top of the cirque would not warrant filling in.

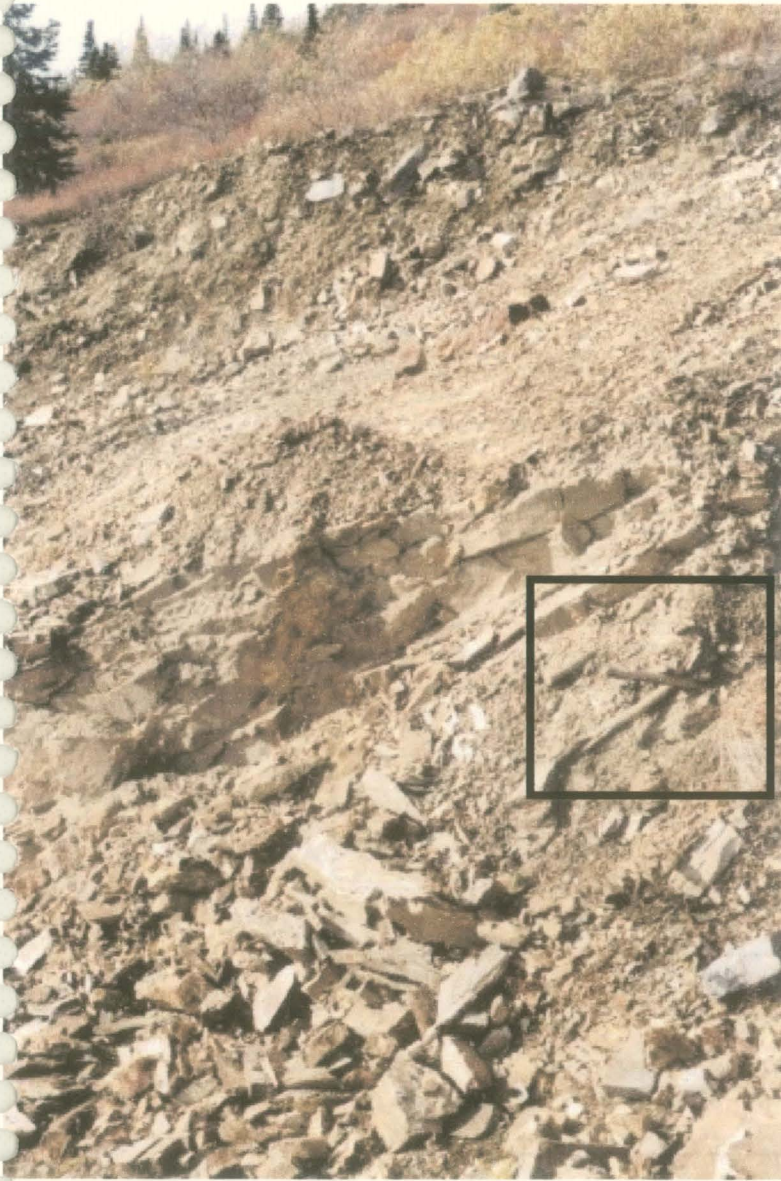
Number one shaft, left, has been collapsed by the trenching done on the East side of the cabin, there is cribbing exposed in the side hill cut done by the cat.

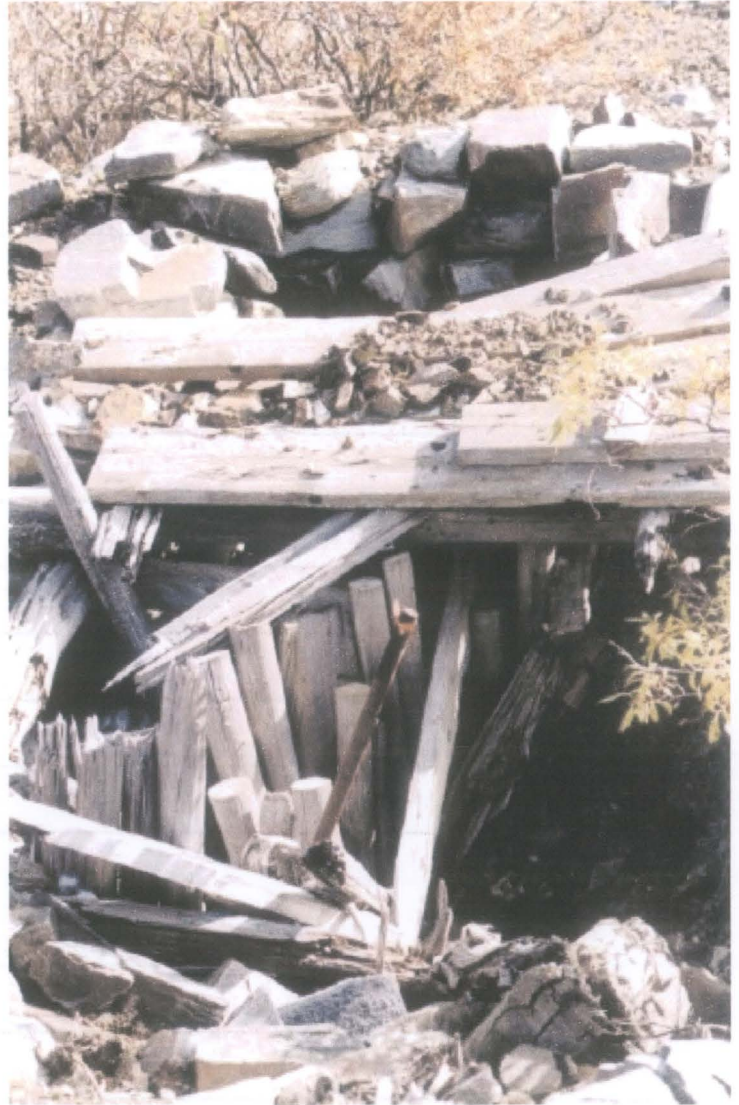
Shaft four, left is in extremely poor condition, and has deteriorated since the last inspection; The shaft depth is roughly 8ft from the surface.

The top edge of the shaft is very unstable, and dangerous.

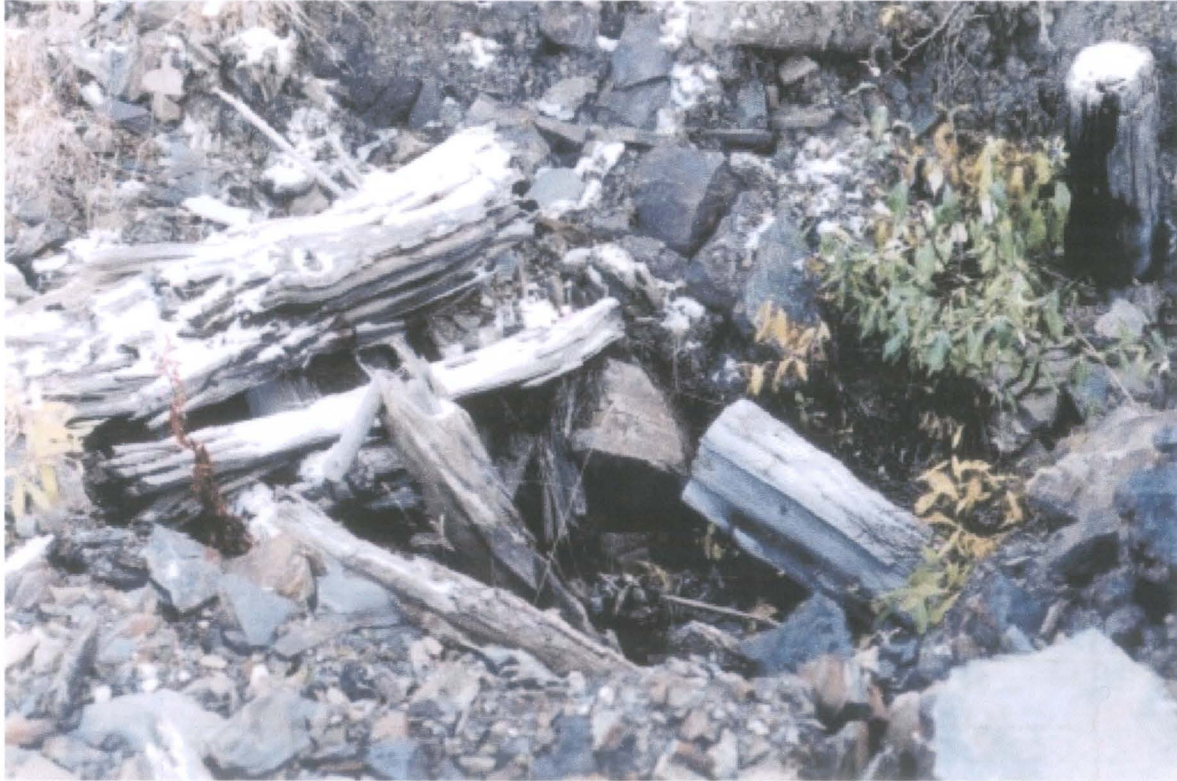
Photo: above, collapsed shaft

The partially collapsed shaft at the head of #4 trench also poses a public safety concern, although it has sloughed in, there is still potential for further deterioration. We would recommend that both the shaft and the adit be permanently closed.

Environmentally we recommend that the shaft and the open adit's access be secured so there is no danger to the general public. The dumpsite at the adit should be cleaned of all loose debris, and discarded electrical batteries. The two frame structures on the upper road landing could be left intact as they are in a relatively stable state, we suggest that the garbage and hard refuse be cleaned.

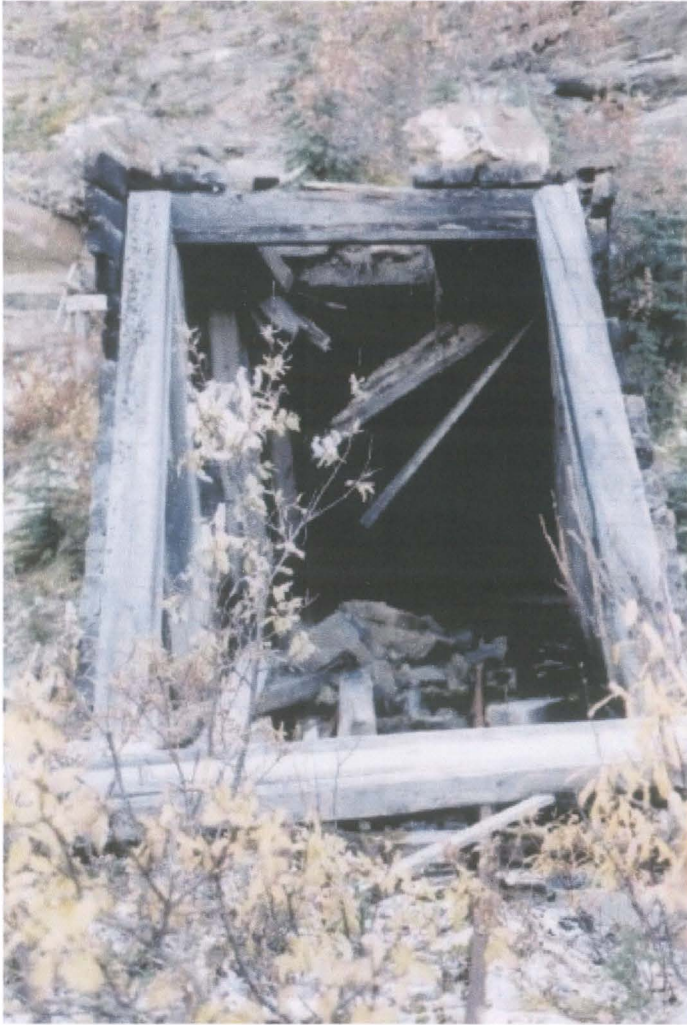
Photo: above, waste dump

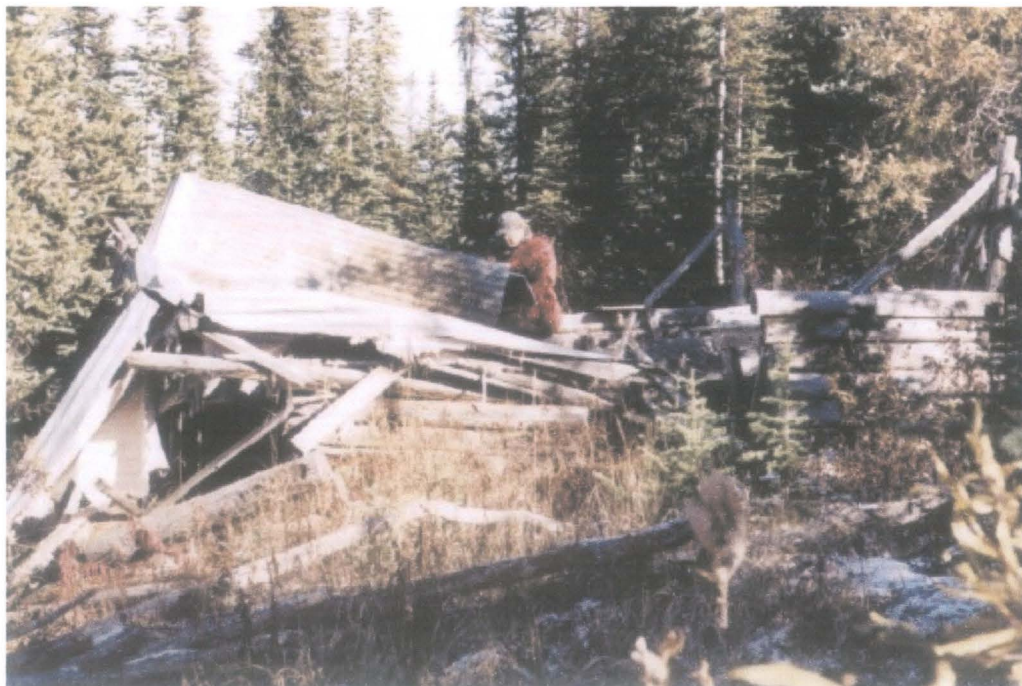
On the lower road that accesses the adit we found a collapsed cabin, which is beyond salvation. This was probably the original building built when the site was established. There is a small barrel cache at this site of seven 45-gallon drums. The building had been roofed with heavy corrugated tin, which now is scattered over a small area; along with this is the standard debris; bed frame, wooden table, various piles of wire and tin cans. About 50 feet down slope from the cabin is a refuse dump.

From a historical perspective the only site on this property, which is of interest, is the original log frame structure located on the lower road to the adit. The building is beyond repair, but there is a high potential to recover old artifacts from the site during a clean up phase. Part of the structure could be left for historical identification.

The log/frame structure on the lower road could be cleaned of all barrels and refuse. Dumpsites are an attraction to visitors though wildlife walking through the debris could step on shards of glass and rusty cans. We feel the dump sites should be cleaned and recover any artifacts for future display.

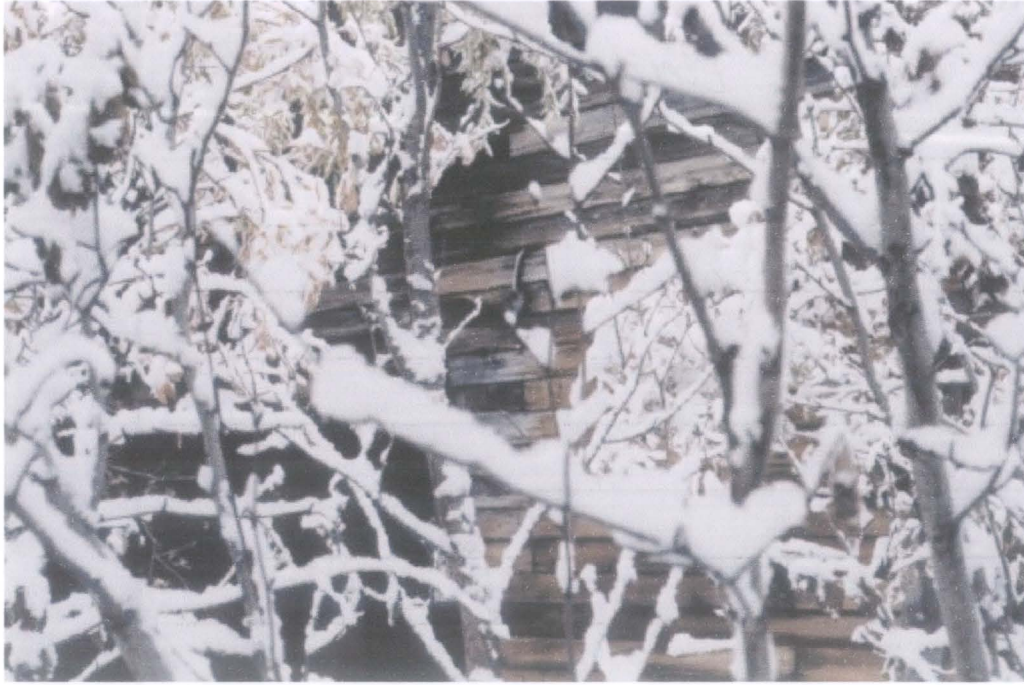
The cabin part way down is structurally sound (above photo) and built with heavy plank material approximately 20 X 25 feet square. The middle and lower adit's both have wooden enclosures built over them, these are both in a state of disrepair and do not stop access to the adit. The lower adit is in a very precarious state of collapse, the timbers have rotted and partially deteriorated.

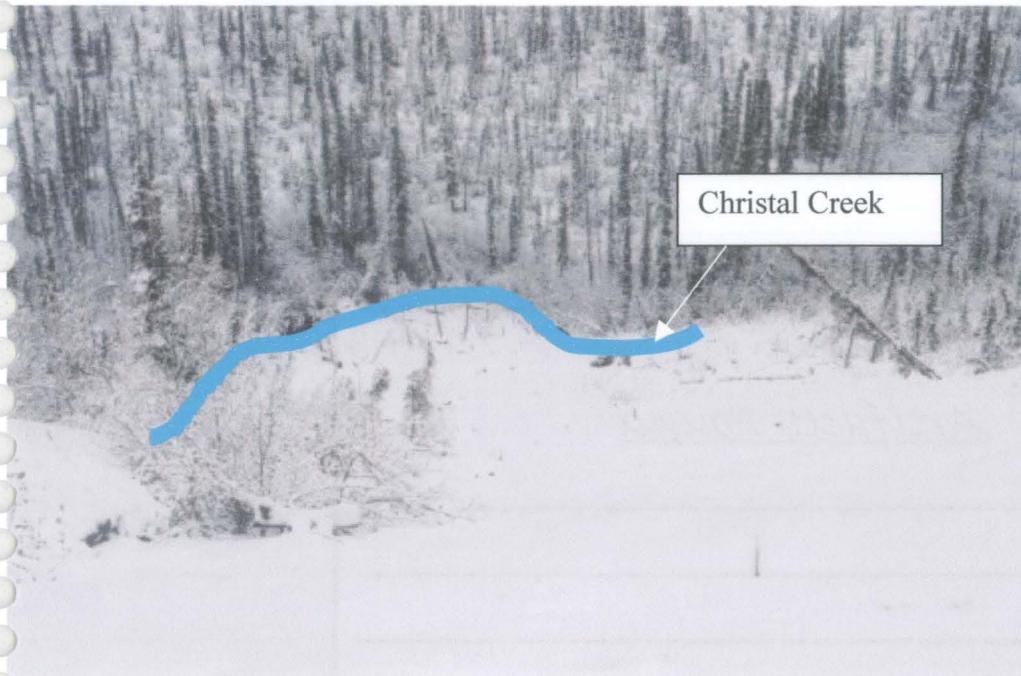
In the 1999 Environmental Baseline Assessment the results showed high levels of acid generating waste rock over the entire dumps surfaces.

Given the fact that the lower dump extends directly into the creek, the water drainage every spring or even when it rains heavily, causes the deterioration of the dump surface with the runoff being discharged into the creek. This can be visibly seen by the run off trenches that have been cut into the dump face. Over time the acid generating potential of the waste will cause sufficient acid drainage at this site to detrimentally impact Christal creek, and therefore remediation actions should be considered at this site.

Environmentally the main issue at this site is the diversion of Christal Creek by the toe of the waste dump at the lower adit. At a minimum we would recommend the contouring of the dump surface so as to redirect the spring run off from further washing the exposed waste material into the creek. This could be accomplished at a minimal cost by back sloping the dump surface and allow the run off to exit on either corner of the dump. At these points the drainage is into natural vegetation and a stable non-waste hillside.

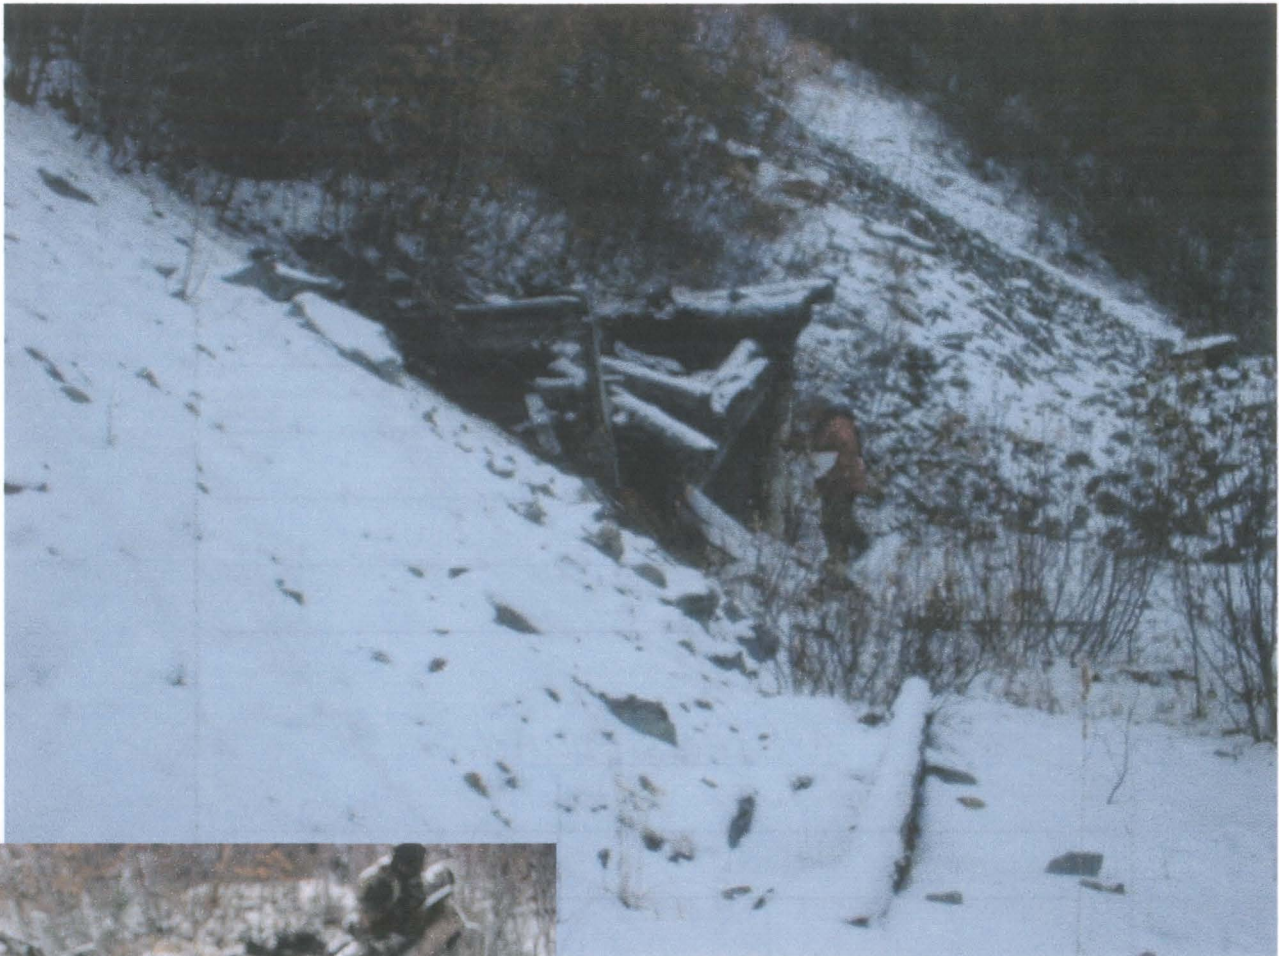
Photos: above, side view of adit.

The major concern as stated earlier is the safety issue with the adit. In this case we feel that what's left of the adit portal could be burnt, and then back fill the open adit to seal it from access.

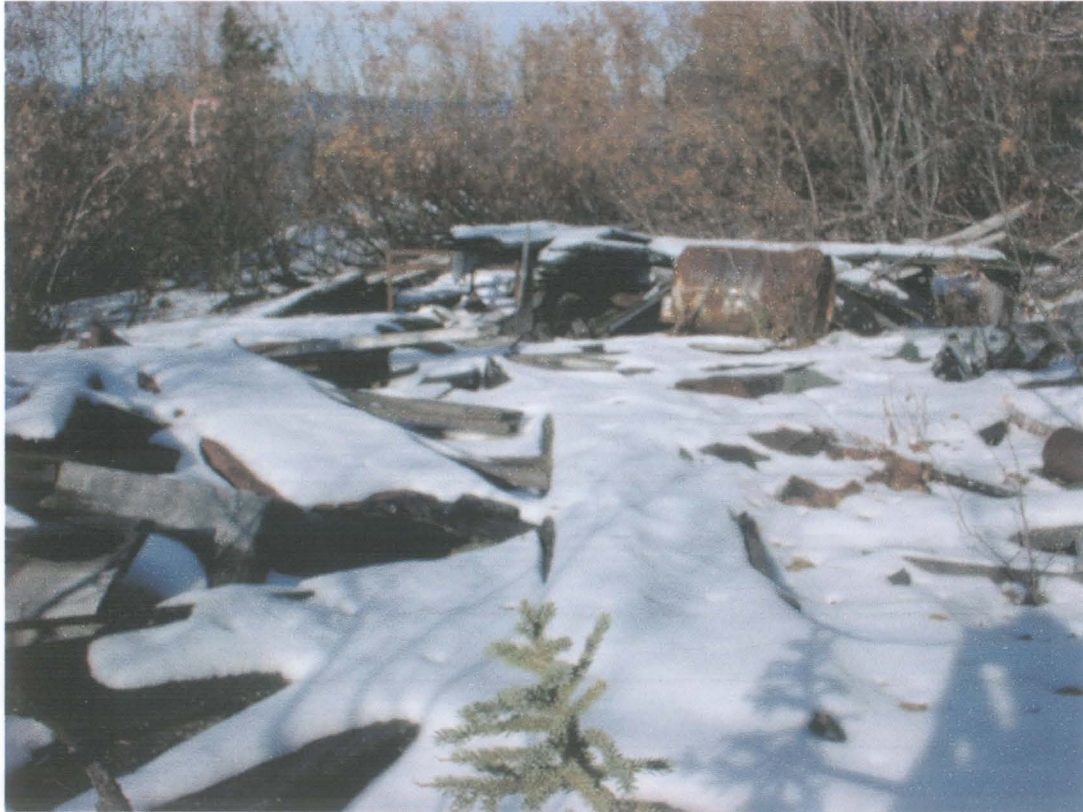
The bunkhouse, below, is located 30 meters to the southeast of the head frame, in dense scrub forest and willow. It has totally collapsed and the condition of the visible surface wood is beyond salvage, however lumber underneath may still be in usable condition. Kitchen debris and building material is spread throughout the area.

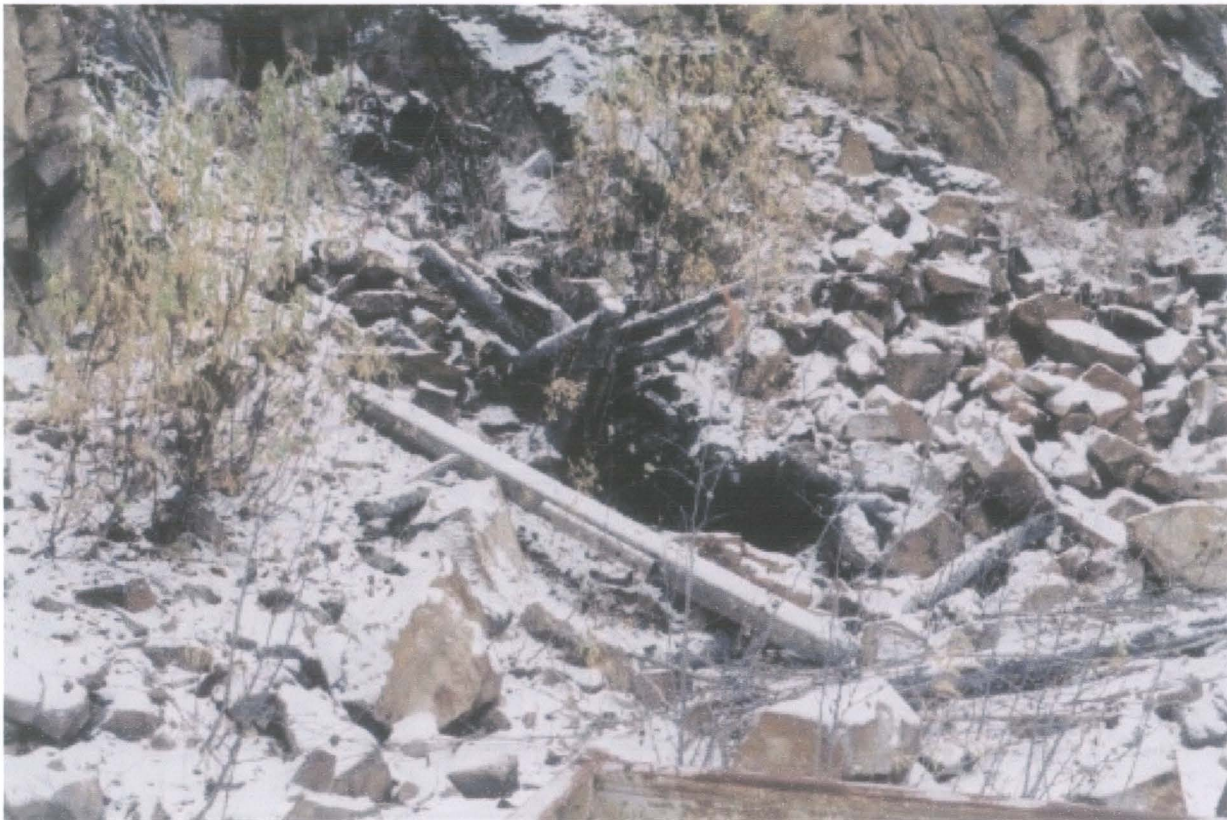
The adit timbers have further deteriorated, although a small access hole exists into the adit under the collapsed timbers. At the time of our inspection there was a small pool of water built up at the adit entrance, it was frozen over with a couple of inches of ice, this could possibly indicate a small discharge from the adit, although in previous studies it was stated that no surface waters were encountered. There is waste rock pile located near the front of the adit, and on the waste rock pile is a number of heavily rusted drums that look like they were full of highly oxidized ore material. Near the adit entrance is an old truck box also carrying oxidized ore.

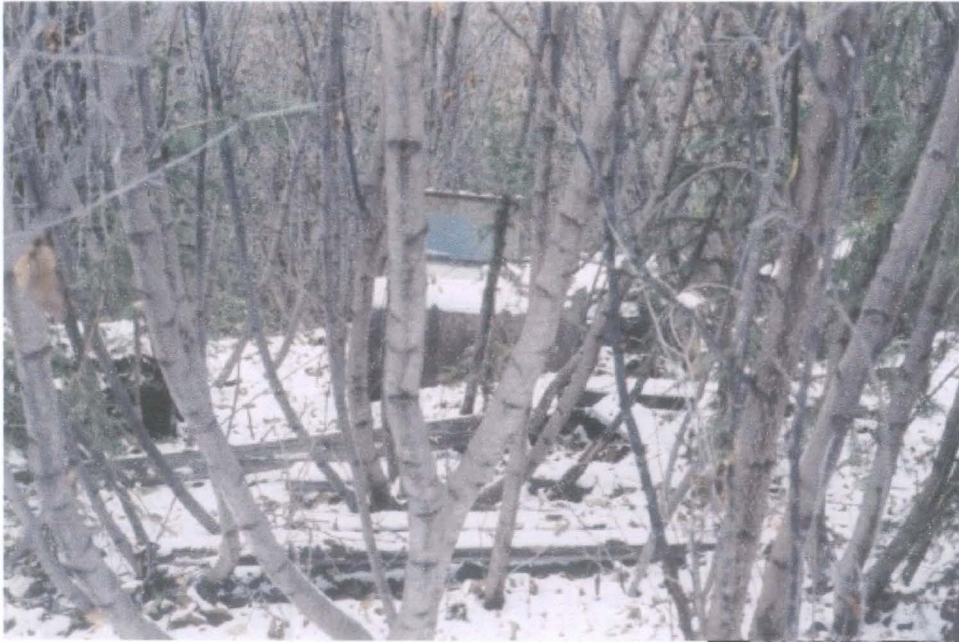
Photo: left, dense overgrowth with fuel drums and other debris on the trail between the adit and buildings.

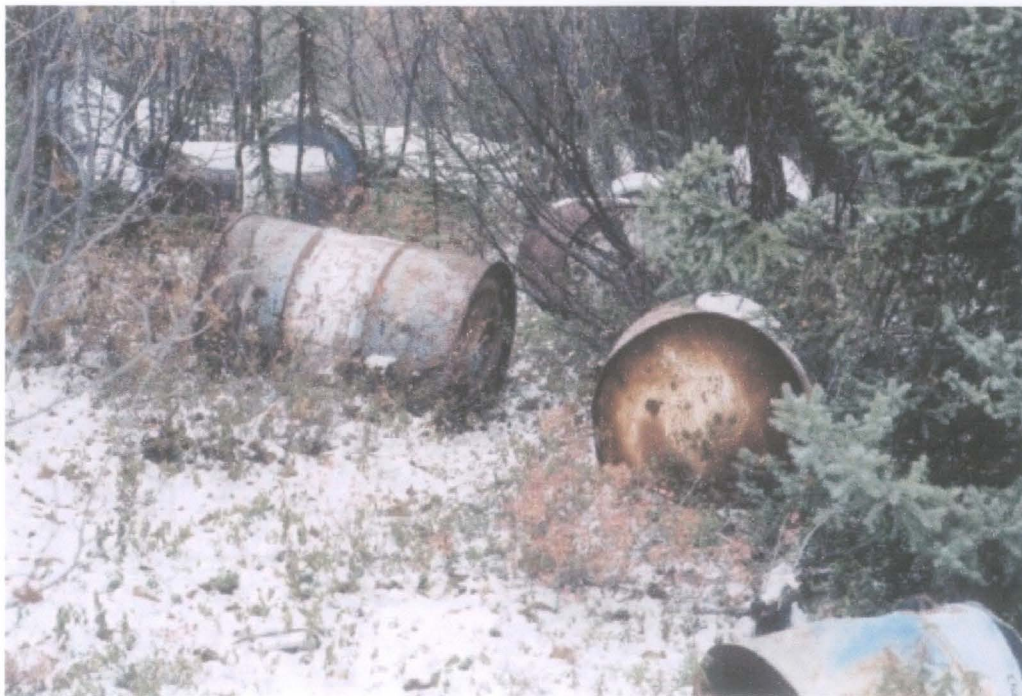
Photo: Right and below batteries and empty fuel drums scattered throughout the site.

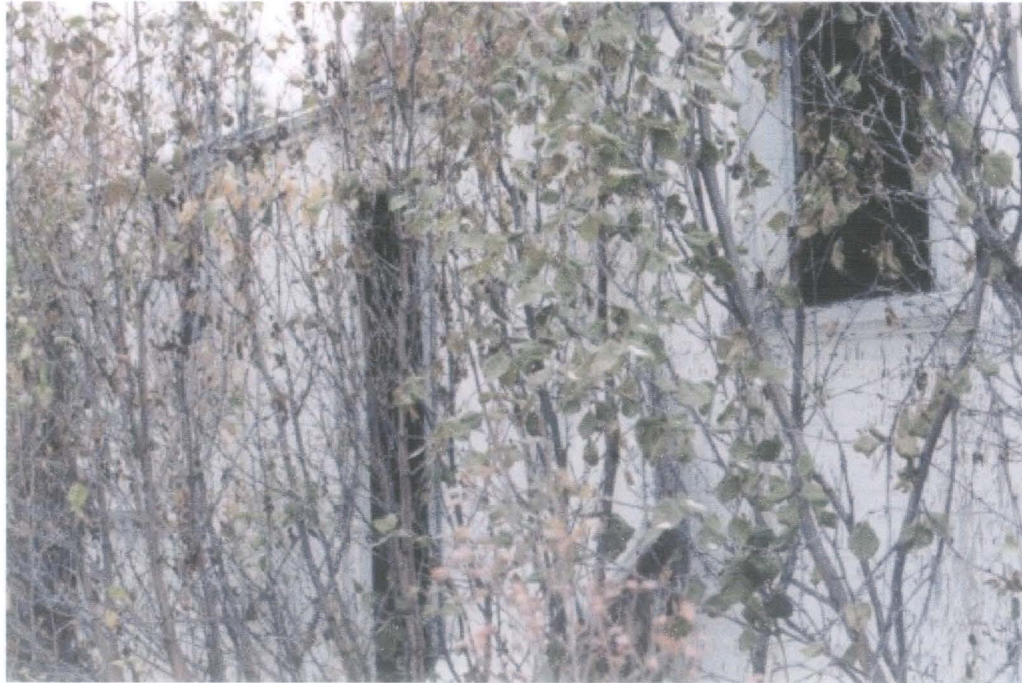
The first of the three buildings is a 12 X 28 foot trailer on a steel skid frame; all the buildings are in a state of collapse as with the roof on this one, which is caving in. About 30-meters west from the trailer is a 14 X16 tent frame that has been sheeted in with thin plywood; in the interior there is metal and glass debris.

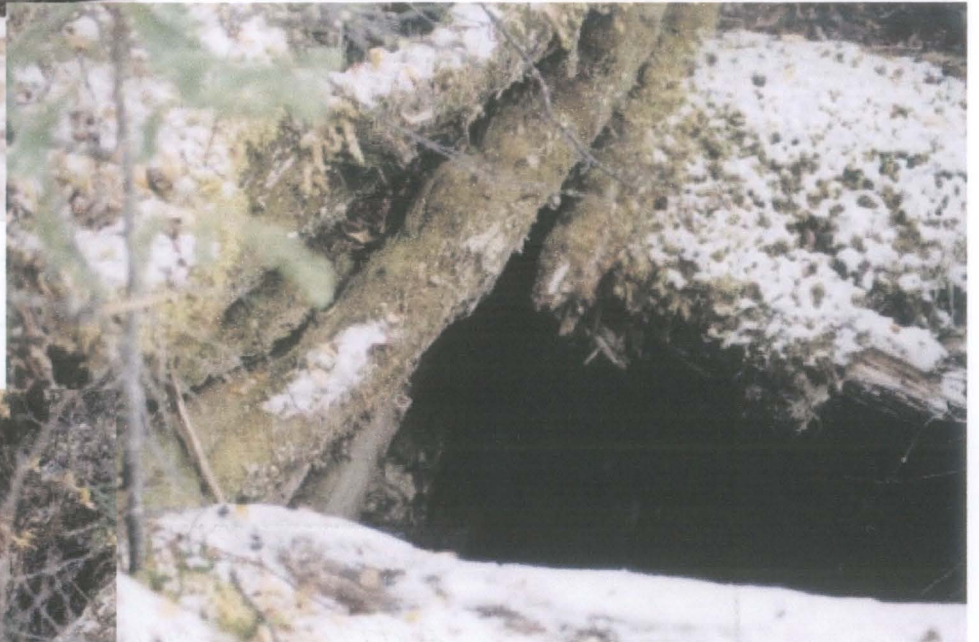
Shaft # 4 below is located down slope about 30 meters from shaft number two. Shaft #4 is in direct line with shafts #1 and #2 and of the same approximate dimension, two meters by two meters with log cribbing which is badly deteriorated and was filled with water to approximately three feet from the top.

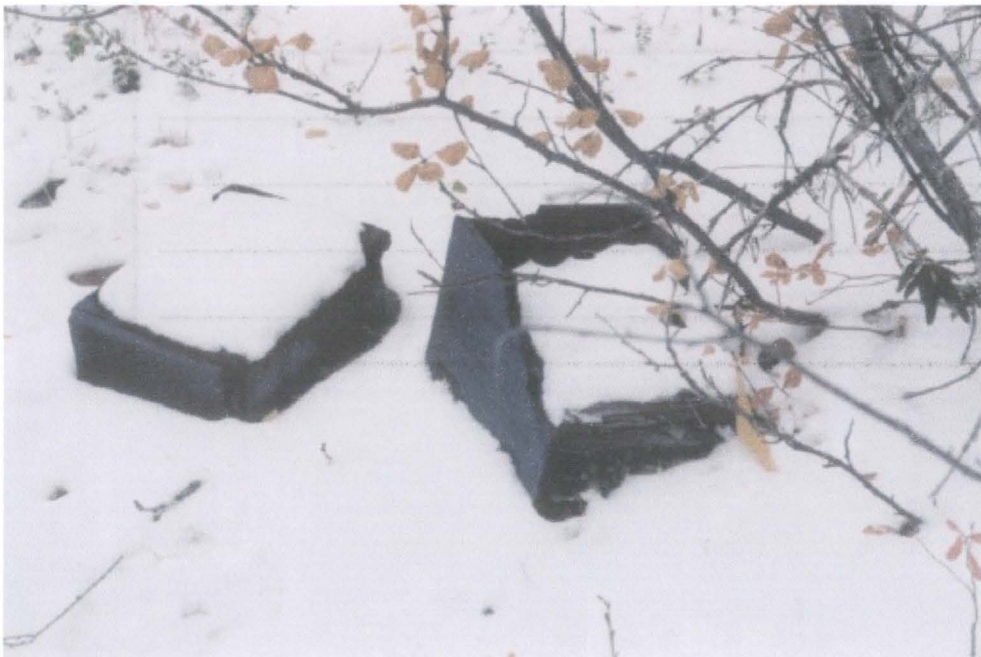
Old Cat Batteries

There is an assortment of hard waste material on the dumpsite; stove-pipe, two old oil heaters, two sheets of plate steel, part of an air receiver tank, and some drill steel. The only evidence of electrical equipment, were two old cat batteries, which were laying on the trail down to the dump.

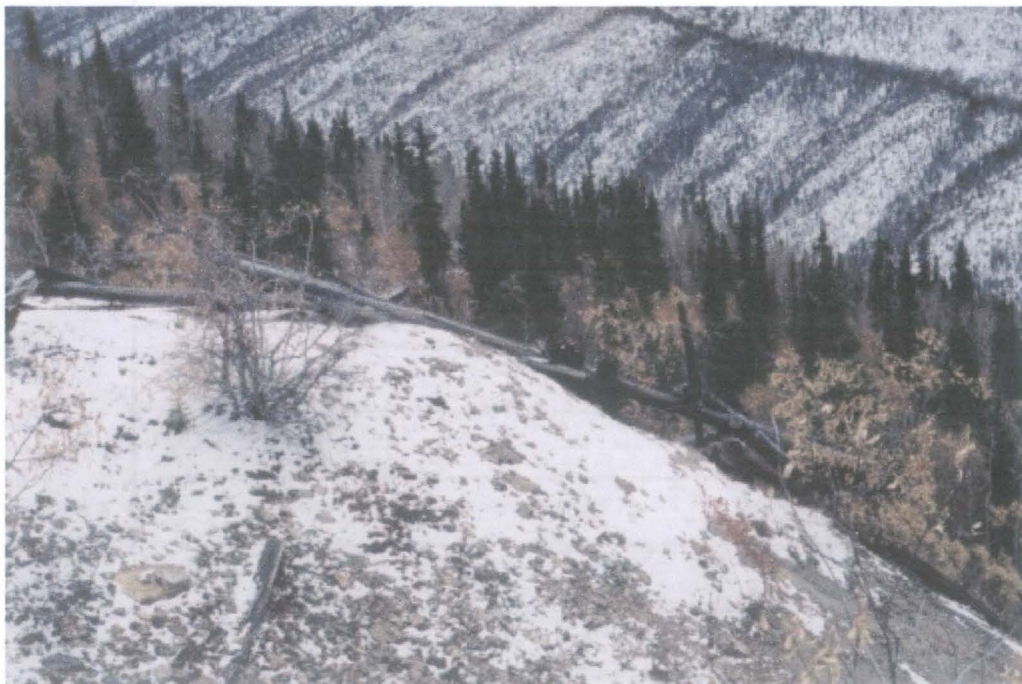
Below: waste dump

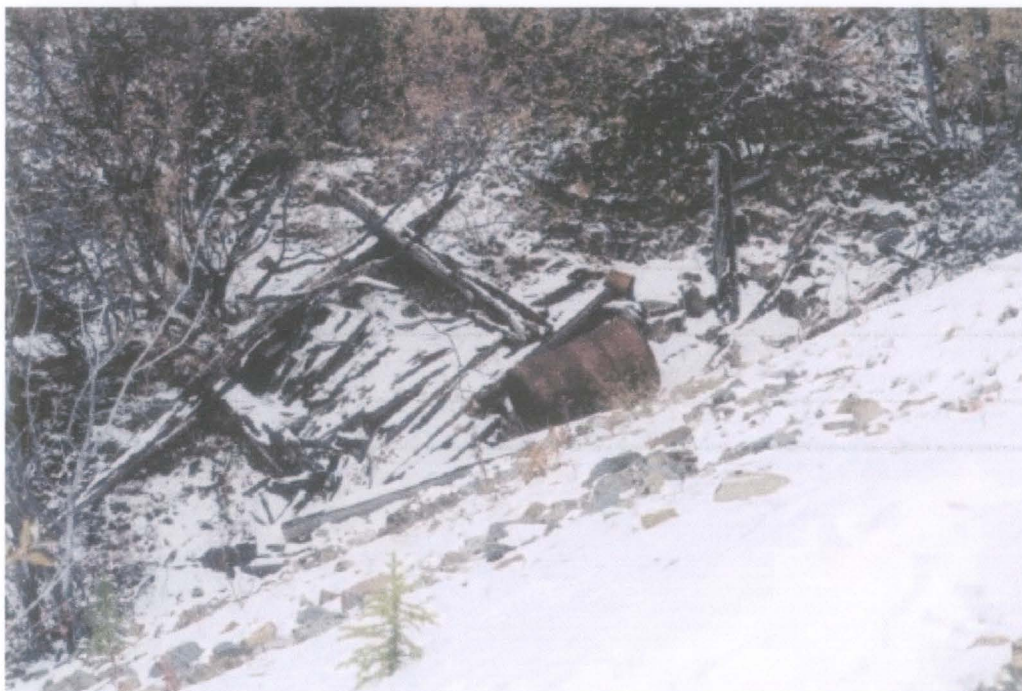
Below: drums and debris below waste dump

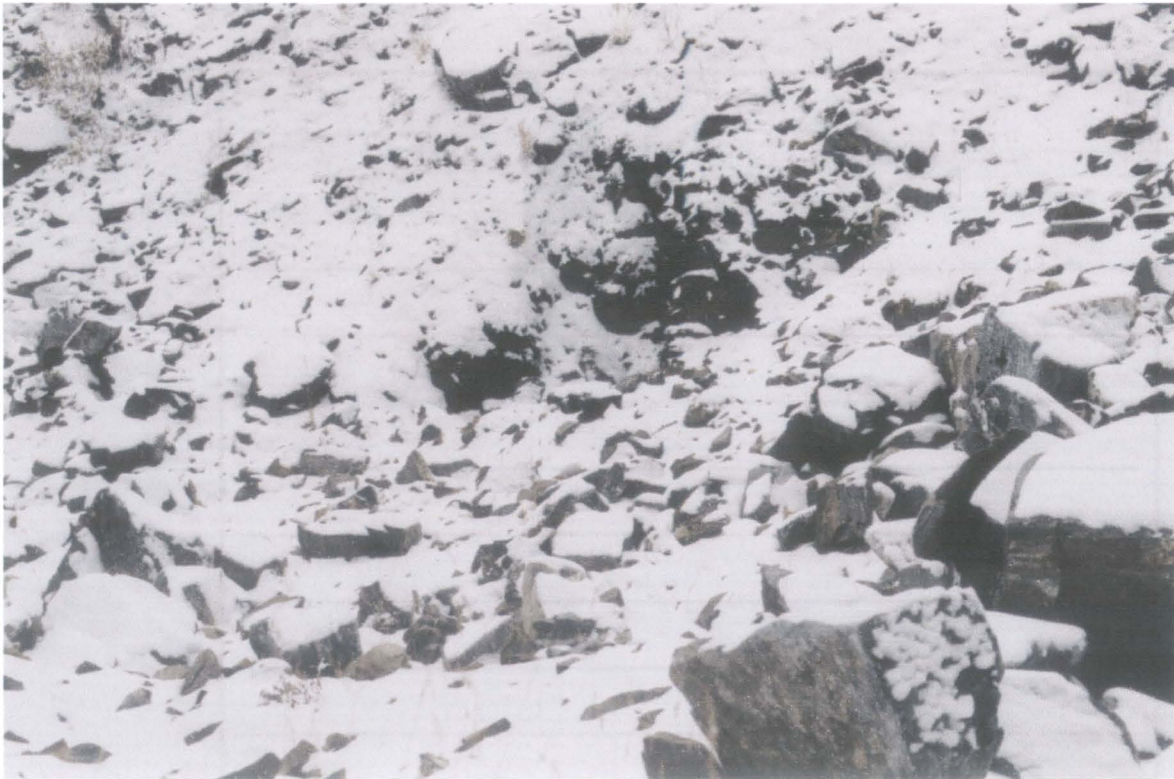
Above photo: Collapsed upper adit

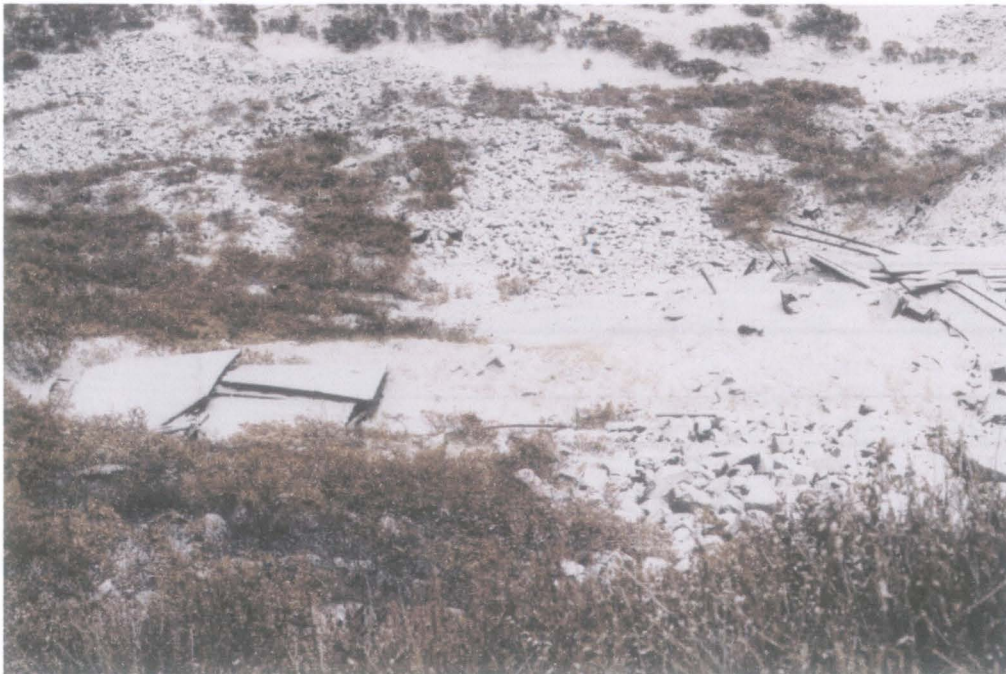
Photo:
Overview of
lower adit
and dump

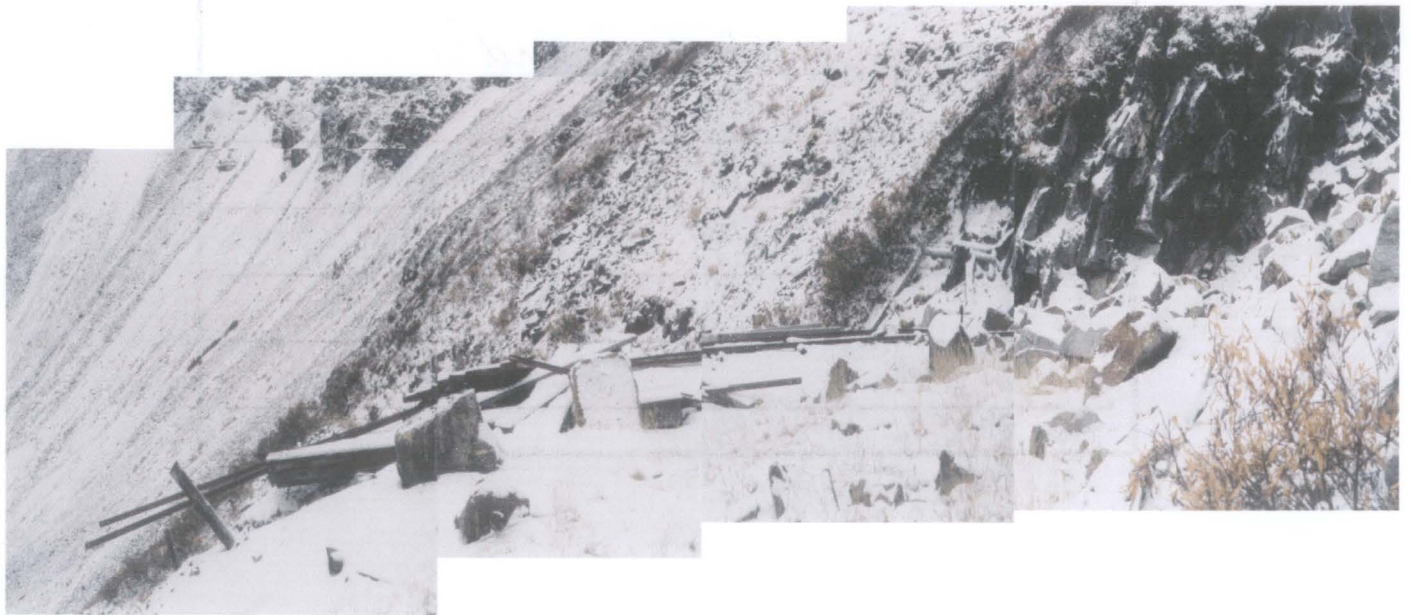
The second and lower adit; Adit has a rail and trestle extending from the collapsed portal; this rail ends at a wooden platform on the edge of the dumpsite, with some of the rail extending down the dump slope.

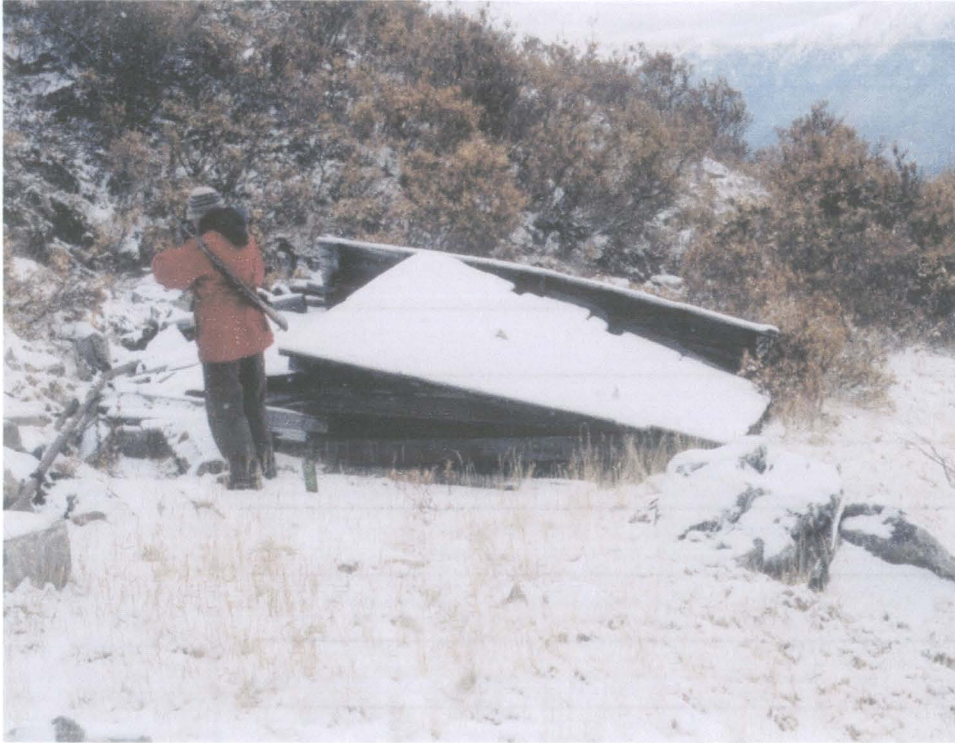
Photo: collapsed building, pipe and steel at the lower adit.
