Investigation of Sliver-Spall Damage at Offutt Air Force Base, Nebraska

Toy S. Poole and Raymond S. Rollings

March 2009

Final report

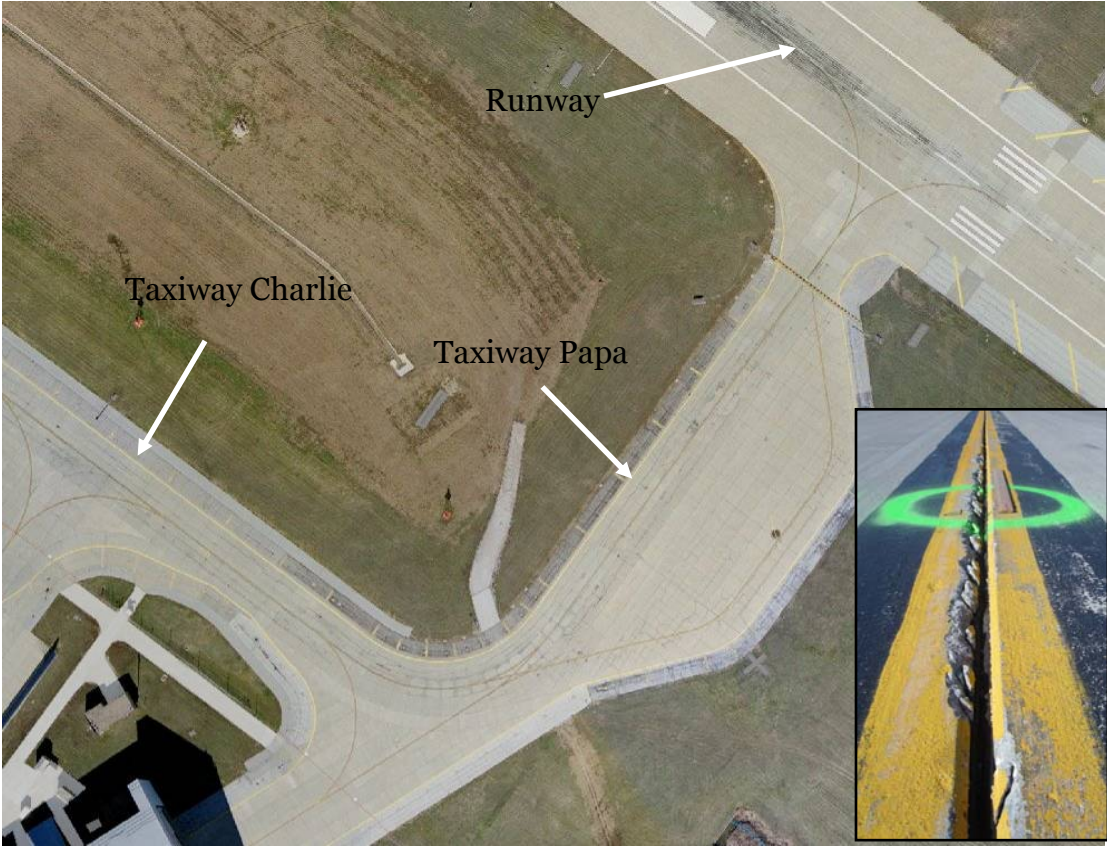
Figure 11. Study site at Offutt AFB with an example of damage inset.

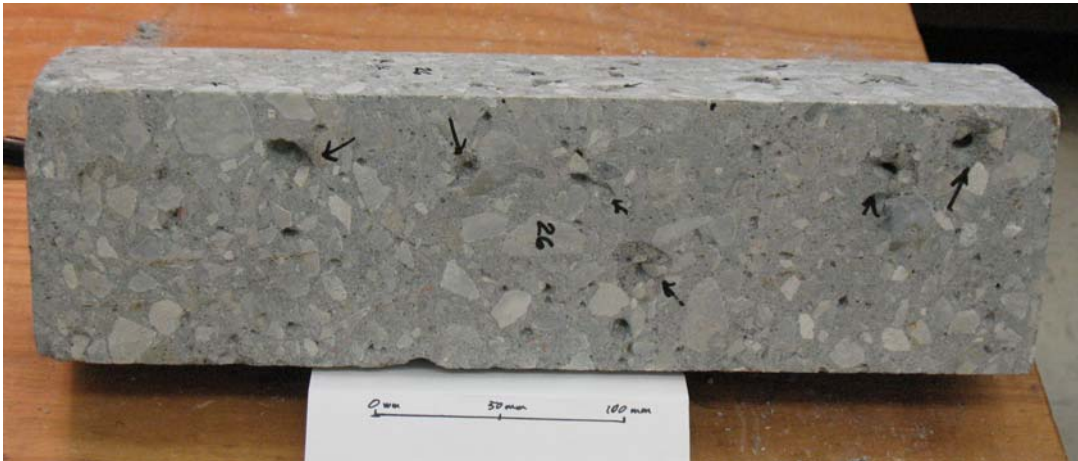
A notable early test damage feature in the C 666 specimens was the development of rather large popouts. Several of these are shown in Figures 16–18. At the base of these popouts, and presumably the cause of them, is usually the remnant of a 5- to 10-mm void that was located within about 10 mm of the surface of the specimen.

Figure 16. Specimen 26 after 81 cycles of freezing and thawing.

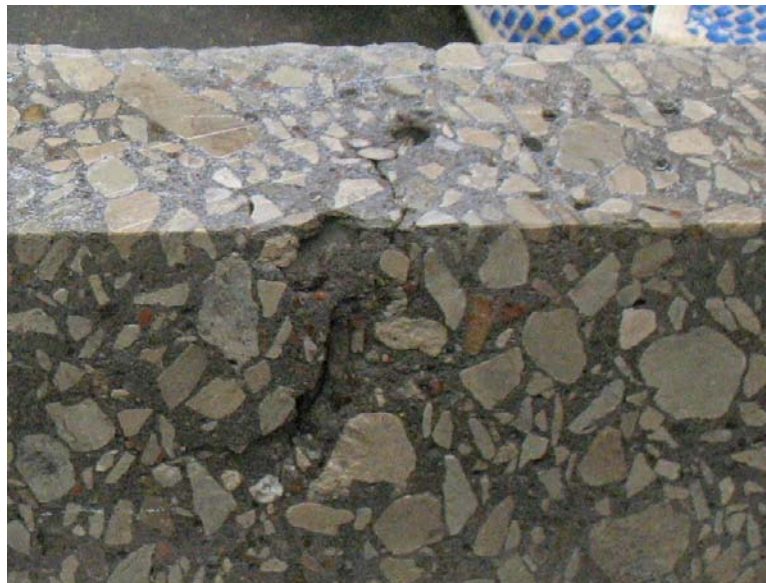
Figure 17. Eppley Core 3 after 70 cycles, showing a circumferential crack at least partially affected by subsurface voids. The arc-shaped damage feature in the lower center is a spall over a subsurface void that is fracturing off.

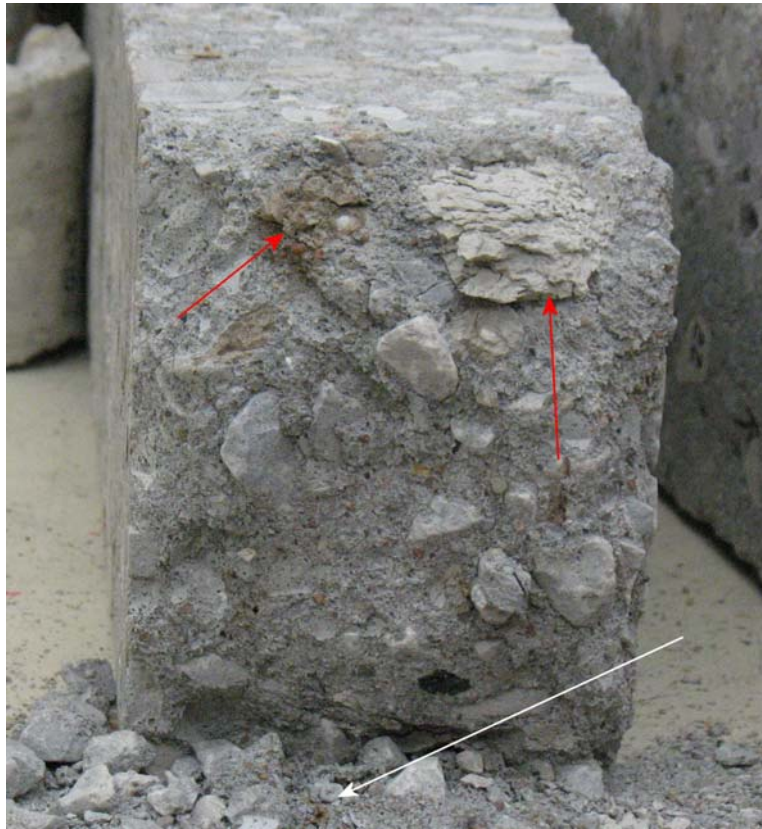
Figure 18. Damage to Offutt sample 26, as shown in 45 x 115 mm cross section, after 186 freezing and thawing cycles. Red arrows indicate two severely damaged aggregate particles. White arrow shows aggregate and crumbled paste that has fallen off of the specimen, typical of damage to the cement-paste fraction of the concrete.

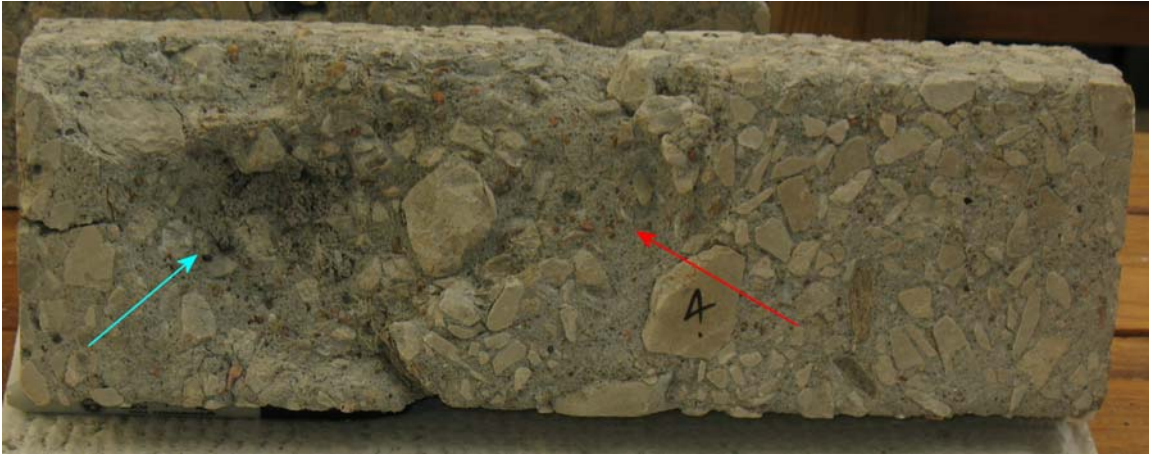
Figure 19. A specimen from Eppley Field after 230 cycles. The red arrow points to a zone of concrete that is deficient in coarse aggregate and probably also air. The blue arrow points to a deeply damaged zone that started as damage from a 10 mm entrapped air void and later enlarged, apparently due to paste damage. Note that the concrete, and specifically the paste, on the right-hand end of the specimen is in good condition.

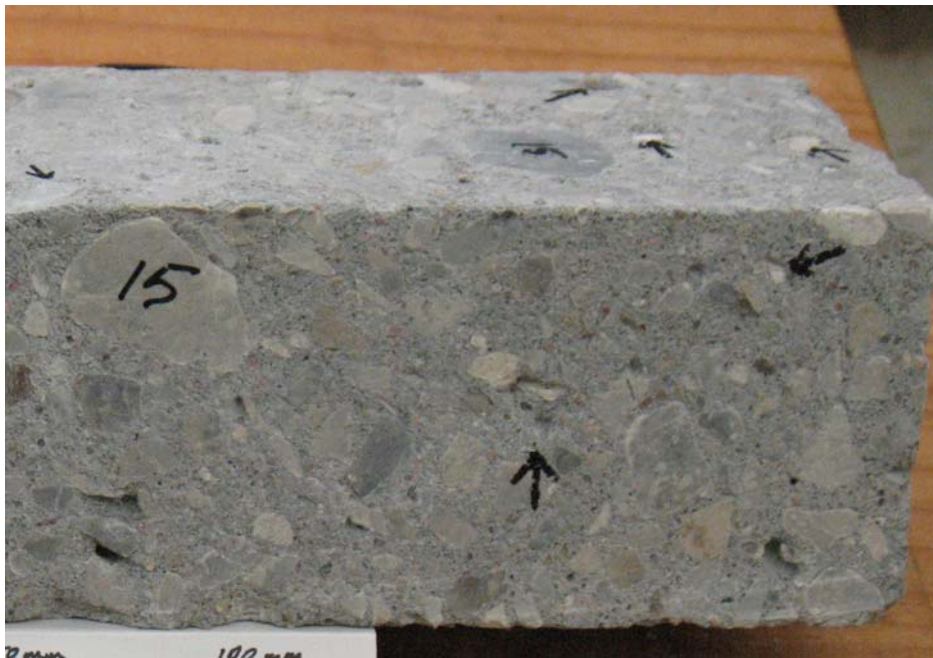
Figure 20. Cement paste fraction of sample 15 after 125 cycles of freezing and thawing. Corners are relatively sharp and paste etching is minimal.

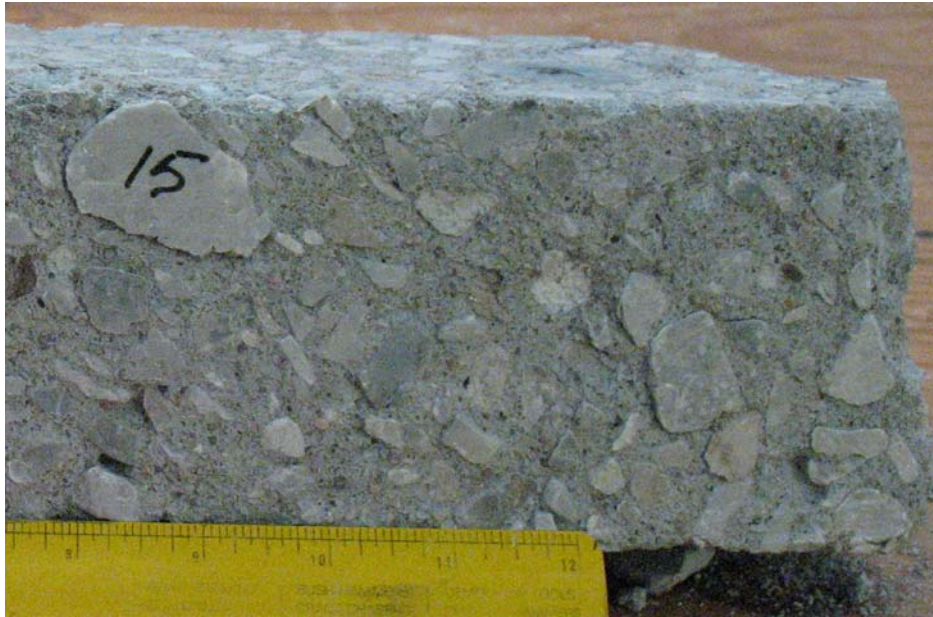
Figure 21. This photograph shows the same area of sample 15 shown in Figure 20, after 230 cycles. The paste is still largely intact, as indicated by the still relatively sharp edges, although the aggregate is clearly undercut due to loss of cement paste.

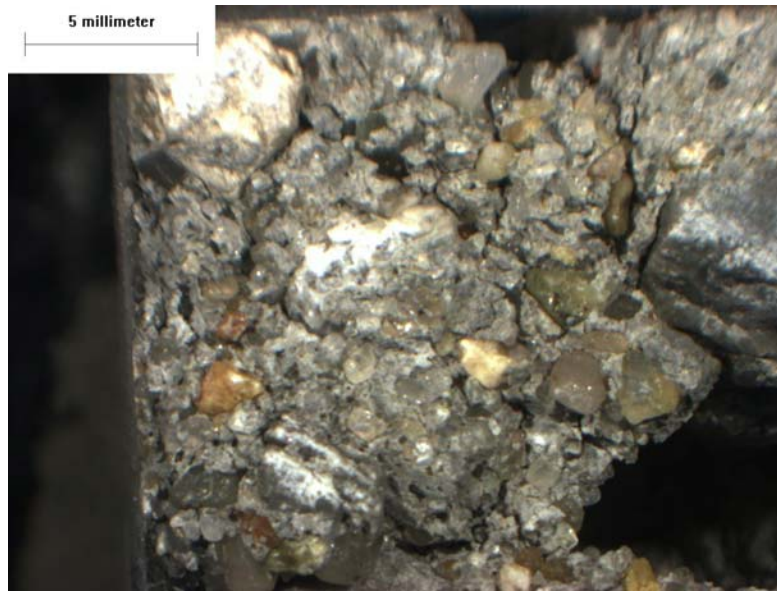
Figure 22. Paste damage in sample 27 after 81 cycles of freezing and thawing.

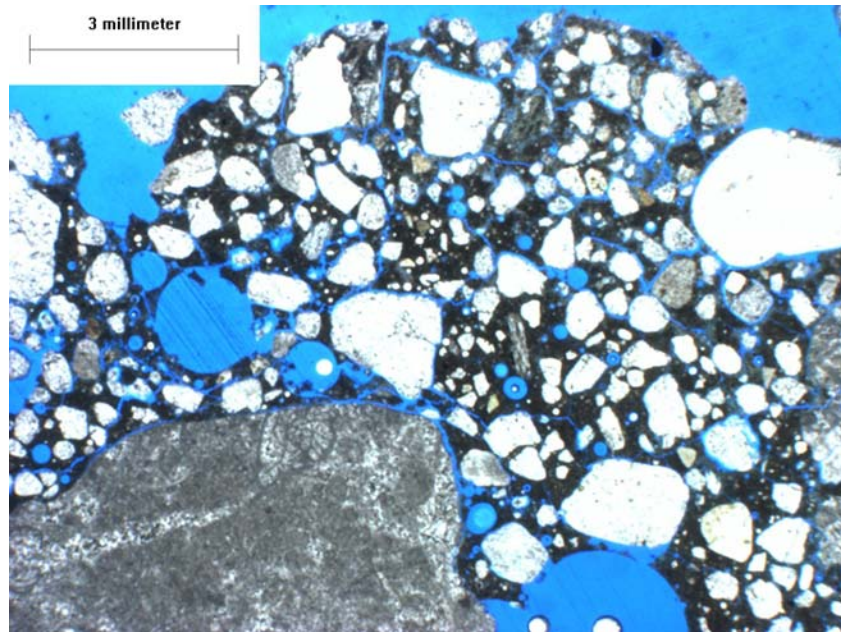
Figure 23. Badly damaged fragment of Core 15 after 125 cycles. Note the many very fine cracks running among the fine aggregate particles, particularly in the upper-right quadrant of the photograph.

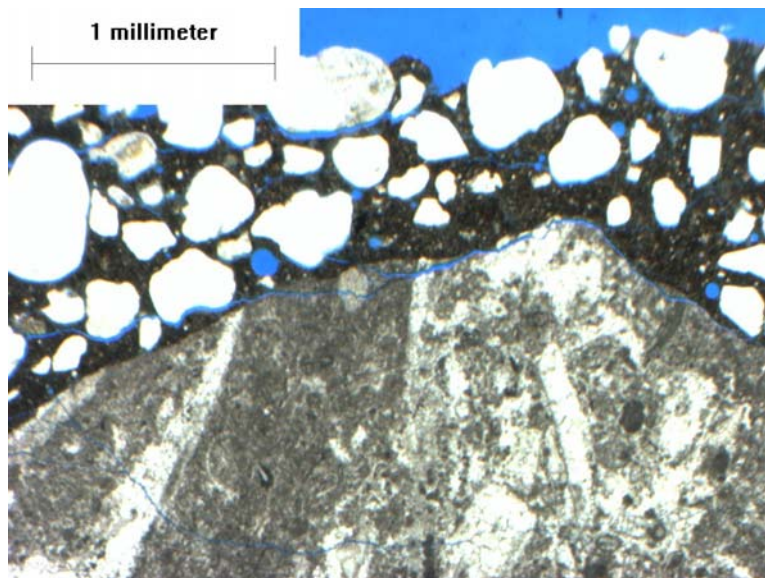
Figure 24. Taken from the edge of C 666 specimen from Core 27 after 81 cycles of freezing and thawing. Cracks in the large aggregate particle at the bottom of the photo are evident. The fine cracks in the paste fraction at the top of the photo indicate paste damage due probably to insufficient air voids.

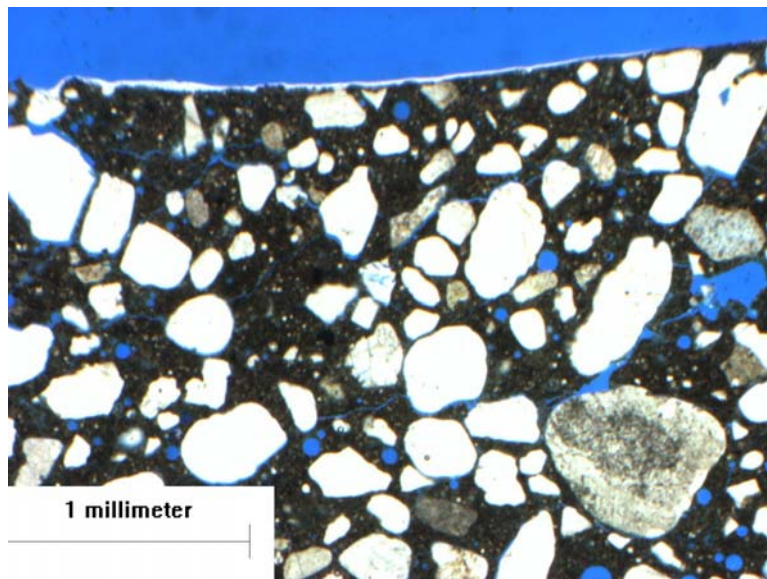
Figure 25. Damage to paste fraction.

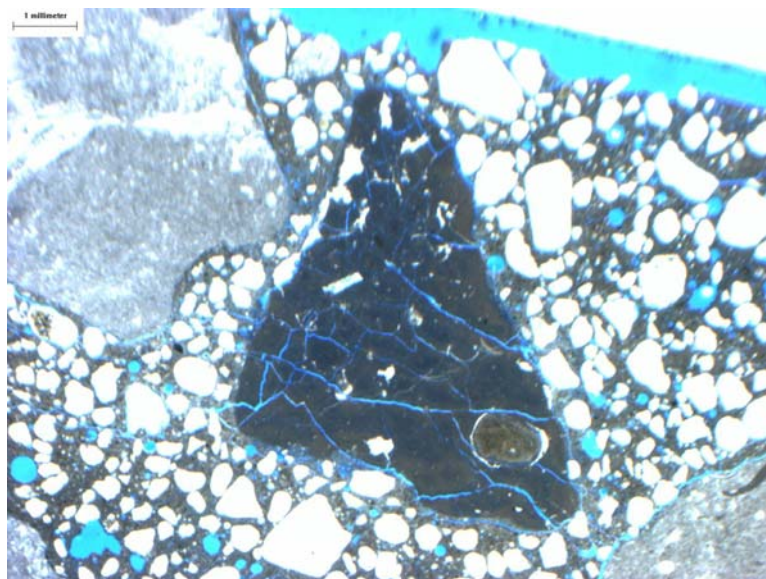
Figure 26. Specimen from Core 18. Aggregate damage is conspicuous and continues into the cement paste.

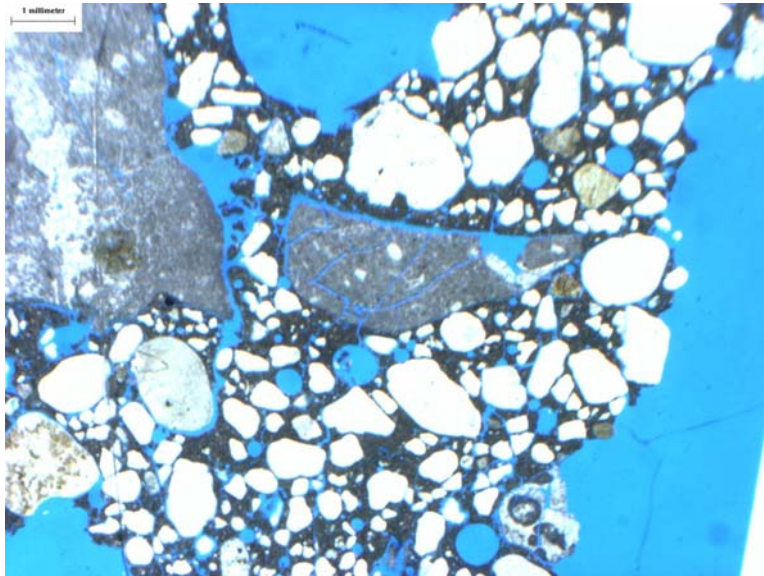
Figure 27. Thin section of a serious damaged part of the C 666 specimen from Core 18.

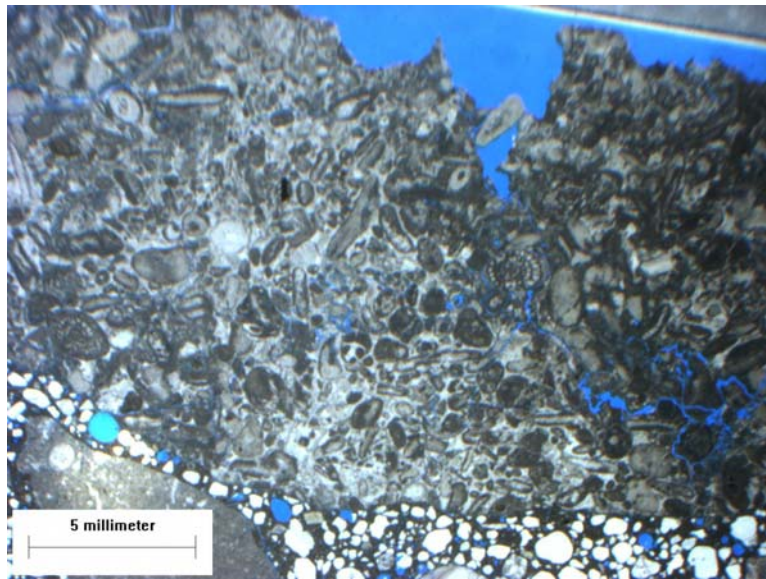
Figure 28. Damage to a piece of coarse aggregate in C 666 specimen from Core 18.

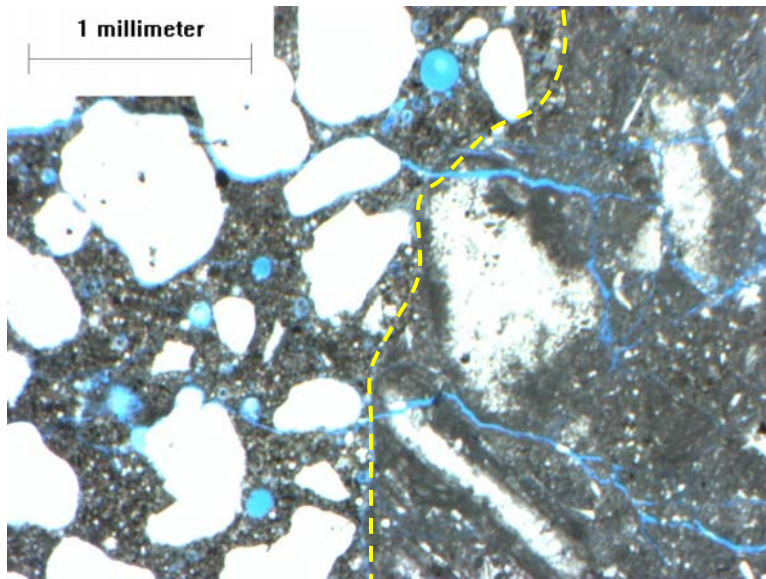
Figure 29. A relatively clear example of aggregate damage propagating into the cement paste fraction of a C 666 specimen cut from Core 24. The aggregate particle is the material to the right side of the yellow line.

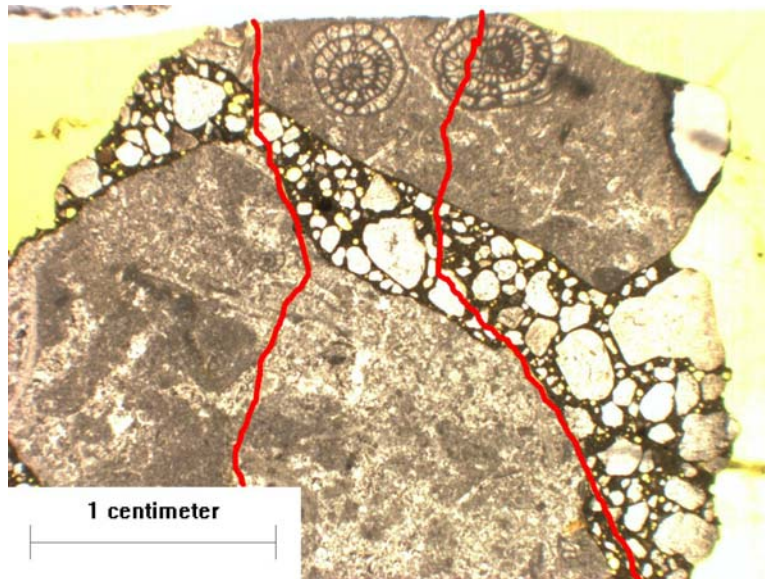
Figure 30. Cracking in a sliver spall taken from a damaged section of centerline joint. The cracks were very fine and have been colored red to highlight their path. The beveled surface is at the top of the picture and sawed surface is to the left. The fractured surface that caused the separation is to the right.

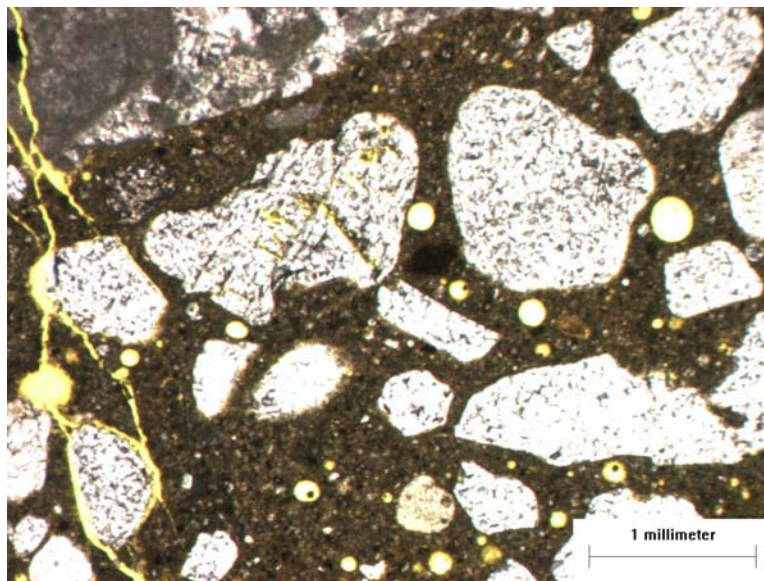
Figure 31. Aggregate-induced cracking in a sample of field exposed concrete taken from near a damaged sawed joint. The coarse-aggregate particle is in the top-left corner.

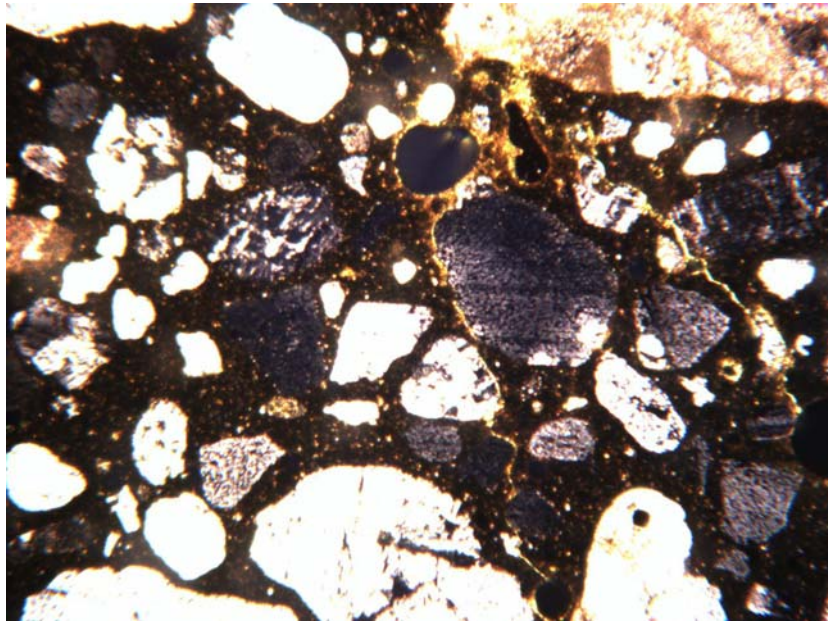
Figure 32. Apparent damage due to a small section of poor air entraining.

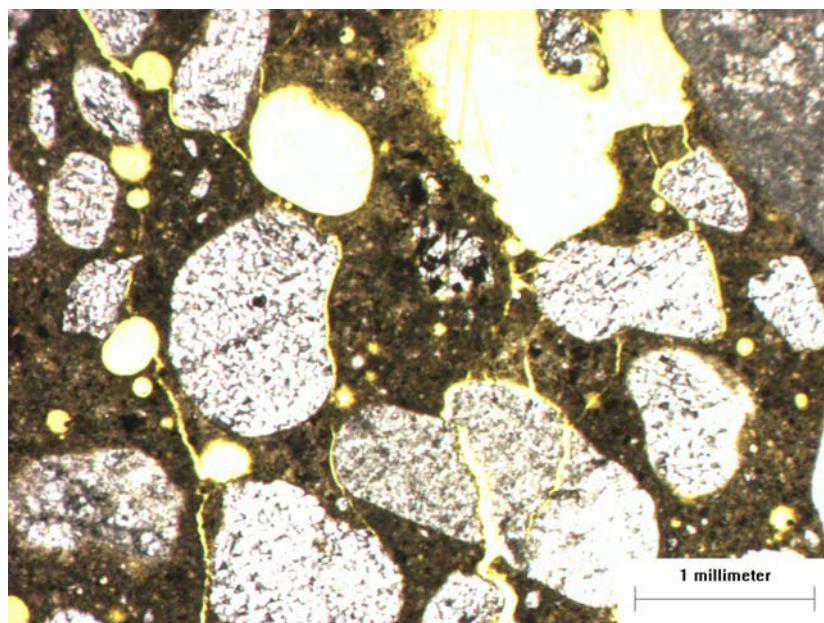
Figure 33. Cracking that resembles the type seen with poor air entraining.

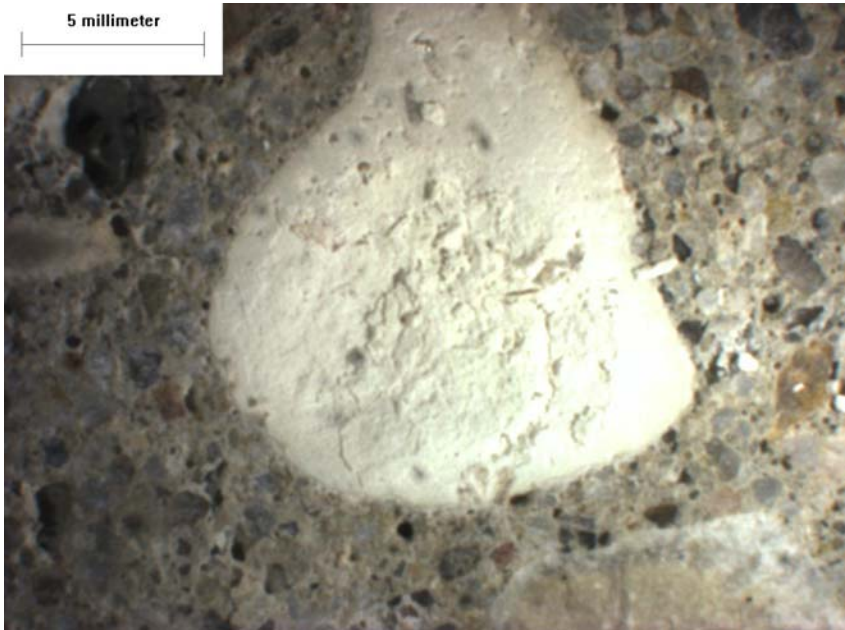
Figure 34. A 10-mm aggregate particle showing first signs of damage after soaking in potassium acetate and then exposure to eight cycles of freezing and thawing in water.

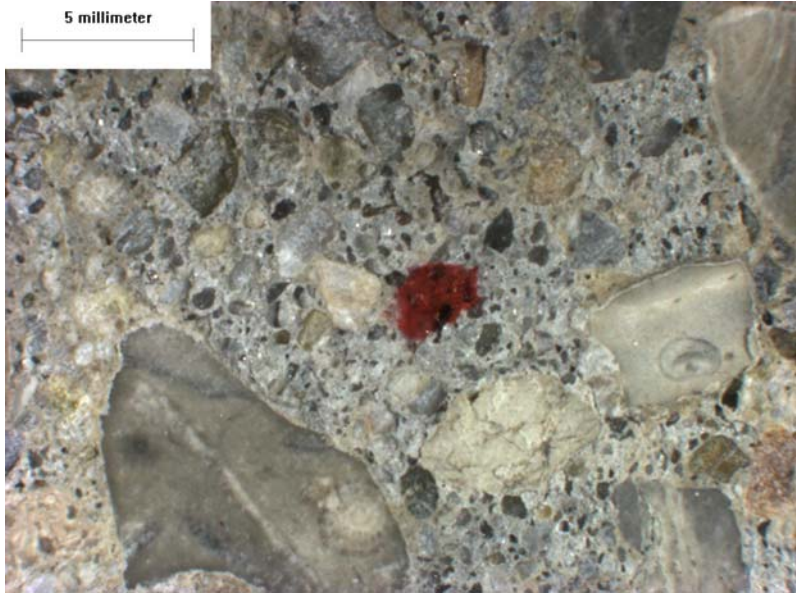
Figure 35. Mortar fraction of Core 16 after soaking in potassium acetate and then exposed to eight cycles of freezing and thawing, showing exposure of aggregate particles due to erosion of paste.

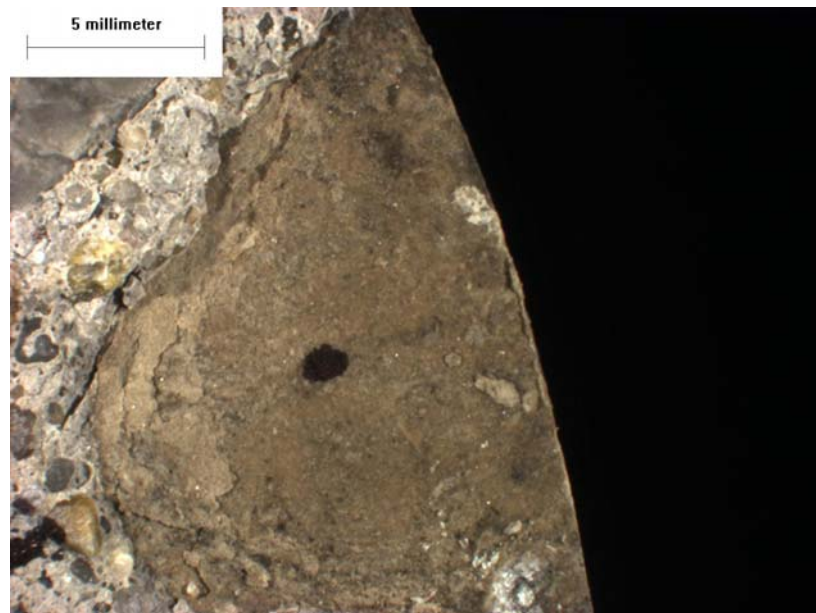
Figure 36. An example of paste etching and aggregate damage (along the left edge) after 19 cycles of freezing and thawing in water after exposure to potassium acetate.

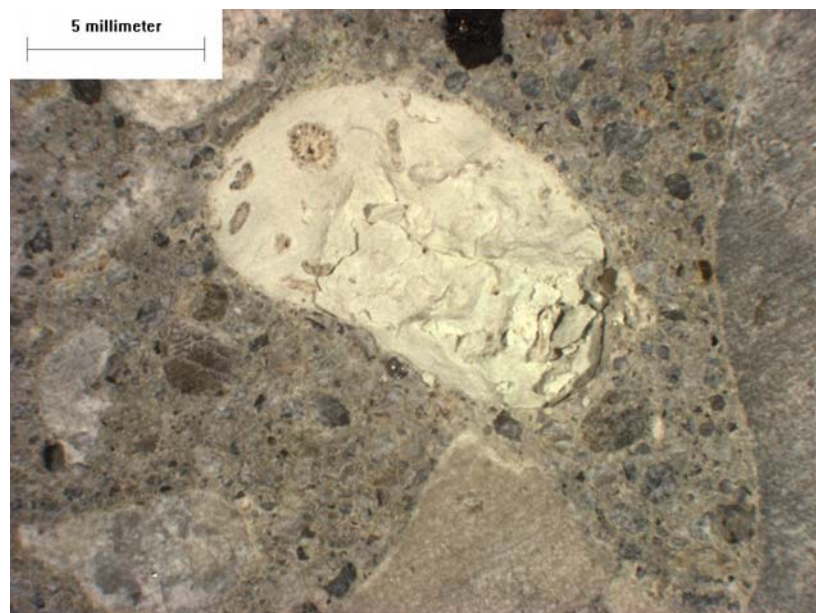
Figure 37. A 10-mm aggregate particle damaged after 19 cycles of freezing and thawing in water after exposure to potassium acetate solution.

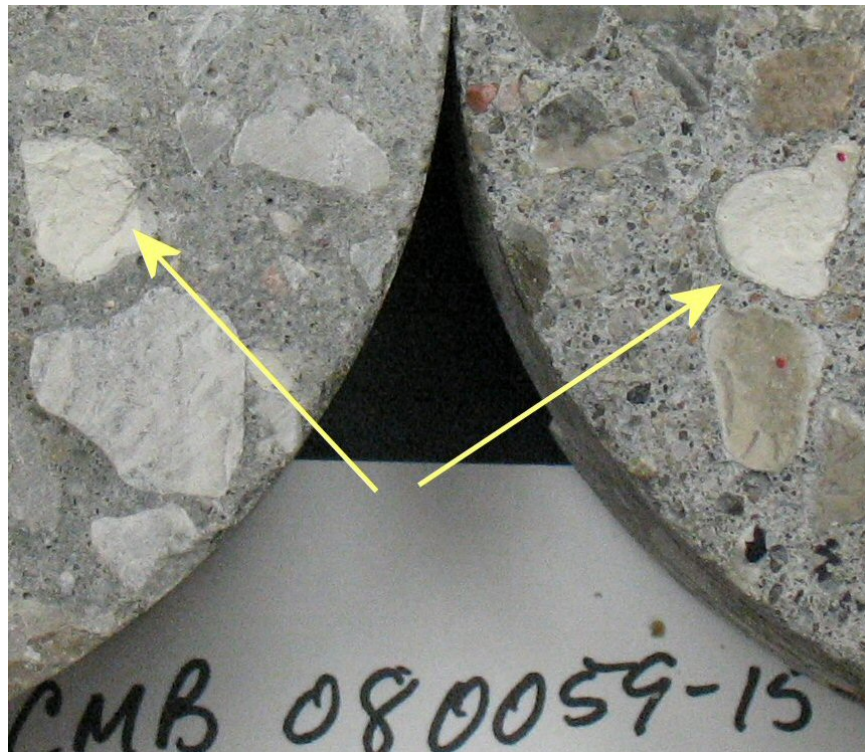
Figure 38. Comparison of control (left) and potassium acetate soaked (right) specimens from Core 15 after 19 cycles of freezing and thawing. The paste fraction of the specimen on the right is etched to about 1 mm. The yellow arrows show a type of coarse aggregate particle common in the Offutt pavement that deteriorates early and about equally with or without potassium acetate treatment.

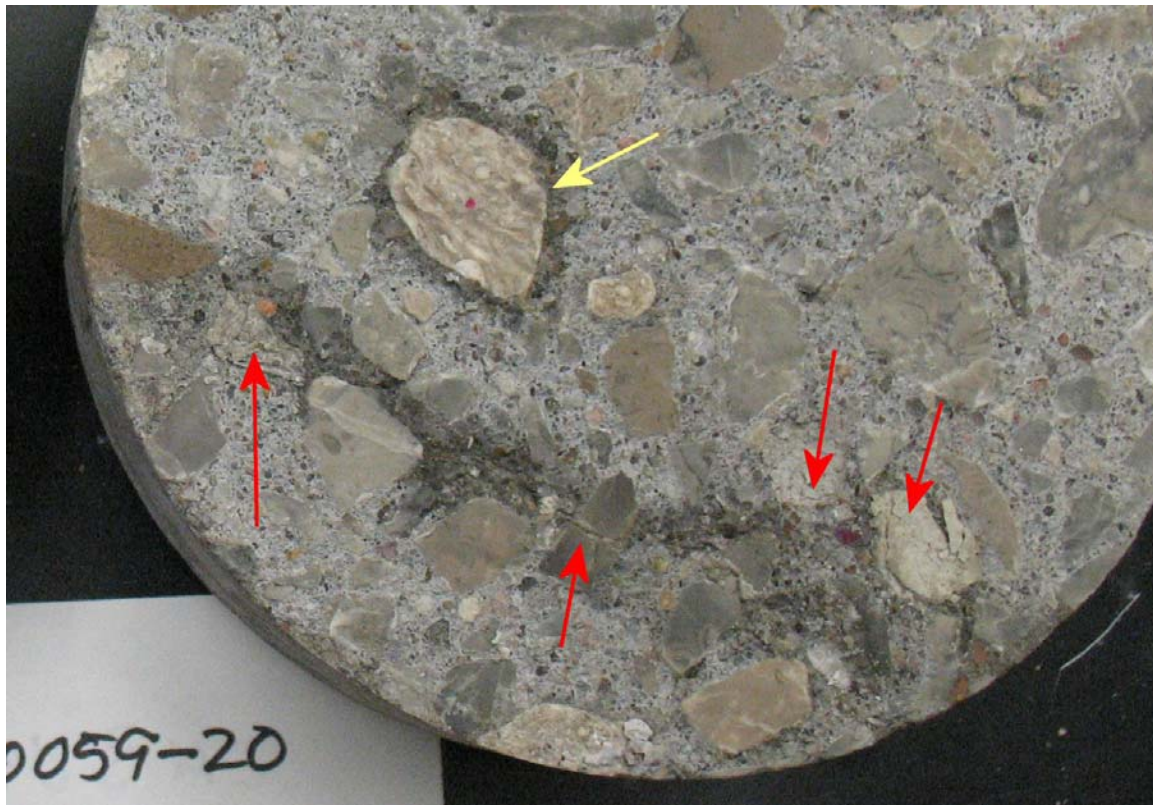
Figure 39. Sample from Core 20 soaked in potassium acetate, then exposed to 19 cycles of freezing and thawing. Red arrows indicate damaged aggregate that appear to have caused a crack (dark zone). The yellow arrow indicates a zone of paste around a coarse aggregate particle that appears to be preferentially taking up potassium acetate.

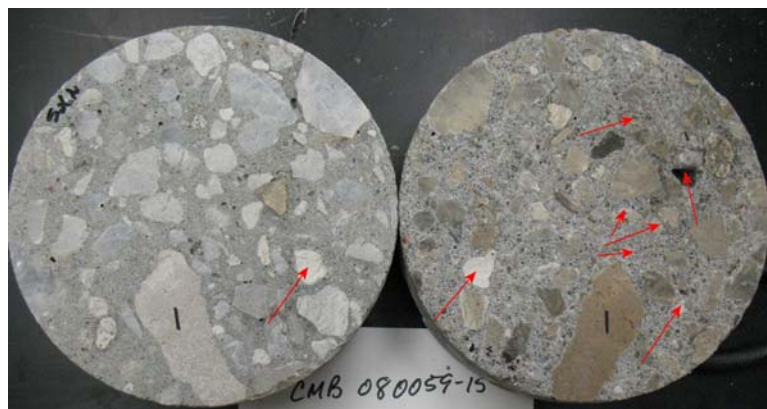
Figure 40. Sample from Core 15. Control is on the left, KAc-exposed is on the right. Red arrows indicate a damaged aggregate particle.

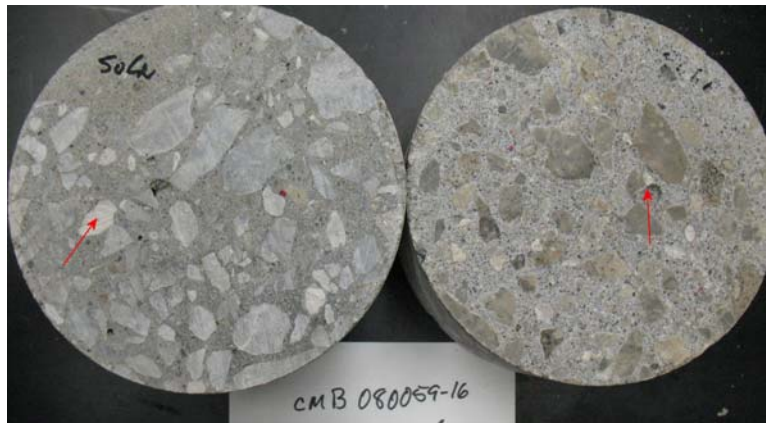
Figure 41. Sample from Core 16. Control is on the left, KAc-exposed is on the right. Red arrows indicate a damaged aggregate particle.

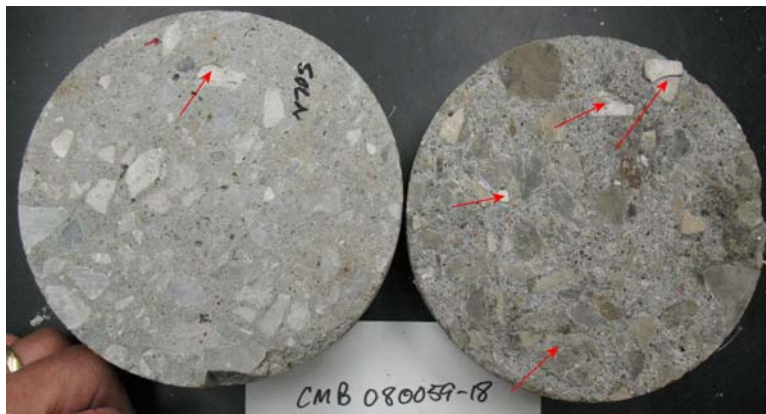
Figure 42. Sample from Core 18. Control is on the left, KAc-exposed is on the right. Red arrows indicate a damaged aggregate particle.

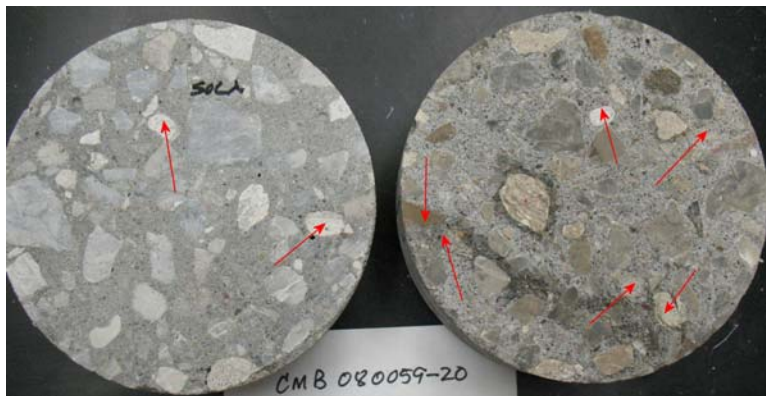
Figure 43. Sample from Core 20. Control is on the left, KAc-exposed is on the right. Red arrows indicate a damaged aggregate particle.

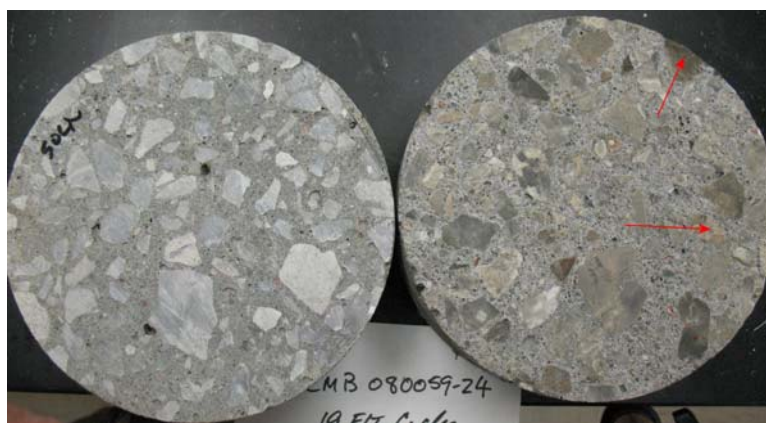
Figure 44. Sample from Core 24. Control is on the left, KAc-exposed is on the right. Red arrows indicate a damaged aggregate particle.

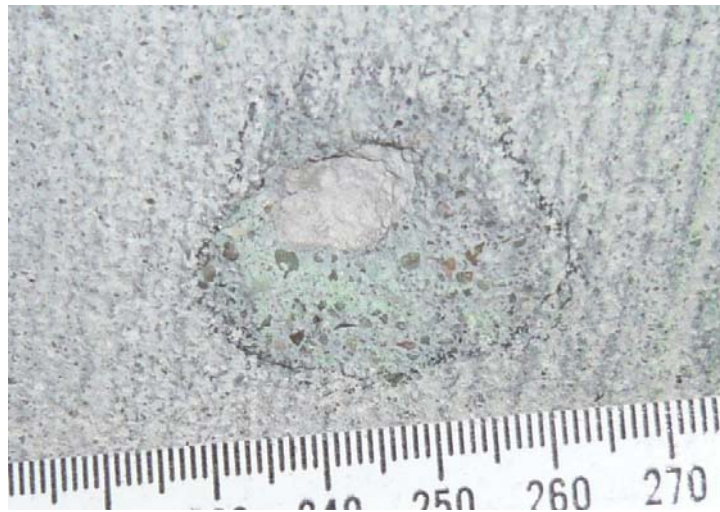
Figure 45. Surface popout on Taxiway P. From Core 21. About 10 mm is exposed, but on dissection this particle turned out to be about 20 mm in diameter.

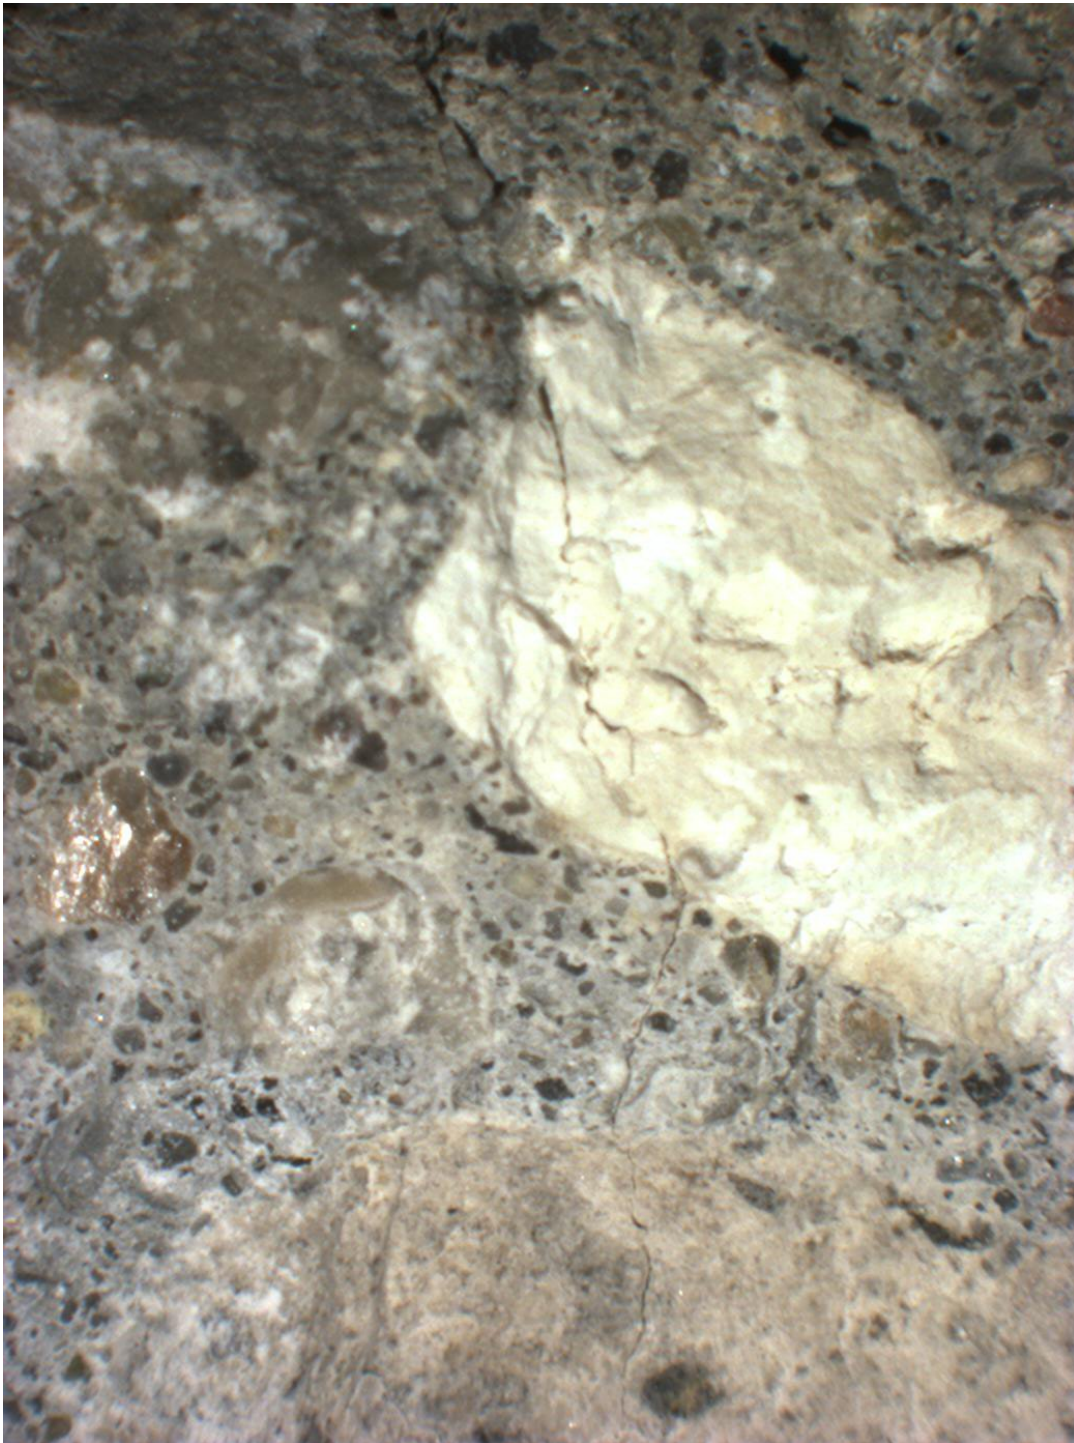
Figure 46. Vertical face of the crack shown in Figure 47. Two fragments of 20- to 25-mm coarse aggregate observed to be nondurable in laboratory testing, which appear to be involved in the origination of the crack. The finished surface is at the top edge of the picture.

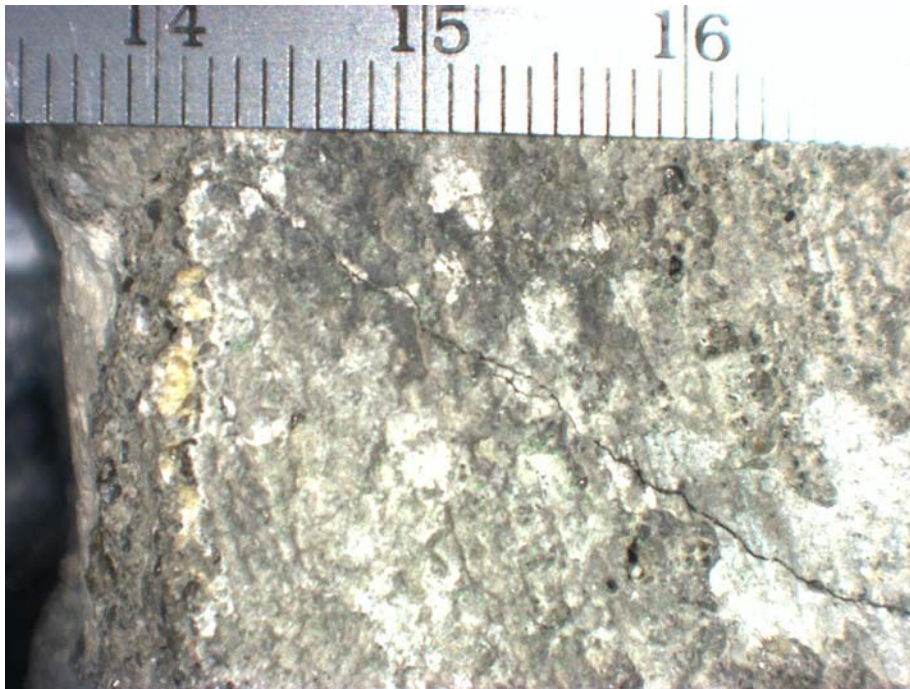
Figure 47. View of a crack on the finished surface of Core 19, taken from TW P. The vertical face to the left is part of an intersecting crack. A piece of nondurable coarse aggregate is visible as the white feature on the vertical face.

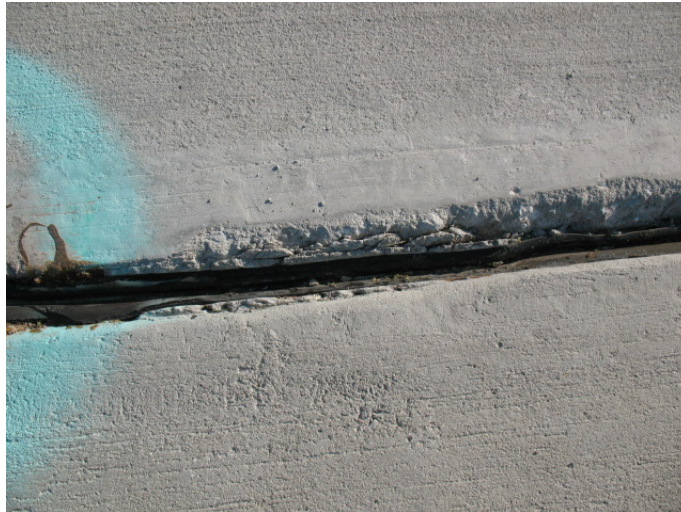
Figure 52. Expansion joint on south side of RW centerline at STA 39+44. Runway slab is to the top.

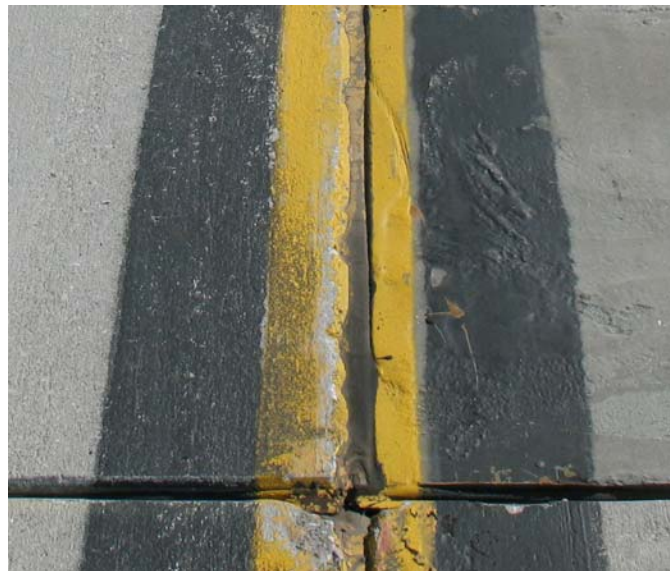
Figure 54. Surface abrasion along a centerline joint.

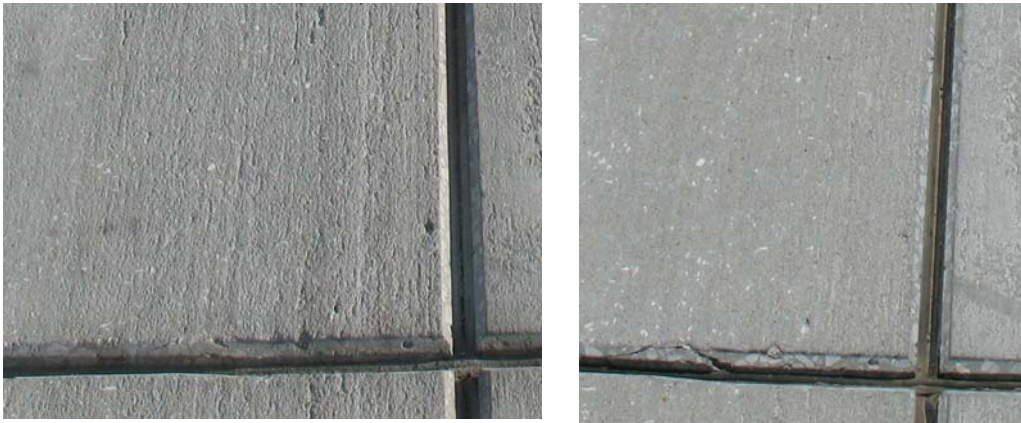
Figure 55. Loss of surface paste and formation of a new spall. Condition in December 2007 is on the left, and condition in June 2008 is on the right.

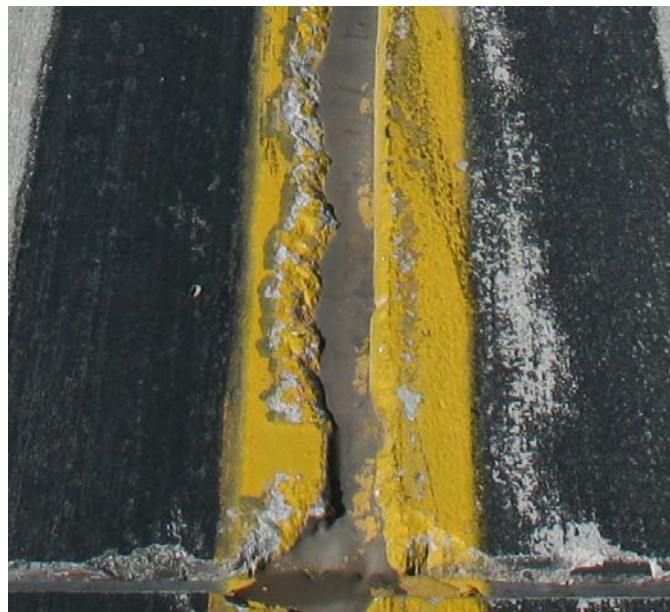
Figure 56. Raveling in the winter of 2007–2008 in damage first created in the winter of 2006–2007.

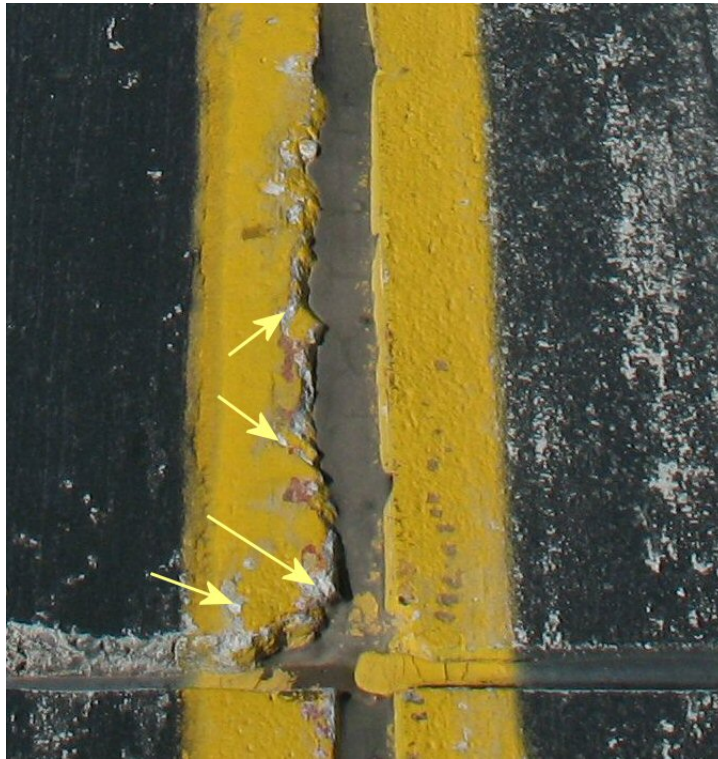
Figure 57. Aggregate suspected of being nondurable in a zone of heavy raveling.

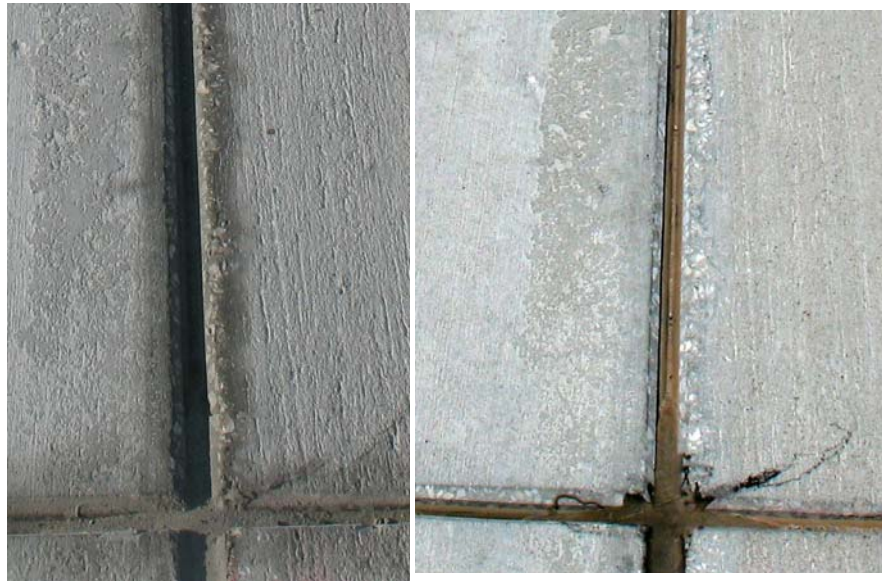
Figure 58. Possible case of deicing salt effect on surface paste. Wet joint in Dec 07 is on the left. Dry joint in Jun 08 is on the right.

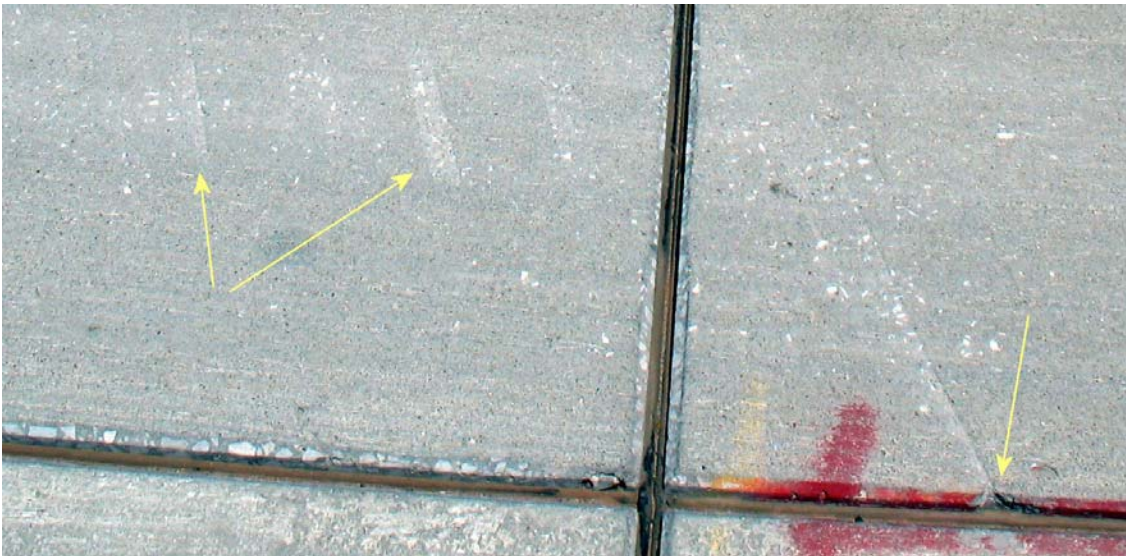
Figure 59. Scars that appear to result from snowplow abrasion, along with damage to the joint (lower right).

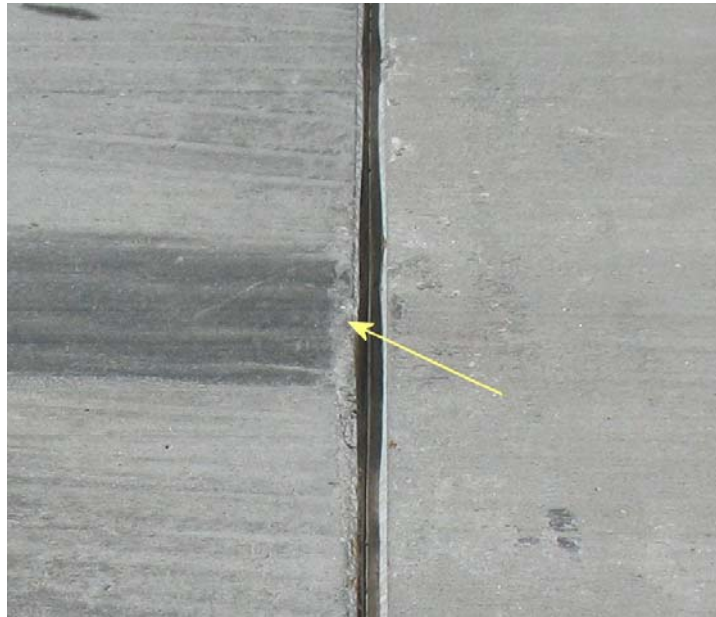
Figure 60. Tire damage along a transverse joint.
