RESEARCH ARTICLE

Failure modes in cedar tree revetments: Observations on rivers and streams in eastern Kansas, USA

How to cite this article: Shelley, J., Haring, C., & Chrisman, N. (2022). Failure modes in cedar tree revetments: Observations on rivers and streams in eastern Kansas, USA. *River Research and Applications*, 1–11. <https://doi.org/10.1002/rra.3997>

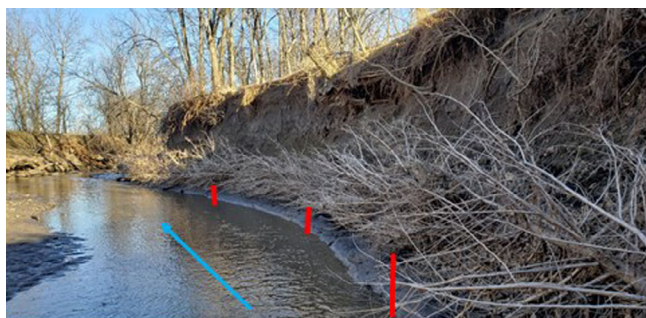
Multiple sites showed evidence of recent bed degradation, the lowering of local base level due to channel incision processes. These channel geomorphic processes have been qualitatively described in Channel Evolution Models (Cluer & Thorne, 2013; Hawley, Bledsoe, Stein, & Haines, 2011; Schumm, Harvey, & Watson, 1984; Simon & Hupp, 1986) that predict channel widening and deepening conditions in degrading channels. At the Wolfley Creek project (Site 12), the bed degraded, which stranded the revetment above the new, unprotected toe. Figure 4 shows the installation of a single row of cedar trees lining the toe of Wolfley Creek. In Figure 5, the single row of cedar trees is visibly perched above the base flow water surface. Multiple knickpoints ranging from 150 to 300 m upstream provided further indication of recent degradation. Based on installation notes (pers. commun., Charles Barden, 2020) and channel changes upstream viewed during the site visit, the channel lowered 0.3 to 0.6 m in elevation since construction of the revetment.

FIGURE 5 Channel bed degradation on Wolfley Creek Cedar tree revetment April 2017 (Nassar, 2019). Red lines indicate channel degradation. Blue line indicates flow direction [Color figure can be viewed at wileyonlinelibrary.com]

streams visited, glacially deposited, resistive clay materials within the toe of the bank and bed likely slow the scour, degradation, and widening processes and provide some level of toe protection behind and below the existing revetment.

At Wolfley Creek, widespread revetment failure had not occurred as of the visit. At other sites where a resistant toe was absent, this level of degradation could lead to toe undercutting and slope failure.

The risk of revetment perching due to channel degradation can be avoided by installation of grade control, anchoring trees to boulders that could launch as the stream degrades, installing the trees above a stabilized toe that has sufficient volume to launch as the bed degrades, or through a myriad of other river engineering techniques (FISRWG, 1998; Newbury & Gaboury, 1993a; Newbury & Gaboury, 1993b; NRCS, 2007). These options would require additional construction equipment, rock material, and permitting that would increase the costs significantly compared to cedar tree revetments alone. For low-cost stabilization using only cedar tree revetments, degrading streams should be avoided entirely.

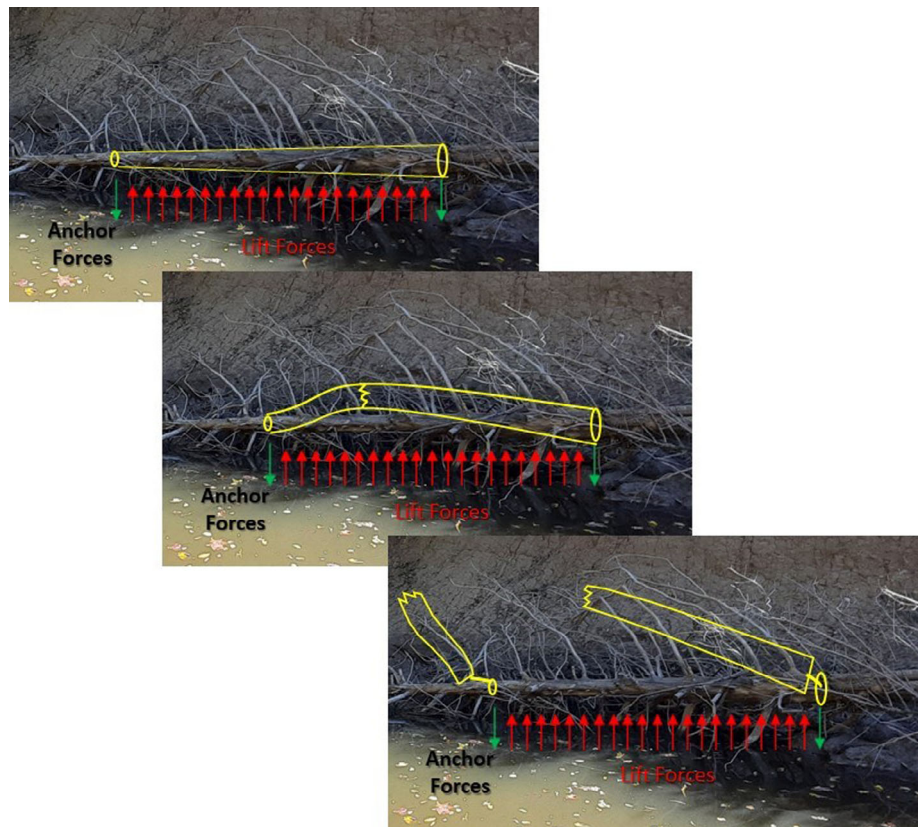
At several sites, the cedar tree trunks snapped somewhere between the anchors. Both sides of the snapped trunk were still attached at one end with cables that were anchored to the bank. This allowed the unattached side of each segment to float freely and oscillate in the current. Figure 6 illustrates this process. In Figure 6, the “lift forces” include both buoyancy and hydraulic lift. The exact mechanisms leading one tree to fail and another to remain intact are unclear; in places only a single tree was missing in a line with no obvious differentiating factors. Tree diameters, anchoring locations, and local hydraulic forces all vary to some degree and contribute to failure of a single tree.

FIGURE 6 Progression of revetment failure in flexion. Force is idealized as uniform [Color figure can be viewed at wileyonlinelibrary.com]

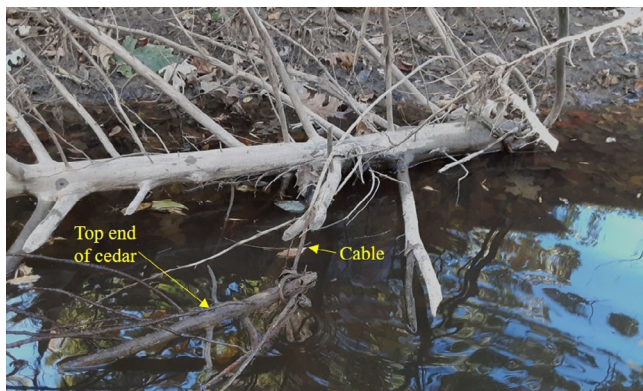
Figures 7 and 8 show the top half of snapped cedar trunks that have displaced or rotated downstream, resulting in a bare, unprotected bank. These failures could be identified because both halves of the trunks were still present.

FIGURE 7 Revetment that failed due to flexion. Project #1 on Homer Creek, KS [Color figure can be viewed at wileyonlinelibrary.com]

Bending stress can be reduced significantly by adding a third anchor between the typical two anchors at the location of maximum moment (Figure 14). This echoes other authors' suggestions that additional anchoring could reduce failures in woody debris structures (D'Aoust & Millar, 2000; Miller & Craig Kochel, 2013; Shields Jr., Knight, Morin, & Blank, 2003). The results in Table 6 indicate that with only two anchors, bending stress may induce failure even in the as-built condition should a sufficiently large hydrologic event occur. Using the equations presented in the Methods section and the dimensions shown in Figure 3, the bending stress is minimized to 17% of the original stress by adding a third anchor 23% of the way from the existing tip anchor to butt anchor, which is the location of maximum moment. Moreover, a third anchor placed at the location of the maximum moment would significantly reduce the magnitude of cyclical bending of the tree, which might decrease weakening over time and lead to increased longevity. Differing dimensions of any given tree will dictate a slightly different optimum placement location for the third anchor, but the anchor should be closer to tip rather than in the middle. To reduce floating should some erosion occur behind the revetment, the additional “middle” anchor should be anchored to the bank or bed below the revetment rather than level with the existing anchors.

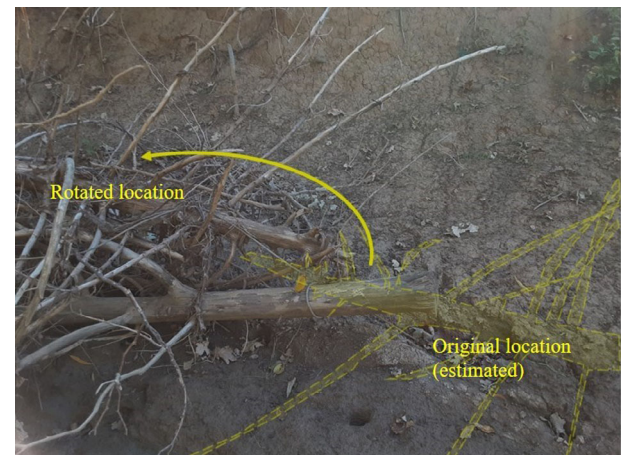
FIGURE 8 Revetment that failed due to flexion. The top end rotated and lodged on top of the next revetment downstream. Project #2 on Homer Creek, KS [Color figure can be viewed at wileyonlinelibrary.com]

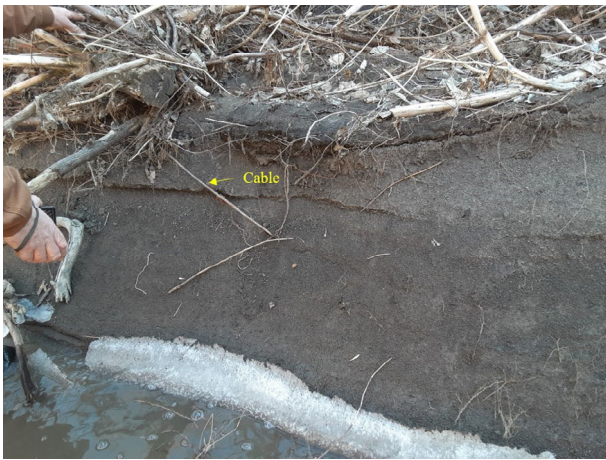
The trees were initially installed tight against the bank toe (for a single row revetment) or against the lower bank face (for the second of a two-row revetment). However, on inspection, many revetments had significant lengths of cable extending from the bank to the trunk of the tree. The anchor force analysis (presented below) does not suggest that excessive forces caused the cables to pull out. Erosion at the anchor site, deterioration of branches on the bank side of the trunk, or improper installation are likely causes. The longer cable allowed the trees to float up during high discharges (Figure 9), which left the toe unprotected. Moreover, longer cables allow the revetment to oscillate in high discharges, which would further encourage pull out, break branches, cause repeated impacts against the bank, and shake loose trapped sediments.

FIGURE 9 Loose cable allowed the revetment to float up during high discharges. Plumb Creek, KS [Color figure can be viewed at wileyonlinelibrary.com]

Finally, the branches on the bank side of the revetment could be trimmed to allow the trunk of the cedar to be flush with the bank (Figure 15)—a technique practiced with success by the Anoka Conservation District in Minnesota, USA (Pers. Commun., Mollie Annen, 2021) but not widely utilized elsewhere. This would eliminate loose cable due to the deterioration of the bank side branches and allow

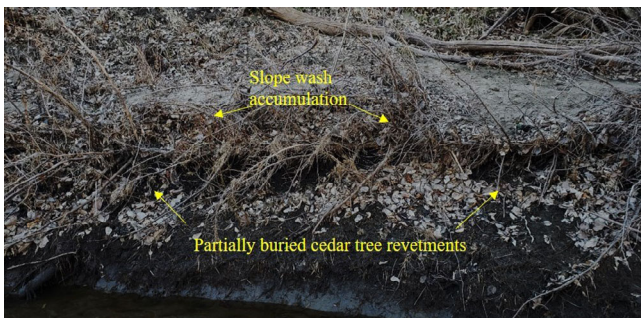
Cedar tree revetments provide energy dissipation at the toe of the eroding bank which reduces near bank velocities (Klein, 2019) and encourages deposition (Sheeter & Claire, 1989). Fine fern and scale-like leaves provide a dense matrix to effectively catch sediment during higher discharges events. Sediment filling also occurs as the revetment catches failed material from the mid and upper bank (Figure 10).

FIGURE 10 Slope wash accumulation forming a bench or berm above cedar tree revetments on Wolfley Creek, KS [Color figure can be viewed at wileyonlinelibrary.com]

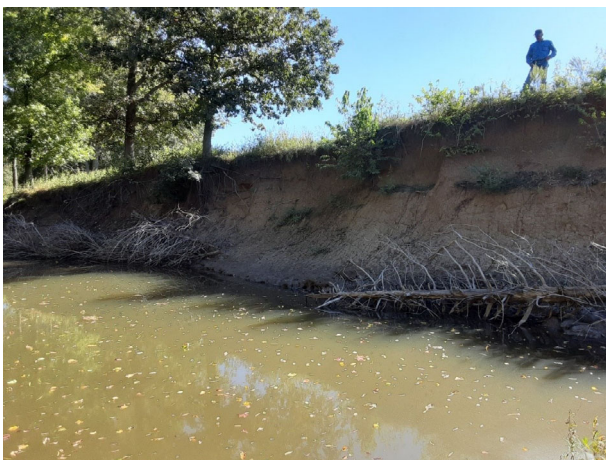
However, at many sites visited, the revetments were not filled with sediment (Figure 11). As discussed above, loose cables could allow oscillation and movement during high discharges, which would

cause the cedars to “shake loose” the sediment. Without sufficient catching and infilling of sediment around the revetments, there is a higher probability of failure.

FIGURE 11 Cedar tree revetments have not captured sediment. One revetment is missing. Homer Creek, KS [Color figure can be viewed at wileyonlinelibrary.com]
