Sinking of US Cargo Vessel SS *El Faro*  
Atlantic Ocean, Northeast of Acklins and Crooked Island,  
Bahamas  
October 1, 2015

NTSB/MAR-17/01  
PB2018-100342

# Marine Accident Report

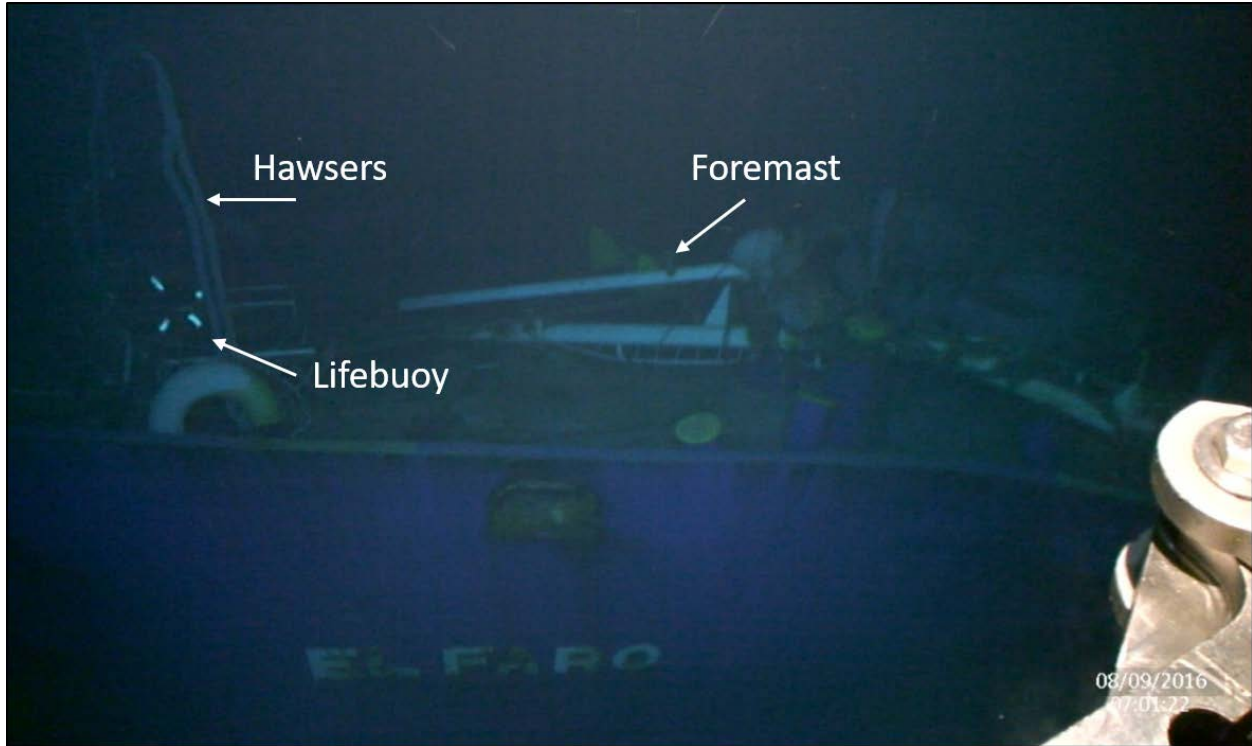
**Figure 32.** Foremast toppled on port side of bow; reflection is from lifebuoy on railing next to hawsers. (Image from mission 3)

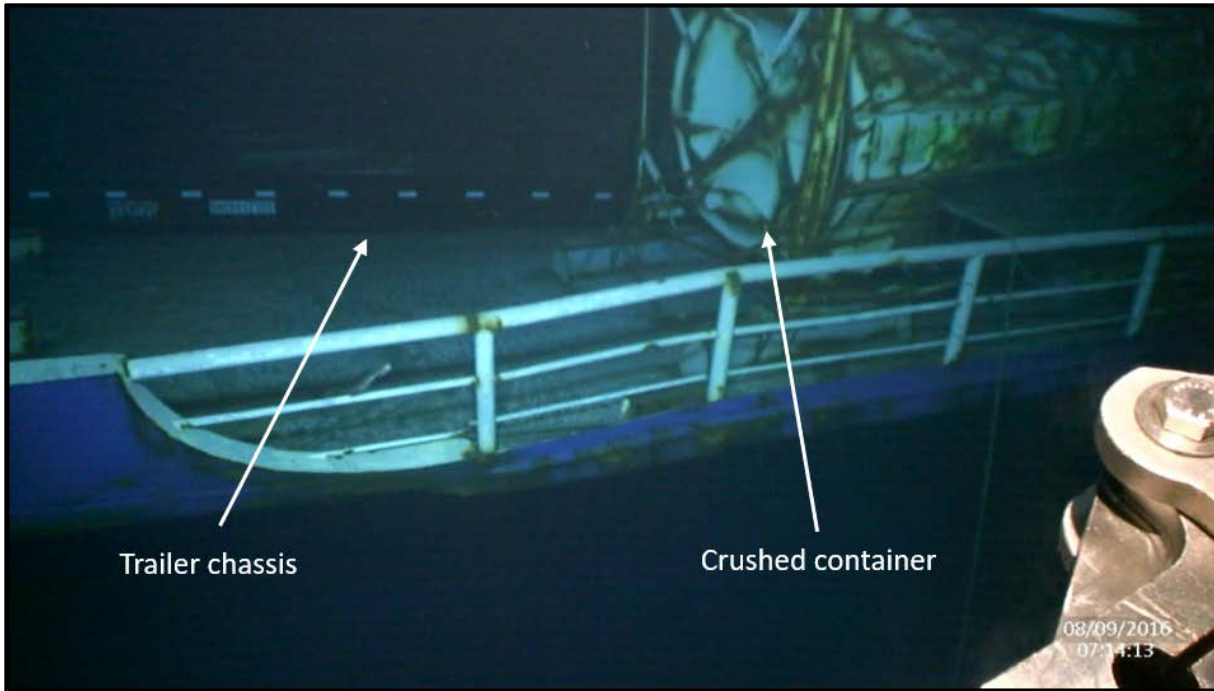
**Figure 34.** Crushed tank container in bay 2, starboard side. (Image from mission 3)

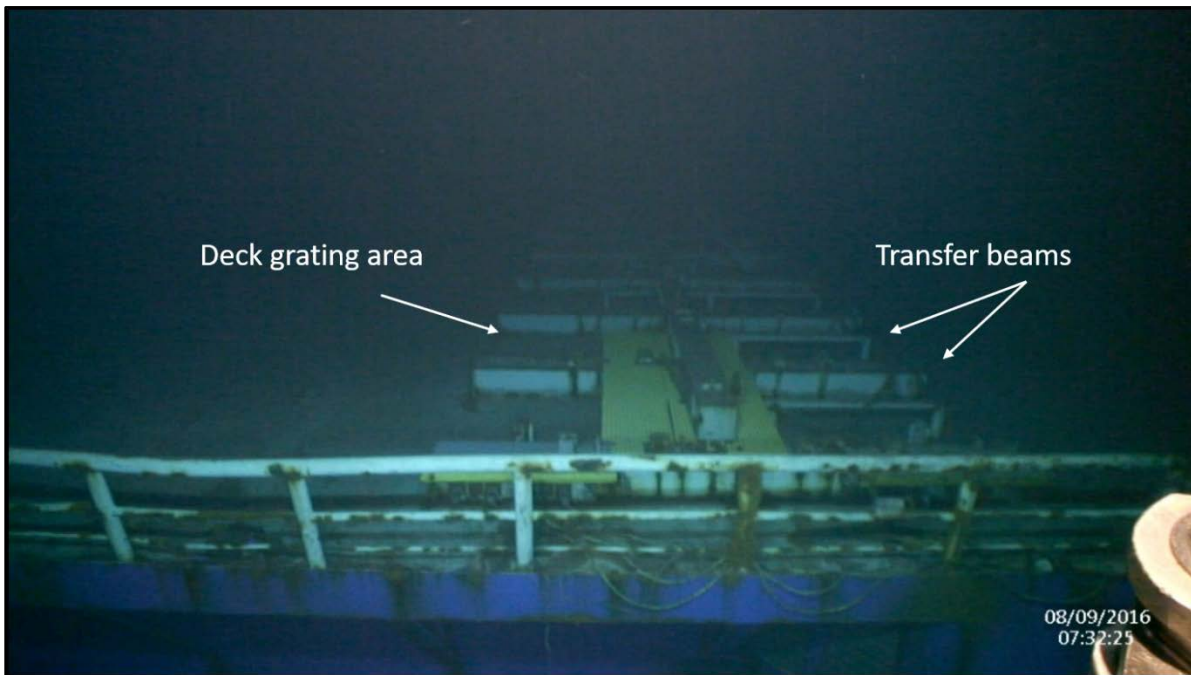
**Figure 35.** Fiberglass deck grating missing from container support beams, port side, with intact transfer beams. (Image from mission 3)

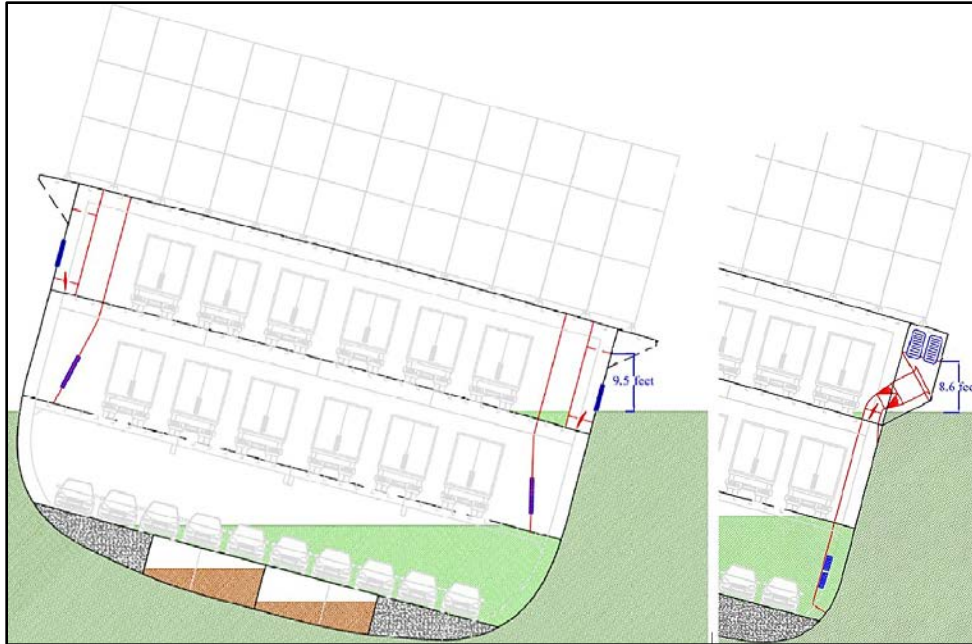
**Figure 59.** Ventilation supply trunk (right) and aft exhaust trunk (left) in hold 3, with flooding of hold to 20 percent (0.7 permeability) and heel angle of 15°. (Adapted from figure 6-18 in MSC 2017)
