Comar Wood Dun

Comar Wood Dun
Archaeological Evaluation and Measured Survey
Cannich, Strathglass, Scotland

Data Structure Report

| RoCAS Report | 2014-02/COM13 |

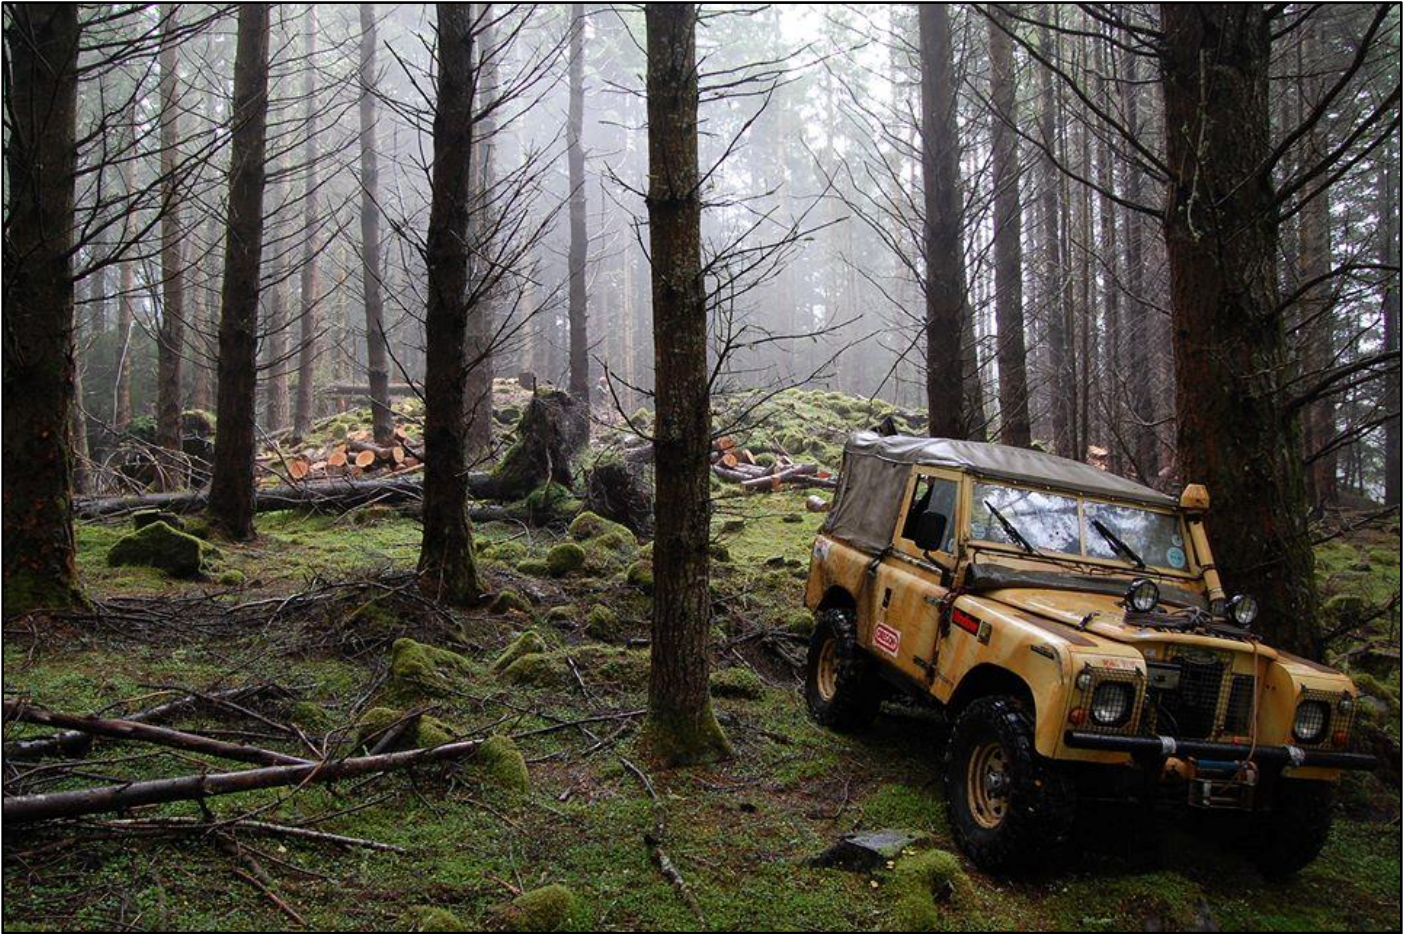
Plate 1: Comar Wood Dun covered in mature Douglas Fir © FCS

The dun had not been subject to forestry ploughing, but a considerable number of tree stumps and roots are embedded into the structure. It was thought that these would most likely have caused damage to the structural elements of the site including the archaeological deposits and features.

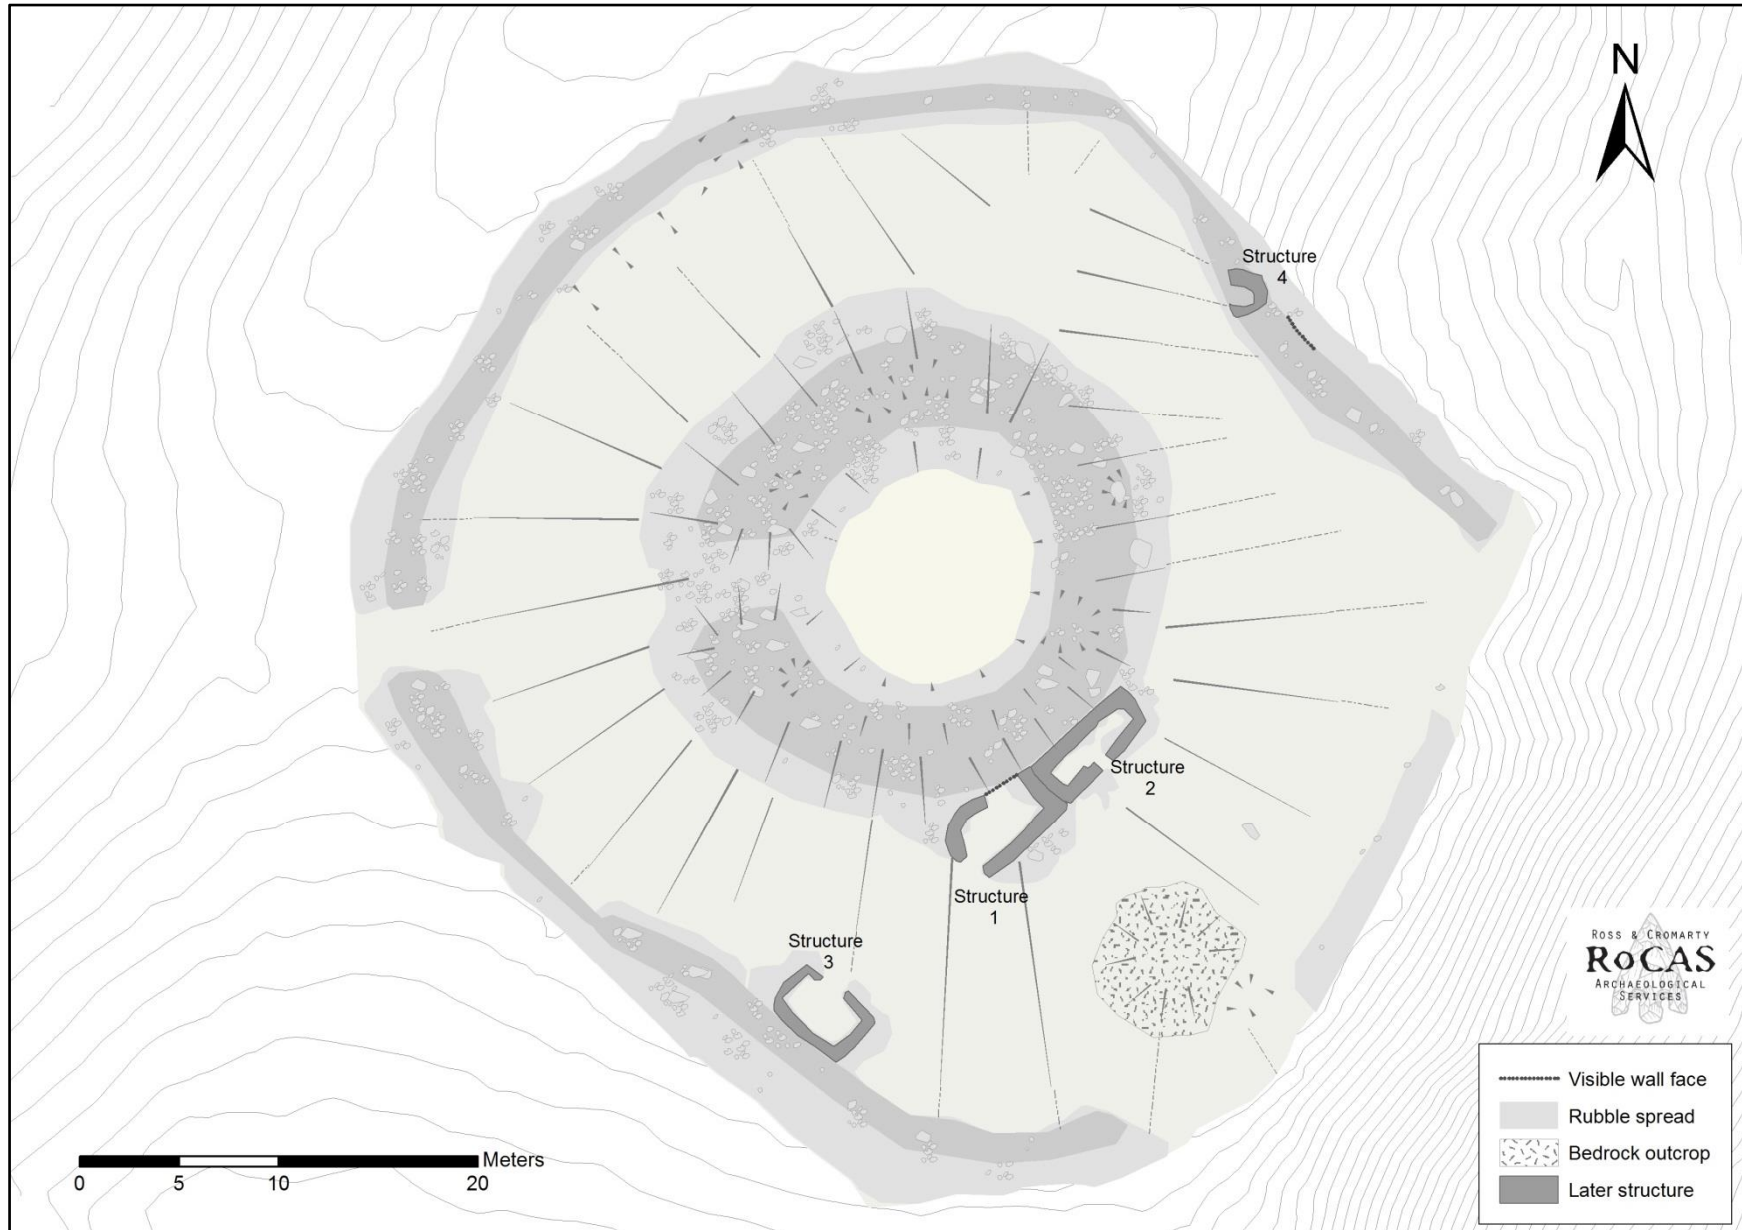
The dun was circular in shape (Figure 3), measuring 22.8m N-S by 22m E-W externally, with a rubble spread increasing the size to 27m N-S by 26.6m E-W and standing to at least 1.5m above the ground surface. The outer wall was best preserved in the arc from north to west with some large facing stones visible; from north to south the surveyors had to project the position of the outer wall in places. The dun entrance was located on the west side of the structure. It was splayed, measuring 2m wide at the outer wall and decreased in size to 1.5m at the entrance to the courtyard. The courtyard measured 14.8m N-S by 14.3m E-W. As with the outer wall, the inner wall of the dun was indistinct in places and its position had to be projected. The width of the dun wall varied from a maximum of 4.2m in the northern section to 3.5m at the entrance. There were several depressions in top of the wall that may have been galleries within the wall or the result of stone-robbing.

Figure 3: Measured survey of the dun, enclosure wall and surrounding landscape.
