ASANTE TRADITIONAL BUILDINGS: SURVEY AND CONDITION ASSESSMENT

January 2014

Survey, Assessment, and Report by:

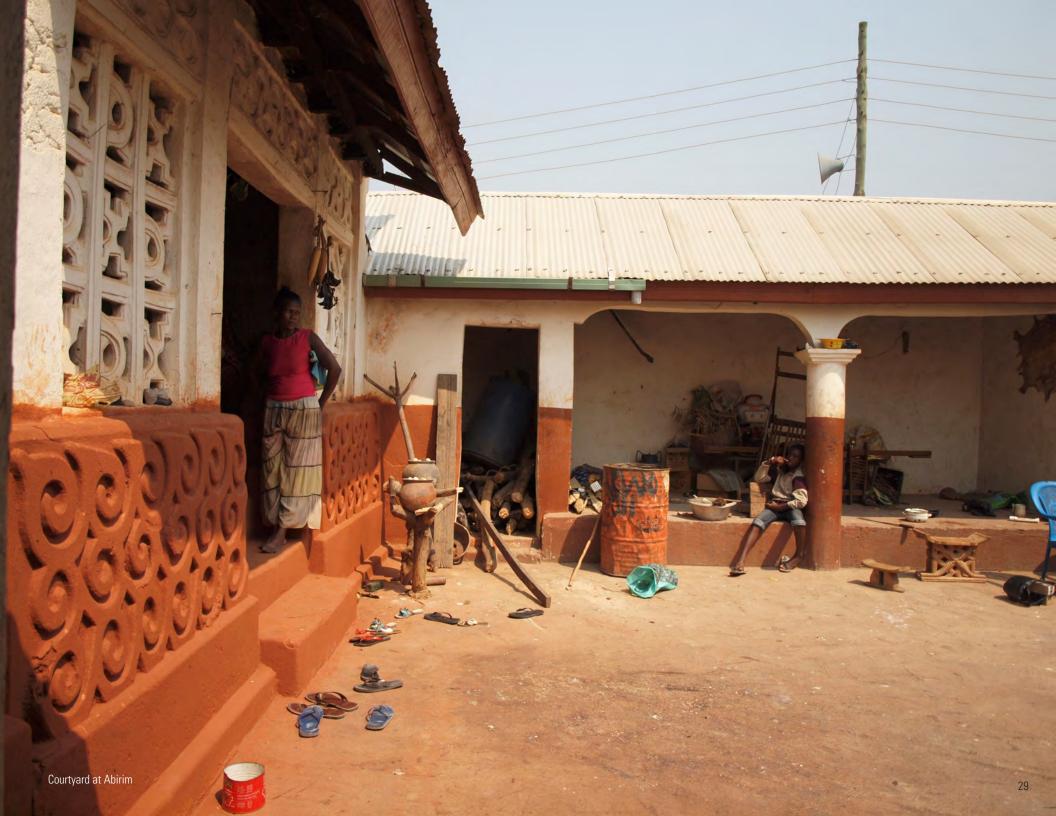
ABIRIM: State of Conservation Visual Summary

1) Custodians have restored the rooms around the courtyard without respect to material authenticity. Concrete columns replaced original thick mud posts, but the Shrine Building itself has remained untouched.

7) The)k) mfo is getting very old and will soon retire.

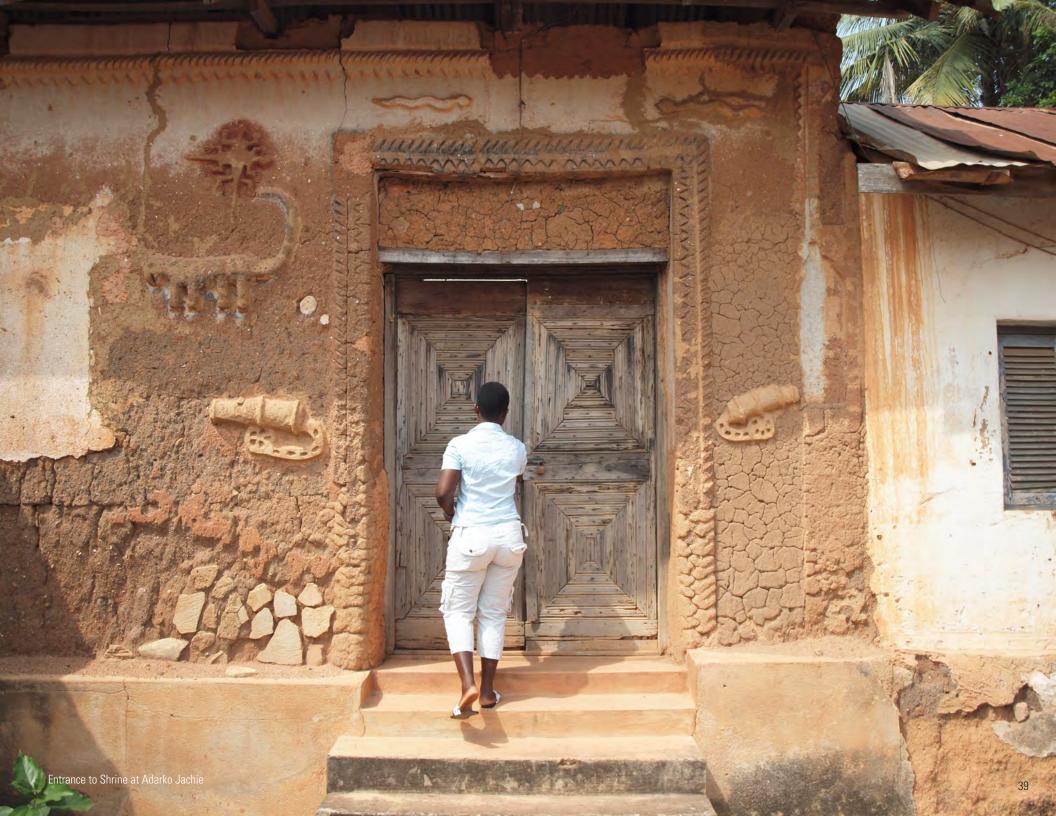
ADARKO JACHIE: State of Conservation Visual Summary

2 The roof, replaced in 1997, is still in very good condition. The decorative elements are very well protected.

but does not contain the shrine, is in very poor condition.

8 New decorative elements, whose quality is unacceptable, have been applied to the building walls.

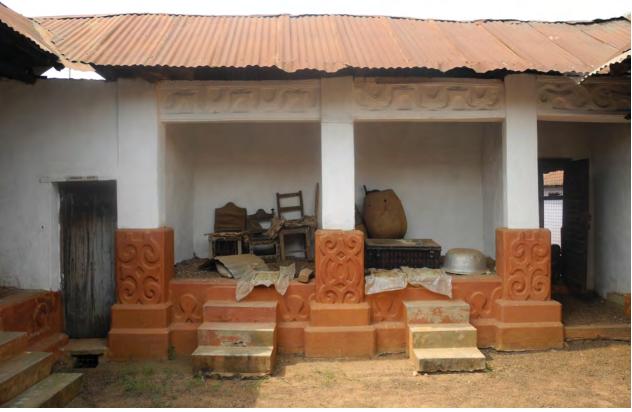
Drummers' Room at Asawase

Movable heritage is in very poor condition and none of the stools and chairs can be used; the drums are beyond repair.

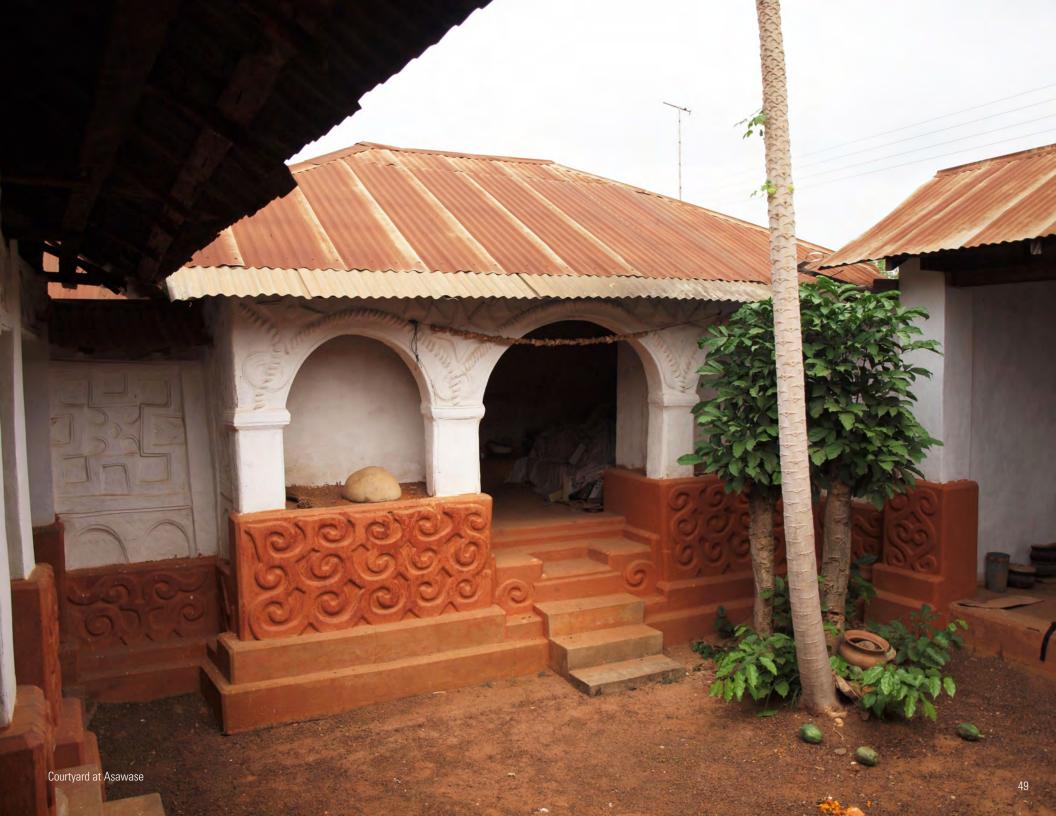
ASAWASE: State of Conservation Visual Summary

1) The roofing sheets are aging and the roof is leaking. Some of the sheets could easily be removed in a severe storm.

(3) The ground at the back of the Shrine Room is highly eroded and over one foot of soil is missing due to erosion.

5 Decorative elements partially broken above the entrance.

6 The furniture is in very poor condition to the extent that none of the stools and chairs can be used and the drums are beyond repair.

Urgent Work Needed

- -Add one truck of laterite at the back of the building to replace the eroded soil.
- -Replace roofing sheets, one hundred ten, and ridge caps.
- -Recreate the decorative element.
- -Adjust the drainage slope along the Drummers' Room.
- -Restore the decorative element above entrance door.

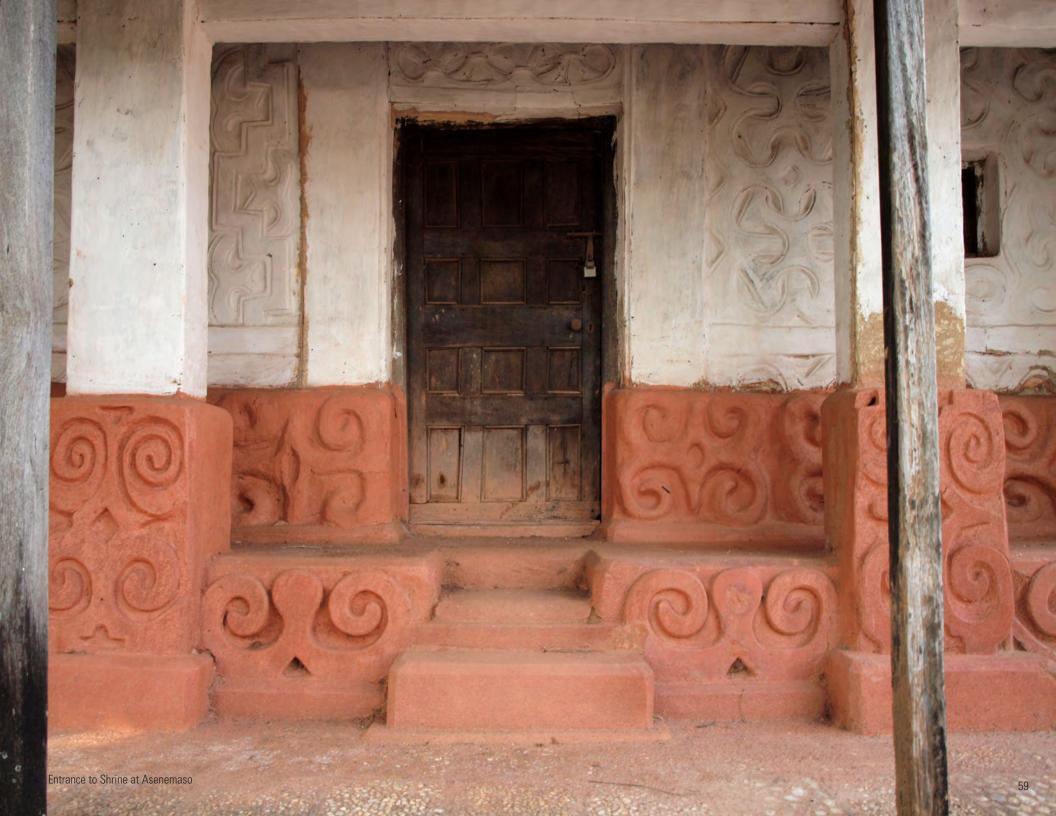
ASENEMASO: State of Conservation Visual Summary

1 Inconsistent and poor repairs to decorative elements.

2 One of the wooden shutters has been replaced by cement blocks.

7 Termite infestation is affecting all of the wood elements.

Urgent Work Needed

- -The two drains should be cleared.
- -The four wooden posts need to be replaced with treated wood, 3 x 3", preferably with a termite shield installed.

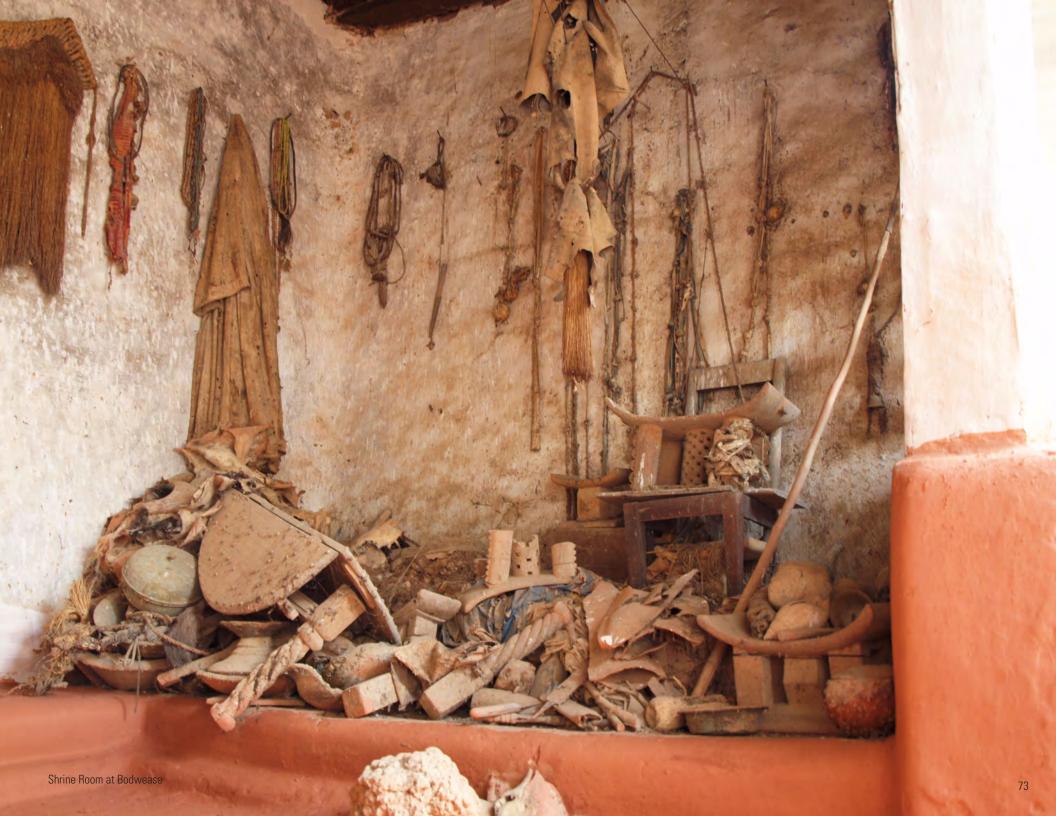
BODWEASE [Chief's Palace]: State of Conservation Visual Summary

2) The structure is sound, and some roofing sheets have recently been replaced by GMMB.

3 Some decorative elements are eroded, but not yet beyond repair.

(5) As a result, the red plinth is very humid.

7 Roofing sheets contain holes.
