APPENDIX C
Aerial and Site Photos

Supplemental Environmental Baseline Survey – Republic of Palau

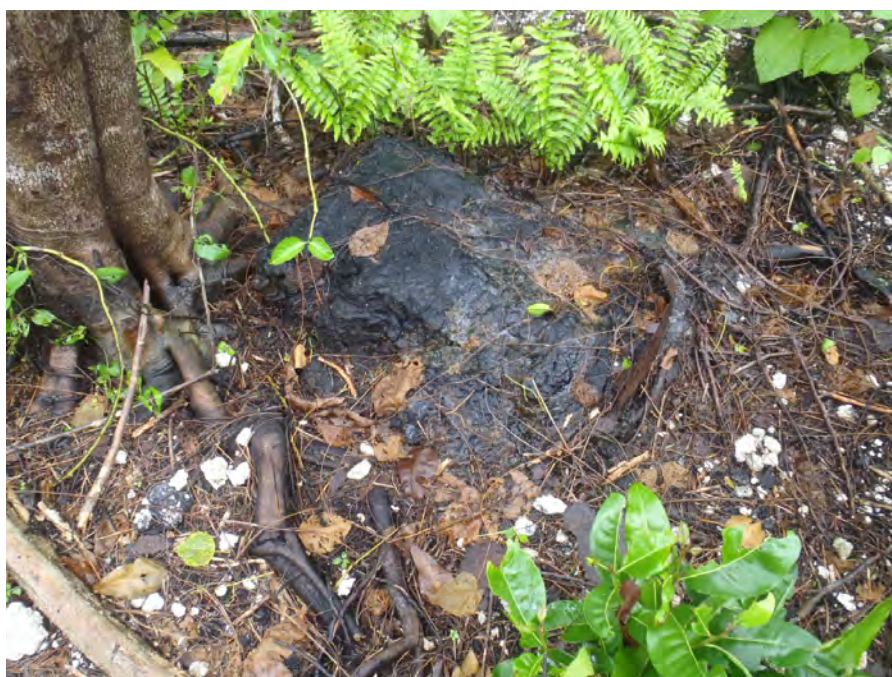
Photo No. 45 – 12 July 2018

Location of sample 18PA-ANG-010 and -011 adjacent to a deteriorated tar drum and spilled bitumen at the Angaur Rx Site. Looking south.

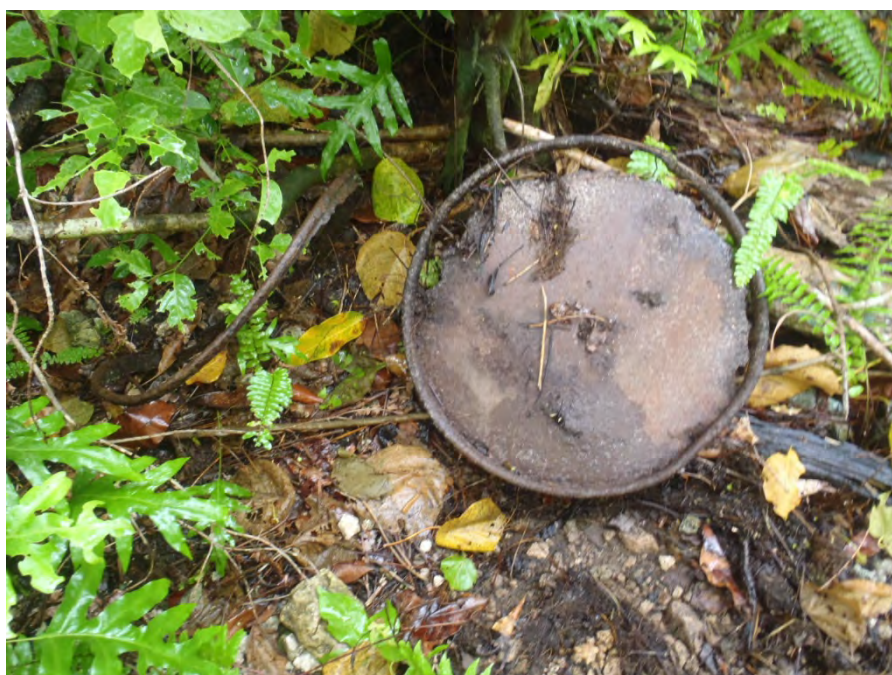
Photo No. 51 – 13 July 2018

Lone deteriorated drum adjacent to soil sample 18PA-ANG-020 at the Angaur Rx Site.

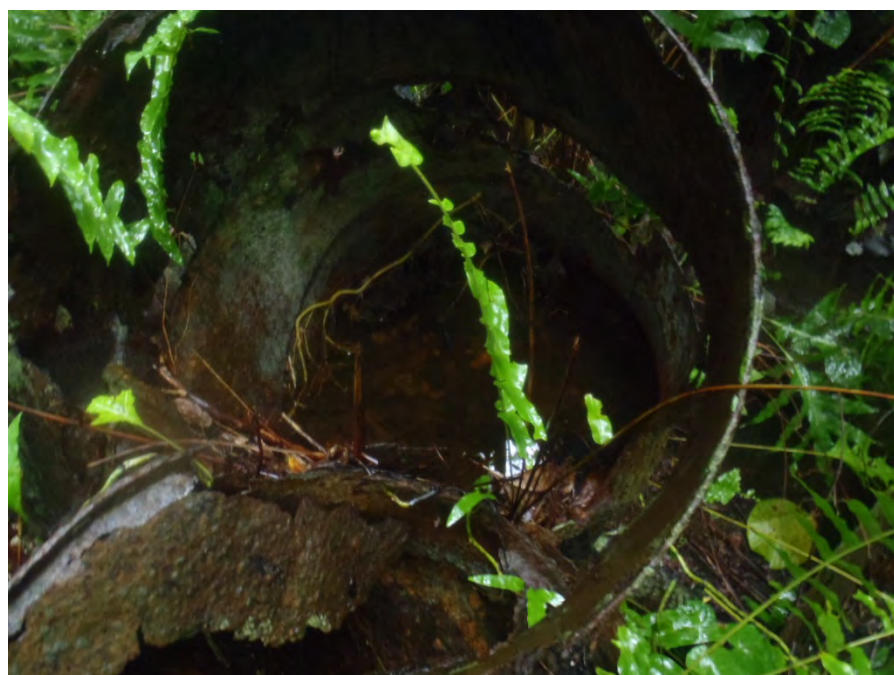
Photo No. 55 – 14 July 2018

Deteriorated drums in the drum dump at the Angaur Rx Site.

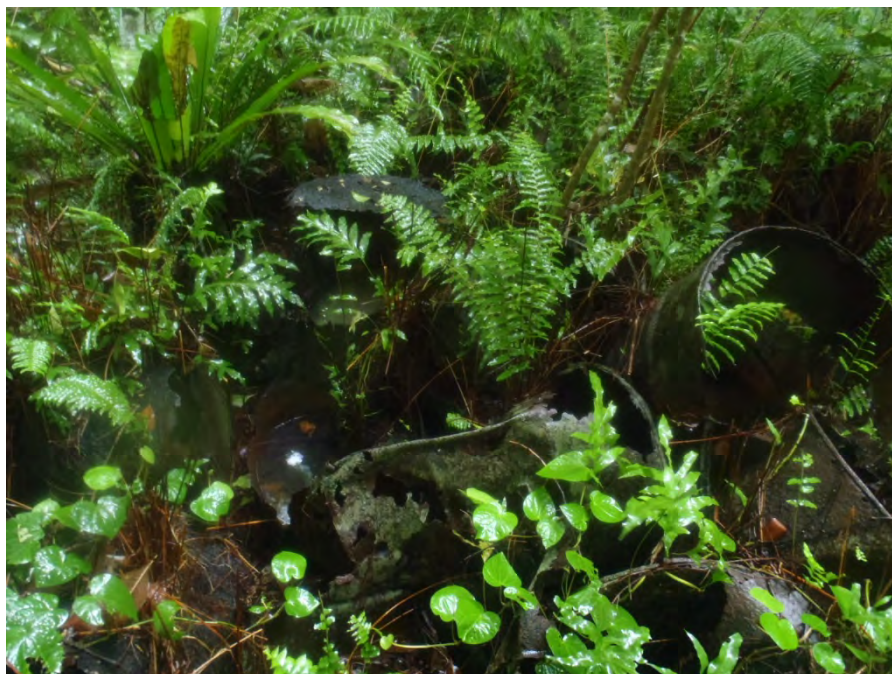
Photo No. 56 – 14 July 2018

Additional deteriorated drums in the drum dump at the Angaur Rx Site. Looking southeast.

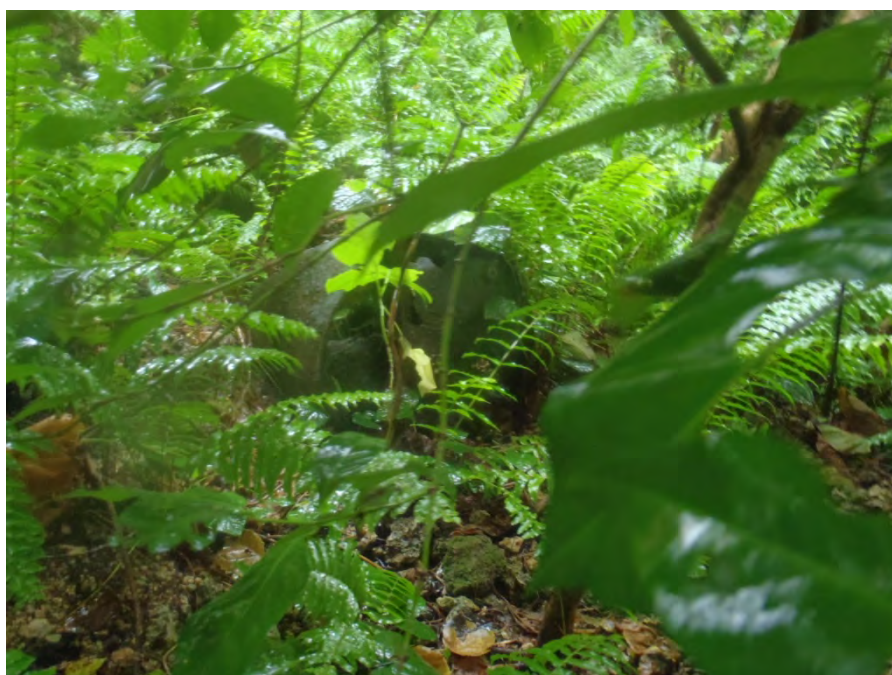
Photo No. 57 – 14 July 2018

Additional deteriorated drums in the drum dump at the Angaur Rx Site. Looking north.

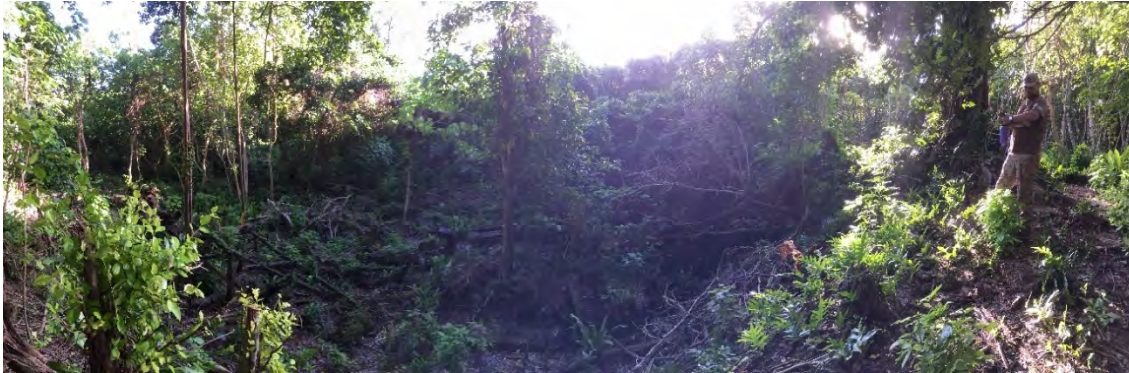
FIGURE 26 Abandoned Pit with Scrap Metal from Past Phosphate Mining and Other Activities; Vegetation Includes *Flacourtia rukam* in the Center and *Asplenium nidus* Ground Cover.
