Dysartgallen Church & Graveyard

Ballinakill, County Laois.

CONSERVATION MANAGEMENT PLAN

November 2020

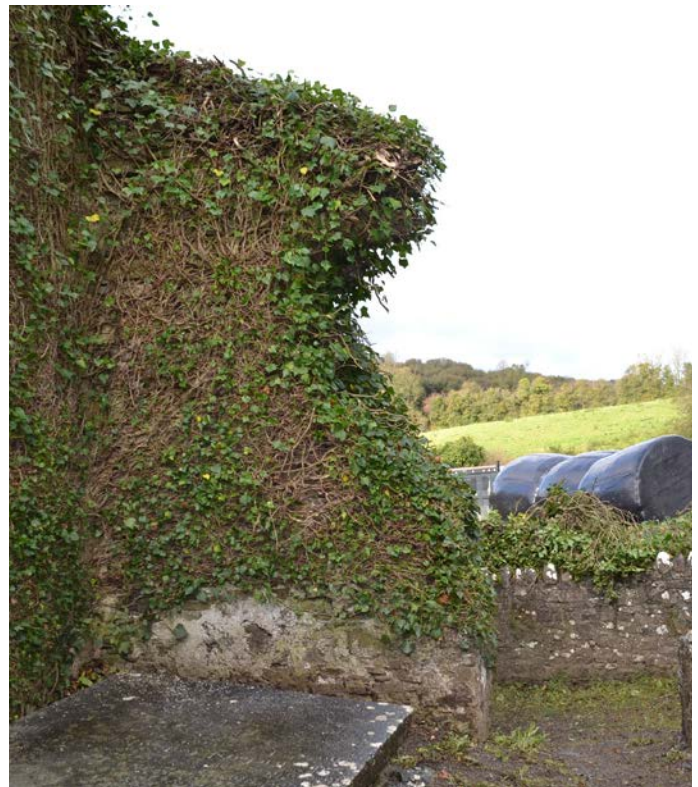
Two areas of loose masonry were noted during our site inspection – one to the arch of the west window and the second at high level on the west jamb of the north doorway. In both cases the loose masonry is restrained by the ivy growth and care will need to be taken during the ivy removal phase to allow for these areas of damage to be consolidated. A stepped concrete plinth was added to the external side of the west gable during the 1960s, presumably to underpin and stabilise the structure at this point, as the ground falls away steeply from the gable. Notwithstanding these previous repairs there were no major cracks visible which suggests that the structure is at rest. Remnants of original plaster coatings can be seen both internally and externally, being visible in several places where the ivy has not yet encroached. It is not yet clear if both of the existing doorways were original as there is no clear evidence of dressed door jambs or thresholds, there is however, what appears to be the remains of a window embrasure on the south side of the nave, where one would expect to find openings. Further evidence will no doubt emerge as ivy is removed.

Loose masonry above north door.

- (Note on Price: Based on an assumption no further root treatment will be required)
- 3.2 Consolidate loose masonry at north door, at head of west window and at chancel arch, and rebuild parts were necessary. ...5,300...

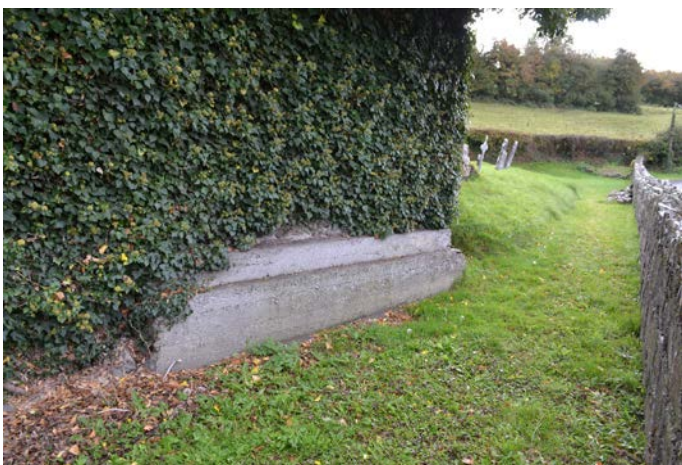
Concrete underpinning to west gable.

A stepped concrete plinth was added to the external side of the west gable during the 1960s, presumably to underpin and stabilise the structure. Remnants of original plaster coatings can be seen both internally and externally. are visible at the northeast corner of the nave. The chancel arch is segmental and constructed in rough sandstone voussoirs. A pronounced slot is on the east side of the east wall of the nave where it abuts the south wall of the chancel. This suggests that the chancel was a later addition, to an earlier single-cell church. There are currently no recognisable features on view within the chancel, although these may come to light following full removal of the ivy, or through excavation of the fill that has raised the internal floor level to approximately 1.2m. A table tomb lies flat on the ground in the north east corner of the nave and probably dates to the eighteenth or nineteenth century. There is no evidence of any roofing material on the site, although if slate coverings had been used some evidence may be contained within the fill. Alternatively, the slates may have been quarried for use in other structures in the area. Similarly, there is no evidence of a floor finish, although the steady build-up of soil has covered most of the original floor levels in both the nave and chancel. There are, however, some stone flags evidence at the west end of the nave, which appear to have been placed in recent years. These flags have been arranged around a nineteenth-century limestone table tomb grave monument that has been turned into a make-shift altar supported on cut and rubble stone together with short length of sawn tree trunks. This was constructed by members of the local community, using salvaged material from the site, to facilitate occasional use for worship. Members of the local community were also responsible for moving four stone grave markers from the floor of the nave to rest against the walls, two on the south wall and two on the north wall.

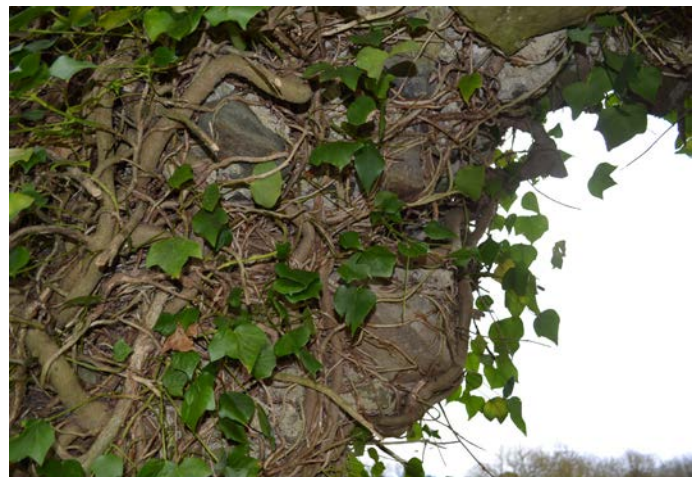
Loose masonry in arch of west window.

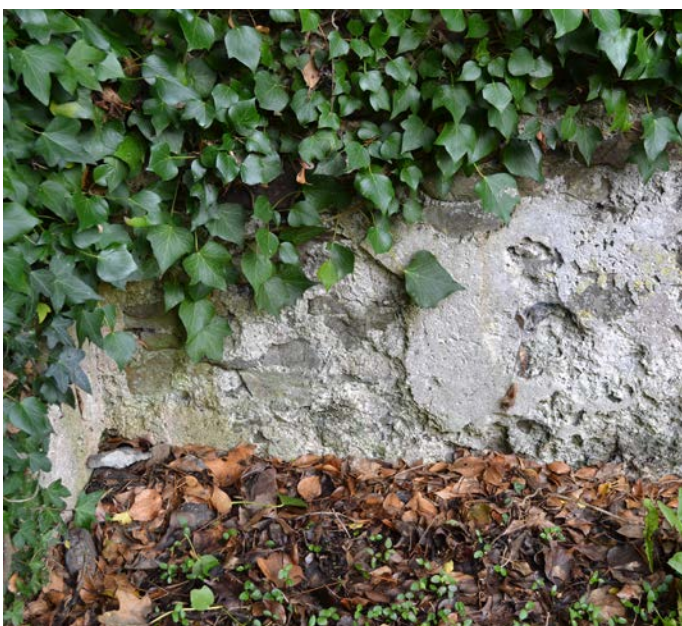
Surviving lime plaster in north west corner of nave.

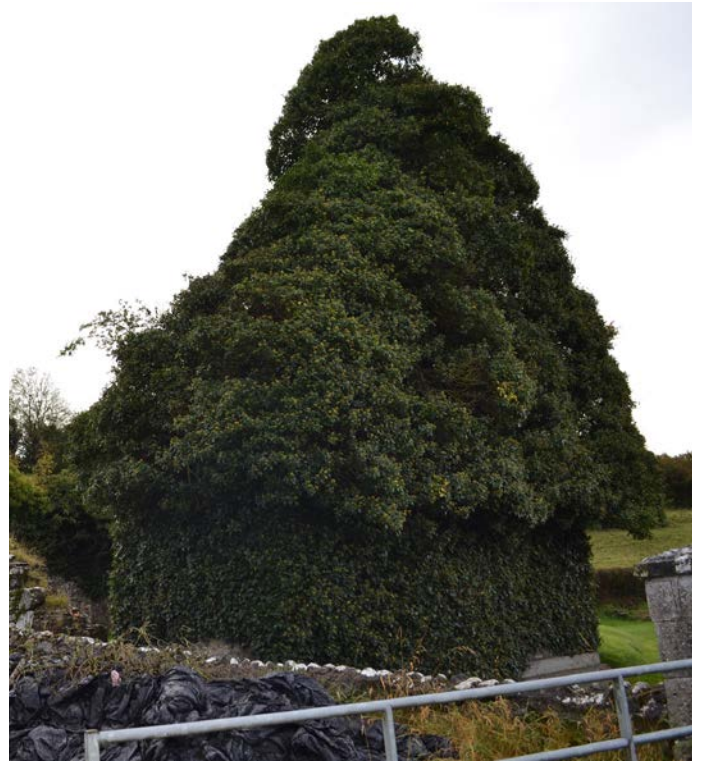
The amount of ivy growing on the ruin is significant, with both sides of both gables and more than 50% of the nave walls covered with a thick covering. Thick mature stems can be seen at ground level, and from the thickness of the secondary stems it is almost certain that the ivy has developed adventitious roots that have penetrated into the masonry. While the early trimming of the ivy, carried out as part of this project has helped reduce the risk of damage by removing pressures caused due to wind load, it will have to be totally removed to avoid future damage. If left unchecked the plant will regenerate vigourously increasing the size of the embedded roots that will eventually split the masonry and cause collapse. To remove this risk all of the ivy should be killed back using an approved biocide, with no cutting of the lead stems, so that the biocide will enter the embedded roots that will in time die and rot. These can then be removed relatively easily and the masonry pinned and pointed in lime and sand mortar.

General view from north west prior to trimming.

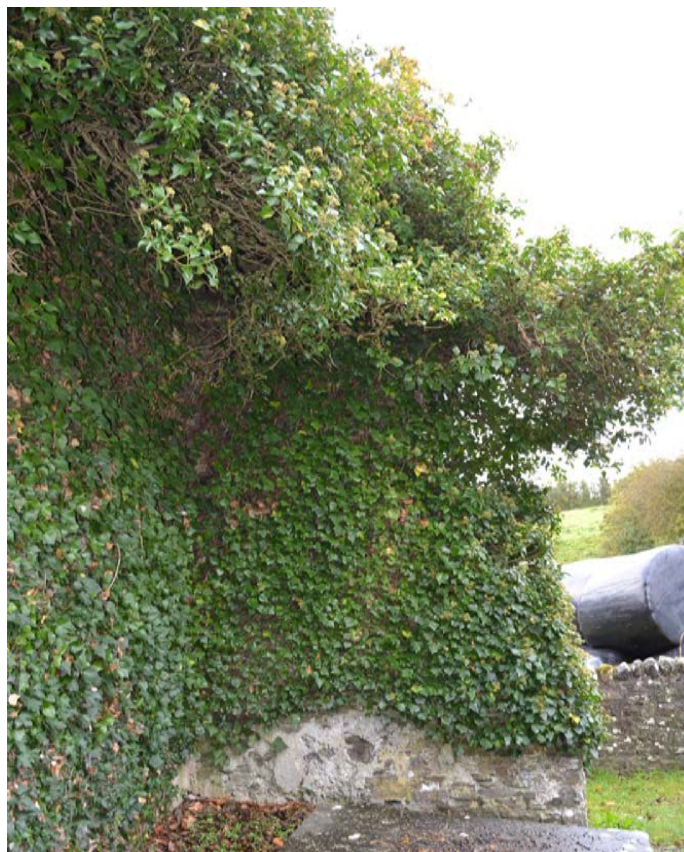
Prolific ivy growth on the church ruins that threatens the structural stability of the building. Image taken before trimming.

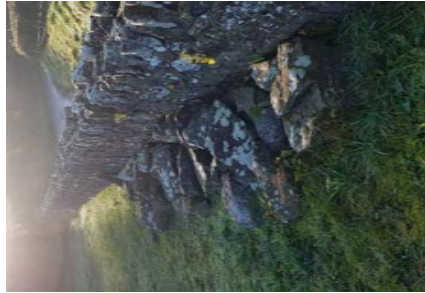
Fallen stone stored on site available for repairs

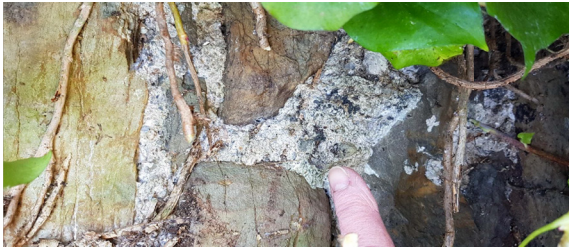
Condition of mortar and stonework behind ivy as seen top LHS of outer face of west elevation generally in good condition

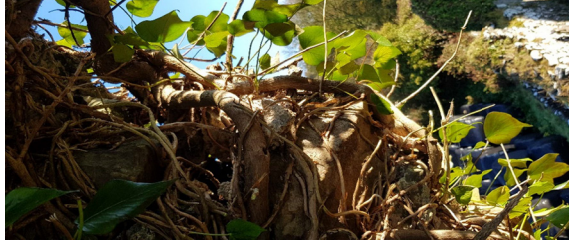
Pictures of ivy to inside edges of west window- Stones are being held in place by ivy therefore ivy removal needs to be carried out by stone mason and stones identified and referenced as dismantled

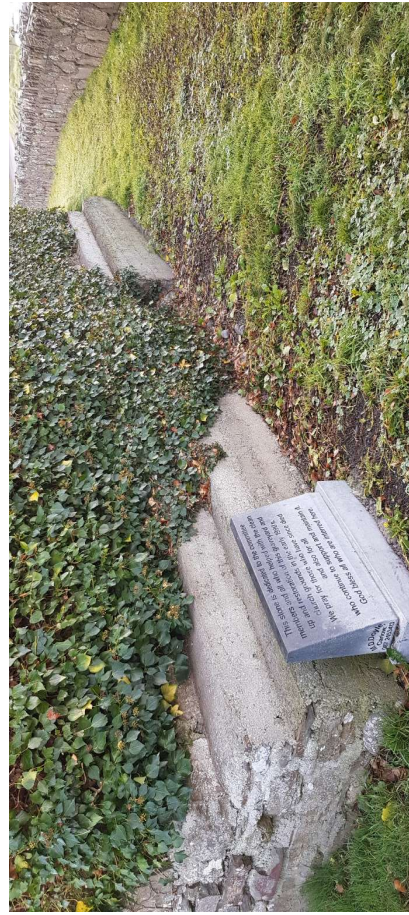
External plinth to outer face of west gable helps stabilise wall against overturning from retaining effect of built up ground internally. The condition of this masonry and its over render appear reasonable but should be further checked when all ivy removed

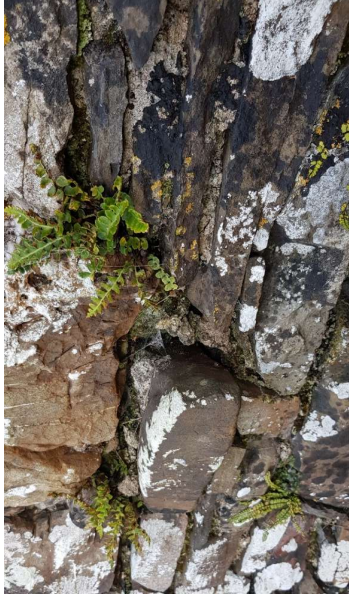
Vegetation growth with shallow roots on wall face, not harmful to wall

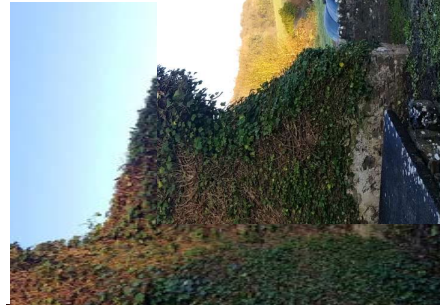
Traces of historic lime plaster evident internally on wall

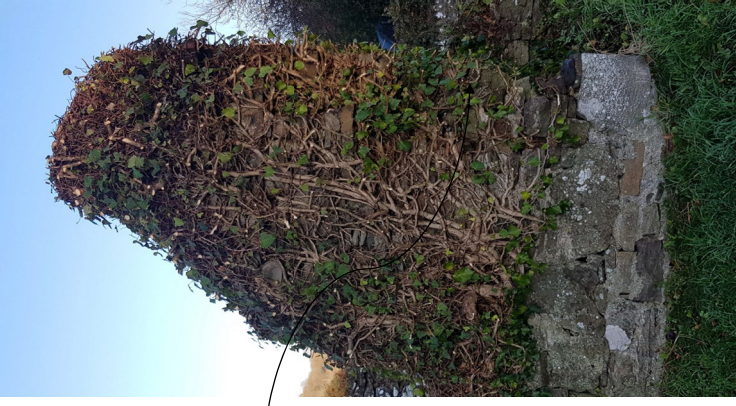
Corners where Quoins robbed out to be rebuilt to match other corners as closely as possible with squared off rubble work
