NIST Special Publication 901

The January 17, 1995 Hyogoken-Nanbu (Kobe) Earthquake

*Performance of Structures, Lifelines, and Fire
Protection Systems*

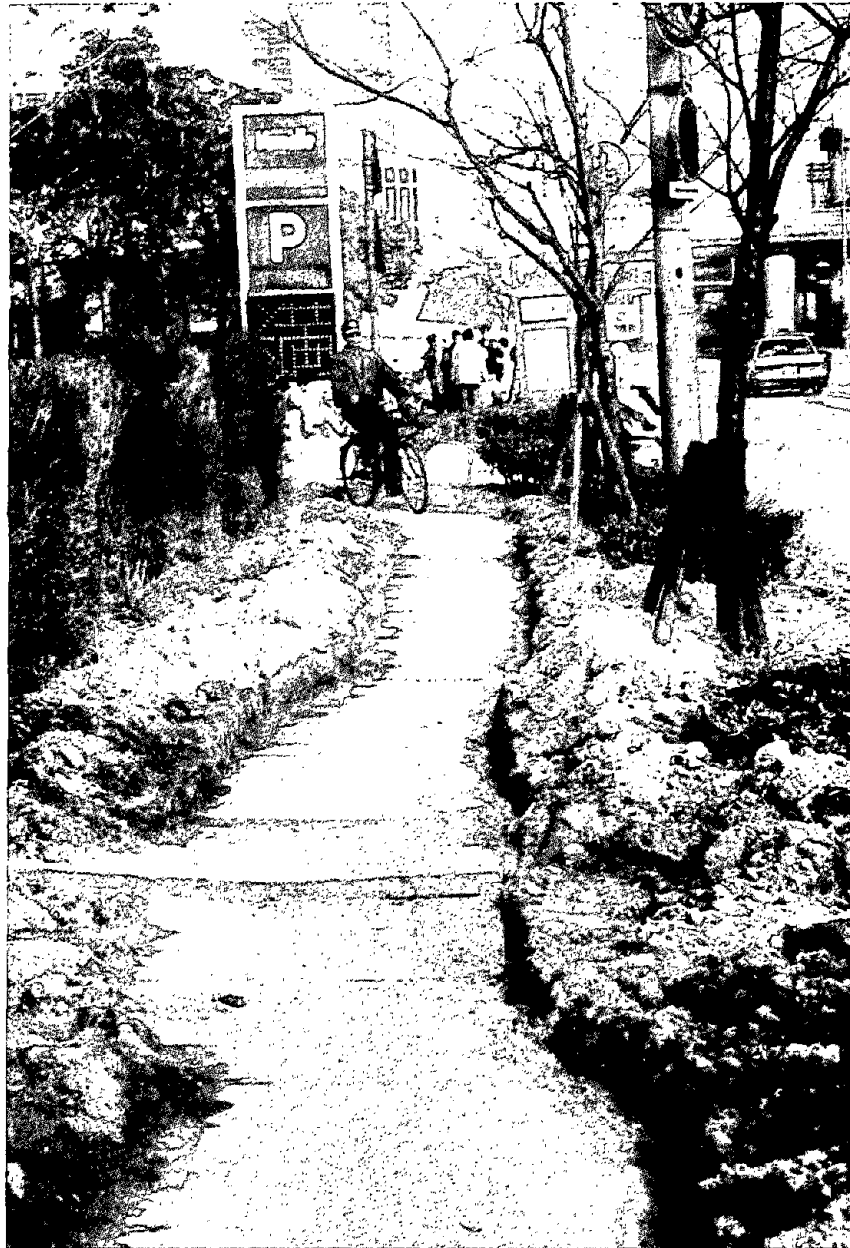
Figure 2.5.1 Path cleared through soil vented by liquefaction that covered sidewalk on Port Island (Photograph by Carol S. Prentice, USGS).

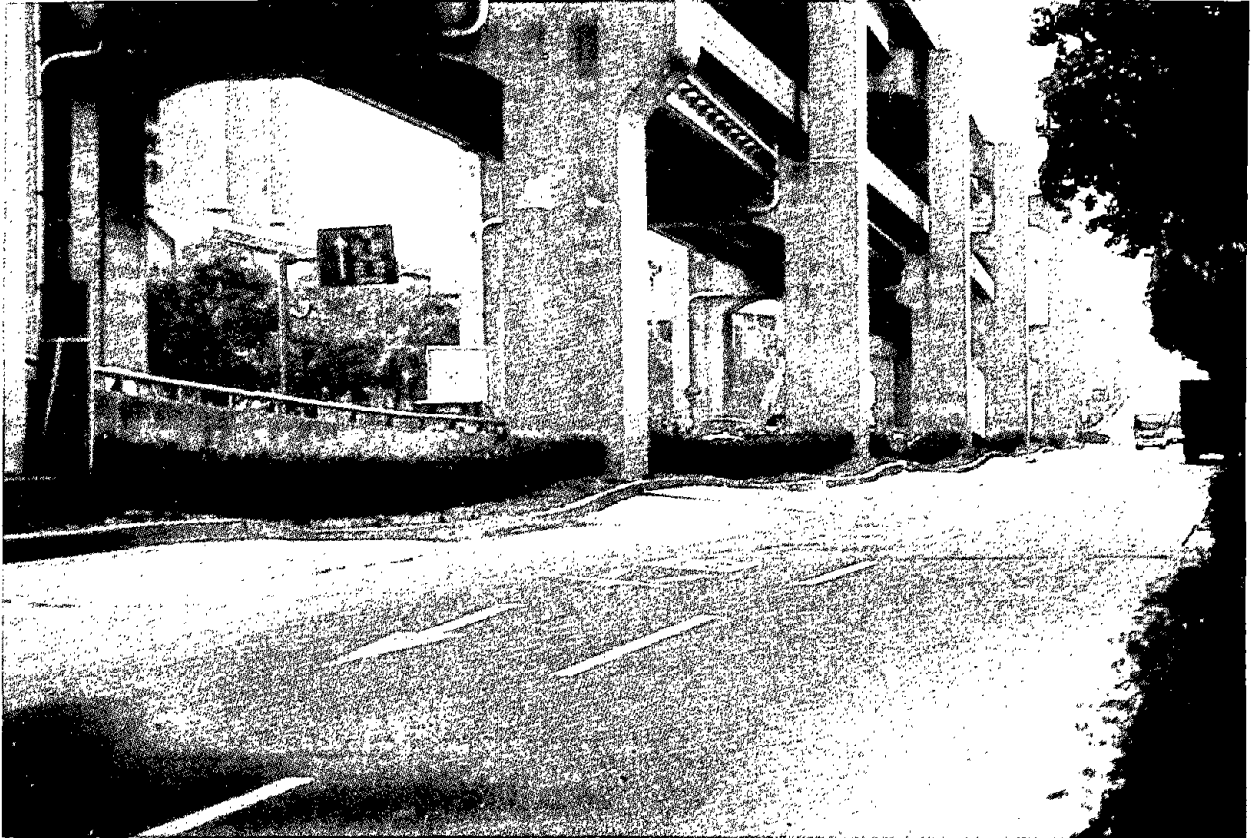
Figure 2.5.4 Differential ground settlement in artificial fill along the Harbor Freeway. Post-liquefaction consolidation cause ground to settle between bridge columns. Columns extend through the liquefied zone. (Photograph by Carol S. Prentice, USGS).

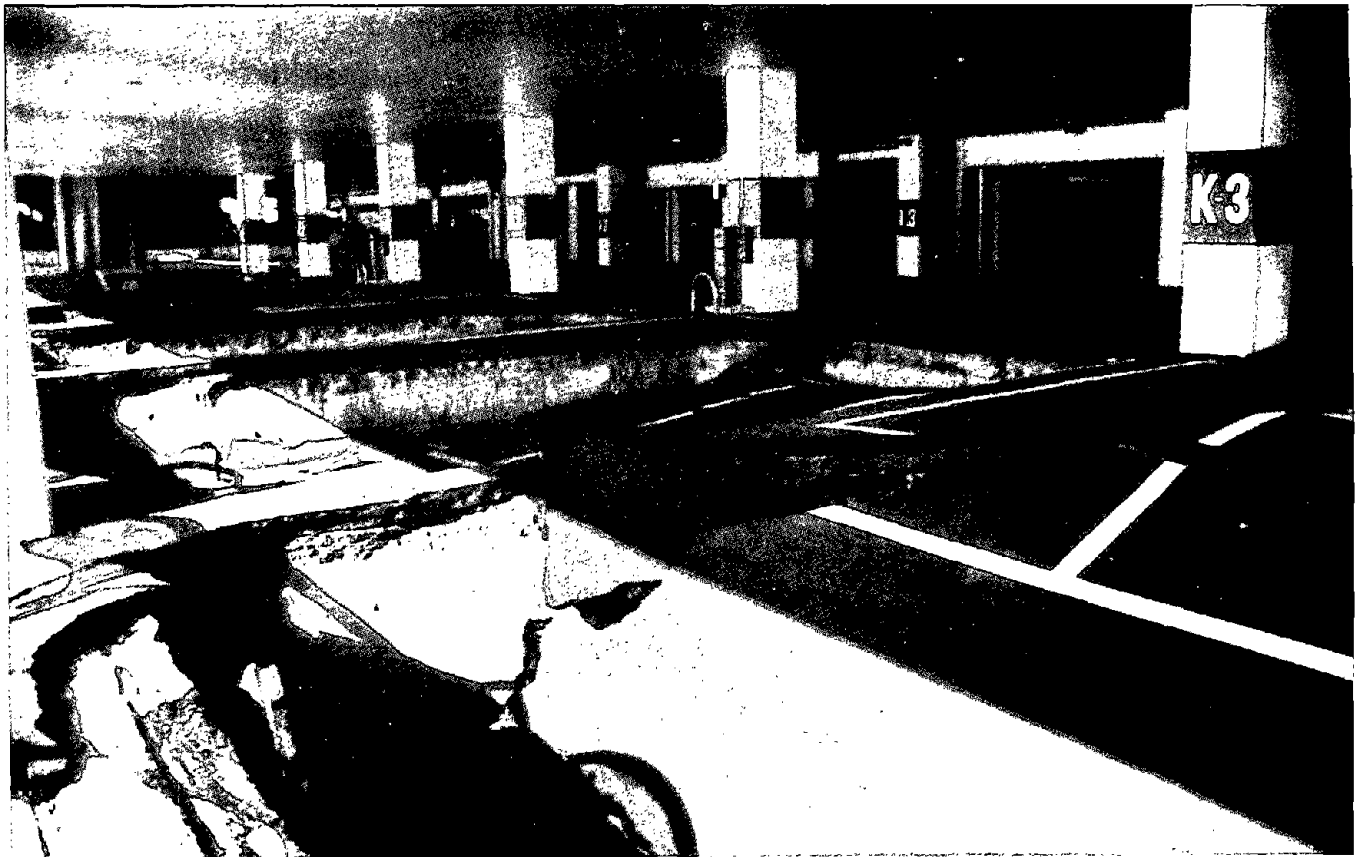
Figure 2.5.5 Differential settlement of about 1 m between columns of parking structure on reclaimed ground near the bridge to Port Island.

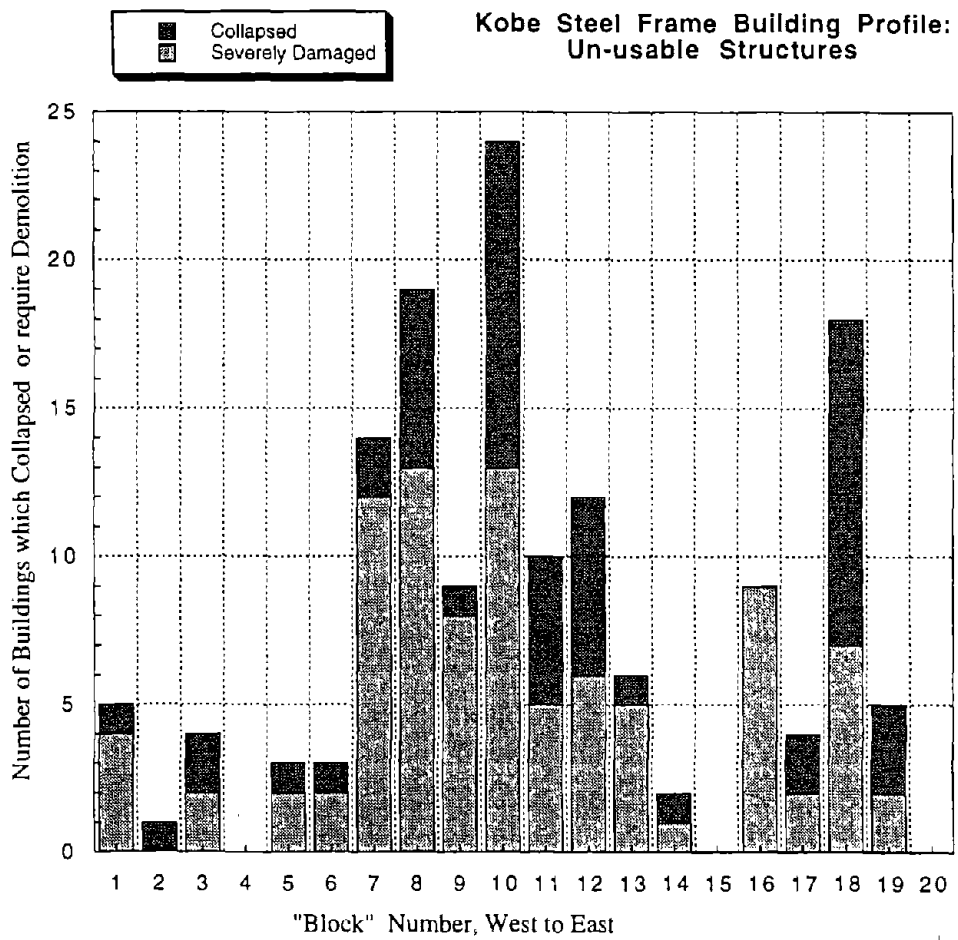
Figure 3.5.5 Kobe Damage Survey: Collapsed and severely damaged steel frame structures.

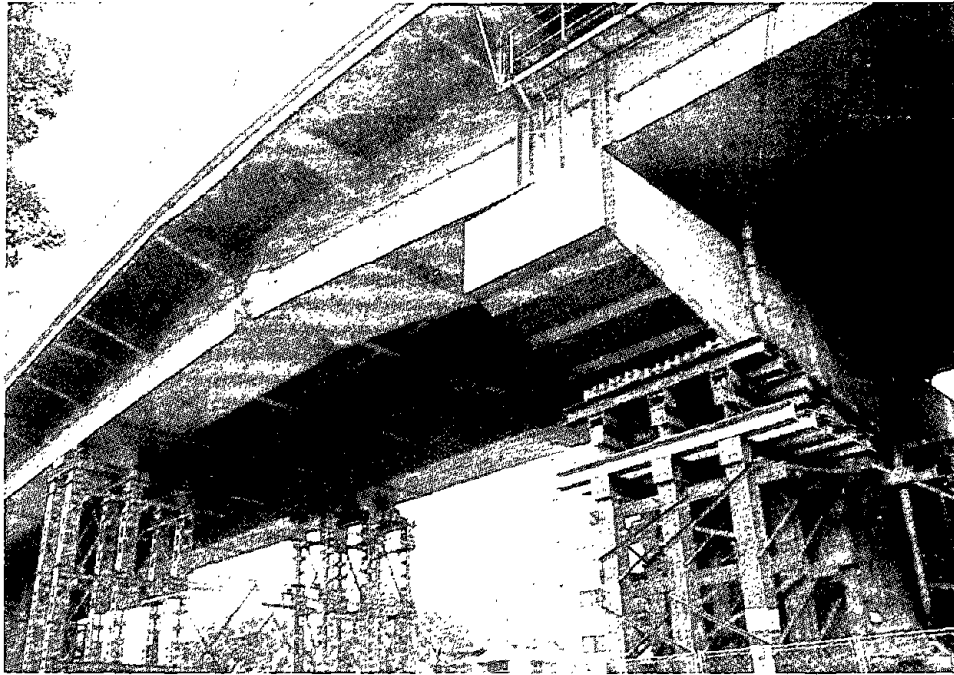
Figure 4.2.20 Compressive failure in lower flange of steel box girder between Piers 238 and 239 of Hanshin Expressway.

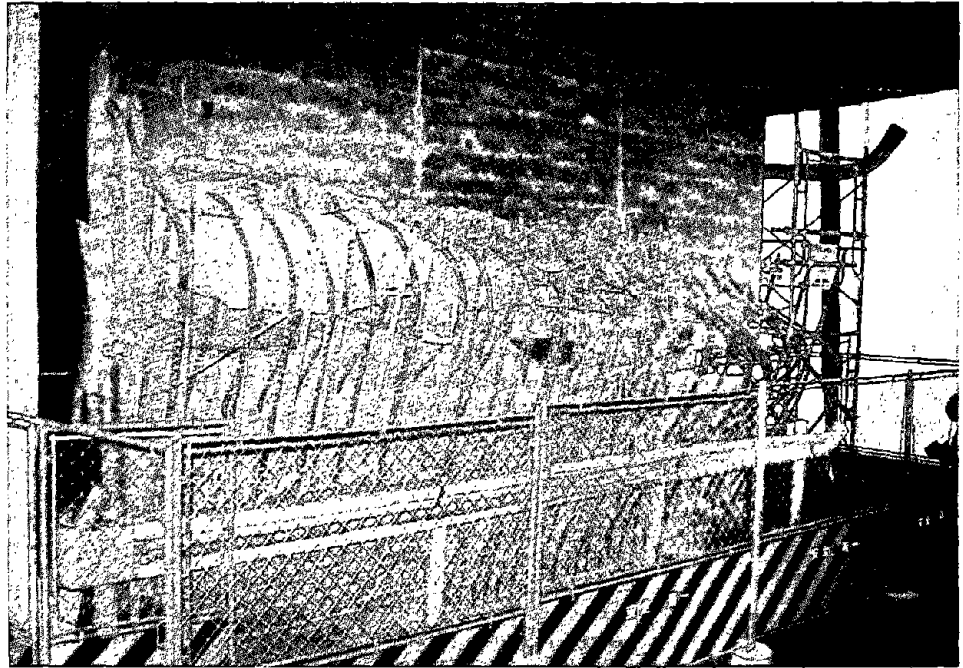
Figure 4.2.24 Shear failure in wall pier (east face), Moribe Viaduct.

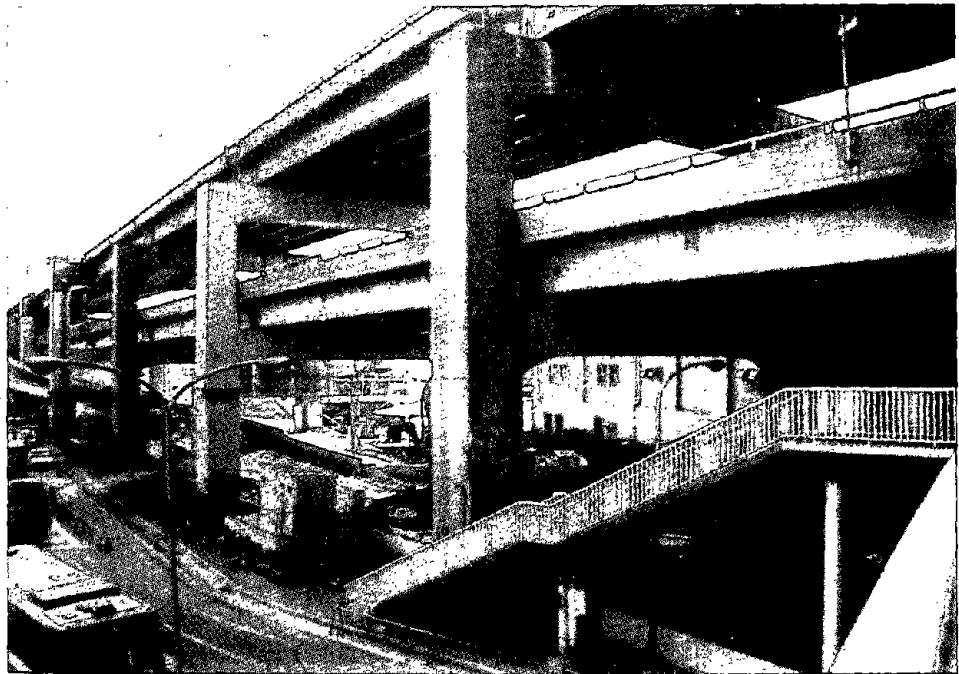
Figure 4.2.25 General view of Kobe-Ohashi Connector near Port Island showing formation of flexural hinges in lower level columns.

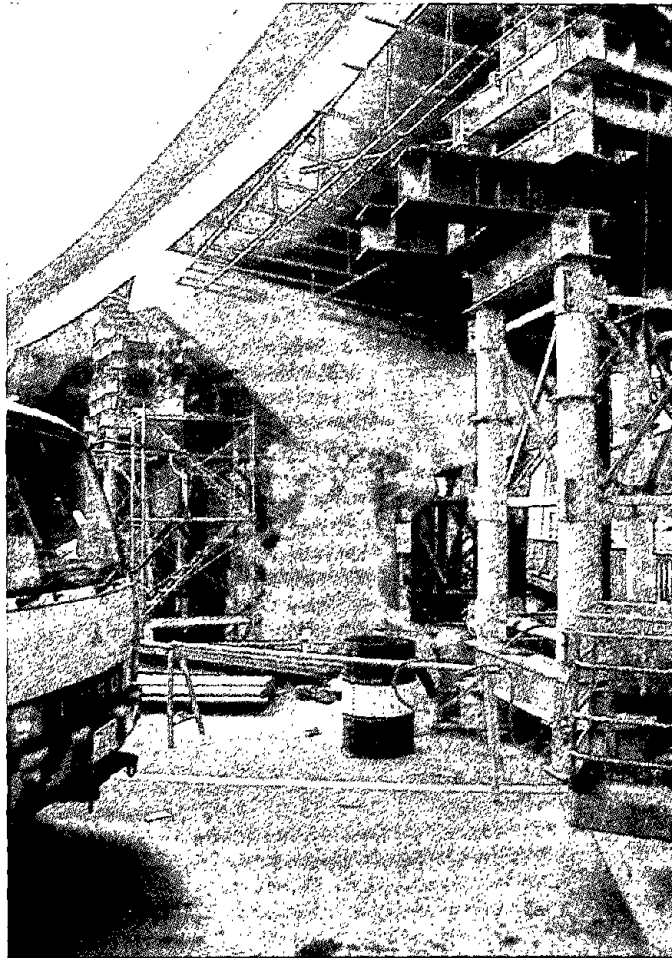
Figure 4.2.30 Column failure in Southwest Ramp at Minatogawa Interchange.

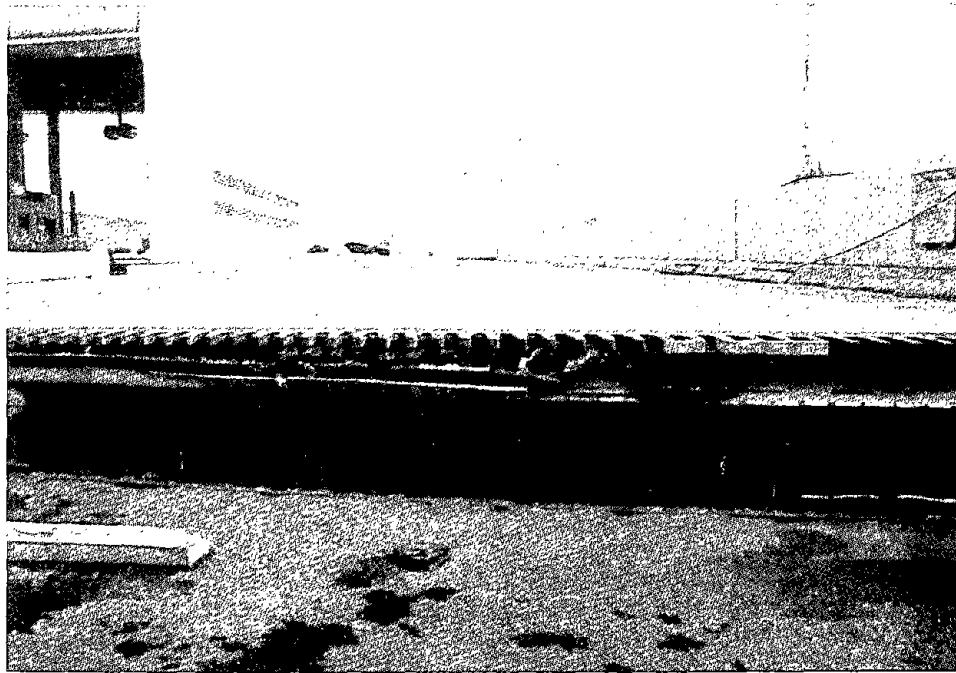
Figure 4.2.43 Vertical offset in the expansion joints above Pier 134 of the Shukugawa Bridge due to bearing failure on the best cap below.

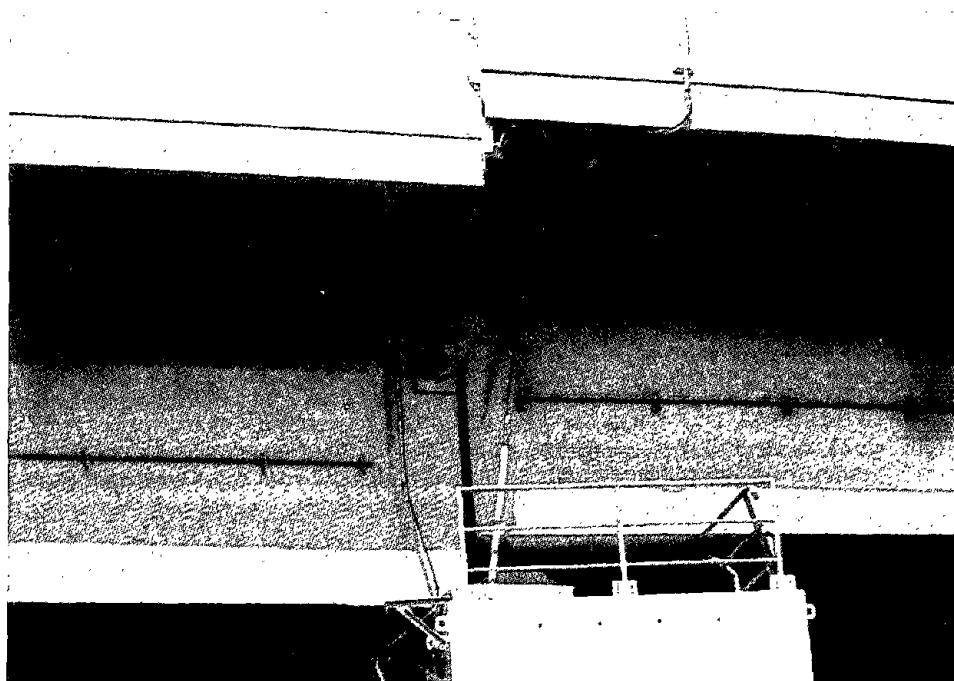
Figure 4.2.44 Approach span at edge of seat at Pier 134 of Shukugawa Bridge due to lateral movement of the pier by about 1 m towards the center of the channel.

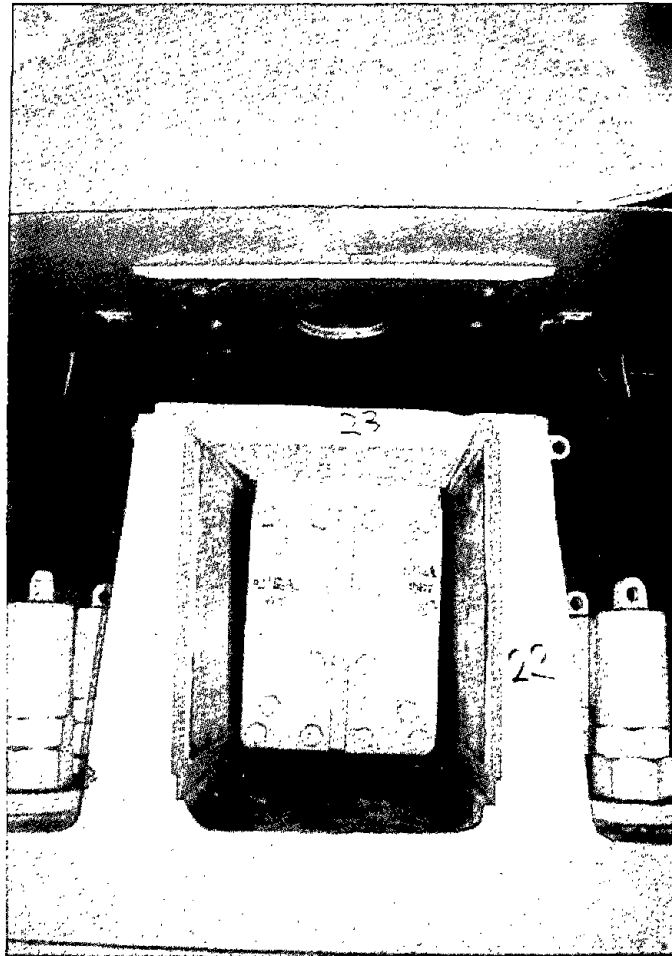
Figure 4.2.48

Failed wind shoe at Pier 187 of the Higashi-Kobe Bridge.

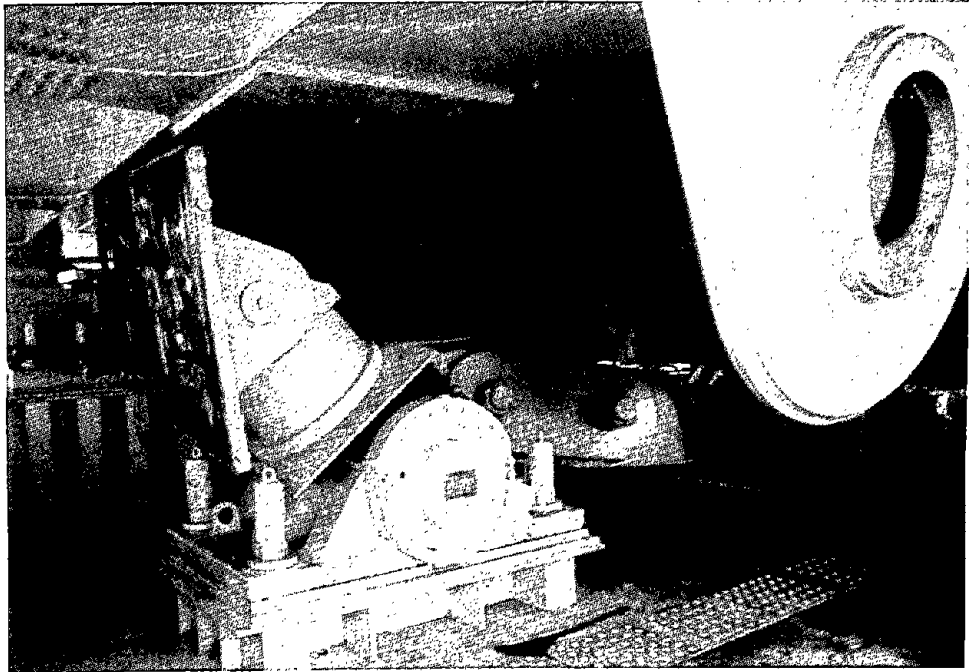
Figure 4.2.49

Failed connection of Vane-type energy dissipator and (at upper right) part of failed dead load tie-down at Pier 187 of the Higashi-Kobe Bridge.

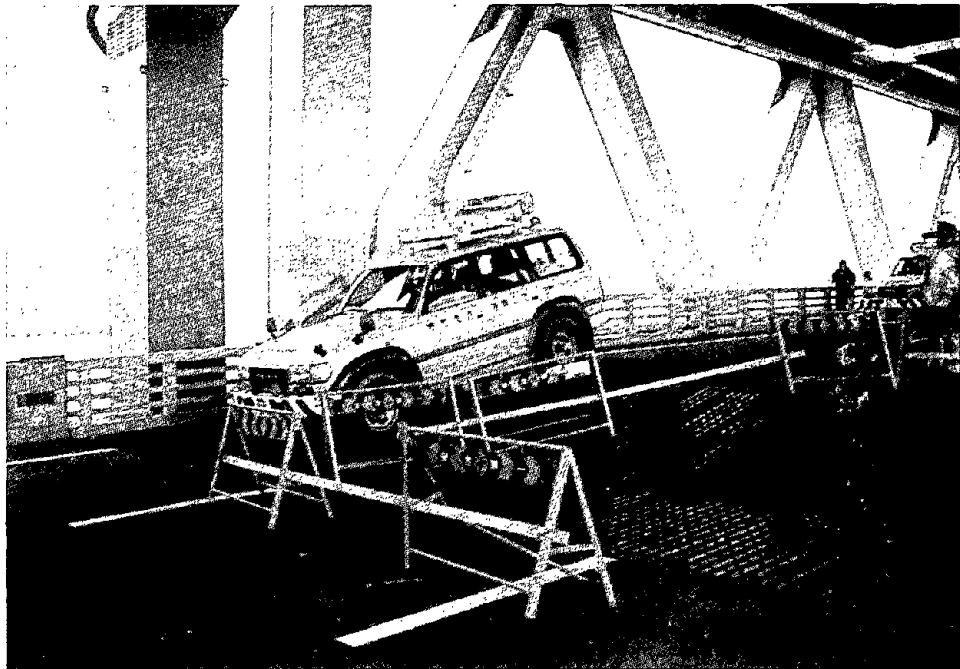
Figure 4.2.50

Uplift at the west end (Pier 187) of the main girder of the Higashi-Kobe Bridge due to failure of the dead load tie-down.

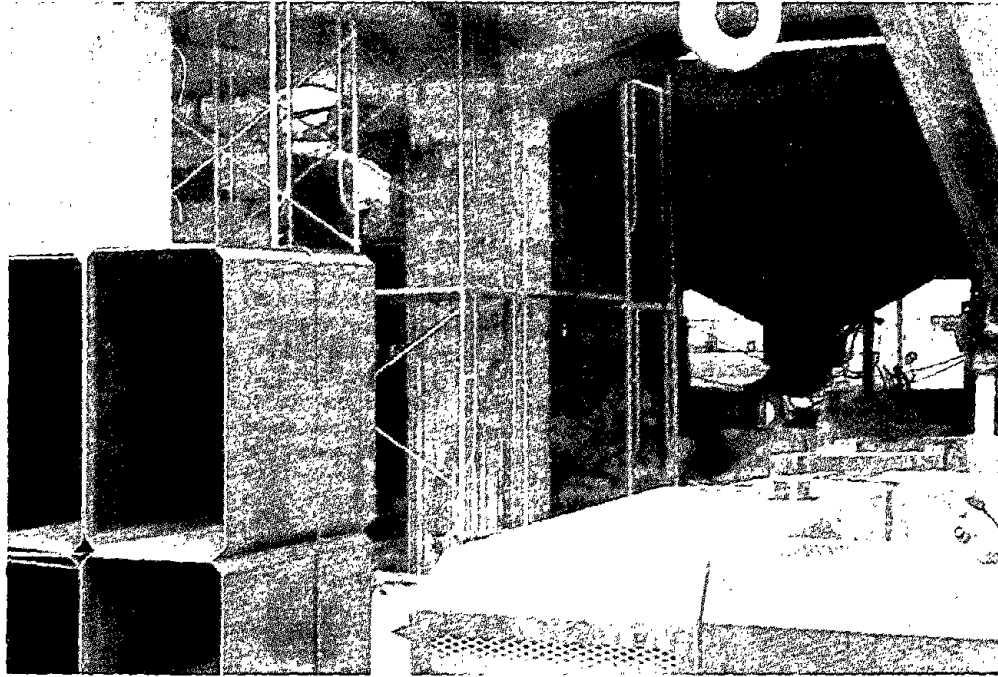
Figure 4.3.7 Column jacketing repair - JR Main Line.

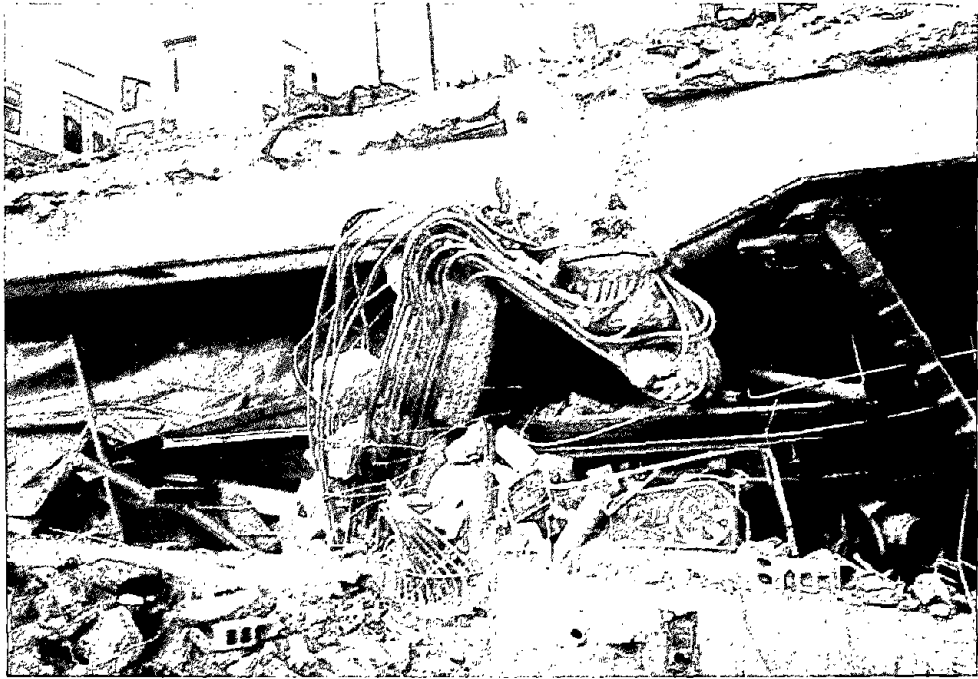
Figure 4.3.9 Failed column at Higashi - Nada - elevated rail yard.

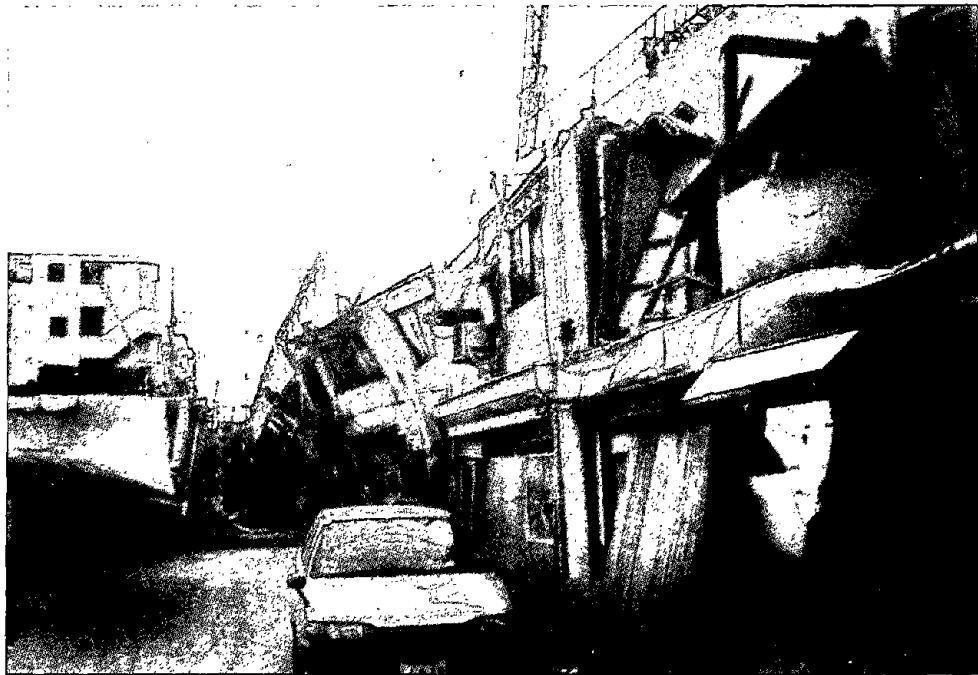
Figure 4.3.10 Collapsed rail yard at Higashi - Nada.

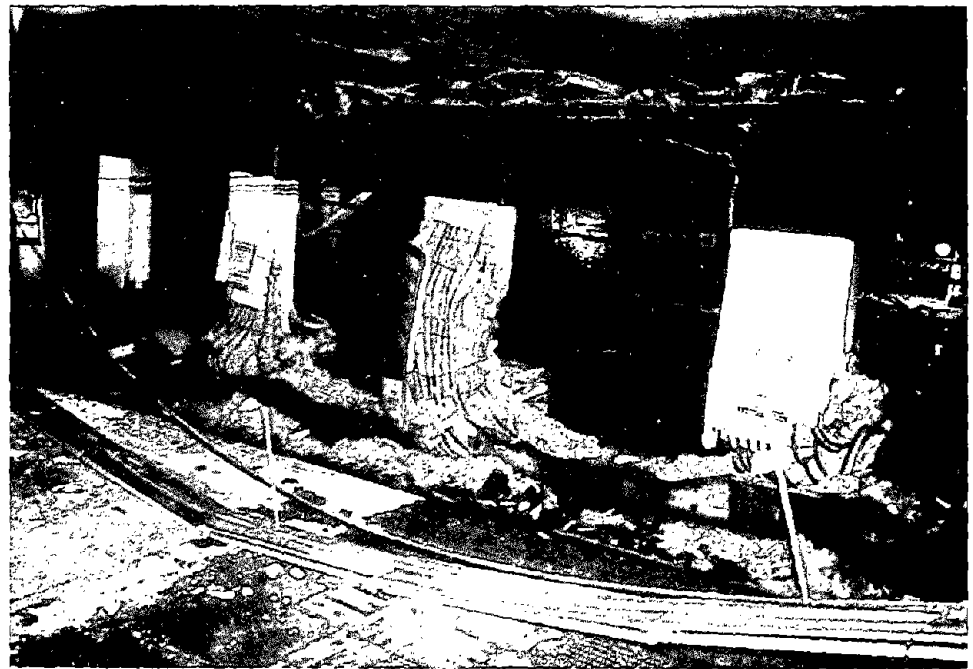
Figure 4.3.20 Compressive failure of center columns at Daikai Station.

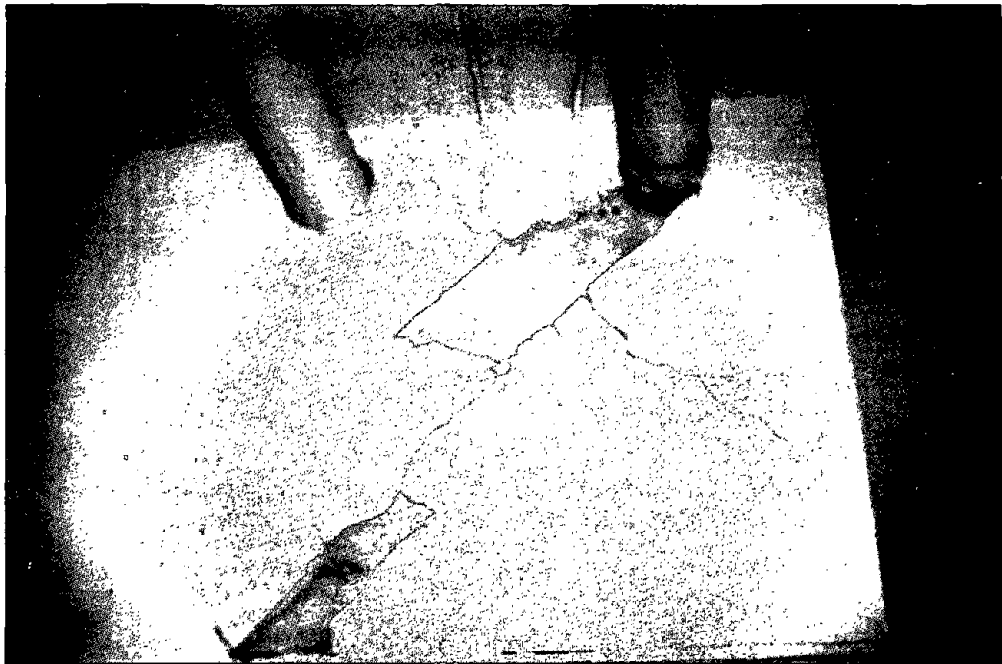
Figure 4.4.27 Cracks in the stair-well shear walls of the Osaka Airport Administration Building.

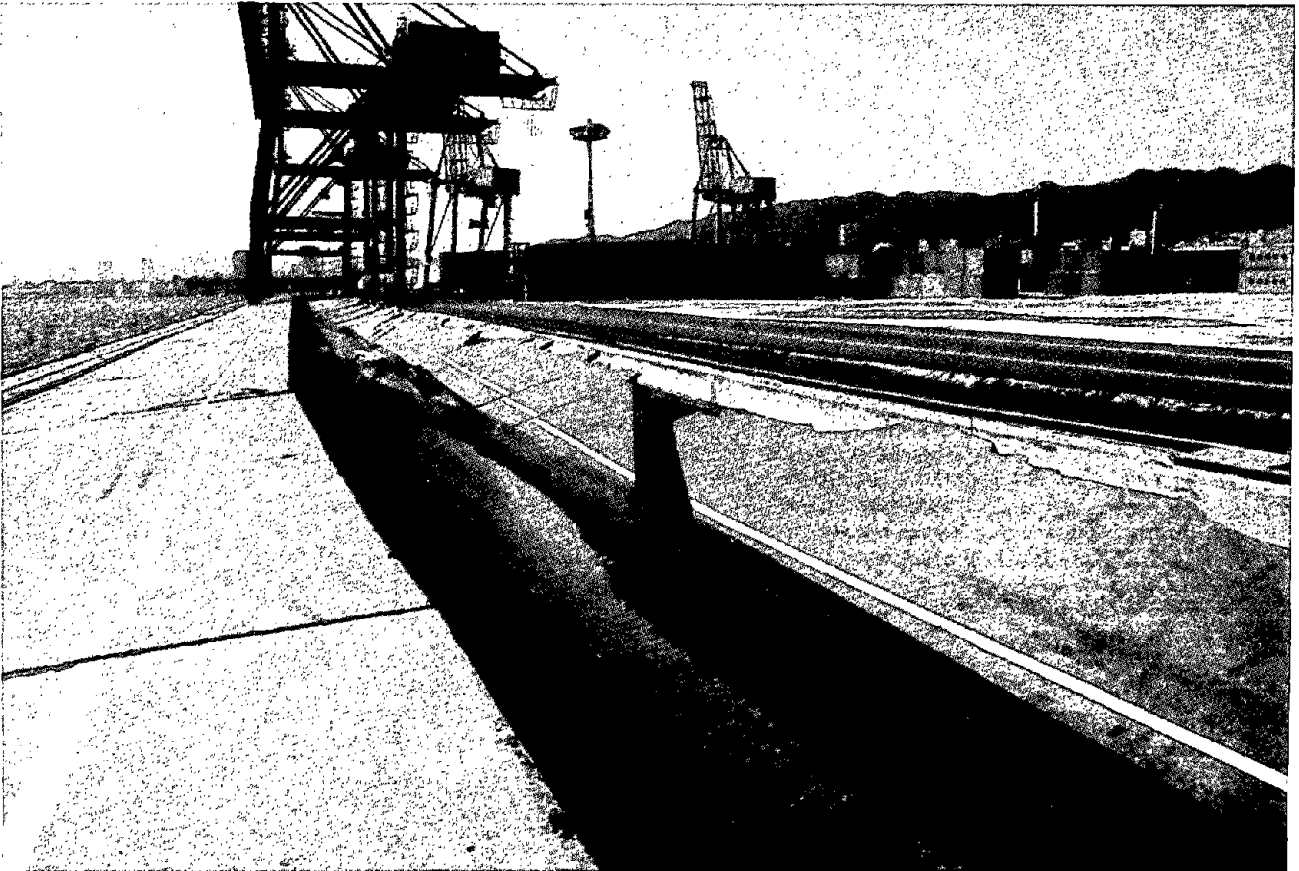
Figure 4.5.5 Damaged to Maya Wharf caused by liquefaction-induced lateral spreading. Downdropped block has formed behind quay wall where land has settled and moved outward. Landward side of block is the pile-supported rear crane rail. Photograph taken February 15, 1995.

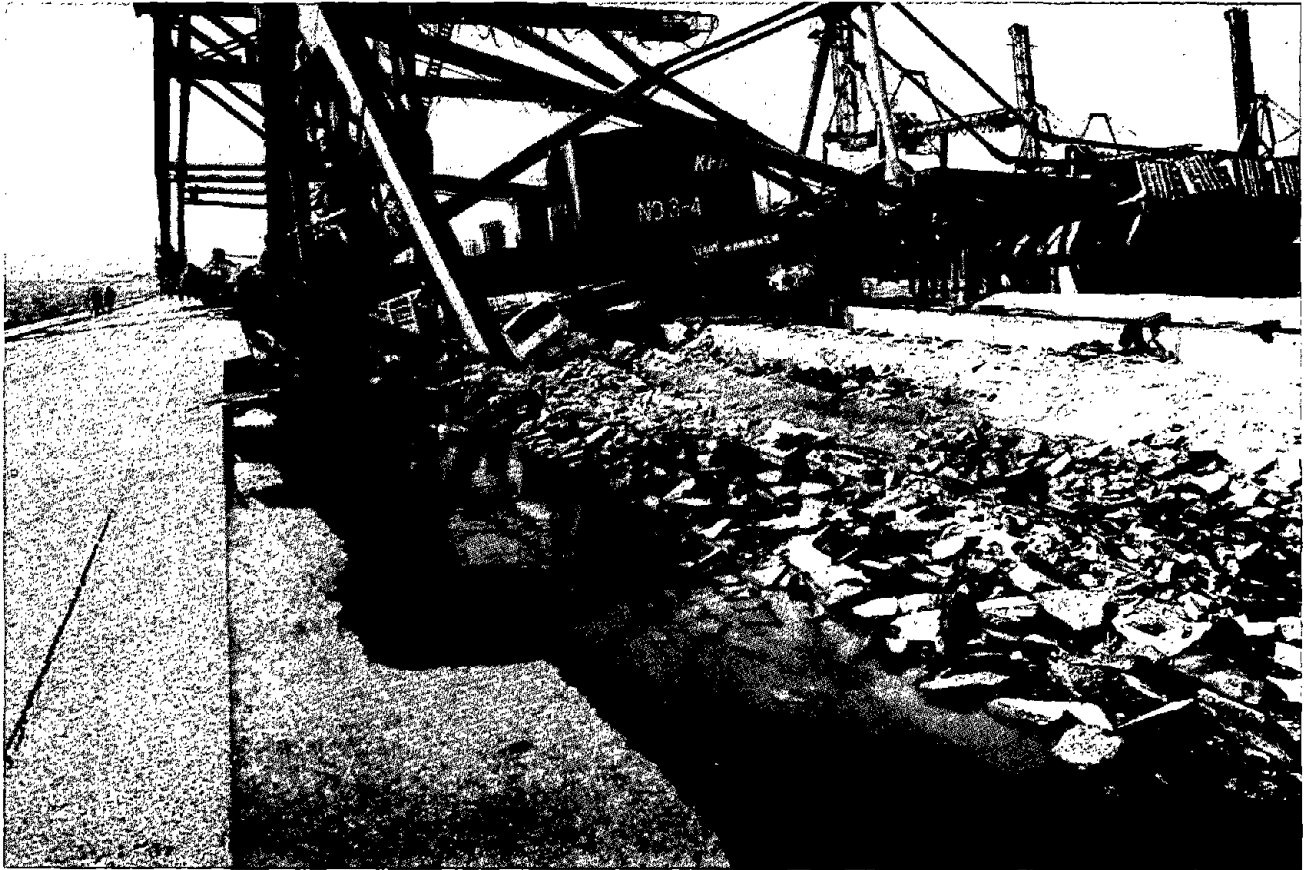
Figure 4.5.6 Collapsed crane caused by permanent differential horizontal displacement between crane rails on Rokko Island. Lateral spreading caused permanent seaward displacement of quay wall and crane rails to pull apart. This caused the legs of the crane to pull apart and crane to topple. Photograph taken February 15, 1995.

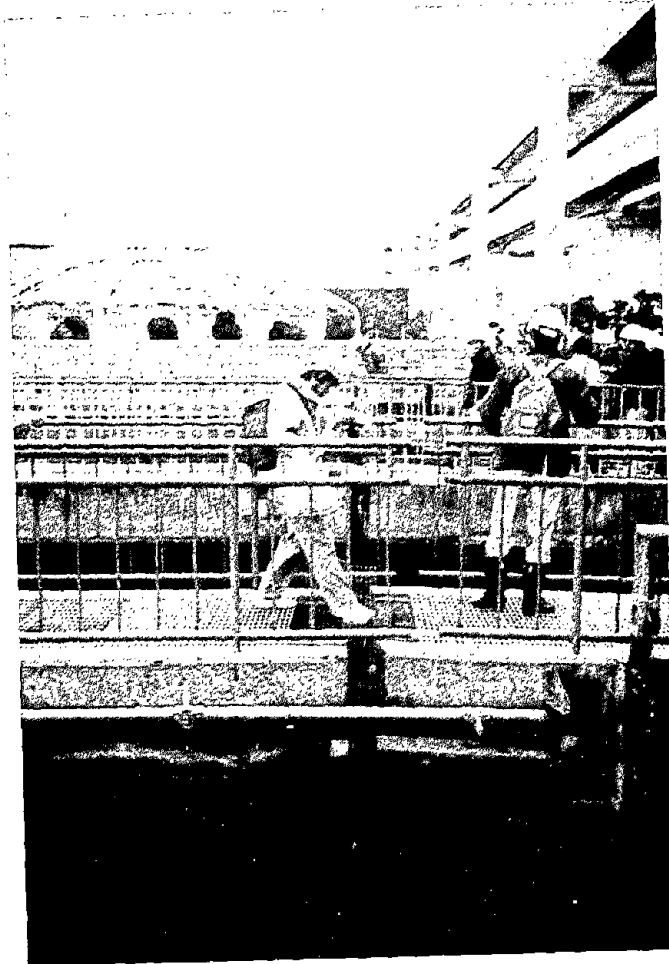
Photo 33 Aeration tanks construction joint separated down the entire bank of tankage as a result of settlement.

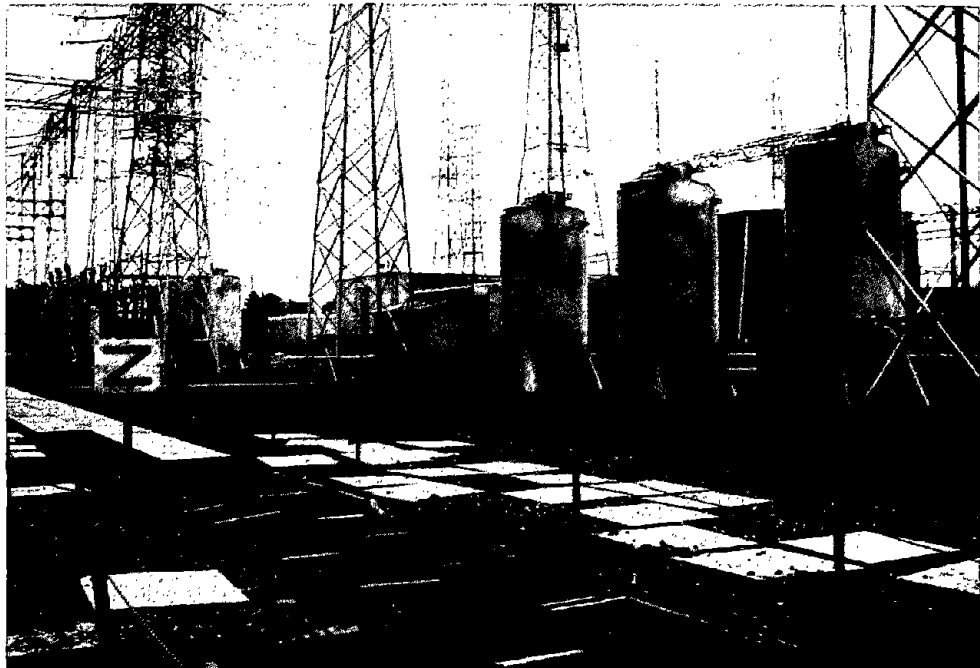
Figure 5.4.26 Bulk-oil circuit breakers with the bushings removed to replace damaged units at other sites.

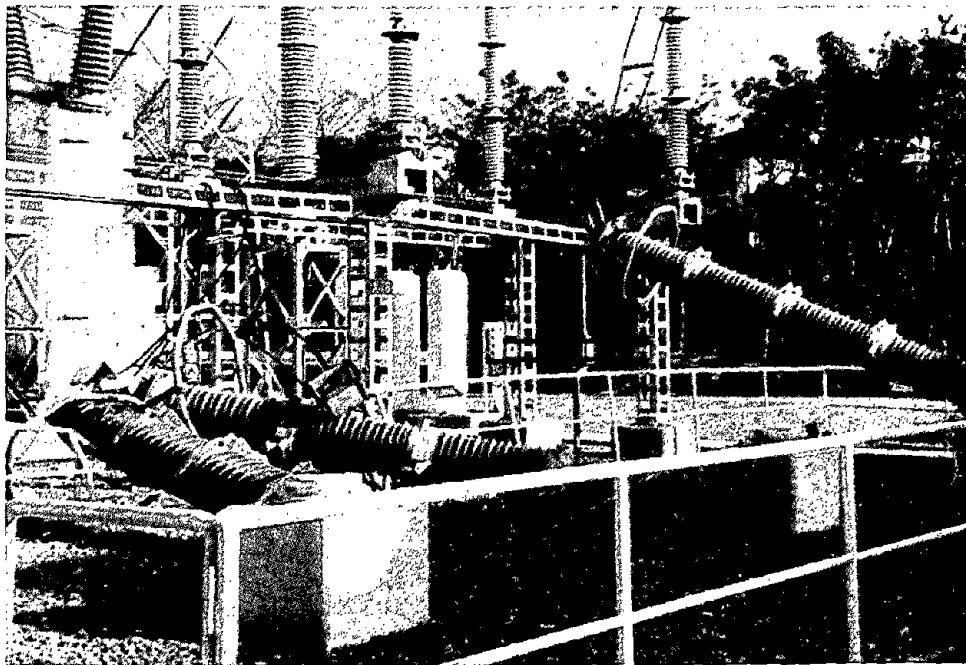
Figure 5.4.30 The standoff incorporated into the design of the base of the lightning arrester failed.

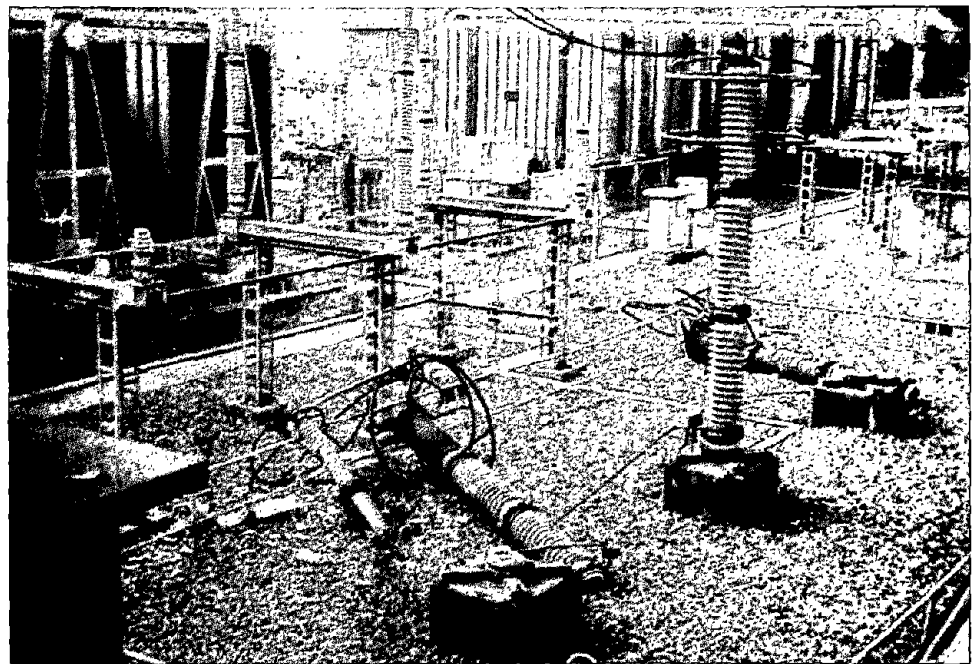
Figure 5.4.55 Lightning arresters failed and probably pulled down adjacent disconnect switched.

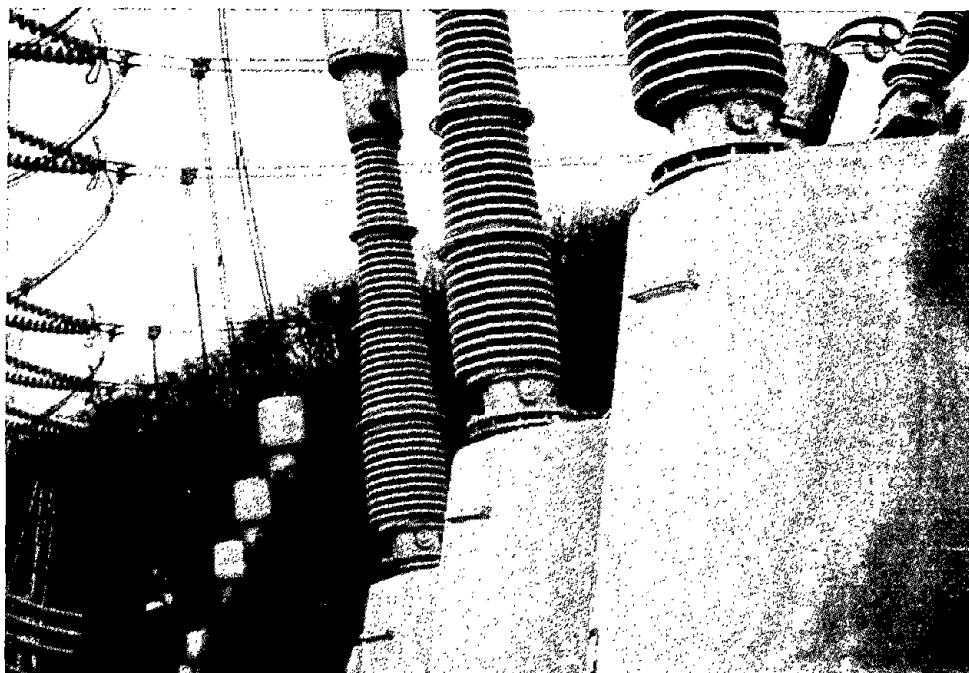
Figure 5.4.56 All three bushings shifted on this 275 kV bulk-oil circuit breaker.

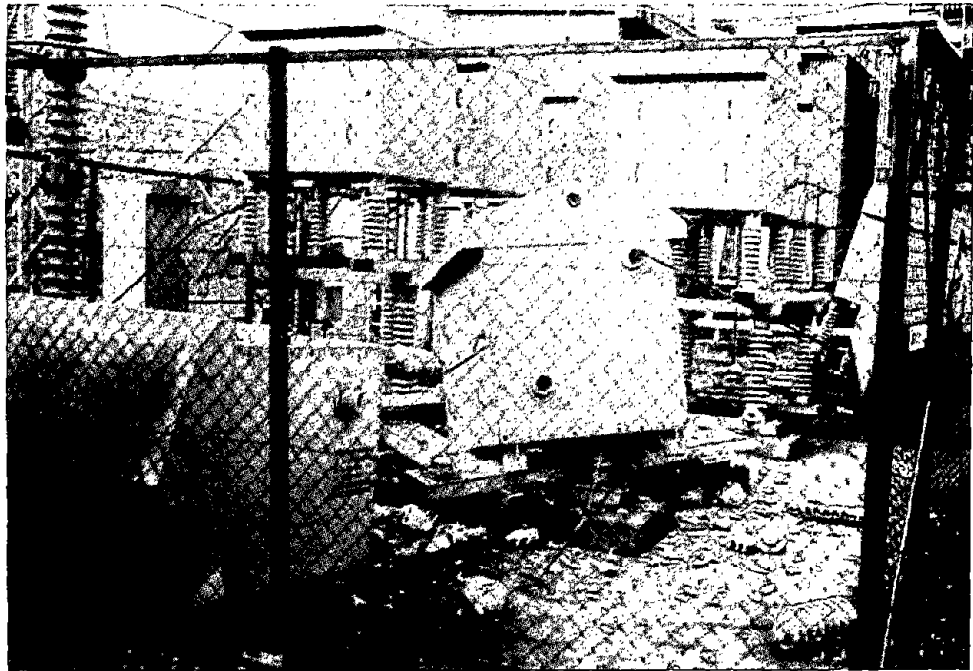
Figure 5.4.58 Neutral resistors failed, a device not used in this configuration in the U.S.

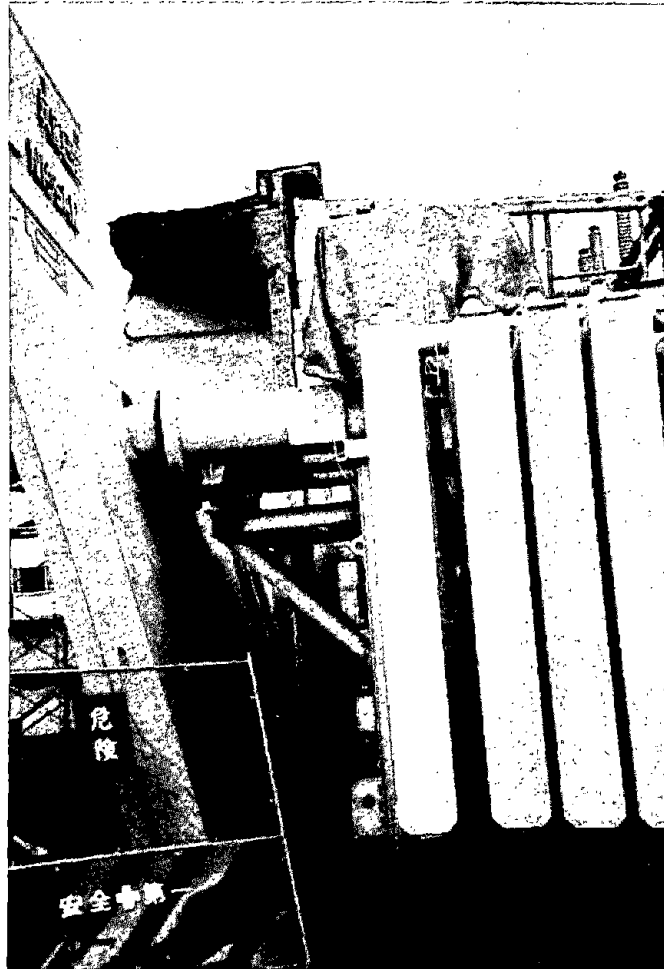
Figure 5.4.61 A transformer pushed over the fire wall after it failed its anchorage.

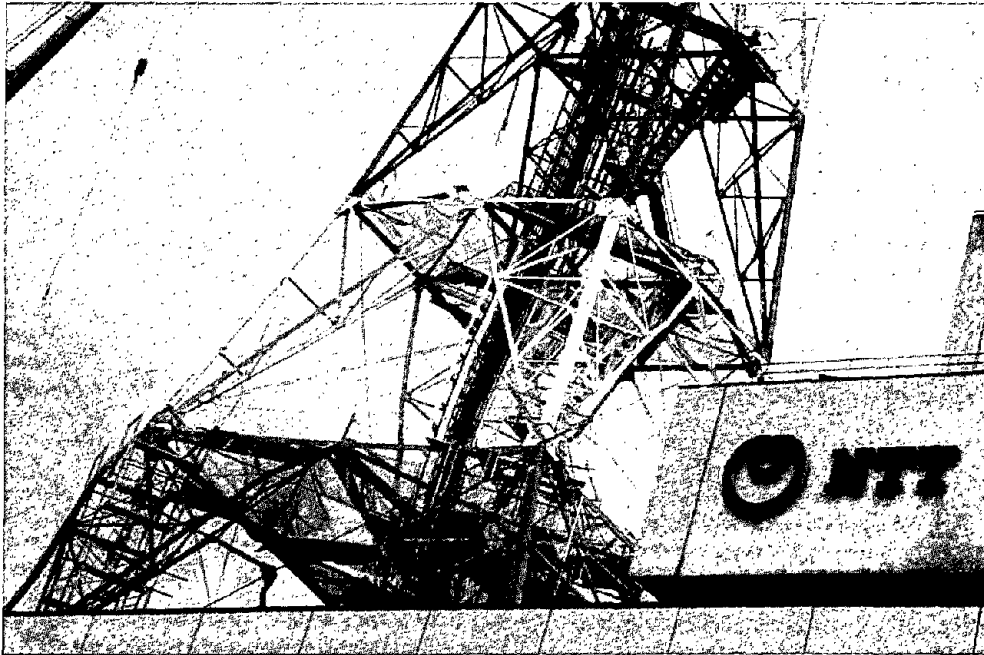
Figure 5.5.1 Microwave tower on top of a central office which was damaged and later removed.
