A BUILDING STONE AND SLATE SURVEY OF THE CALLANDER CONSERVATION AREA

OPEN REPORT OR/11/011

A building stone and slate survey of the Callander Conservation Area: recording, matching and sourcing for the built heritage

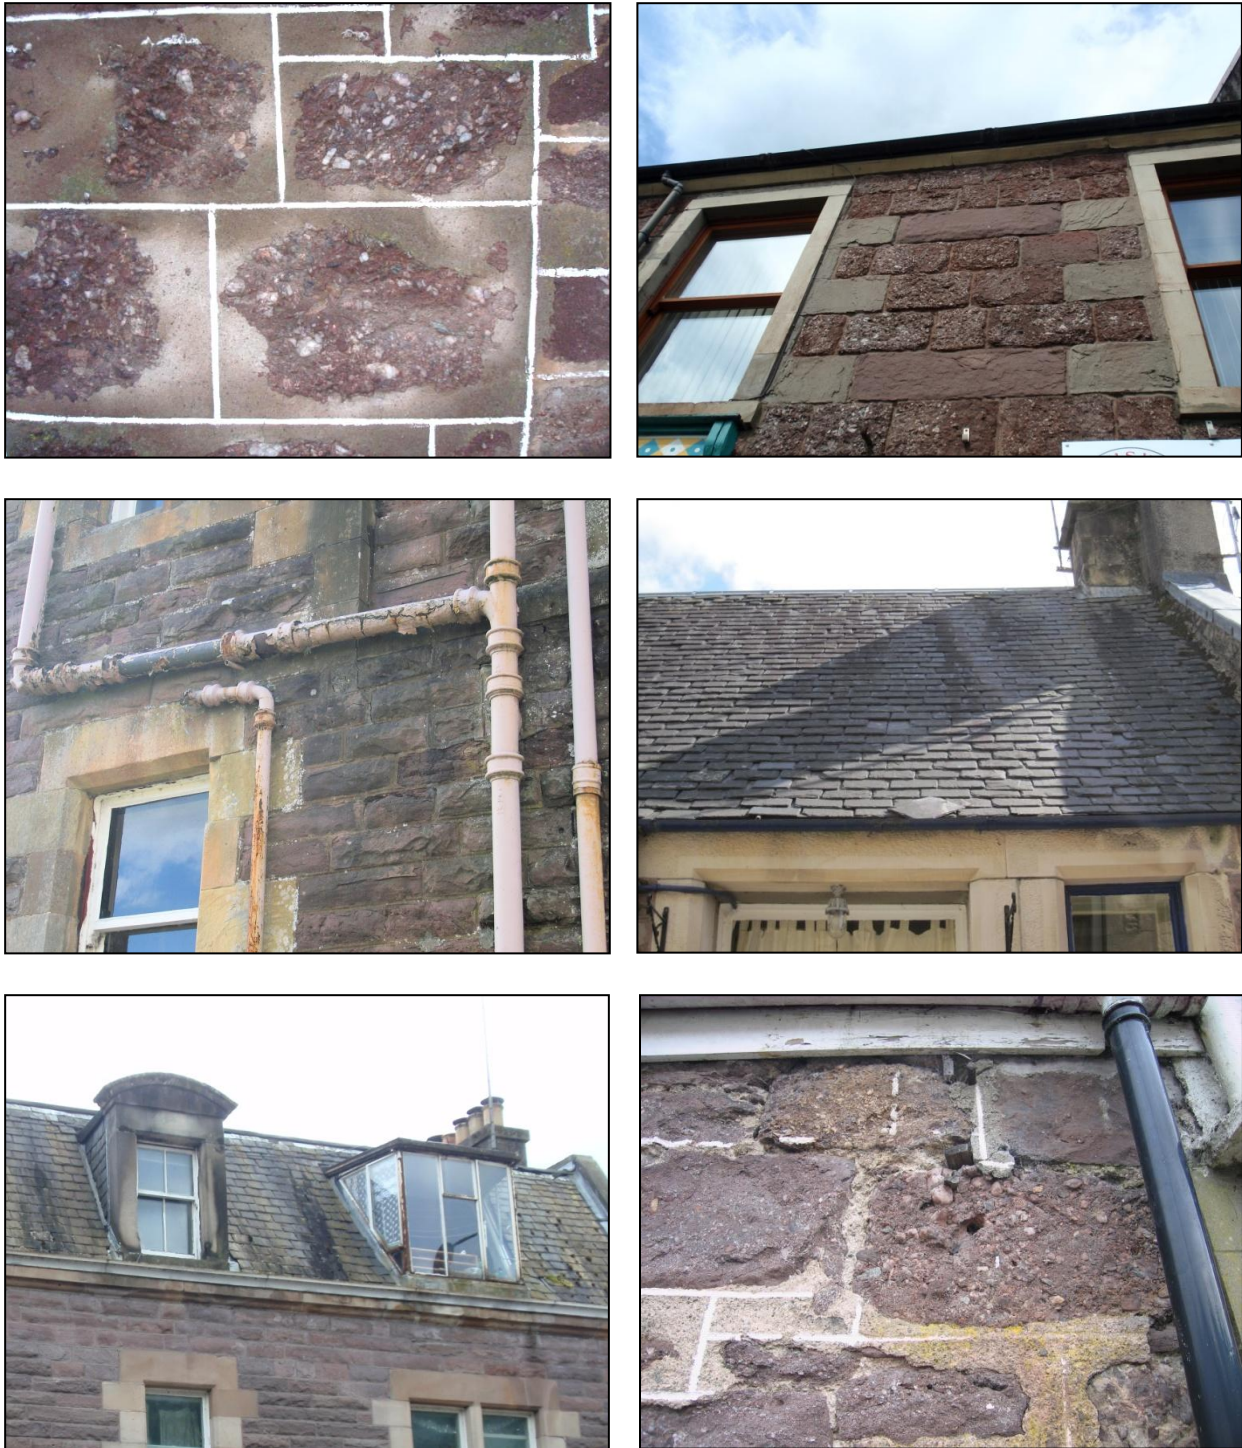
Figure 18 Examples of the most serious conservation issues affecting buildings in the CCA.

Top left: cement pointing/patching to stone masonry walling. Top right: face-bedded F1 and F2 flagstone blocks in window surrounds showing the effects of splitting along bedding. The vertical window surrounds have been mortared and painted, probably concealing damage caused by splitting along bedding.

In all future stone walling repointing works, lined-out margins should be retained or re-instated where they currently exist or previously existed.

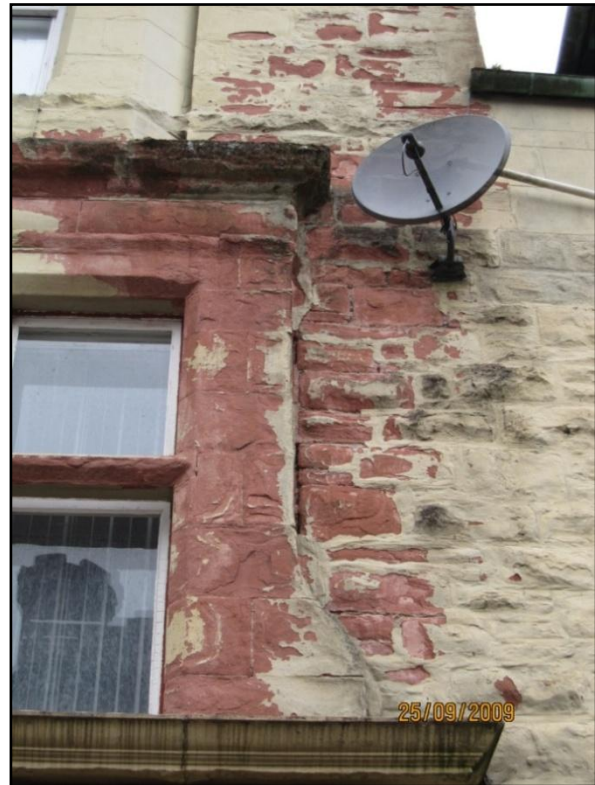
Figure 2 Cross Street elevation. Examples of scaling, crumbling and areas where repointing is required. Paintwork is flaking off.

Cement has been applied to many parts of the surveyed building, for example in the construction of the walled dormers, first storey bay window, the Shell Centre entrance, and alongside the side and base course of the ‘Desirables’ shopfront—mainly on the Main Street elevation. Although it is likely that the applied coatings were a ‘cosmetic’ solution to already damaged masonry, it is apparent that these products have a relatively short life and may result in further decay to any remaining stonework underlying the current construction.

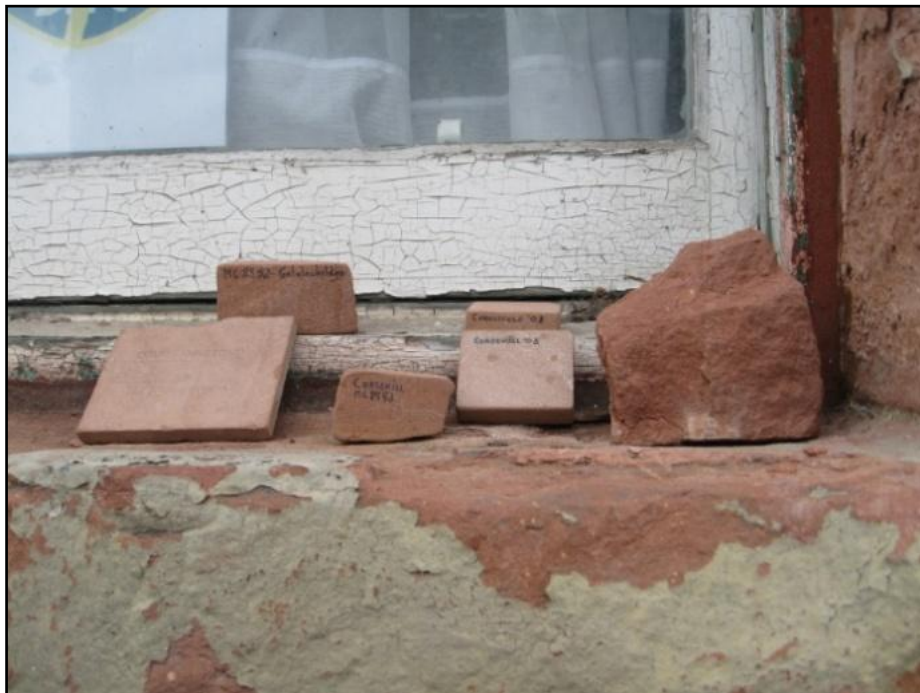
Figure 4 Example of visual stone matching. The sample most to the right is the original stone from the building. Samples to the left are currently available red sandstones.

Currently available matching stones, in order of decreasing similarity:

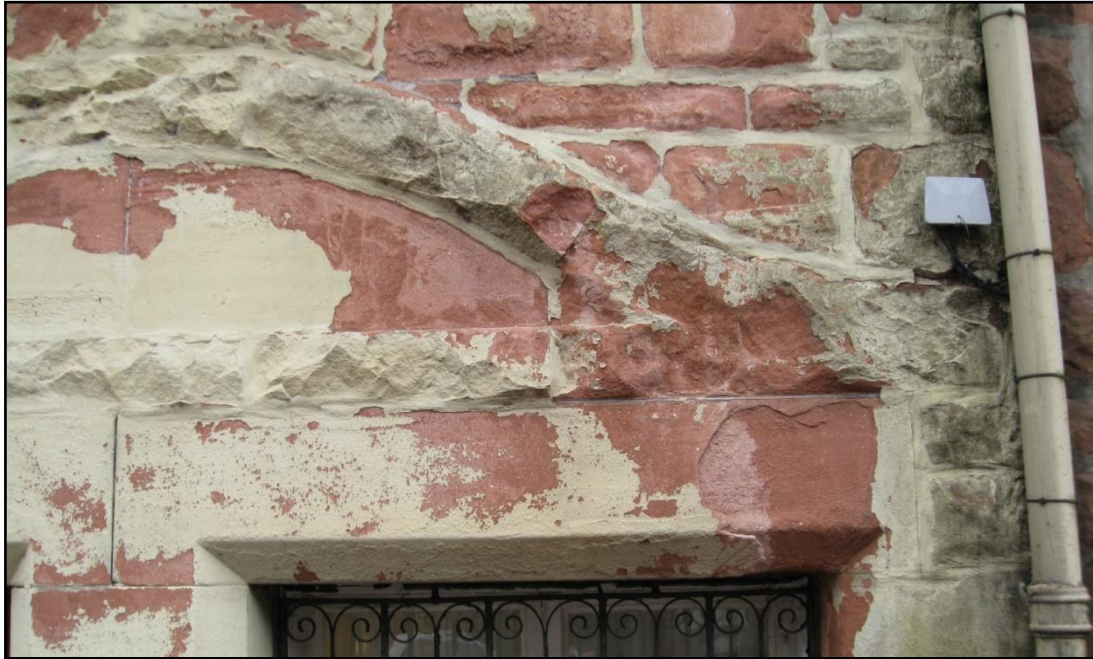
Red sandstones are typically relatively permeable, making the stone prone to water ingress and saturation, and leading to the common problems of soiling and consequent decay such as is observed in this surveyed building. The permeable nature of the Desirables sandstone makes it particularly important that the building is maintained in such a way that water is deflected off the face of the masonry in order to avoid stone decay. Due to the high porosity and permeability of this sandstone, it is also important to note that lead flashing may be required to further protect masonry from excess water penetration, where appropriate.

Figure 5 Damage to a hood mould on Cross Street elevation. It is possible that the complete removal of this water shedding element was thought to be a better solution than repairing and restoring the protruding masonry; however, this has only led to the enhanced decay of the stone facade below.

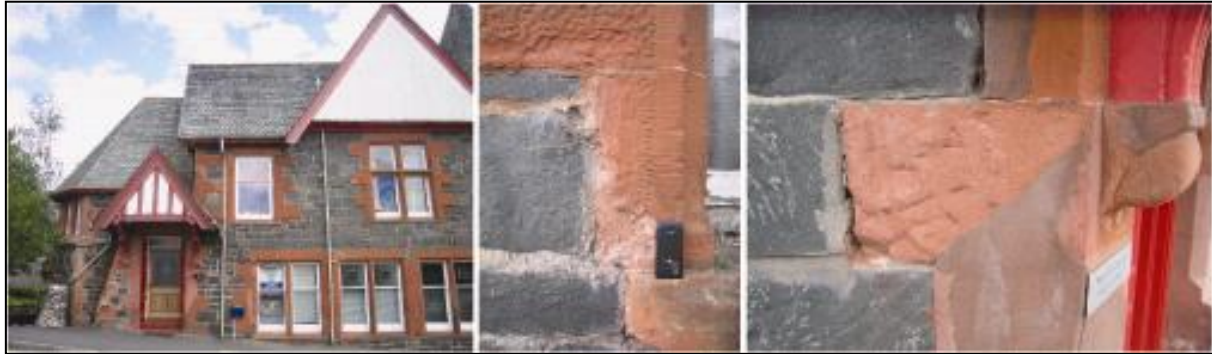
Figure 8 Main Street and Trossachs Road, Aberfoyle. C(s) listed building (c.1886) with squared and snecked whinstone rubble and red sandstone dressings. The red sandstone dressings are similar to the 'Desirables' stone type and display some of the similar features of stone decay.
