# NATIONAL PROPERTY INSPECTIONS, INC.

## TECHNICAL BULLETIN

October, 2006

TOPIC: Entran II Tubing.

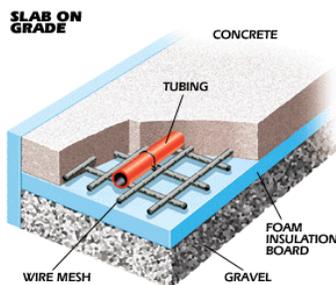
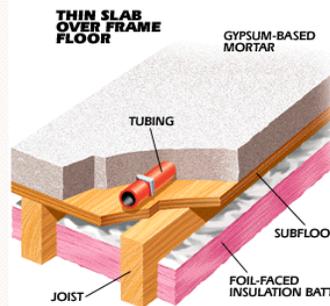
### TYPICAL INSTALLATION CONFIGURATIONS

**In-slab** – the tubing is installed and looped in a typical concrete floor, or used as a snowmelt system in the driveway or garage.

**Thin slab or thin set** – the tubing is installed and looped in light weight concrete on a wood or concrete floor.

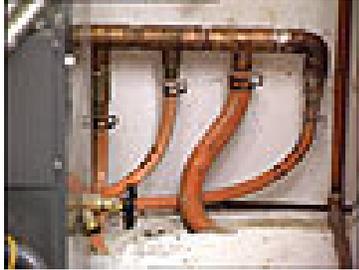
Entran II was also used as a conduit between baseboard heating elements and the heat source.

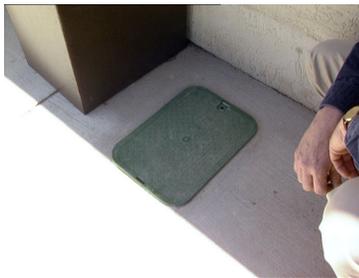
Because Entran II hose is often buried under floors or embedded in concrete, it can be difficult to find and to identify. The first place to look is the boiler room where the tubing attaches to a manifold. The manifold may be concealed by an access panel or located in the control box of a snowmelt system. These boxes are often made of plastic and resemble the boxes used to house lawn sprinkler system valves.

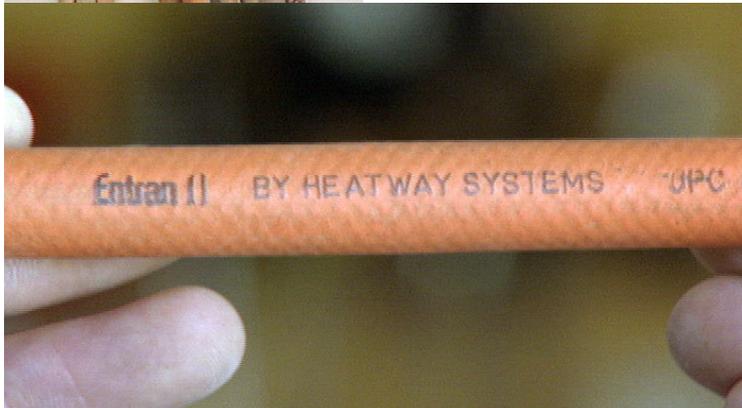
When Entran II is found it may be in working order. Look for the following signs of failure:

1. Tubing that is hard at or near the connections.
2. Tubing that has changed color, usually going from orange to dark red, or reddish-brown, but sometimes white.
3. Leaks at the connections.
4. The entire hose is brittle, leading to other leaks.
5. A black sludge seeping from the hose and into the mechanical components of the heating system, causing other components to fail.

Entran II is reddish-orange in color. The words "Heatway" or "Heatway Systems" and a trade name such as Entran II, Twintran, Nytrace, Entran Trace, or Entran 2 Wire is usually stamped clearly on the outside of the tubing. The inside diameter of Entran II hose is about  $\frac{1}{4}$ " to  $\frac{3}{4}$ " of an inch, and the outside diameter is  $\frac{3}{4}$ " to 1". The Goodyear date code has both date, numbers, and a letter "A," "B," "C," "D," or "Z."
