資料 5 : 参考資料

資料5-1 PEARとCEARの要求事項比較

Inspection Record : Old Wharf (No.1~20)

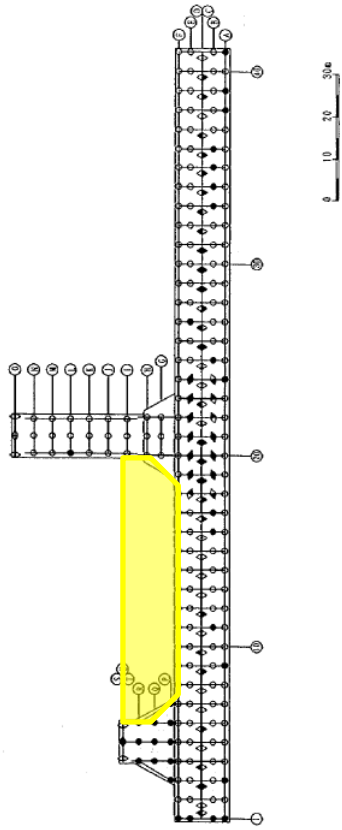
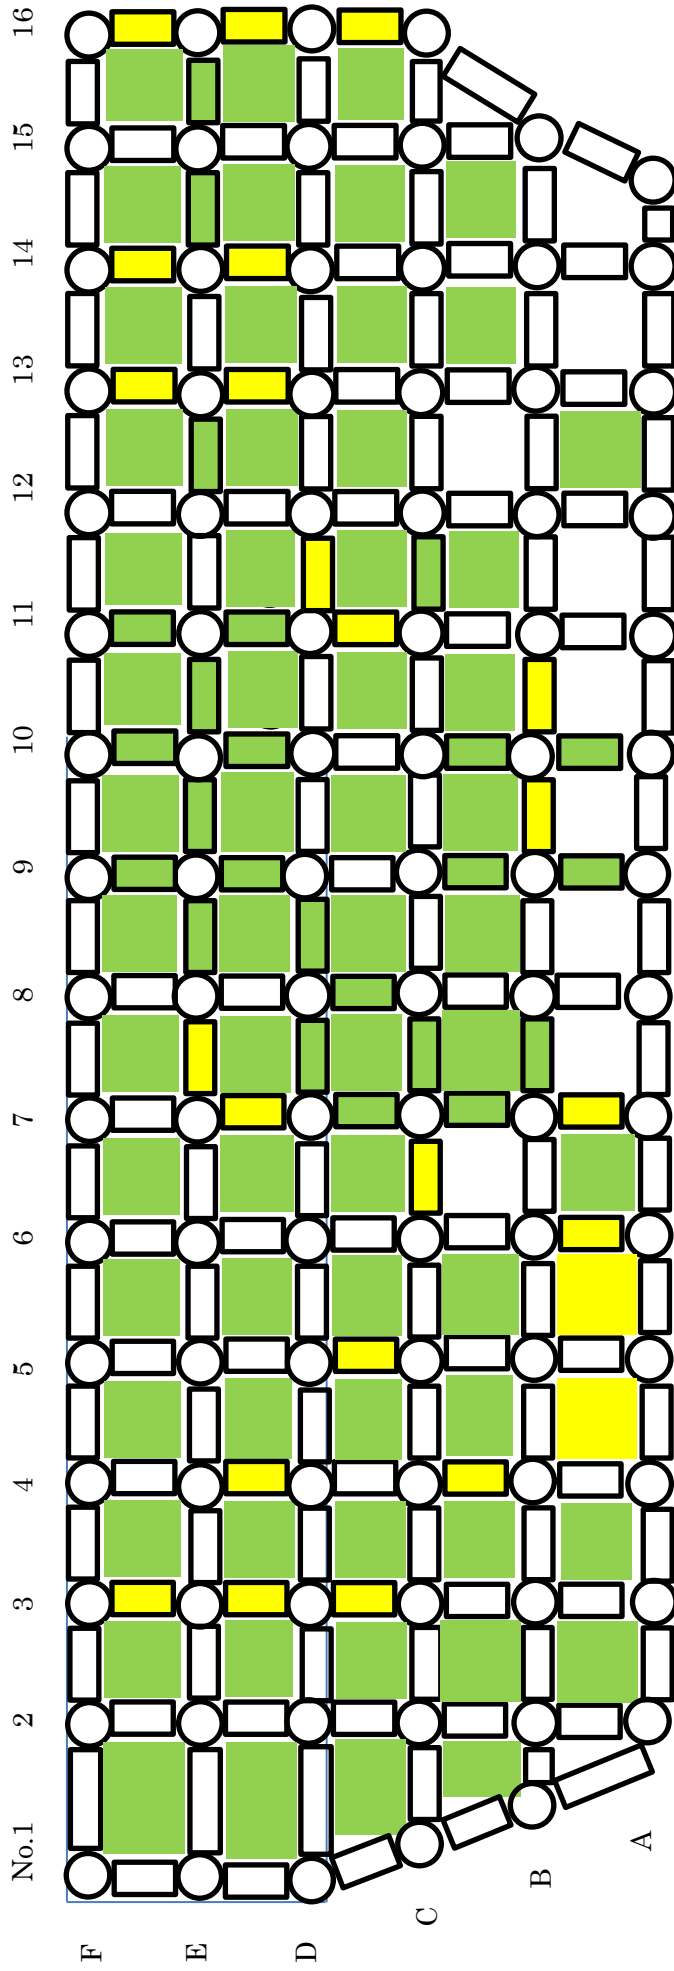
# Inspection Record : Under the Deck

- : Collapse & Crack
- : Collapse
- : Crack

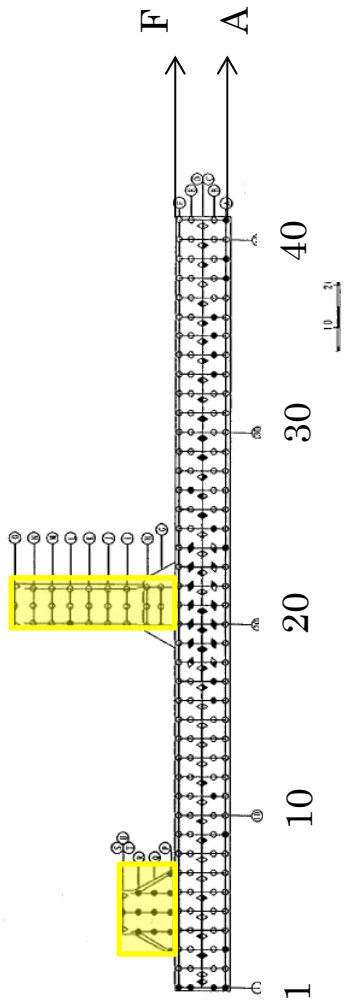
# Inspection Record : Approach

- : Collapse & Crack
- : Collapse
- : Crack

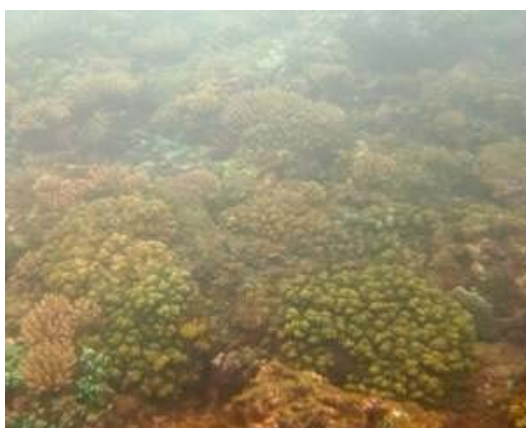
**Figure 3.14 Condition of transect survey line (West)**

The West transect had 40% hard coral cover 5% macro-algae & 45% dead coral rock and sand. There was 10% cover of an encrusting sponge, probably a *Dysidea* species. Figure 3.14 shows the condition of the West transect survey line.

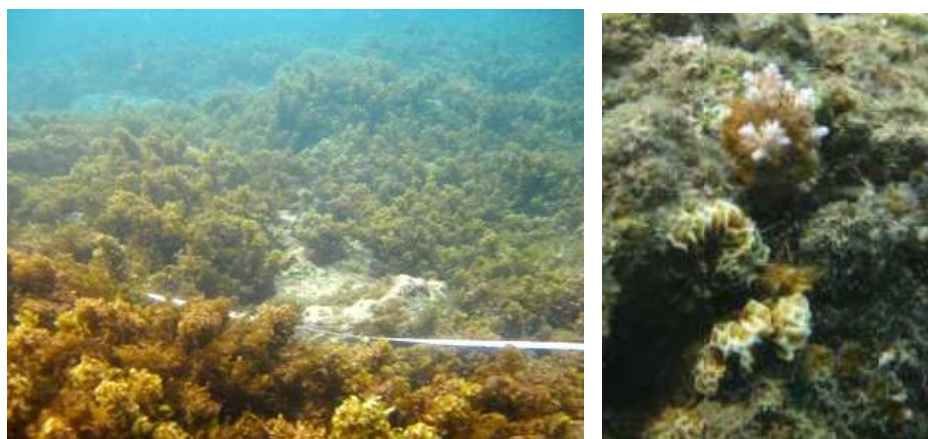
Figure 3.16 Condition of transect survey line (North)

Figure 3.16 shows the condition of the North transect survey line. The North transect was 51% bare reef substrate (rock) with 44% algal cover. There were a few small hard coral colonies (4% cover) in gaps in the algae.

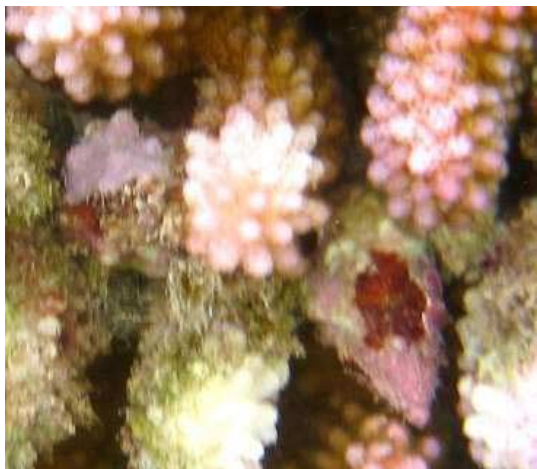
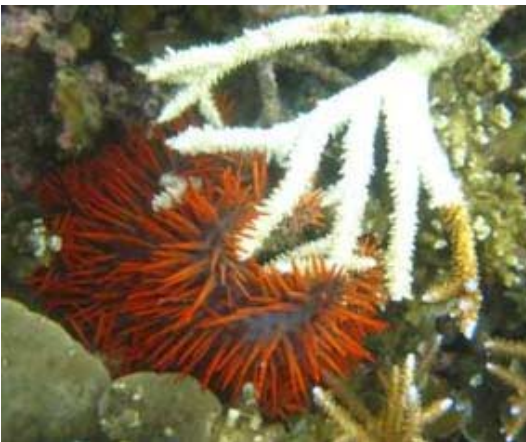
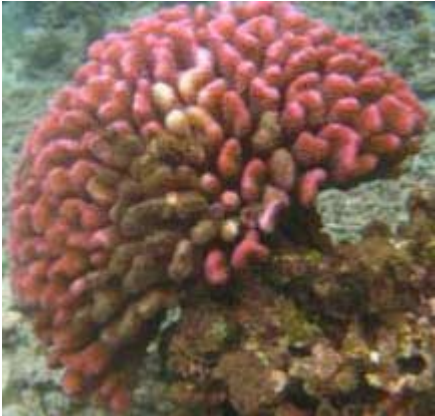
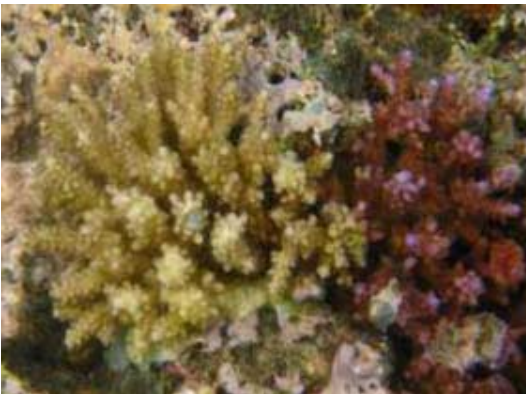
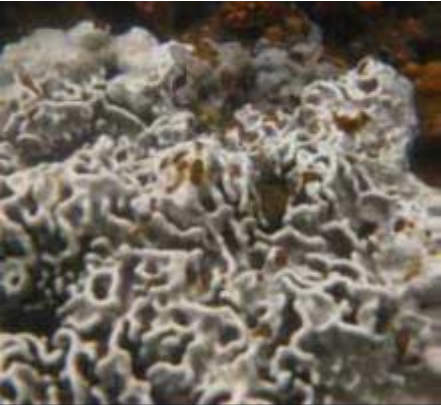
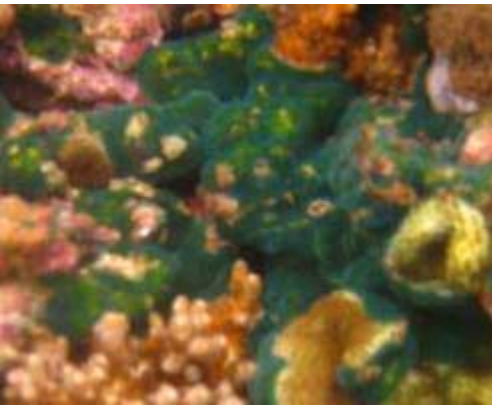
Figure 3.20 Photographs of coral damage

<p>Corallivorous snails <i>Drupella conus</i></p>	<p>Crown of Thorns star eating coral at Palolo Deep</p>

<p>Dead patch on <i>Pocillopora</i> coral colony caused by <i>Drupella</i> predation</p>	<p>Dead <i>Acropora</i> coral (left), living coral (right), probably due to <i>Drupella</i> predation</p>

<p>Encrusting Sponge, probably <i>Dysidea</i> spp</p>	<p>Encrusting Tunicate, possibly <i>Tridemnum</i> spp</p>

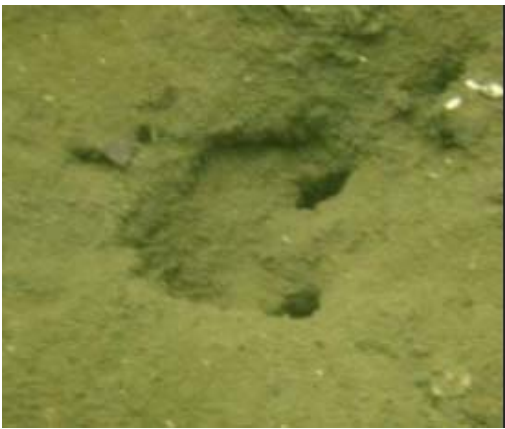
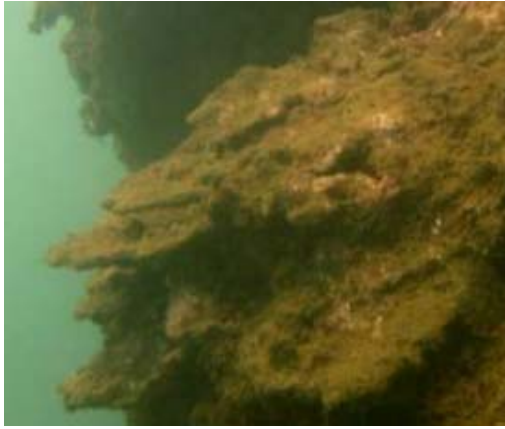
**Figure 3.21 Photographs of coral damage caused by sedimentation (West transect)**

<p>Deep, soft sediment 10m deep on the sea bed off the West transect, near the Government Buildings</p>	<p>Dead corals covered in silt at 6m deep on the reef slope off the West transect, near the Government Buildings</p>

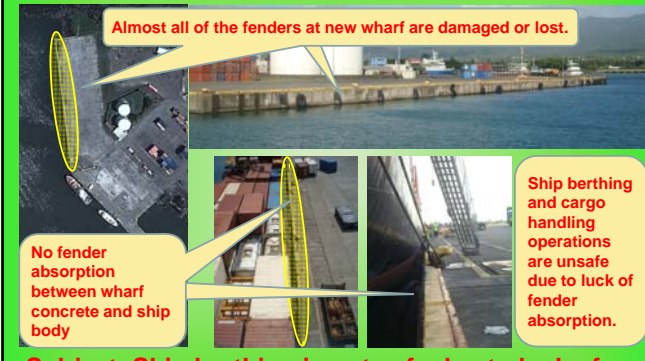
**Fender System: Present Conditions**

Almost all of the fenders at new wharf are damaged or lost.

No fender absorption between wharf concrete and ship body

Ship berthing and cargo handling operations are unsafe due to lack of fender absorption.
