BASRAH INTERNATIONAL AIRPORT INITIAL AIRPORT MANAGEMENT ASSESSMENT (CLIN 001)

4. CONDITION SURVEY AND OPERATIONAL ASSESSMENT

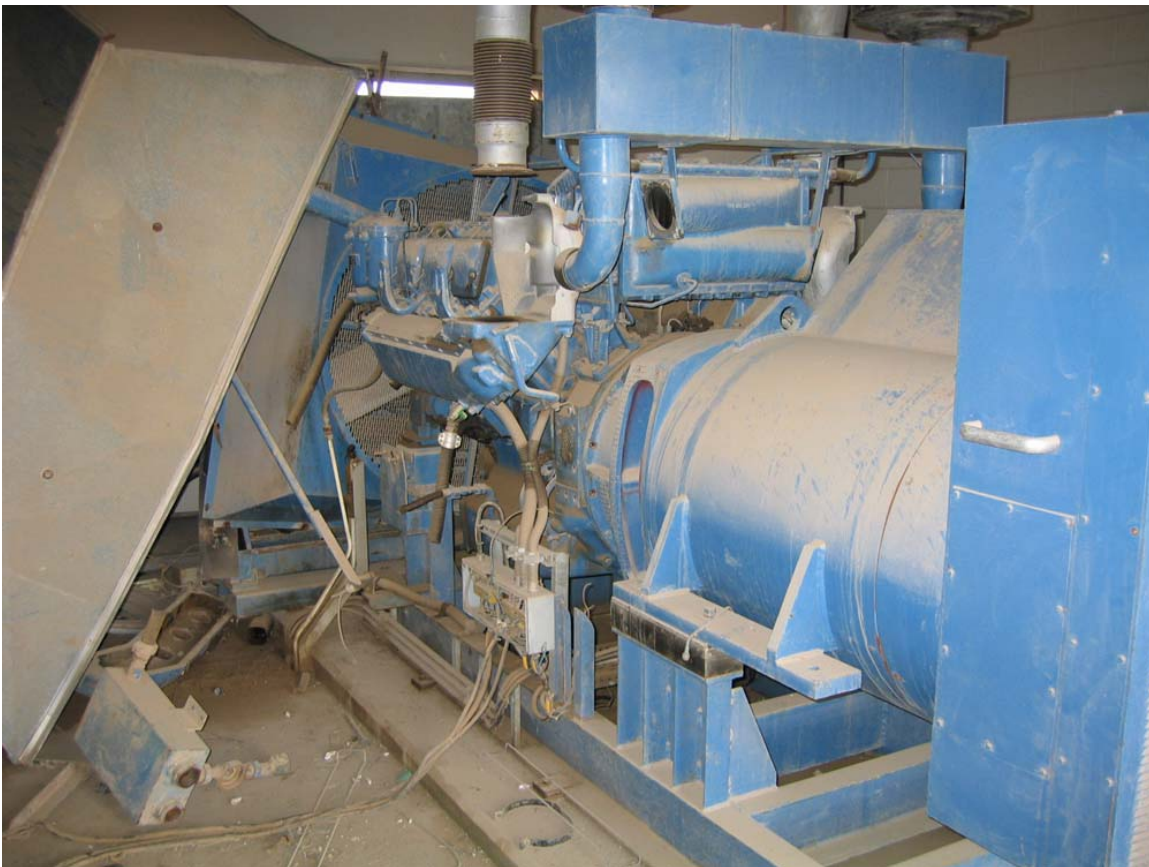
Damaged generator set at Field Electrical Centre

- The Field Electrical Centres (FECs) at end runway end have been damaged with the lighting control cabinets, switchgear, standby generators and regulators (CCRs) all vandalized. We understand that the CCRs that originally were supplied for the AEG lighting system were removed and sent to Baghdad a few years ago. The existing units are over 30 years old and their coils have been removed for copper content. The FEC buildings are in good condition with only

minor door and air-conditioning units requiring replacement. However all other internal electrical components will require replacement.

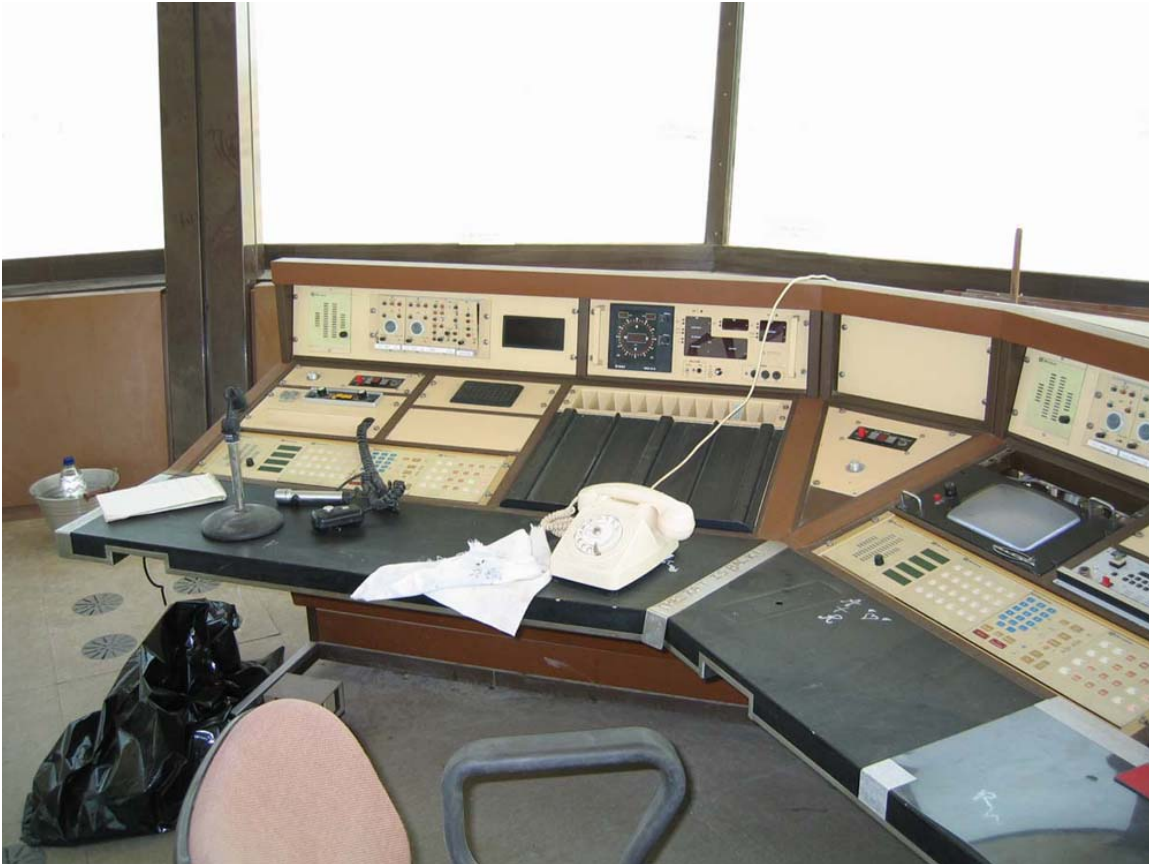
The equipment, including consoles, switches and recorders was assessed as extremely antiquated and all was unserviceable. The Iraqi SATCO who was interviewed during the assessment explained that due to the imposition of sanctions, the majority of the equipment had not been maintained due to an inability to obtain spares.

Control tower - consoles

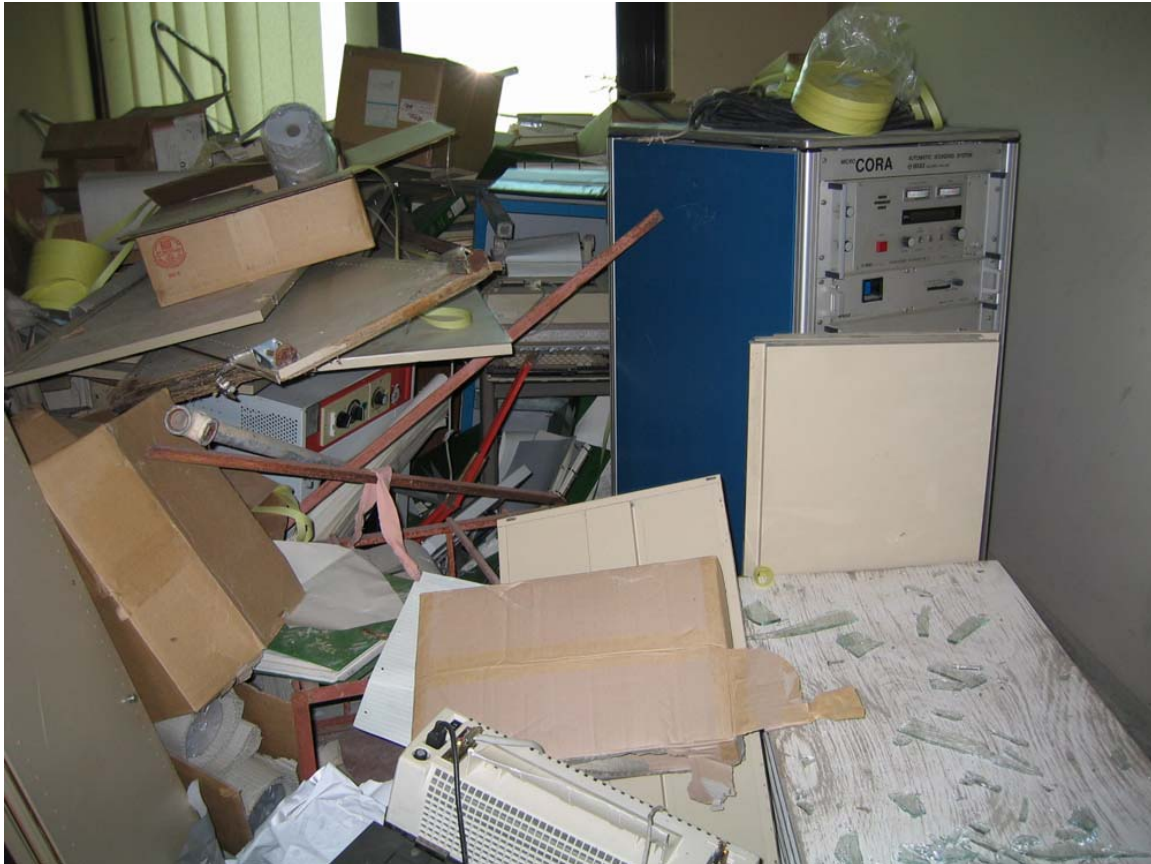
The meteorological building complex located west of the radar site is in relatively good structural condition. The rooms have been looted and equipment has been damaged or removed, but there is no major damage to the MET building envelope, observation room or the upper level balloon launching building.

Evidence of looting at the Met Office

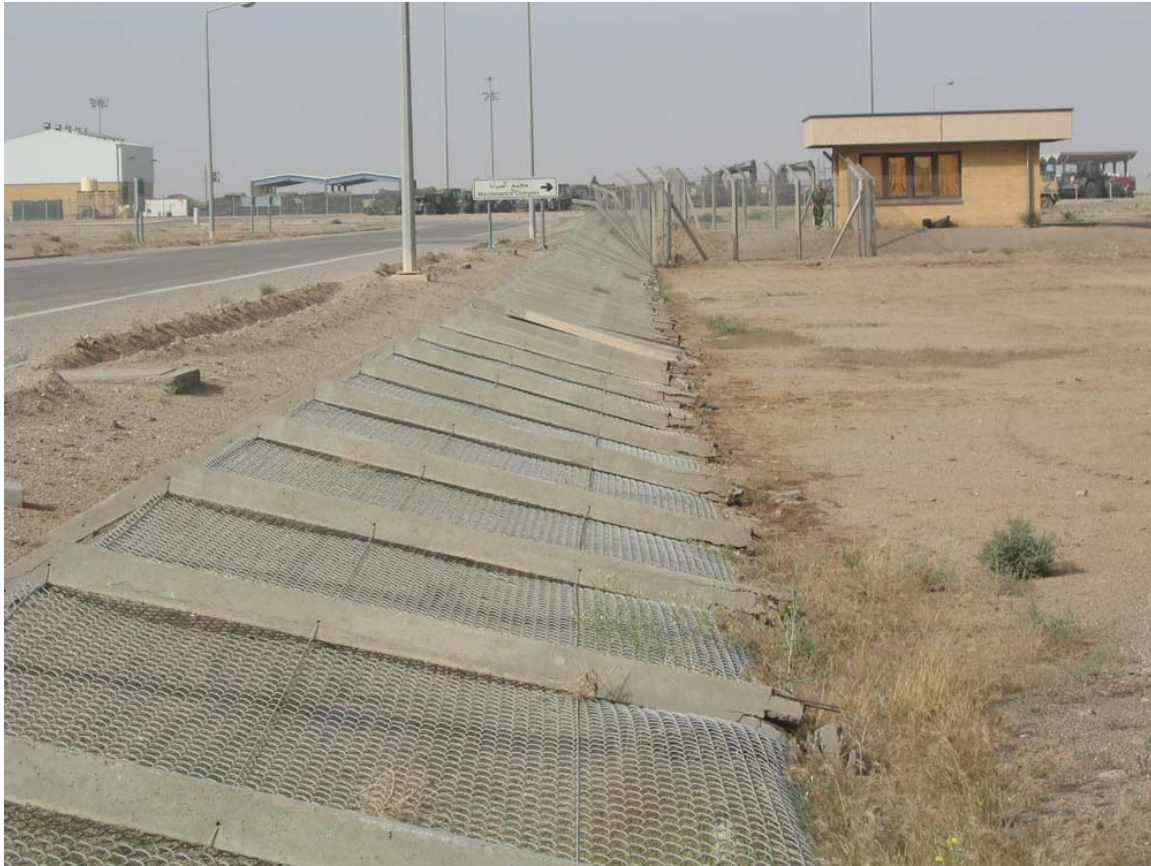
The overall airport property encompasses approximately 2300 hectares (5687 acres) and is full enclosed by a chain link security fence topped with three strands of barbed wire. (All the concrete posts are deteriorating at the ground line due to chemical attack by the salt-laden soils.)

A chain link fence with 3-barbed wire top strands, all supported by reinforced concrete posts provided the airport security. The concrete post reinforcing steel, where buried, has deteriorated from the salts of the original salt marsh to the extent that whole fence runs have collapsed or are in danger of collapsing. To maintain security, the concrete posts will have to be replaced by new posts reinforced by epoxy coated or galvanized reinforcing steel or just galvanized steel pipe posts. The later would be preferable from timing prospective. The top barbed strands could also be supplemented with coiled razor wire to provide better security protection.

Security fence posts damaged by salt attack
