# **Final Report No. 2156 of the Swiss Accident Investigation Board SAIB**

concerning the accident involving the  
C525 aircraft, registration HB-VOV

on 16 February 2011

at Grenchen regional airport (LSZG)

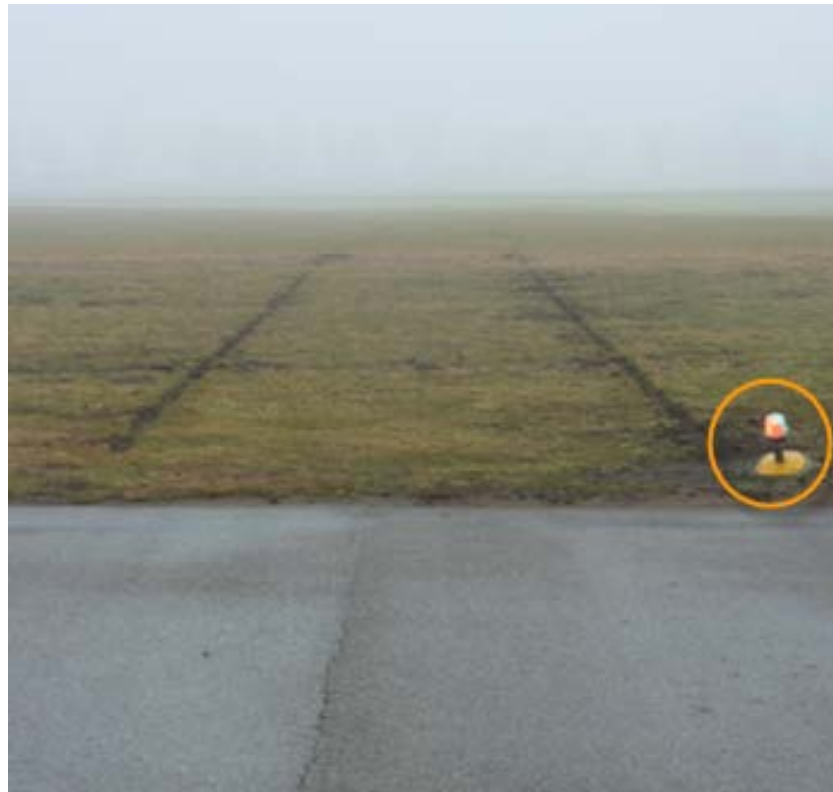
**Figure 1:** View in the direction of departure at the end of runway 07. In the foreground on the right: the end-of-runway light which was struck (circled in orange).

As a result of the collision of the right main landing gear of HB-VOV with the end-of-runway light and the subsequent crossing of the stream bed, structural damage was found in the area of the nose gear and main gear, as well as to both rear wing spars. Also, a certain asymmetry was ascertained in the dimensions of the aircraft.

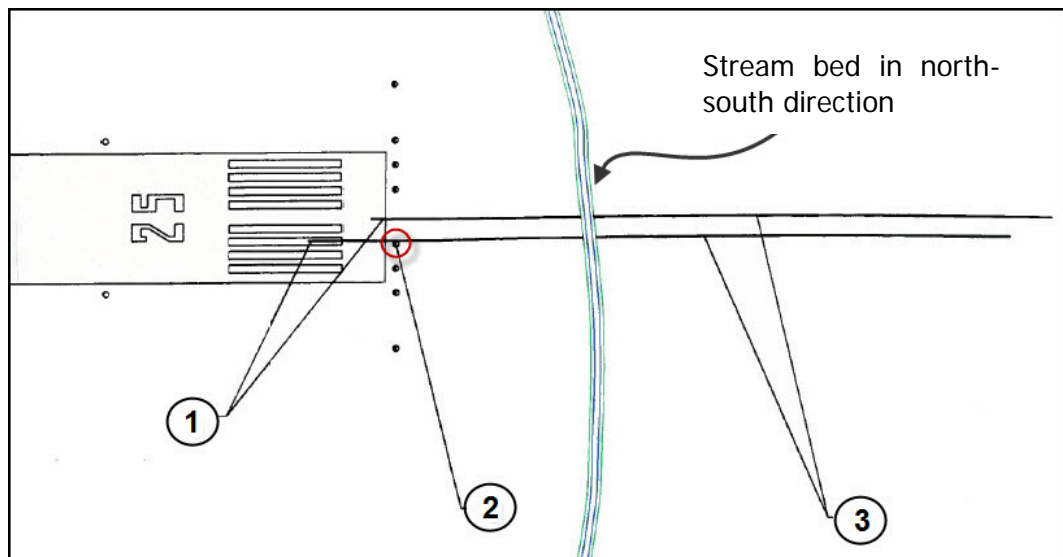
**Figure 2:** Adjacent meadow beyond the end of runway 07 at Grenchen regional airport. 1: Traces of blocked brakes shortly before the end of runway 07 with a length of 2.6 m and 13.6 m respectively; 2: damaged end-of-runway light; 3: tracks in the adjacent meadow with a total length of approximately 118 m and 110 m respectively. After almost 40 metres, a small stream bed runs from north to south.

Based on the severe damage of the aircraft and the marks at the end of the runway it can be concluded, that the take-off was successful only by chance and could have lead just as well into a catastrophe.

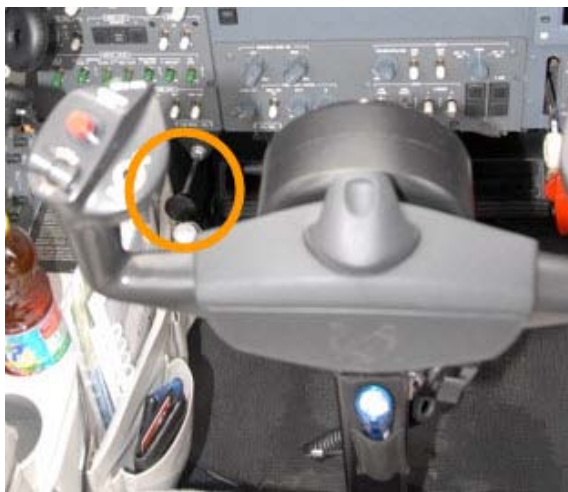
**Figure 3:** The actuating lever for the parking brake is located left of the commander's control column (circled in orange).

The commander also stated that the actuating lever of the parking brake was not easy to identify from his seat (cf. Figure 3 and Figure 4). To see this, he would have had to bend forward or move his left knee to the right towards the control column.

The fact that the visibility of the actuating lever for the parking brake was reportedly difficult for both crew members to see, together with the absence of a warning if a take-off is initiated with the parking brake set, led in the present case to the fact that the set parking brake remained unnoticed during the take-off roll.

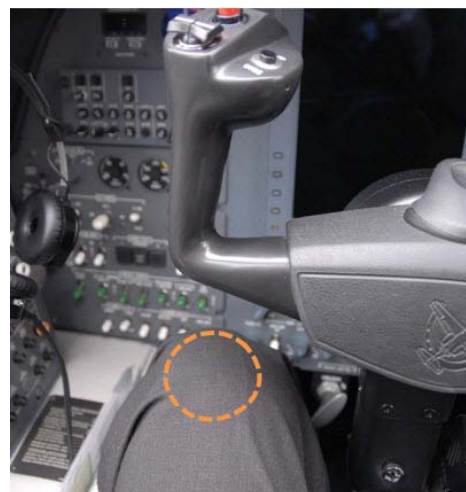
**Figure 4:** The actuating lever of the parking brake is concealed by the commander's left knee.

The copilot stated the actuating lever of the parking brake was not easy to identify from his seat; he would have had to bend forward and turn his head to the left.
