WARRANTY BULLETIN

WB15-19G

SUBJECT: BITZER A/C COMPRESSOR VIBRATION -

ADDITION OF A REINFORCEMENT BRACKET

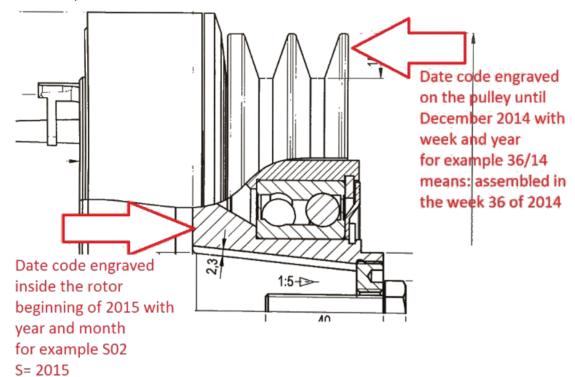
Date code engraving location has changed beginning of 2015 (image below).

10.5. Check the date code on the clutch pulley. If it is before S05 (May 2015), install a new coil #950533 in replacement of this one.

10.6. IF CLUTCH DOES NOT HAVE A DATE CODE, OR CODE FORMAT IS DIFFERENT FROM BELOW, DO NOT REPLACE THE COIL

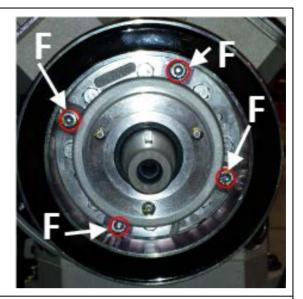
Caution: Pay attention to the precise seat of the coil. A non-observance may cause the destruction of the clutch components during operation.

18. Reinstall the electromagnetic clutch coil. Position cable lead on the right side. Slip the coil on the retainer on the compressor flange. Fasten the coil with 4 screws to the compressor.

Coil mounting screws (**F**): **22 lbf-ft** (30 N-m). *Use blue Loctite 243.*

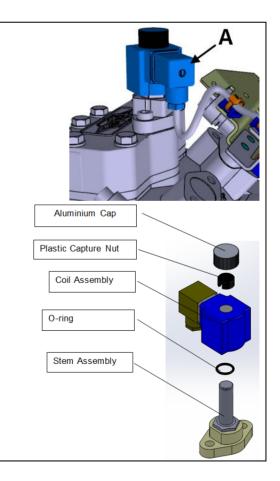
A new "clip-on" type unloader coil must be installed in order to avoid unloader failure.

- Loosen the screw securing the connector to the coil and then unplug the connector (A).
 Keep the screw and the connector rubber gasket for later use.
- 2. Unscrew the aluminum cap and discard.
- 3. Remove the plastic capture nut and discard.
- 4. Remove the coil and discard
- 5. **Keep the O-ring** on the stem.
