Service Information Bulletin

SUBJECT	DATE
SPN 3509 (ACM) (GHG17) SPN 3510 (ACM) (GHG17)	October 2016

Publication Number / Title	Platform	Section Title	Change
DDC-SVC-MAN-0191	GHG17 DD Platform	SPN 3509/FMI 3 - GHG17	Updated GHG17 procedures with new graphics.
		SPN 3509/FMI 4 - GHG17	
		SPN 3510/FMI 3 - GHG17	
		SPN 3510/FMI 4 - GHG17

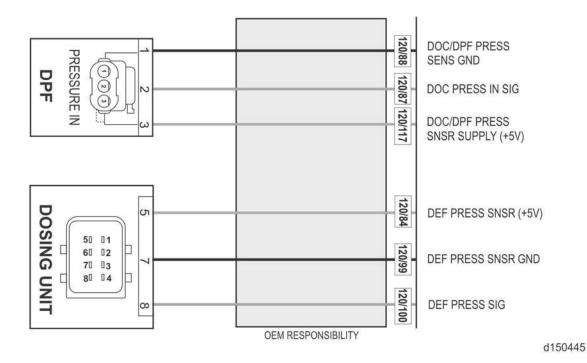
The 5V Sensor Supply Bank 1 Circuit Failed High

NOTE: Additional faults SPN 3610/ FMI 3 Diesel Particulate Filter (DPF) Outlet Pressure Circuit Failed High and SPN 3609/FMI 3 DPF Inlet Pressure Circuit Failed High may also be present.

- 1. Turn the ignition ON (key ON, engine OFF).
- 2. Disconnect the Diesel Oxidation Catalyst (DOC) inlet pressure sensor connector.
- 3. Inspect the sensor harness for bent, spread, or corroded pins. Is any damage present?
 - a. Yes; repair as necessary.
 - b. No; Go to step 4.

- **4.** Measure the voltage between pin 3 on the harness side of the DOC inlet pressure sensor connector and ground. Is voltage greater than 5.5 volts?
 - a. Yes; repair the short to battery between pin 3 of the DOC inlet pressure sensor connector and pin 117 of the ACM 120-pin connector.
 - b. No; repair the short to battery between pin 1 of the DOC inlet pressure sensor connector and pin 88 of the ACM 120-pin connector.

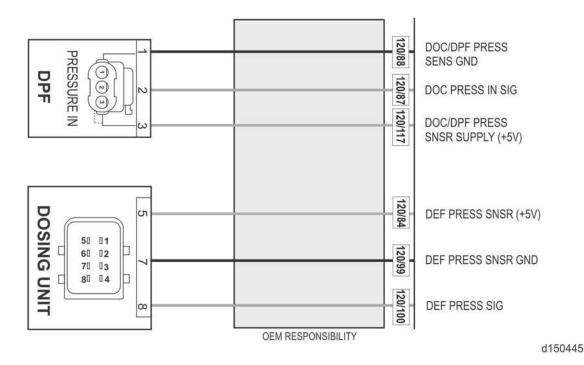
The 5V Sensor Supply Bank 1 Circuit Failed Low

- 1. Turn the ignition OFF.
- 2. Disconnect the Diesel Oxidation Catalyst (DOC) inlet pressure sensor connector.
- 3. Inspect the sensor harness for bent, spread, or corroded pins. Is any damage present?
 - a. Yes; repair as necessary. Verify repairs.
 - b. No; Go to step 4.
- 4. Disconnect the ACM 120-pin connector.
- 5. Measure the resistance between pin 3 on the harness side of the DOC inlet pressure sensor connector and ground. Is the resistance less than 1k ohms?

- a. Yes; repair the wire between pin 3 of the DOC inlet pressure sensor connector and pin 117 of the ACM 120-pin connector. Verify repairs.
- b. No; replace the DOC inlet pressure sensor.
 For 1-BOXTM, Refer to section "Removal of the Diesel Oxidation Catalyst Inlet Pressure Sensor". Verify repair

For 2-BOX, Refer to section "Removal of the Diesel Oxidation Catalyst Inlet Pressure Sensor". Verify repair.

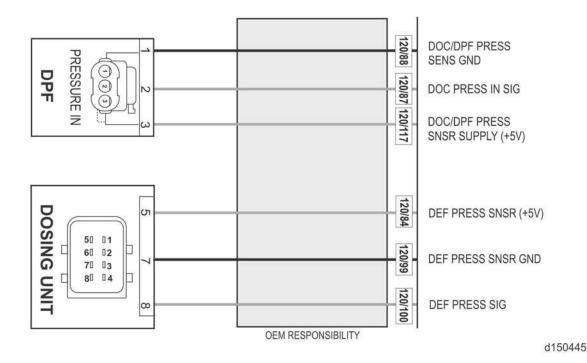
Aftertreatment Control Module 2 Sensor Supply 2 Short to Battery

- 1. Turn the ignition ON (key ON, engine OFF).
- 2. Disconnect the Diesel Exhaust Fluid (DEF) dosing unit electrical connector.
- 3. Inspect the DEF dosing unit harness for bent, spread, or corroded pins. Is any damage present?
 - Yes; repair as necessary. Verify repairs.
 - b. No; Go to step 4.
- 4. Measure the voltage between pin 5 on the harness side of the DEF dosing unit connector and ground. Is the voltage greater than 5.5 volts?
 - a. Yes; repair the short to battery between pin 5 of the DEF dosing unit connector and pin 84 of the Aftertreatment Control Module (ACM) 120-pin connector. Verify repairs.

b. No; repair the short between pin 7 of the DEF dosing unit connector and pin 99 of the ACM 120-pin connector. Verify repairs.

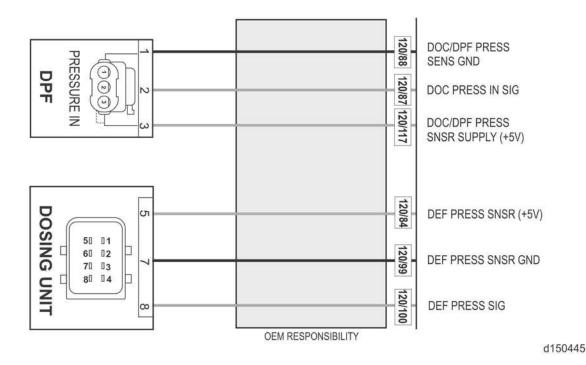
Aftertreatment Control Module 2 Sensor Supply Bank 2 Short to Ground

- 1. Turn the ignition OFF.
- 2. Disconnect the Diesel Exhaust Fluid (DEF) dosing unit electrical connector.
- 3. Inspect the DEF dosing unit harness for bent, spread, or corroded pins. Is any damage present?
 - Yes; repair as necessary. Verify repairs.
 - b. No; Go to step 4.
- 4. Disconnect the Aftertreatment Control Module (ACM) 120-pin connector.
- 5. Measure the resistance between pin 5 on the harness side of the DEF dosing unit connector and ground. Is the resistance less than 1K ohms?

- a. Yes; repair the wire between pin 5 of the DEF dosing unit connector and pin 84 of the ACM 120-pin connector. Verify repairs.
- b. No; replace the DEF doser unit.
