LR Door Seal Improvements LR, LRBE

FSB 845-003, LR Door Seal Improvement

(January 2022).

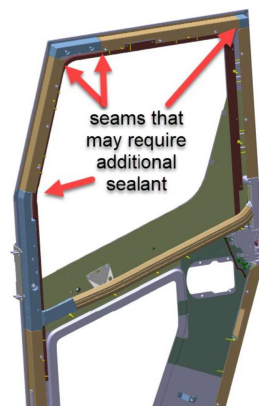
C8180009

Sealant locations as seen in the graphic. Same locations on right and left door (right side door shown for reference).

If additional sealant is required use 3M 540 Polyurethane Sealant. Follow directions on the product packaging for best results
