Bulletin No.: PIT5899

PIT5899 Diagnostic Tip for Back-up Camera, Back-up lamps and/or Vanity lamps inoperative

Brand:	Model:	Model Years:	VIN:		Engine:	Transmissions:
			from	to		
Buick	Encore	2014 - 2019	All	All	All	All
Chevrolet	Trax	2014 - 2019	All	All	All	All

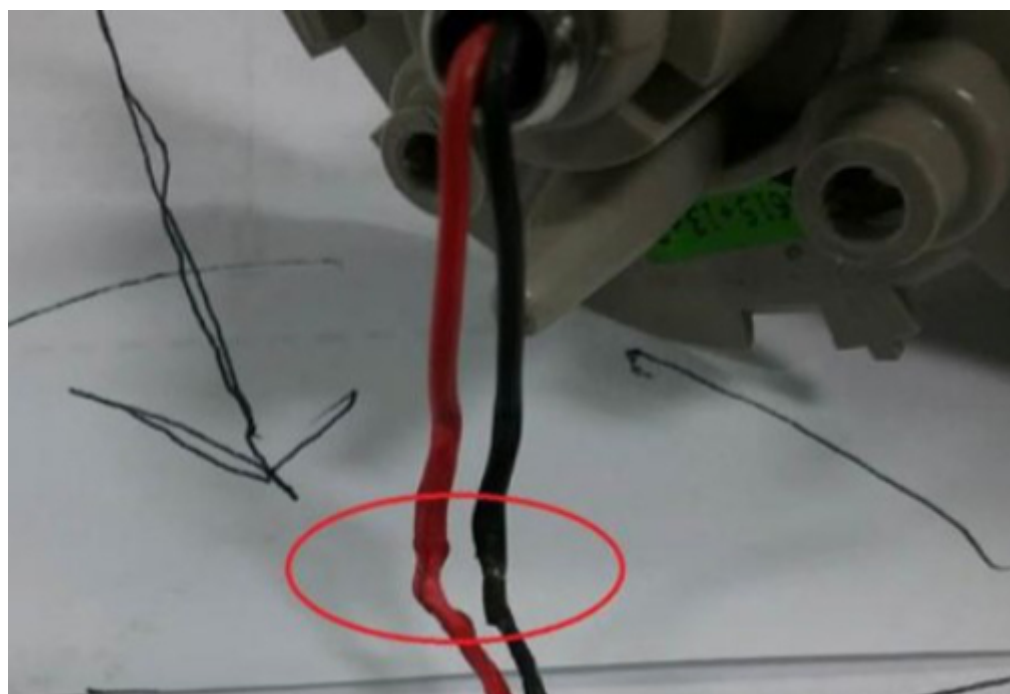
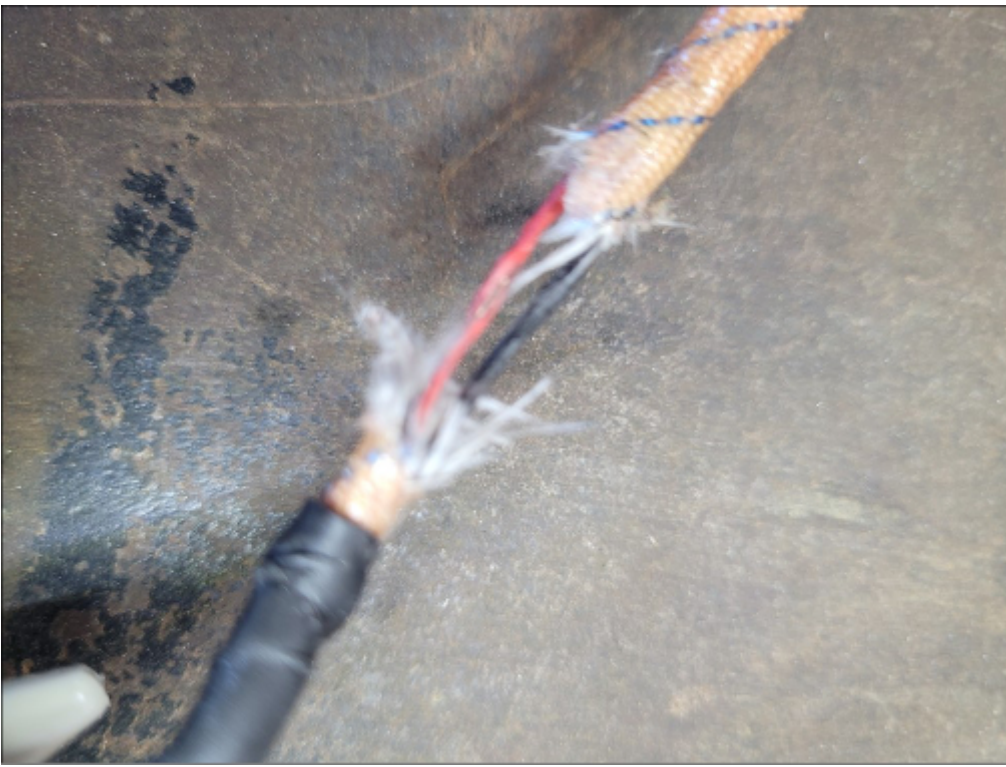
Involved Region or Country	North America
Additional Options (RPO)	UVC
Condition	Some customers may notice that back-up camera, back-up lamps and/or vanity lamps are inoperative. Technicians may find any of the following DTC's B127B, B133B or B2545
Cause	This may be caused by an open fuse F6DA, which could be caused by the headliner harness or vanity lamp harness being pinched at the either LH or RH sunshade mount.

Dealers should remove both sunshade assemblies and inspect the headliner or sunshade harnesses for being pinched. If harness is pinched, dealers should perform a wire to wire repair as outline in Service Information.
