GROUP	MODEL
ELE	2020-2022MY Sportage (QL)
NUMBER	DATE
299	June 2023

TECHNICAL SERVICE BULLETIN

REAR COMBINATION LAMP INSPECTION AND SOFTWARE UPGRADE

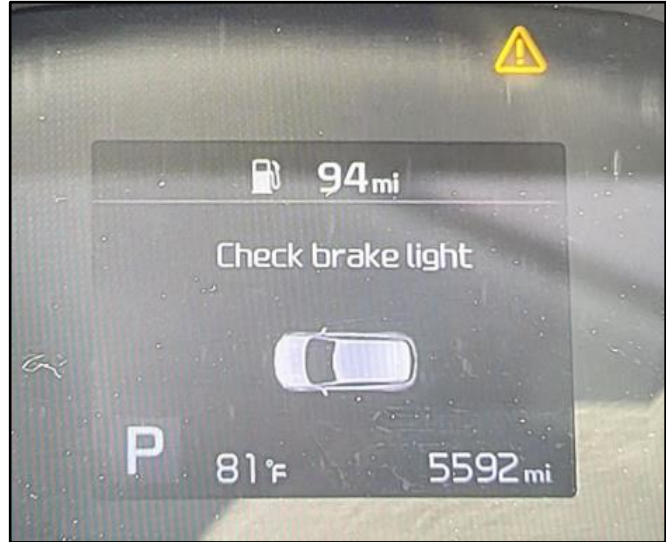
1. Confirm customer concern of the 'Master Warning Light' and/or the "Check brake light" message are displayed on the instrument cluster.

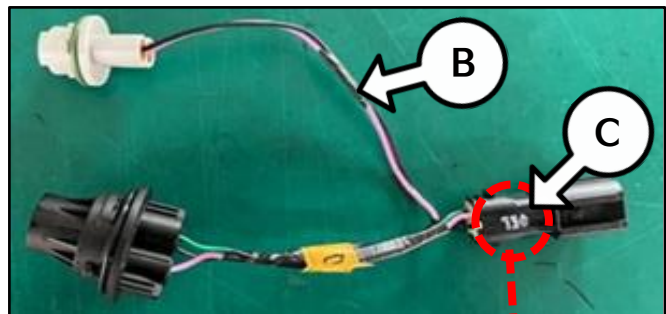
Locate the LOT No. (C) printed on the connector.

- 3a. Remove both left and right rear combination lamp holder and wiring harnesses (B).

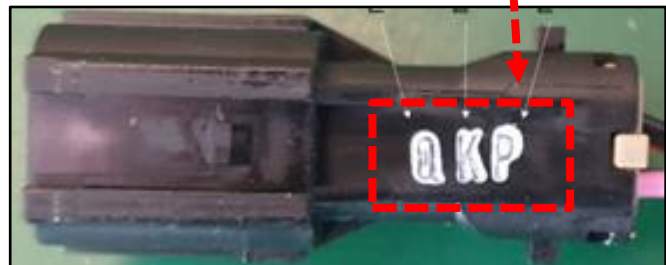
- 3b. Refer to LOT No. Chart on page 3.

- If the LOT No. is **before** April 1, 2019, replace the rear combination lamp holder and wiring harness.
- If the LOT No. is **on or after** April 1, 2019, the rear combination lamp holder and wiring harness does not need to be replaced.

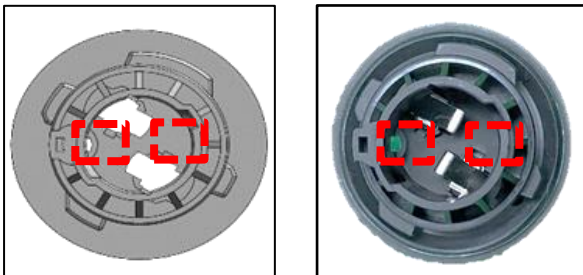
No Bulb Stopper

If the LOT No. is unclear and difficult to read, inspect if the bulb socket is/is not equipped with a bulb stopper.

- If the bulb socket is **not** equipped with a bulb stopper, replace the rear combination lamp holder and wiring harness.
- If the bulb socket **is** equipped with a bulb stopper, the rear combination lamp holder and wiring harness **does not** need to be replaced.
