**UNITED STATES AIR FORCE**  
**GROUND ACCIDENT INVESTIGATION**  
**BOARD REPORT**

**Hazardous Materials Storage Building**  
**18TH LOGISTICS READINESS SQUADRON**  
**18TH WING**  
**KADENA AIR BASE, JAPAN**

**TYPE OF ACCIDENT: FIRE**  
**LOCATION: BUILDING 3150, KADENA AIR BASE, JAPAN**  
**DATE OF ACCIDENT: 22 JUNE 2020**  
**BOARD PRESIDENT: COLONEL DOMINIC A. SETKA, USAF**  
**Conducted IAW Air Force Instruction 51-307**

**Hazardous Materials Storage Building Fire  
Kadena Air Base, Japan  
22 June 2020**

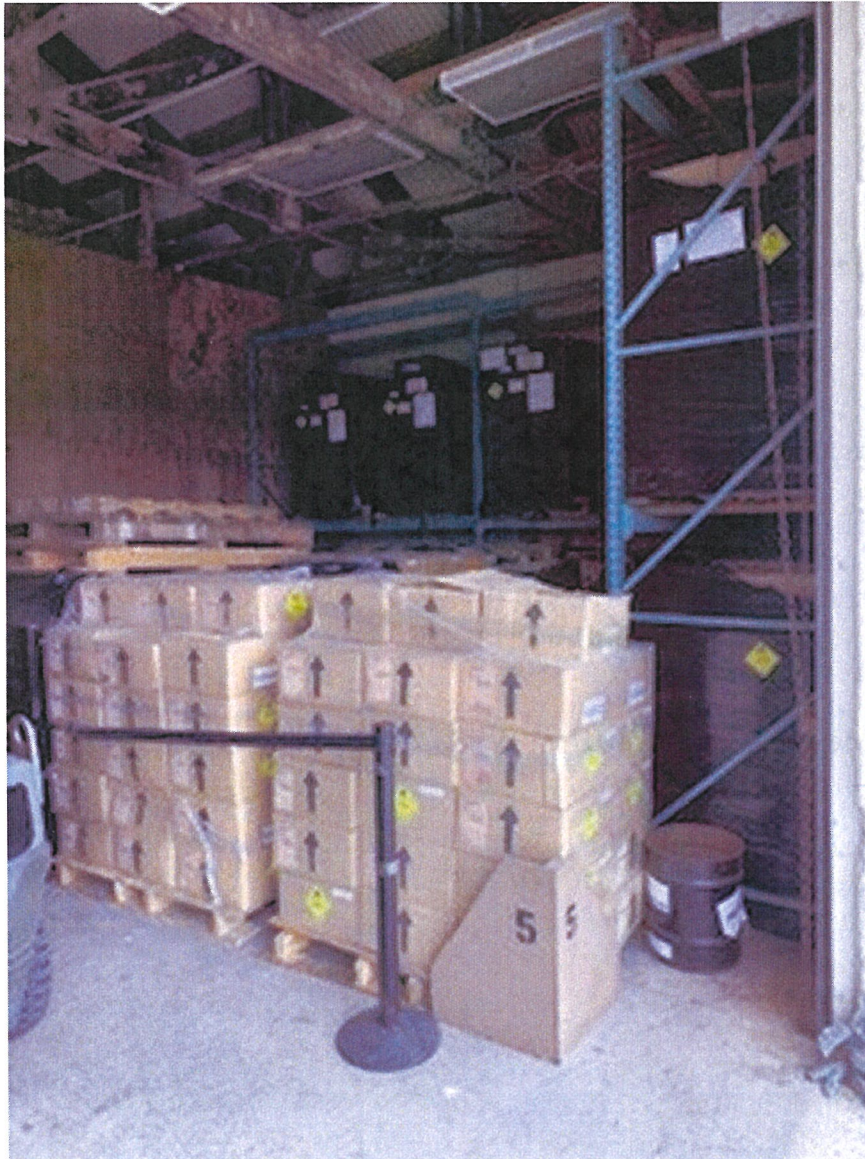
**Figure 1:** Photograph taken in August 2019 depicting CH.  
(Tab S-2)

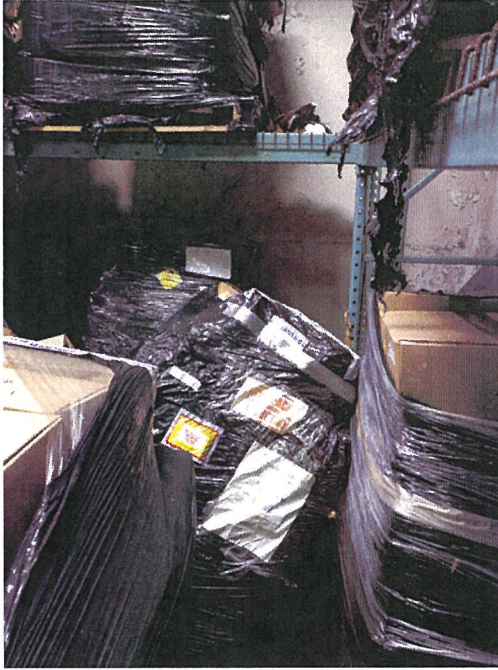
**Figure 2:** CH packages in MB.  
Photograph taken on 1 June 2020.  
(Tab S-6)

As shown in Figures 2, 3, 4, and 5, by June 2020, the plastic wrapping was frayed and torn, the cardboard boxes were disintegrating, bags containing the CH in the MB were breaking open, and loose CH was visible on the concrete floor of the MB (particularly in Figure 5). (Tab R-99) CH was exposed to hot, humid air, and was left on the floor where it risked being exposed to friction from foot traffic. (Tab R-99)

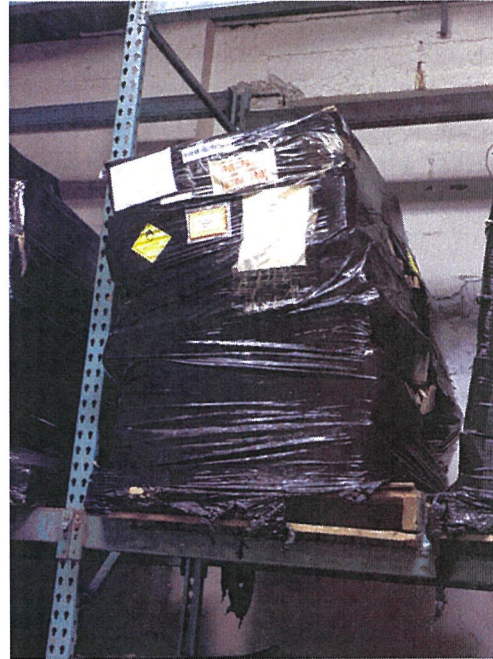
**Figure 3:** CH packages in MB.  
Photograph taken on 1 June 2020.  
(Tab S-17)

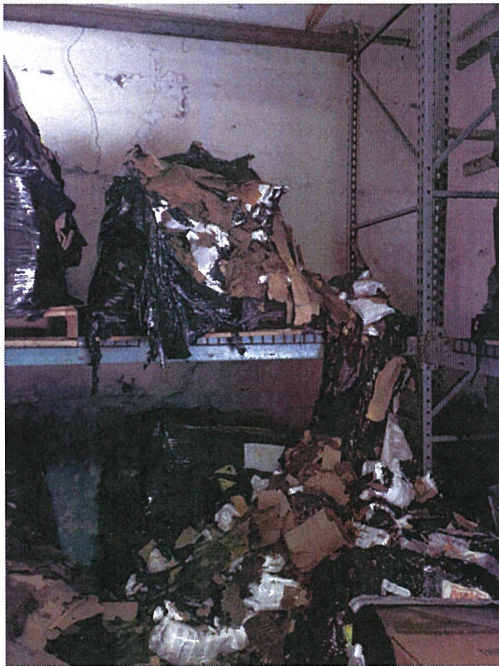
**Figure 4:** CH bags coming out of  
packaging in MB. Photograph taken  
on 10 June 2020. (Tab S-13)

As depicted in Figure 4, some of the packaging and pallets were in a severe state of disrepair. (Tab S-13) Bags of CH had come completely out of their original cardboard and plastic packaging, leaving their contents vulnerable to the heat and humidity of the outside air. (Tab S-13)

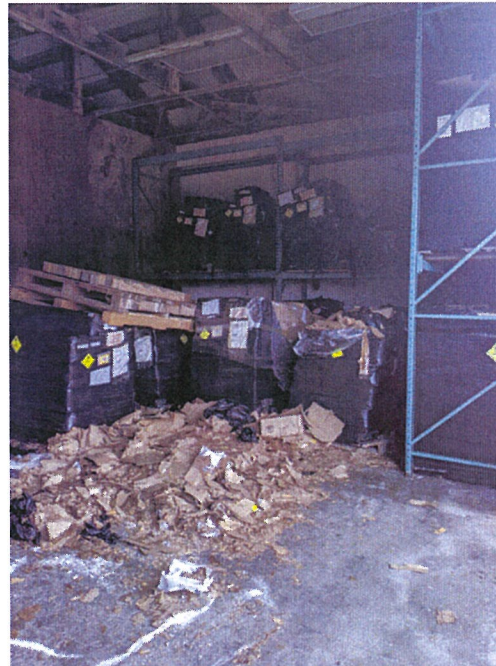
**Figure 5:** CH packages in MB on 11  
June 2020 after repackaging of CH  
that day. Lines of CH visible on floor  
of MB (Tab S-7)

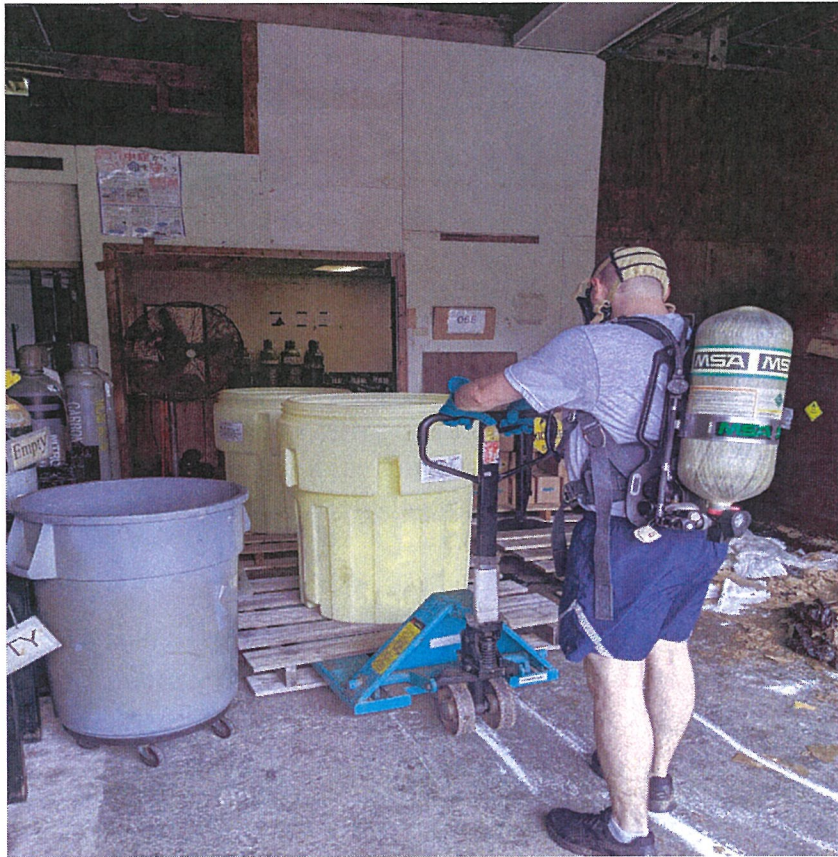
**Figure 6:** EM member moving CH with SCBA on 11 June 2020 at the MB. (Tab S-18)

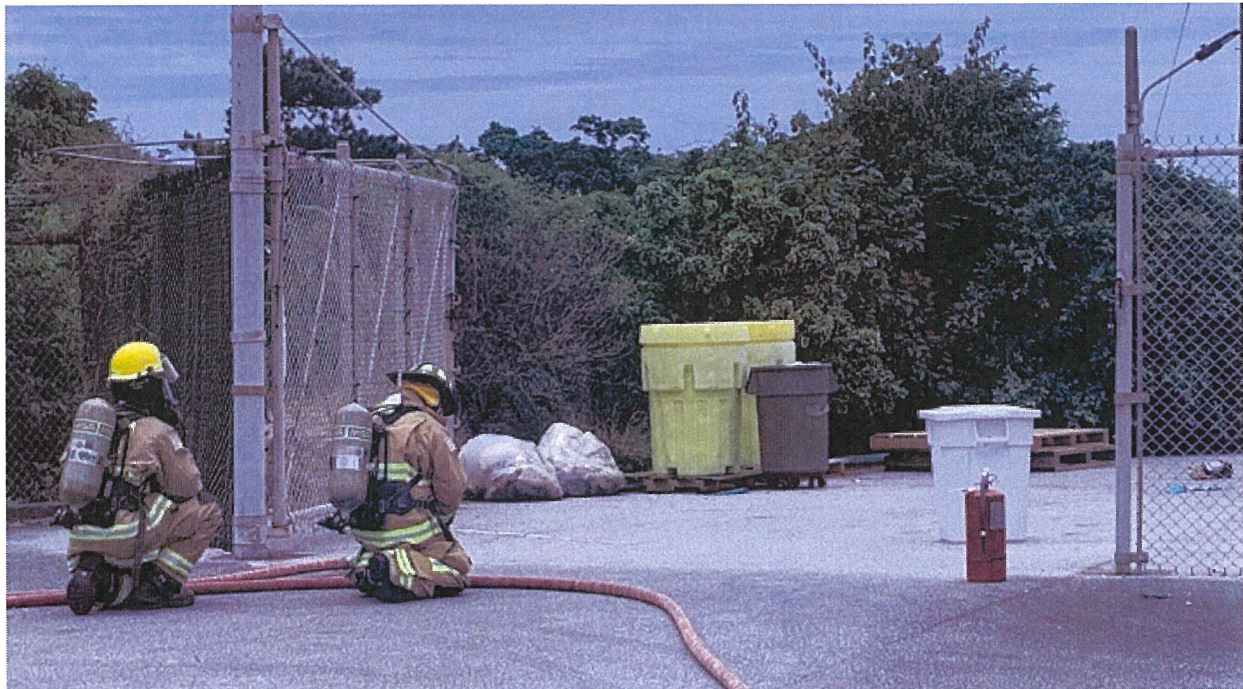
Between approximately 1000L and 1030L, CH granules in the garbage bags began to off-gas, emitting gases that slowly filled the garbage bags. (Tab R-104) One garbage bag in particular started to inflate and emit smoke. (Tab R-79) On seeing this, MW3 stopped operations and moved the team away from the smoking garbage bag. (Tab R-79) At 1150L, MW3 called the Fire

**Figure 7:** Photograph depicting FD response to 11 June 2020 incident. Photograph shows two garbage bags with CH that had been placed to the south of the MB. (Tab Z-11)

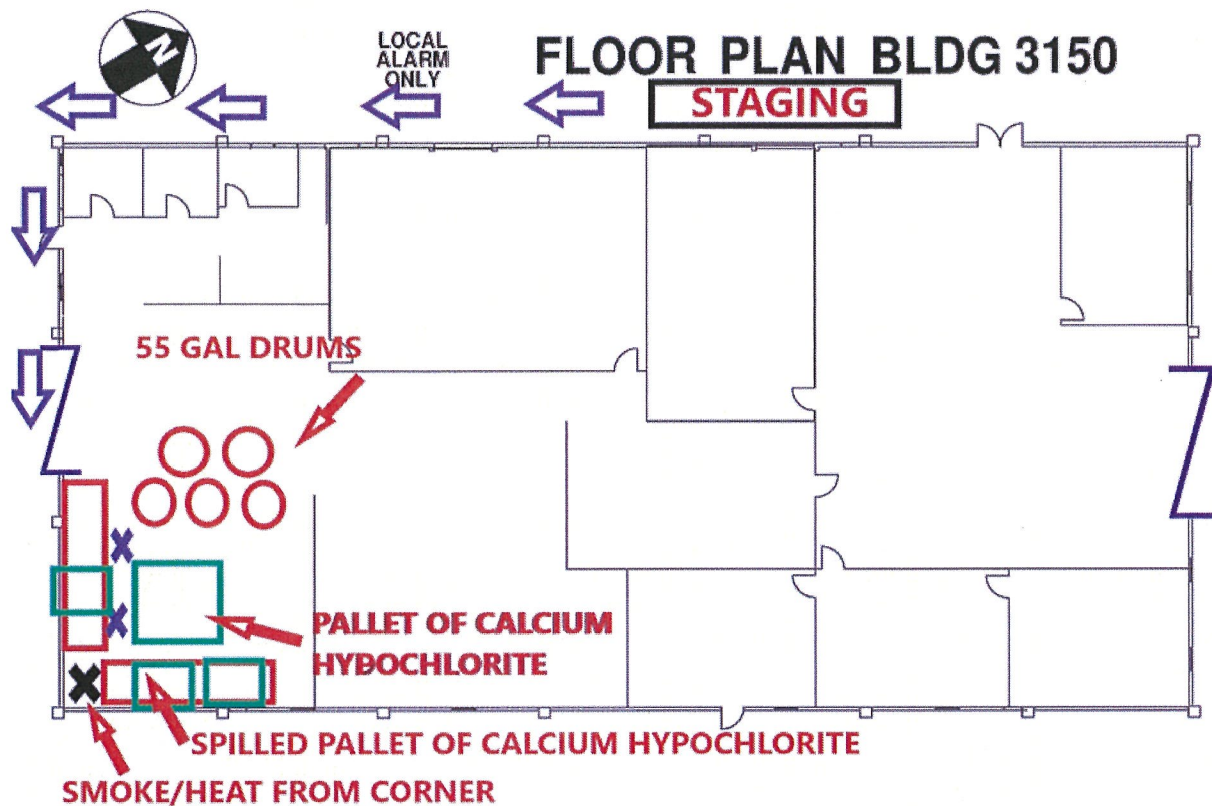
The MT gathered at a staging area outside the north corner of the MB (see Figure 9). (Tab V-3.1 to V-3.2) Entry Team 1 (ET1), consisting of MW2 and MW4, would enter the MB for the first shift while Entry Team 2 (ET2), consisting of MW3 and MW5, waited at the staging area. (Tab V-3.2) After a gear check, ET1 put on their Level B HAZMAT suits and entered the MB through a large rolling door on the south side of the building. (Tab V-3.2) ET1 did not turn on the overhead lights in the MB upon entry. (Tab V-3.5) ET1 began working in the MB at approximately 0707L, moving approximately 286 bags of CH into three plastic barrels and one 55-gallon metal barrel. (Tab R-47 and R-63) Several of the bags of CH were inadvertently breaking open and the cardboard boxes they were in were falling apart to the touch. (Tab R-63)

**Figure 9:** Floor plan of MB with overlaid descriptions based on witness testimony and diagram. (Tab V-3.1 to V-3.6 and V-5)

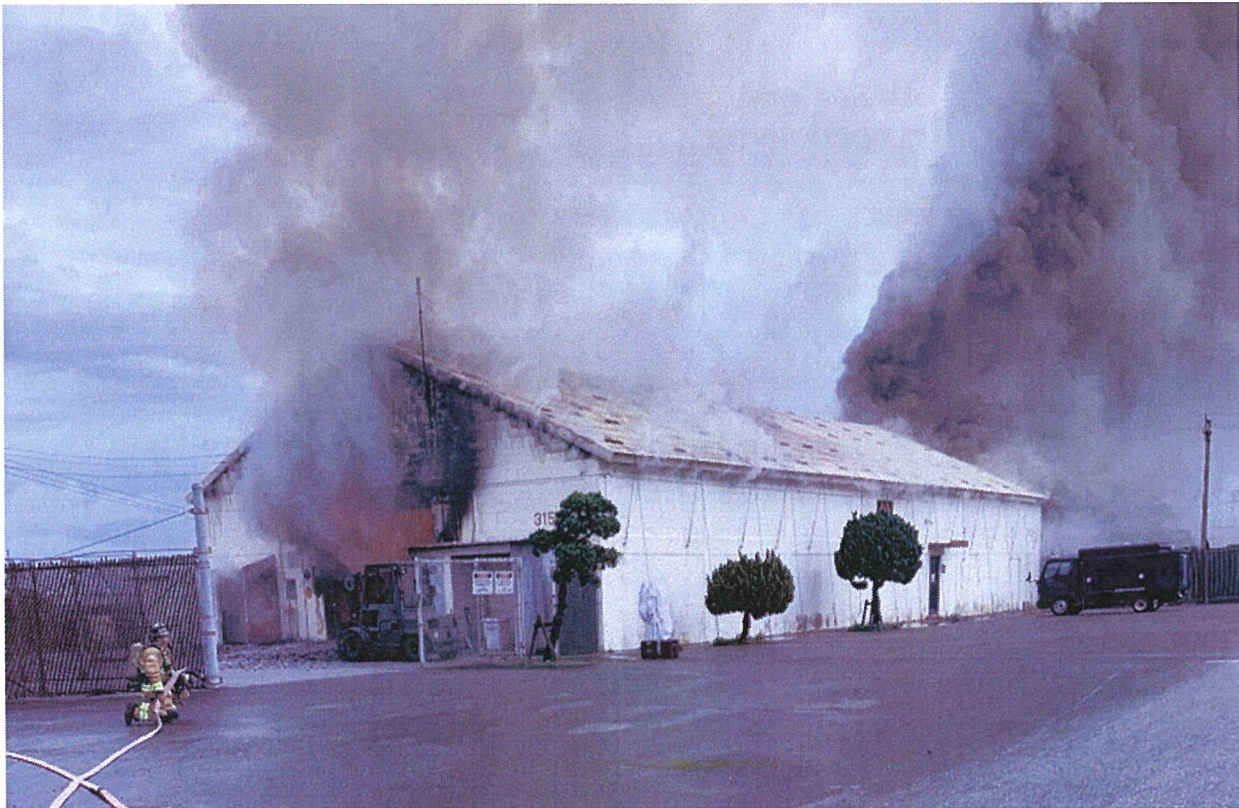
**Figure 10:** Photograph depicting the fire in MB at approximately 0858L on 22 June 2020. (Tab Z-8)

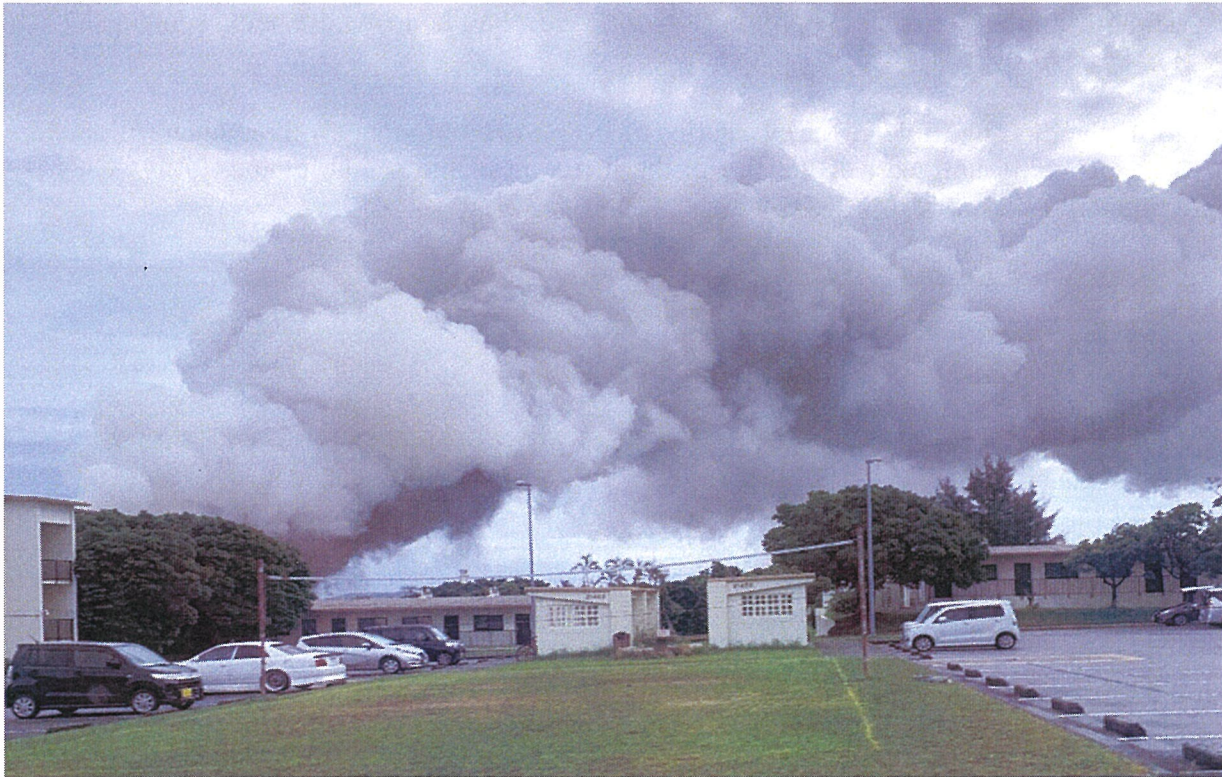
**Figure 11:** Photograph depicting plume drifting northeast from the MB at approximately 0857L on 22 June 2020. (Tab Z-9)

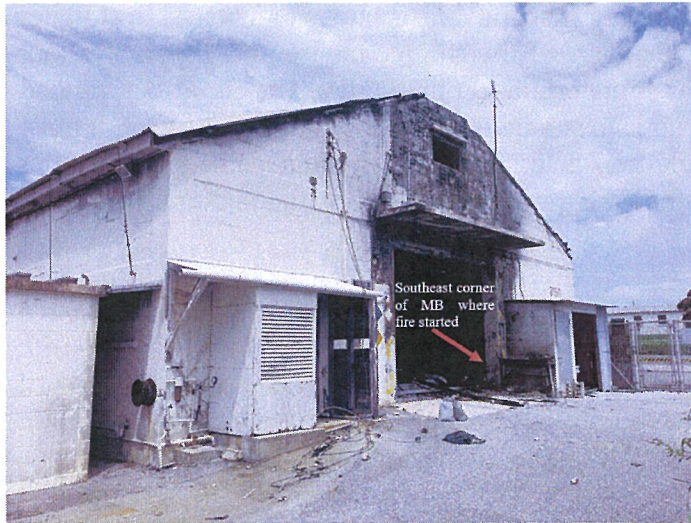
The fire ultimately destroyed the MB, everything stored within it, and any equipment affixed to the MB before responding personnel could extinguish the flames, resulting in an estimated government loss of approximately \$2.6 million. (Tab P-1 to P-2)

**Figure 12:** Photograph taken outside MB on 31 July 2020. (Tab Z-1)

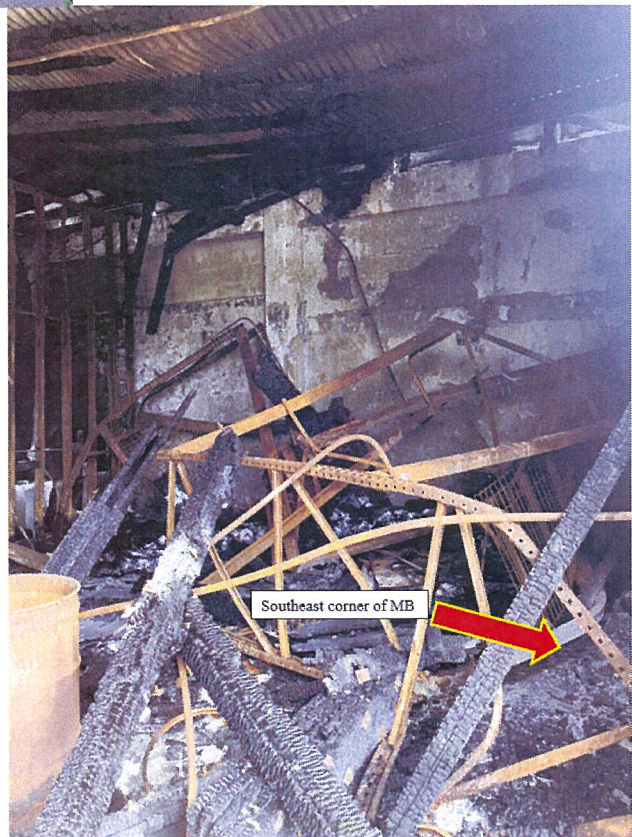
**Figure 13:** Photograph taken inside of MB on 31 July 2020 from south entrance depicting collapsed shelving and remaining metal barrel. (Tab Z-2)

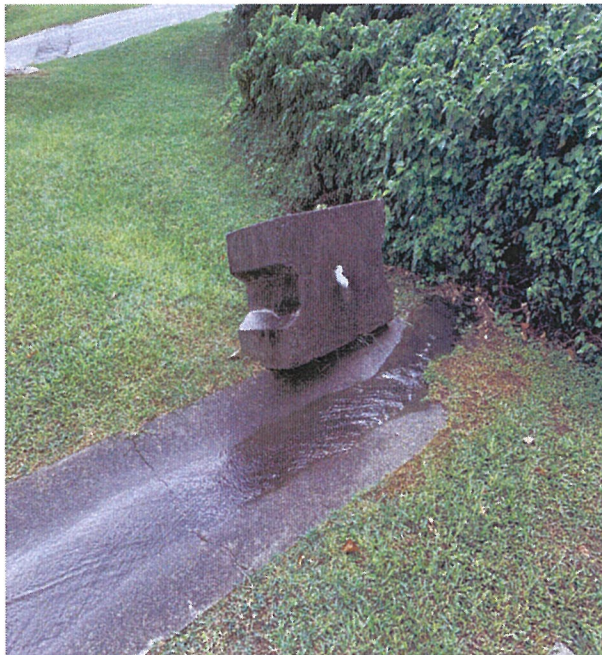
**Figure 14:** Photograph taken during stormwater outfall monitoring on 22 June 2020. (Tab W-23)

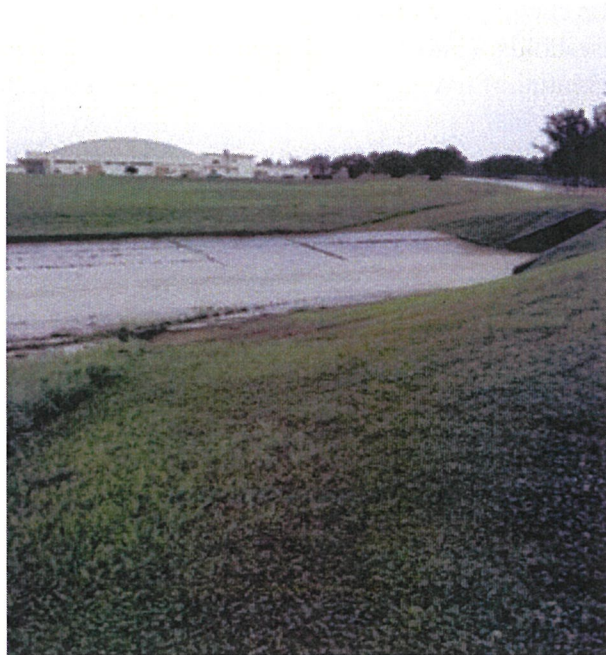
**Figure 15:** Photograph taken during stormwater outfall monitoring on 22 June 2020. (Tab W-20)
