D-5 Report on the Environmental and Social Impact Assessments for the Rehabilitation of the Philip Goldson Highway between Miles 8.5 to 24.5

**Ministry of Works
Belmopan, September 2017**

D-5 Report on the Environmental and Social Impact Assessment

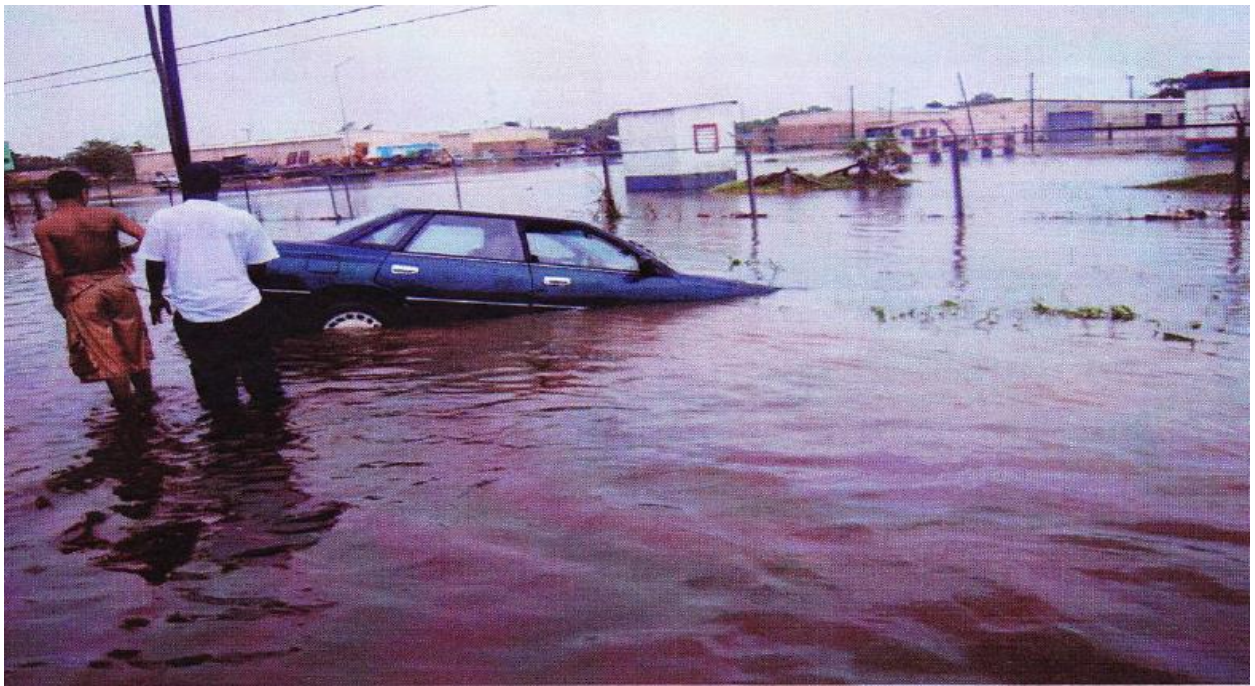
Figure 1.1: Flooded section of the PGH in Ladyville caused by torrential rains associated with a tropical disturbance on August 27, 2007.

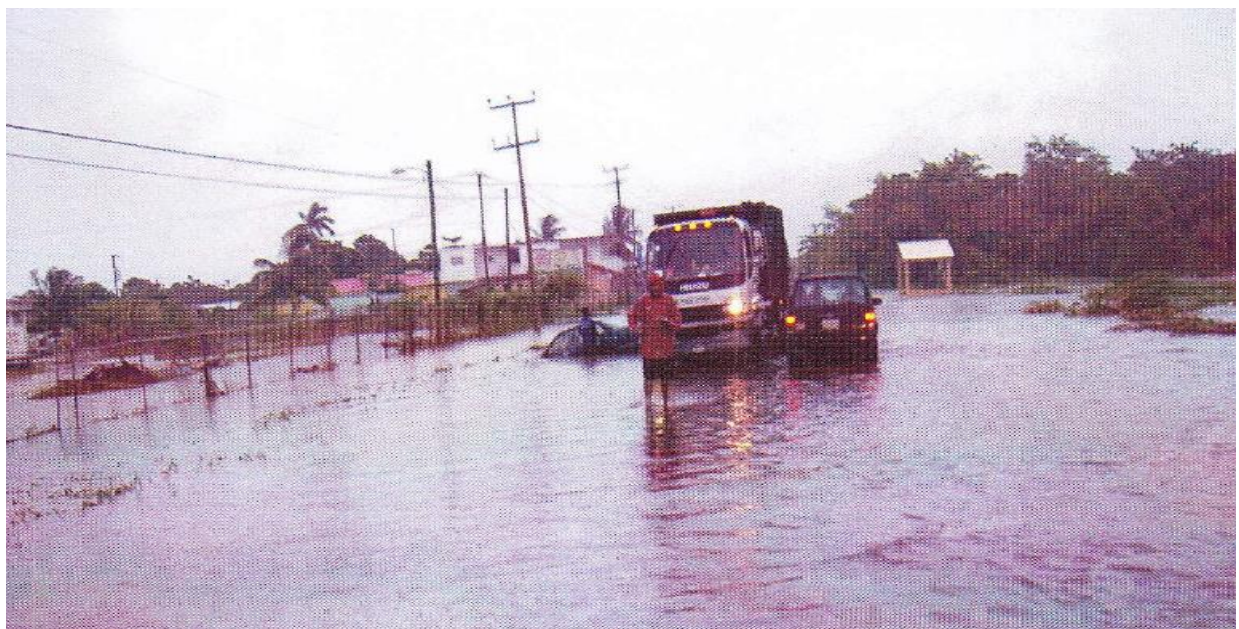
Figure 1.2: Another scene of flooded section of the PGH in Ladyville caused by torrential rains generated by a tropical disturbance on August 27, 2007.

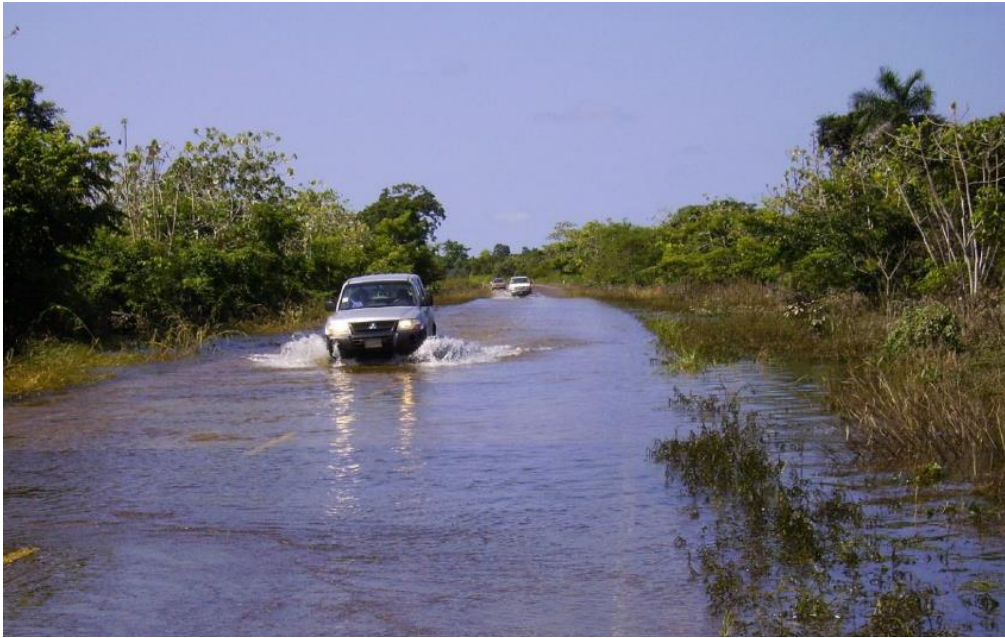
Figure 1.4: Flooded Section of the Burrell Boom Road west of the Boom Bridge during the TD-16 2008 Major Flood Event.

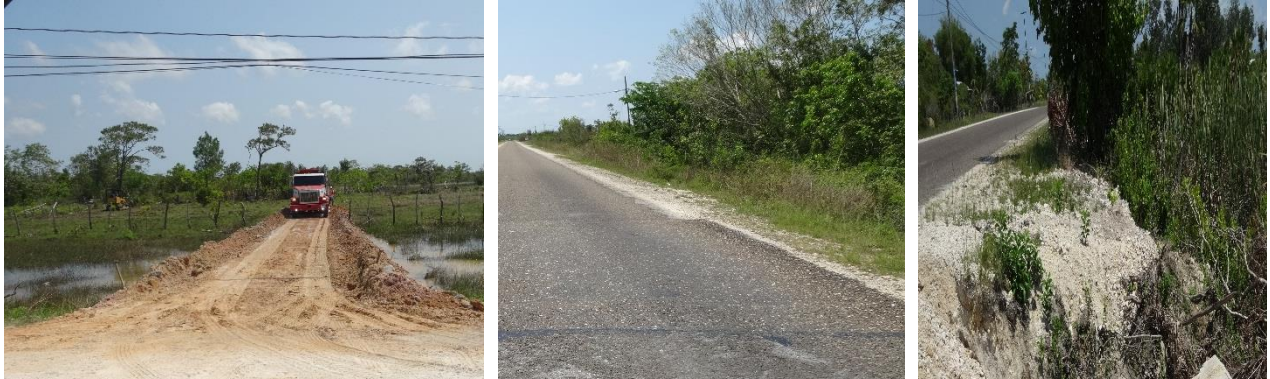
blocked. Water logged areas are being filled up to make provision for development. There is limited provision for channelling water away from the pavement structure. Private developers have in some instances provided longitudinal drains parallel to the PGH but these again have no definite channelization for the removal of the water away from the pavement structure.

Figure 2.3: Longitudinal side drains are overgrown with vegetation and being filled up for new development between the junction of the old Northern Highway with the Philip Goldson Highway up to the Gardenia/Biscayne Village (mile 24.5).

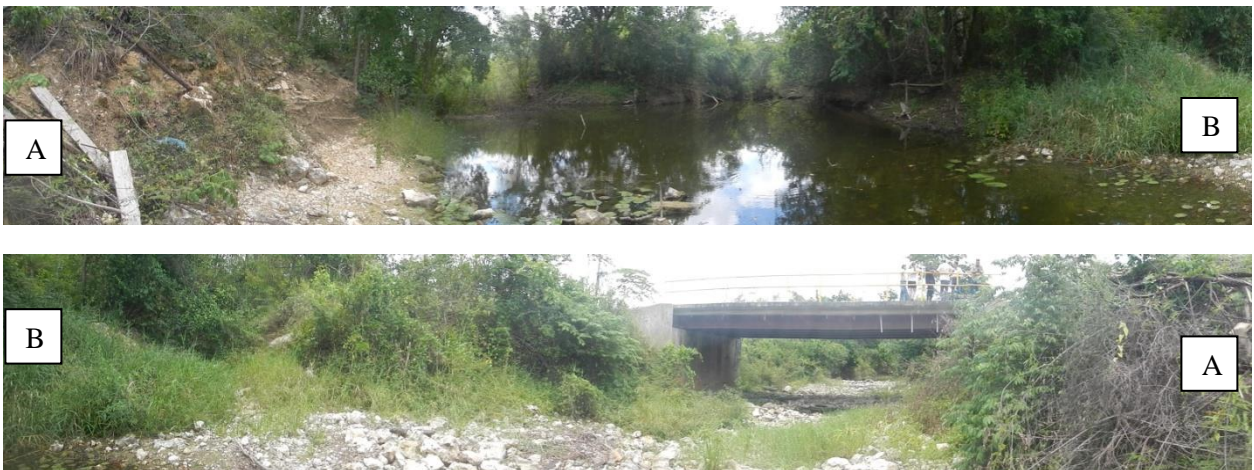
Material that was used either for the temporary bypass or as coffer dams while the bridge was being constructed, was not properly extracted, and now restricts the proper flow of the Mexico Creek affecting the proper draining of the Jones and Mexico Lagoons during the dry season. An assessment of the bridge foundation is recommended to determine whether the imported material on the stream bed can be removed or not without causing any adverse effects such as scouring to the bridge sub-structure proper or the bridge approach (Figure 2.4).

Figure 2.4: AB (North)-Mexico Creek Bridges showing impounded water from Jones Lagoon and BA (South)-dry creek just before Mexico Creek Bridge.

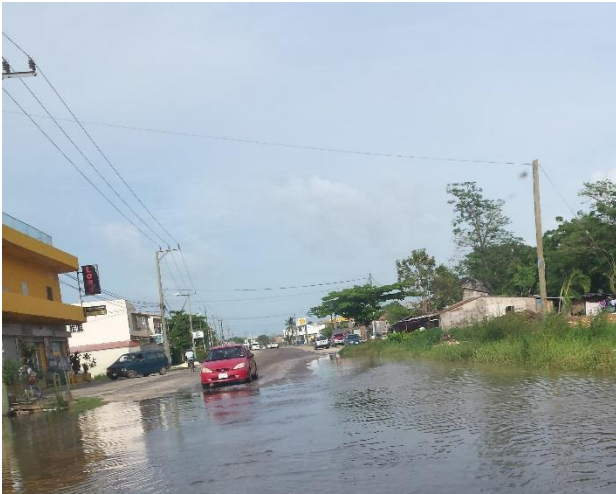
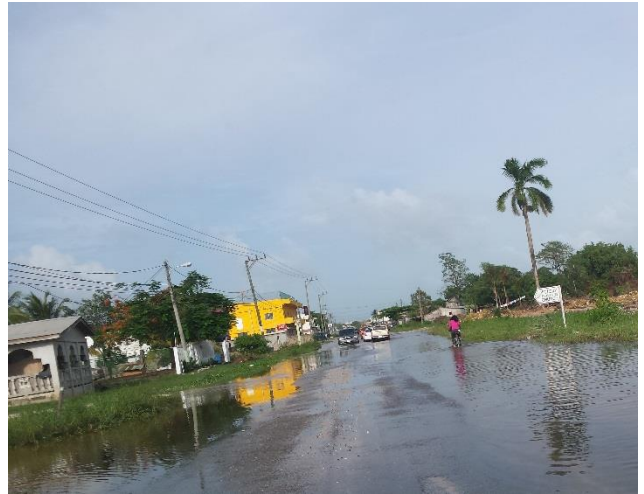
Figure 2.7a: Flooded Ladyville Village section of the PGH in 2016. The filled land is to the left of the second photo.

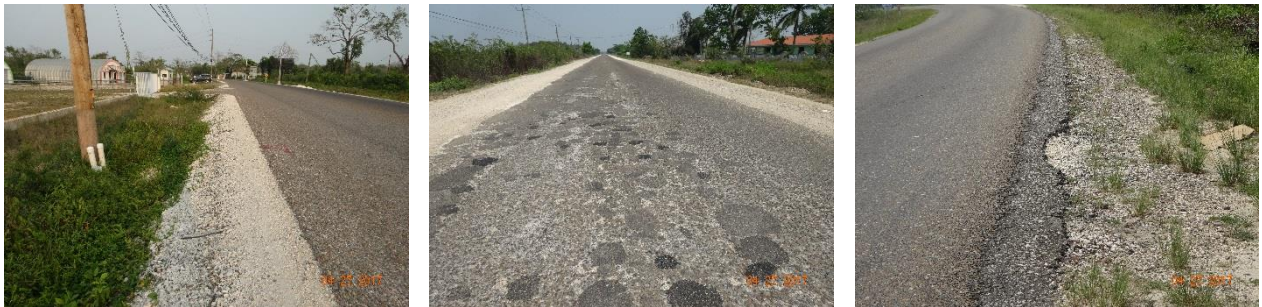
The existing running surface for the most part is in fair to poor conditions with the exception of one mile of pavement structure at the start of the project section which is of recent construction (2016-2017).

Figure 2.8: Pavement surface along Section 1. (Left) Recently surface-dressed pavement with paved shoulders (note no longitudinal side drains); (centre) Pavement in poor condition in the Lagos Community area; (right) Pavement surface in fair conditions with slight surface deformation and broken pavement edges.

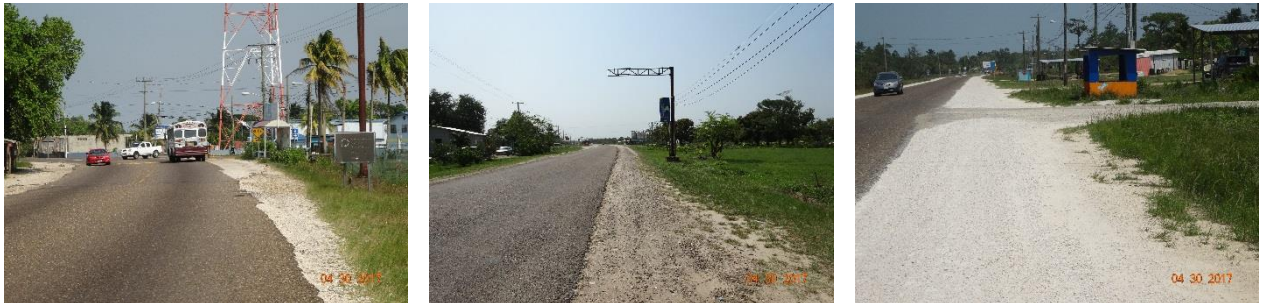
The pavement surface in this project section is considered to be fair.

Figure 2.9: Pavement surface along Section 2. (Left) Pavement near the Burrell Boom junction surface in fair conditions, no paved shoulders no line marking and broken pavement edge; (Center) Pavement in fair condition, shoulder drop in dire need of replenishment, signs are outstanding at the old Northern highway junction; (Right) Pavement surface in fair conditions with recently completed shoulder replenishment works which since is not sealed creates a dust pollution problem.

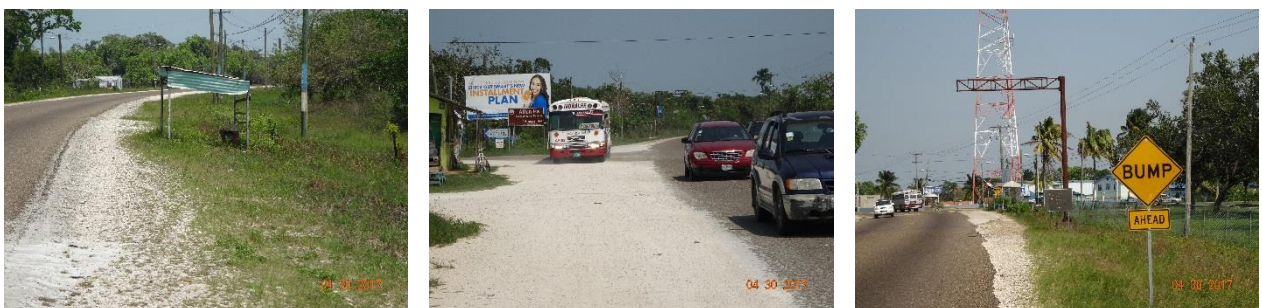
Figure 2.12: (Left) Unauthorized covered bus shed too near the edge of the pavement, creating visibility problem; (Center) public transport using Old Northern Highway access road as bus stop this in the absence of a designated bus lay-bys; (Right) missing directional signs at major intersection of the Burrell Boom road and the PGH.

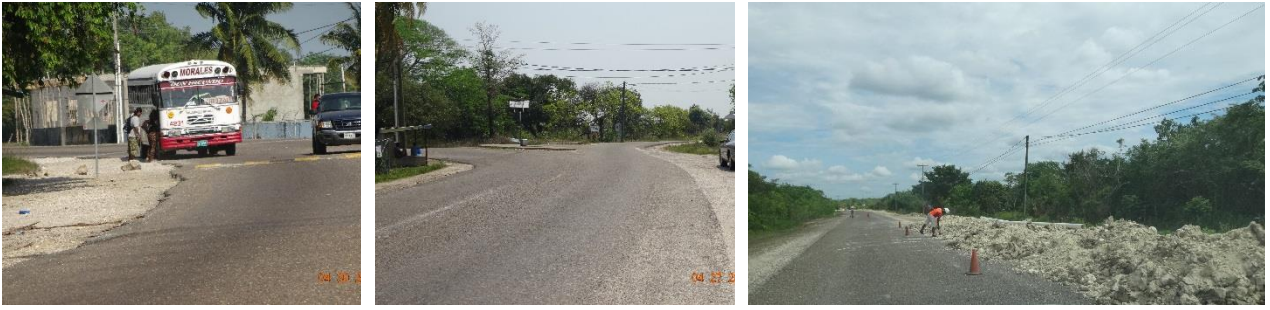
Figure 2.13: (Left) Public transport using the carriageway as a bus stop for the embarkation of passengers; (Center) lack of traffic signs and the need to maintain solar powered caution flashing light; and (Right) no safety signs were noted on this major potable water main installation works along the PGH.

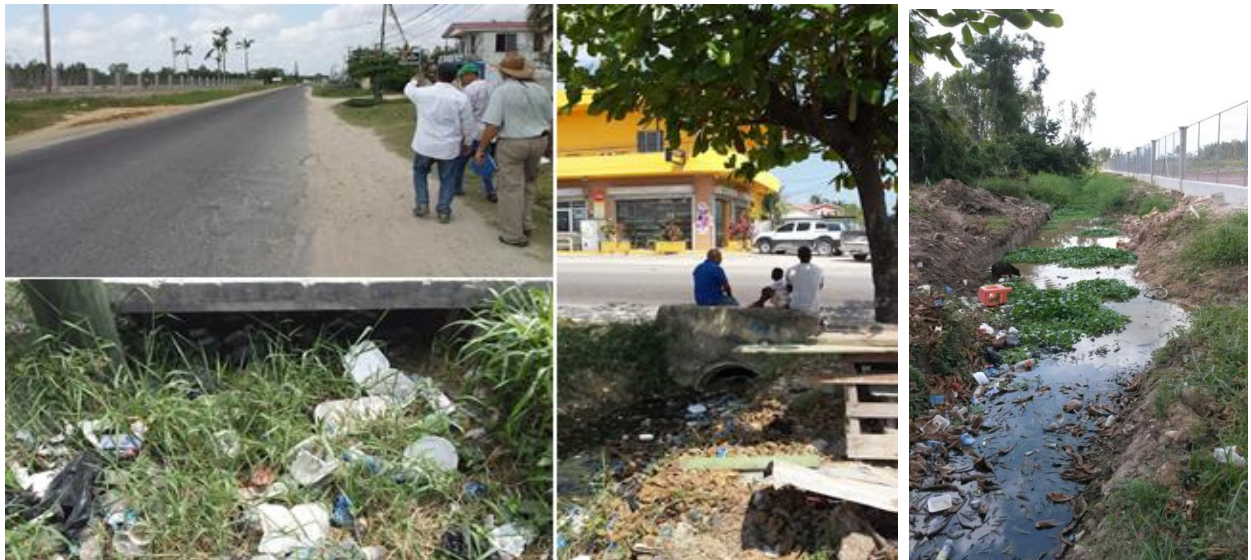
The poor conditions of the drainage on the road side and in the village itself were quite obvious. Culverts were blocked with sediments; vegetation and garbage (see Figure 4.23). Also evident was the clearing and filling up of the wetland, now turned into some 14.801 acres of private property on the Airport side of Ladyville, facing the Mitchell estate area. This wet land was a natural reservoir for the runoff during heavy rainstorm. A deep trench was dug on the southern, western, and eastern sides of the property with no free exit or outlet to discharge the runoff. One exit is towards the Ladyville Yellow culvert, however this culvert which crosses under the highway, is generally clogged with sediment and debris. In addition the water runoff flows away to the west of this culvert. At the western end of this trench, the drainage leads nowhere. This situation will exacerbate future flood events if not addressed properly. The proposed link canal in the area should mitigate the flooding.

Figure 4.23: Drainage Conditions in Ladyville.

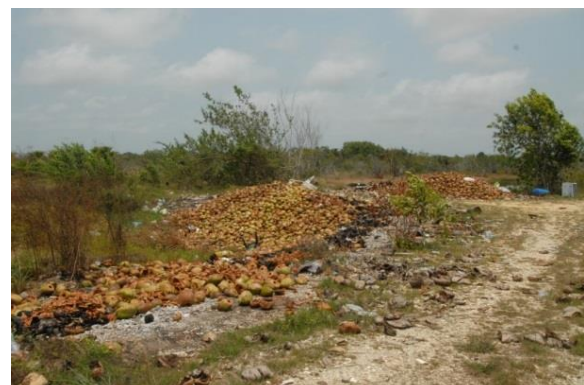
Figure 4.40: Cocunt husks dumped on the road side.

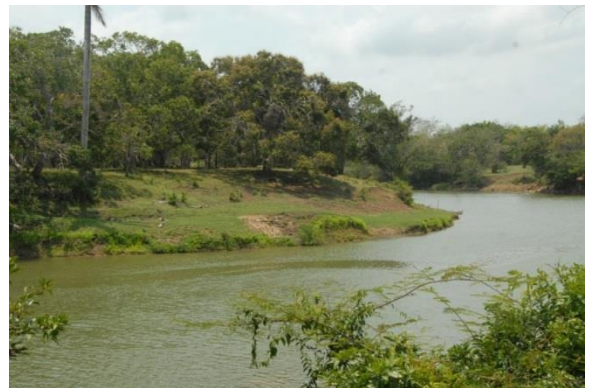
The functionality of some ecosystems in the maintenance of water quality is also largely removed in some areas, such as the Grace Bank area where riparian forest has been completely cleared to the water to provide access to water for cattle in rough pasture (Figure 4.4.1). This is in contravention of the policies of both the Lands Department and the Department of the Environment, but is often unenforced.

Figure 4.41: Riparian forest removed at Grace bank.

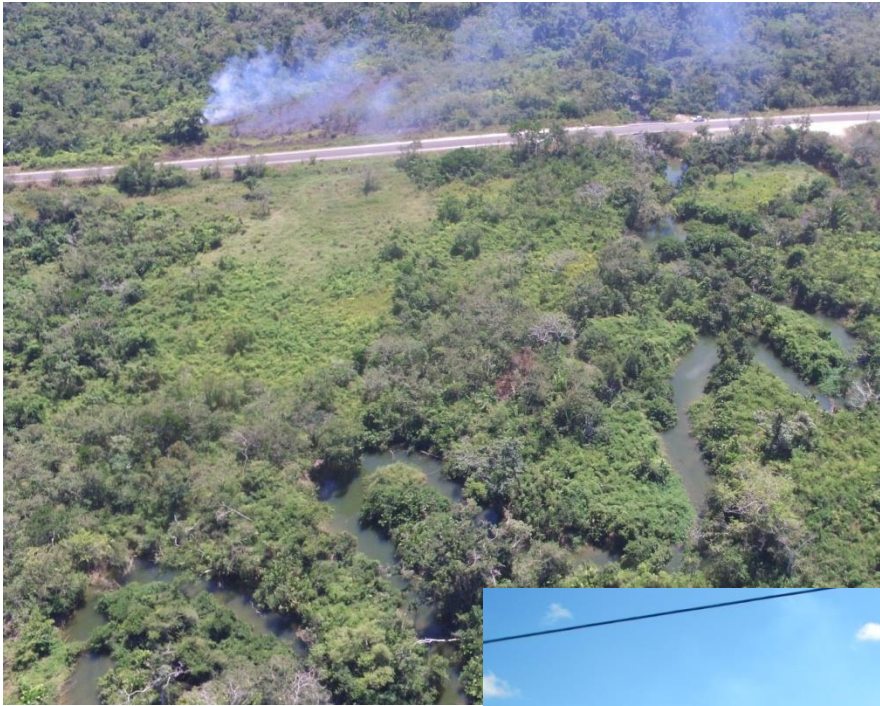
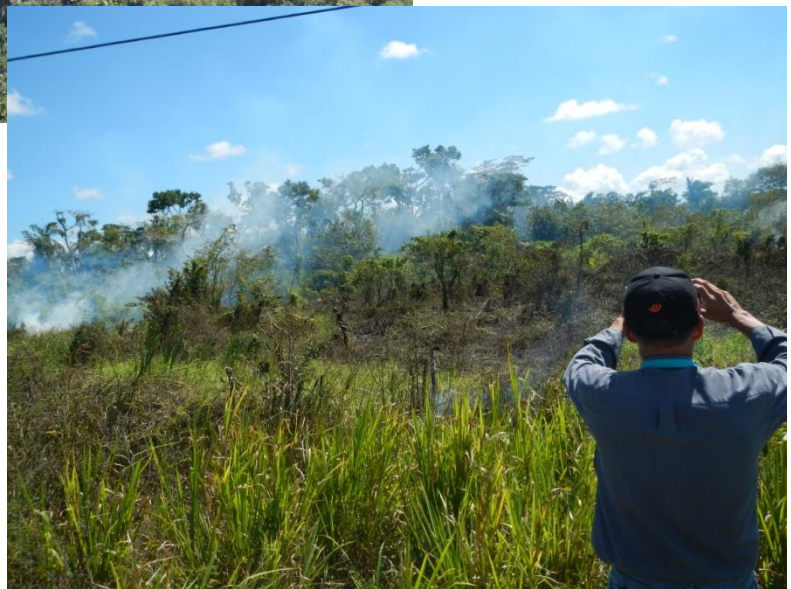
Figure 4.53: Top: Drone bush fire near Mexico Bridge. Bot.: Close-up of bush fire. Source: BET March 12, 2017.

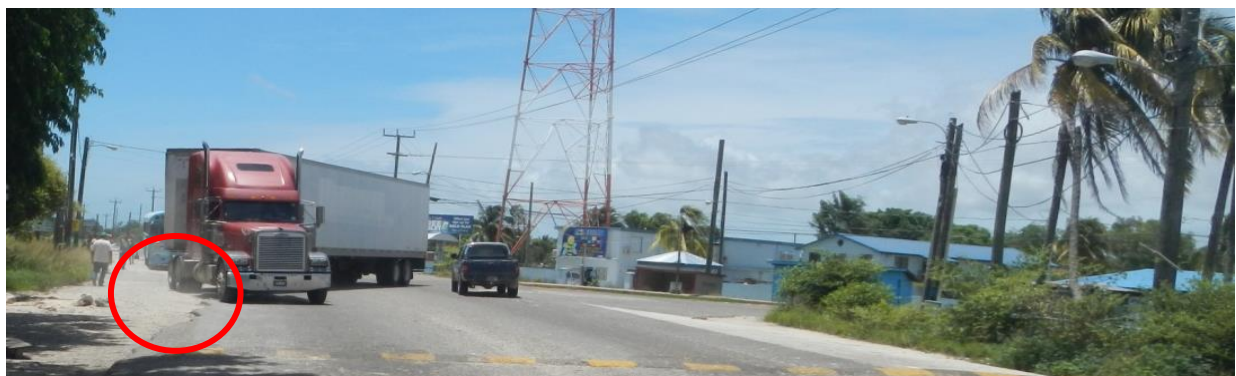
Figure 7.4: Tractor Trailer manoeuvring the Burrell Boom Junction tracking off pavement.
