*Archaeological Assessment including;
an intra-riverine survey and detection survey in advance of repair work Farnanes Bridge,
(Farnanes/Drumdrasdil townlands), Co. Cork*

Dive licence 22D008 (intra-riverine), Detection licence 22R0043

Maurice F. Hurley, D.Litt, MA, FSA, MIAI

March 2022

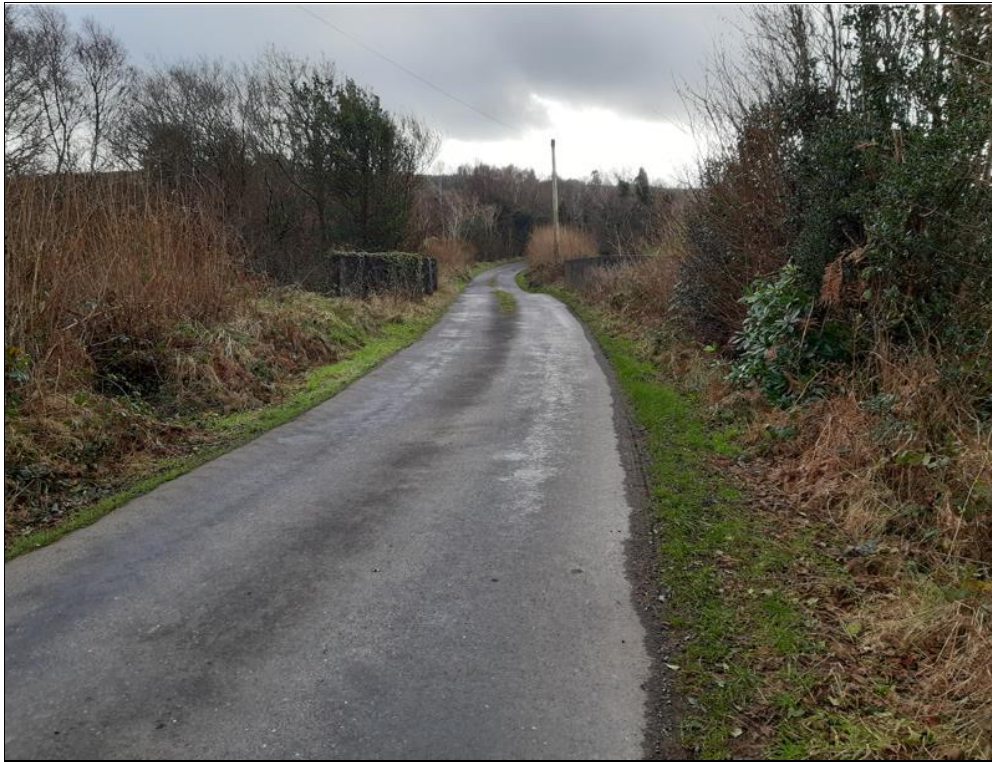
Plate 1. Farnanes Bridge looking S. at the point where the L4612 crosses the River Bandon

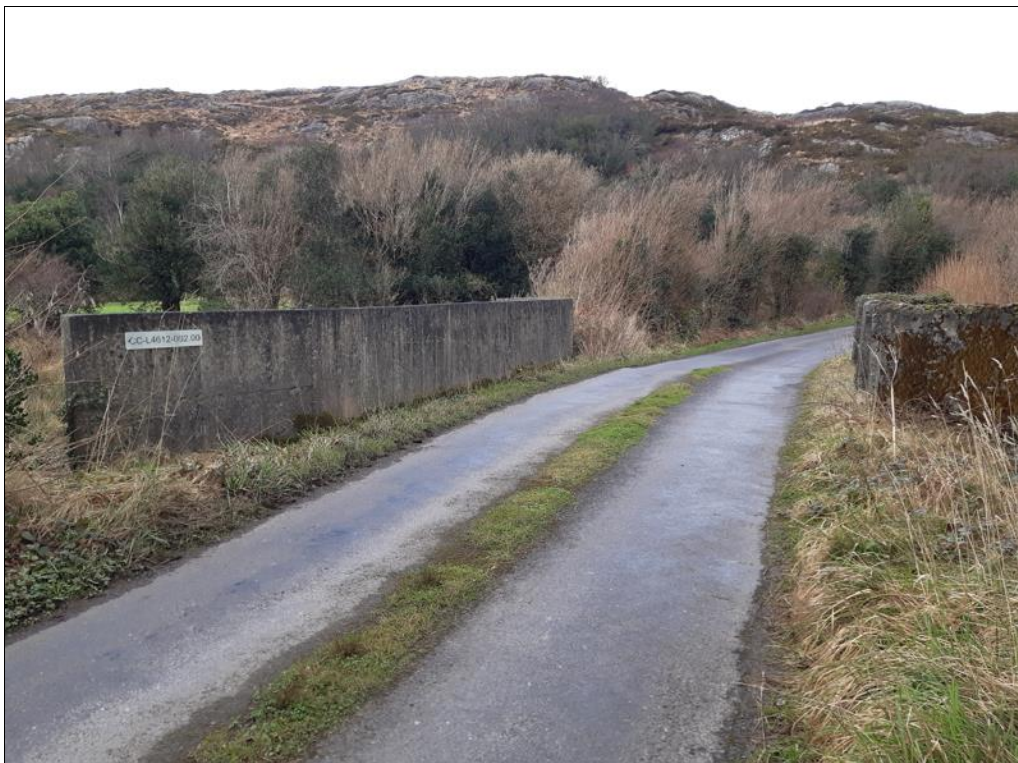
Plate 2. Farnanes Bridge looking N. at the point where the L4612 crosses the River Bandon. A ridge of rock lies c. 50m to the north of the floodplain.

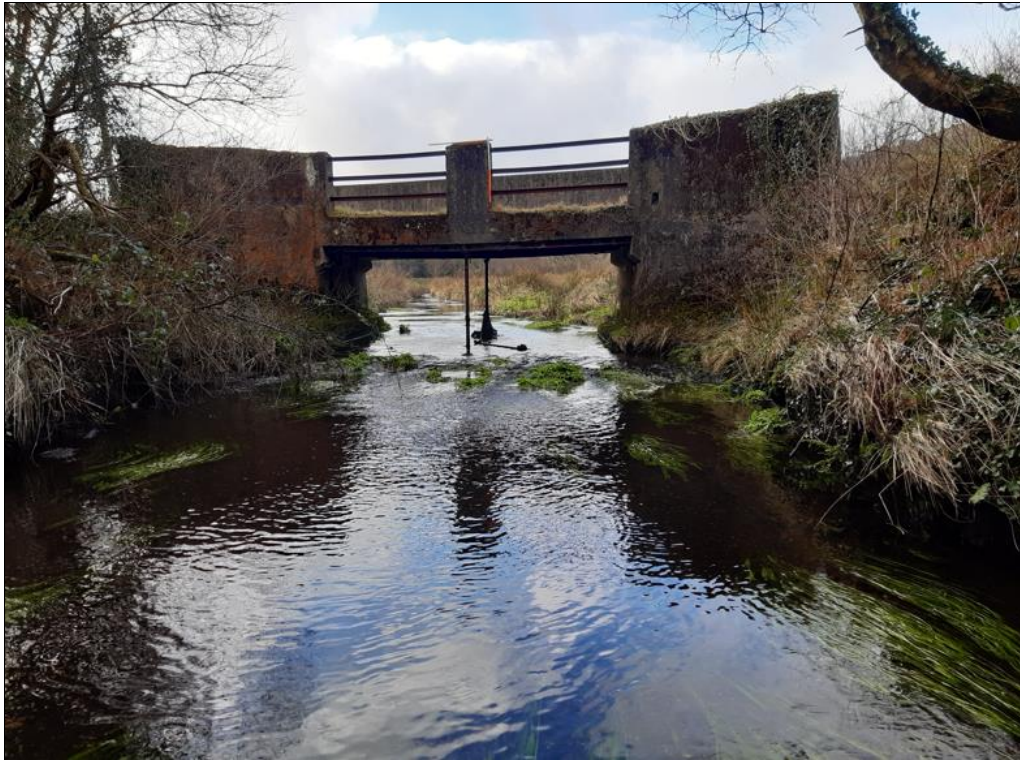
The parapet walls are of mass concrete construction, that on the upstream side being solid (Plated 1 & 4) and that on the downstream side being composed of three solid units and two open areas wherein steel railings form the parapet (Plate 3 & 16); each unit has three railings.

The span length is 5.75m. The bridge crosses the river at 90 degrees. The out-to-out width is 4.56m and the carriageway width is 2.82m (Plates 3-5).

Plate 3. Looking west from the downstream side looking upstream

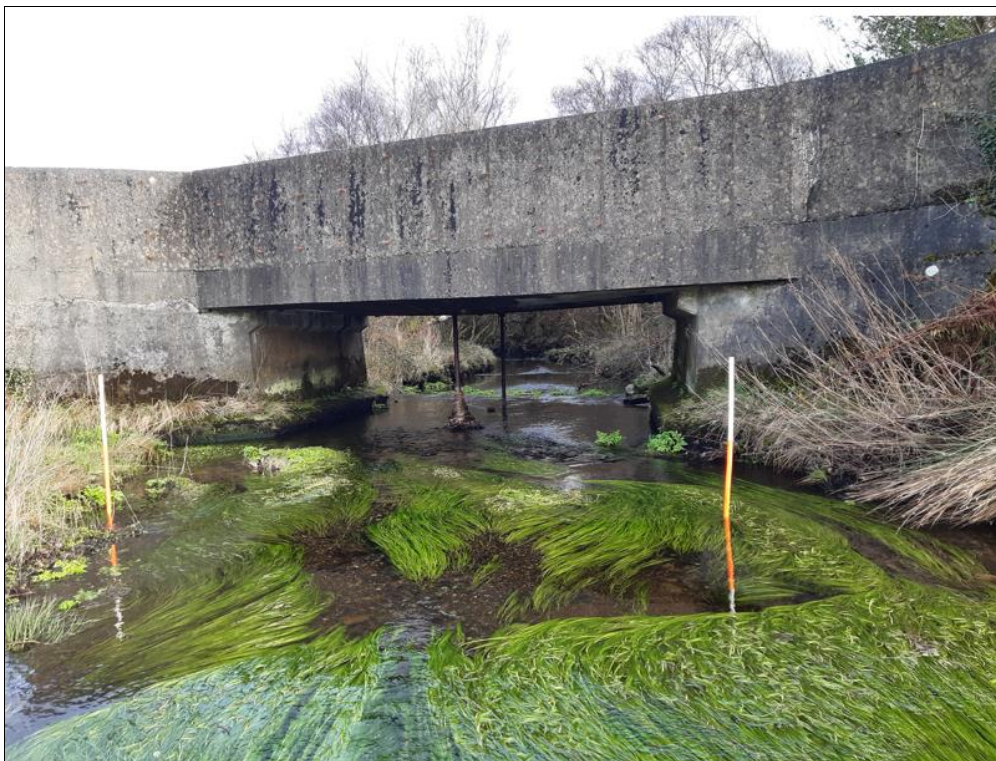
Plate 4. Looking east (downstream), the channel is characterised by the growth of water-crowfoot which is particularly characteristic of the River Bandon (Angel, 1981).

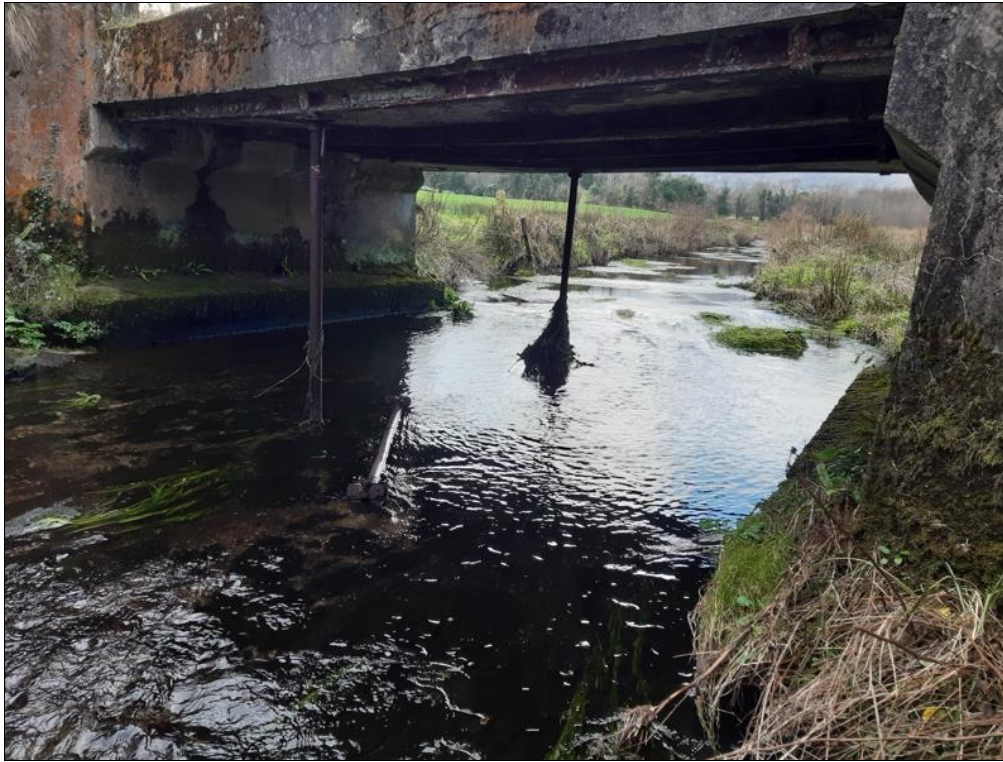
The concrete slabs of the single span bridge are carried on steel girders. The girders have sagged of late and are now supported by Acros (a temporary solution to support the sagging element of the bridge), but flooding when the river is in high spate has washed away some of the temporary supports, only two of which now remain in place, one is collapsed in the river and one or two are lying by the riverbank. The structural issues with the bridge are not in doubt and repair/replacement is essential.

Plate 5. The concrete slabs of the single span bridge are carried on steel girders. The girders have sagged on late and are now supported by Acros, only two of which now remain in place, one is collapsed in the river and one or two lying by the riverbank.

The demolition of the existing Farnanes Bridge (Bridge Ref: CC-L4612-002.00) along the L4612 will be undertaken and replaced with a precast concrete portal frame culvert bridge. The precast units are to be founded on reinforced concrete spread foundations. Steel parapets and vehicle restraint system will be added to the bridge structure (Figure 3). Resurfacing and regrading of the approach roads along the L4612 will also be undertaken (Plates 1-2).

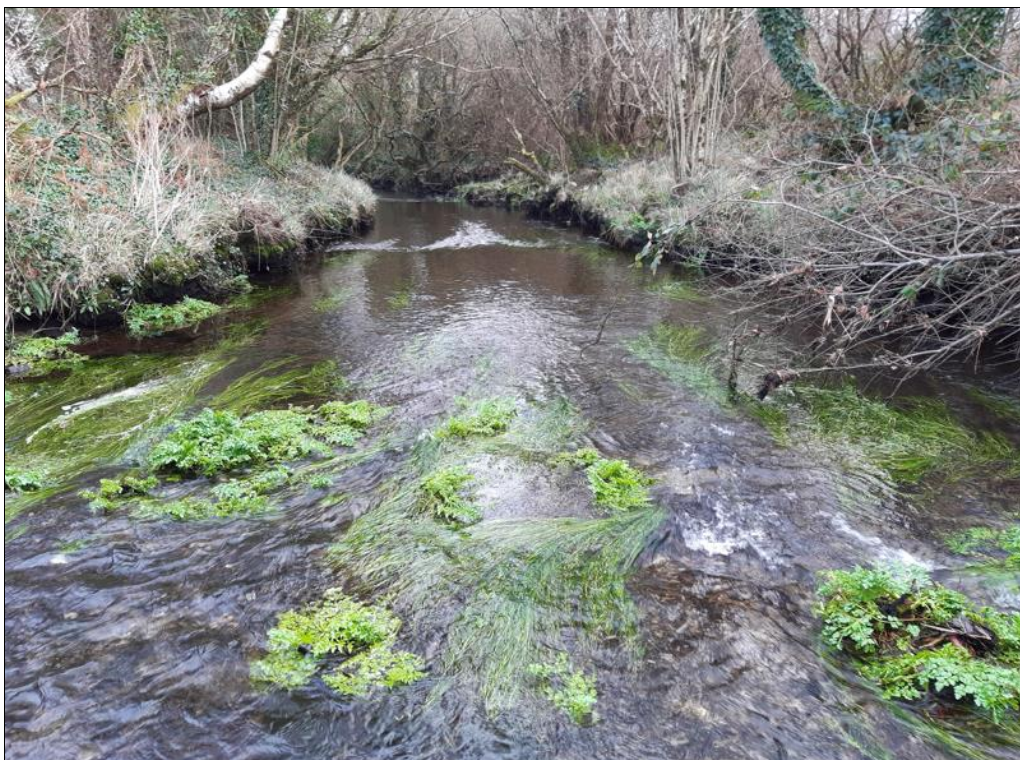
Plate 6 c. 20m downstream of Farnanes Bride where the water picks up speed. The channel appears to have been drained (and straightened?) from this point downstream; both banks are mounded with gravel upcast from the drainage that probably took place in the 1970's judging by the tree regeneration.
