UNITED STATES COAST GUARD

REPORT OF THE INVESTIGATION INTO THE

FPS AUGER

LIFEBOAT FALL WITH LOSS OF LIFE ON JUNE 30, 2019

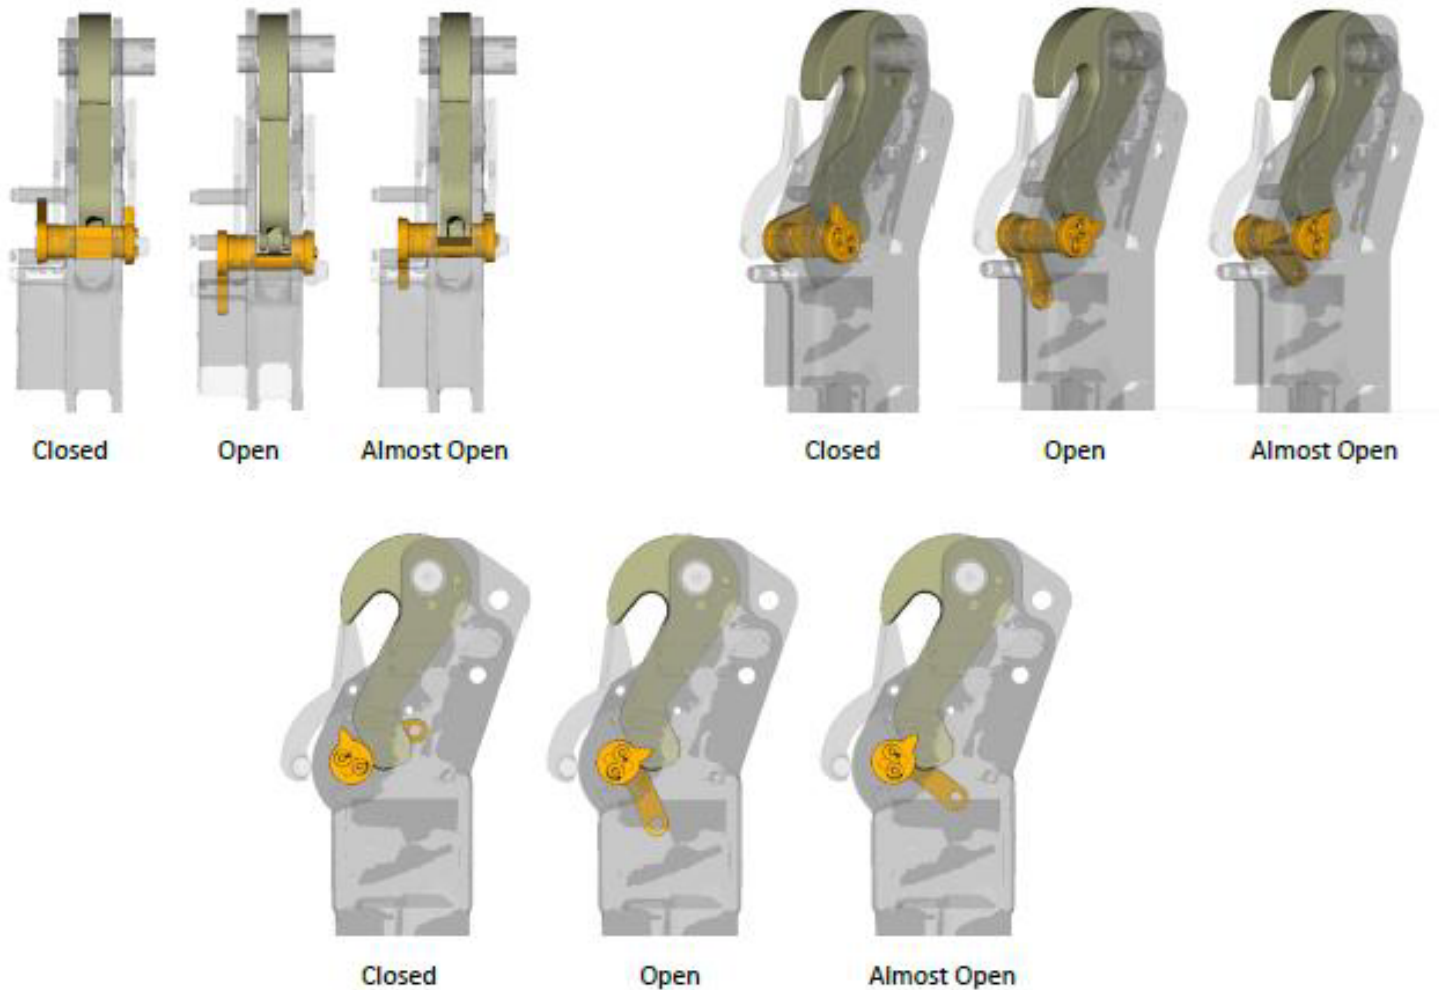
During the course of the investigation, the Coast Guard, Shell, and Palfinger Marine (the original equipment manufacturer or "OEM") identified a previously unknown vulnerability in the system: if all three layers of the conduit of a hook control cable separate or break, during a reset the locking shaft may not return to the fully closed position. Rather, the locking shaft may come to rest at an "almost open" position (see Image 5). In such a position, the hooks can support the weight of the boat and its occupants during retrieval. However, an additional load can cause the locking shaft to rotate to the open position, releasing the hook.

Image 5: Hook cutaway views of LHR3.5M2 hook in closed, open and almost open positions. Locking shaft depicted in yellow. Credit: CG (hook component data provided by DNV-GL).

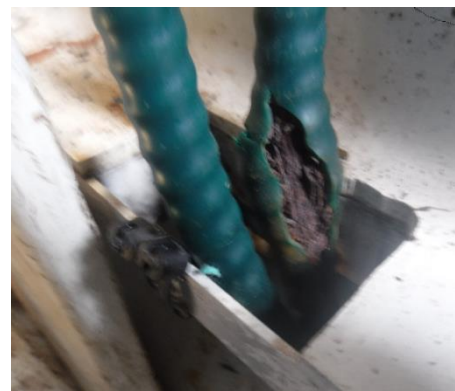
On the day of the casualty, the crew cycled the hooks (open to closed position) two times while in the water. If a cable conduit is already damaged, the act of cycling exposes the conduit layers to additional stresses, including compression and tension (stretching). It is probable⁴ that during the second cycling event, the

Image 6: Photograph of damage to Lifeboat No. 6 aft control cable dated June 6, 2019. Credit: Palfinger.

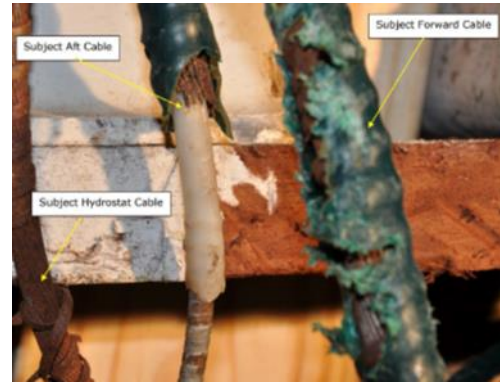
conduit, already weakened and damaged, separated during the closing action (see Image 7). As a result, when the system was reset, the locking shaft on the aft hook did not return to the fully closed position, but rather, came to rest at an “almost open” position. In this position, the hook could support the weight of the lifeboat and its occupants as the lifeboat was hoisted from the water to the davit. However, at the davit, additional forces applied to the hook and the lifeboat, as a result of the winch pulling the boat against the bumpers, caused the locking shaft to rotate from the “almost open” to the open position. Under load, the aft hook was free to open and release from the lift ring (a ring attached to the end of the fall cable (wire rope); often called the “D” ring). The forward hook, not designed to bear the entire load of the lifeboat or operate outside of specified angles, was unable to sustain the weight of the lifeboat, separated from the hull and eventually opened.

Image 7: Photograph of aft control cable after casualty. Photograph documents separation of three layers of the conduit: the green plastic cover; a steel wire; and a white polyethylene liner. Credit: DNV-GL.

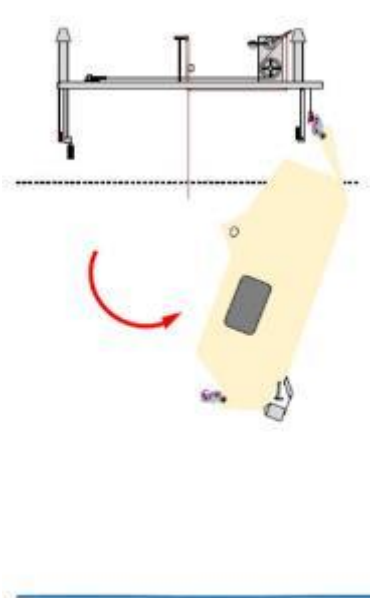
Figure 11: The aft hook releases and the lifeboat swings placing all the weight onto the forward hook.

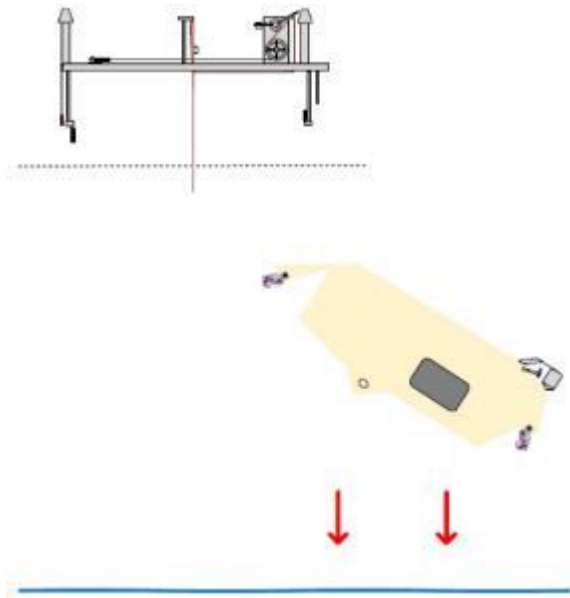
Figure 12: The forward hook, not designed to bear the entire load of the lifeboat or operate outside of specified angles, was unable to sustain the weight of the lifeboat, separated from the hull and eventually opened. The lifeboat fell and landed inverted in the water.

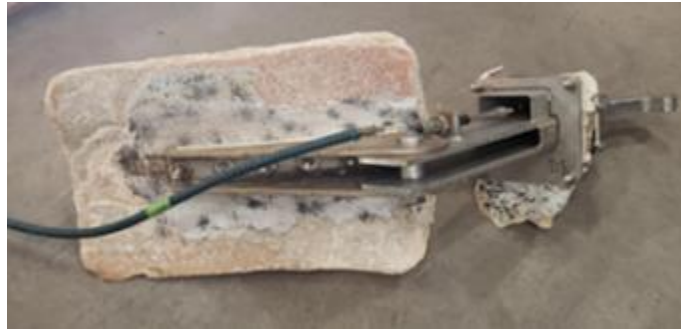
4.2.4.2.1. The bow end of the hull split, and the bow hook was torn free of the hull (see Figures 21). The bow split arrested approximately halfway along the length of the boat.¹⁵ The patch that pulled out is consistent in shape with a previous repair made to the FRP around the bow hook (see Figure 21).

Figure 21: Bow hook and surrounding FRP post-casualty. Credit: CG.

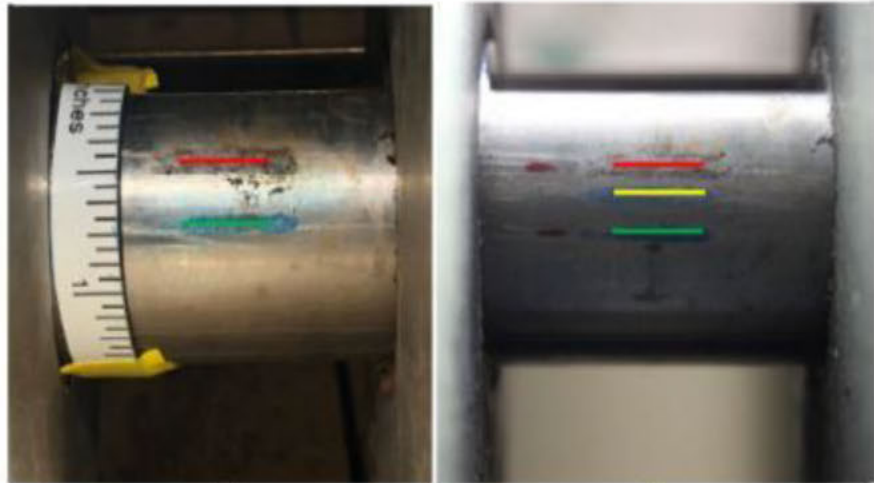
“The position of the red line relative to the green and yellow line may have been created in two possible ways: (1) under load, the location of contact between the hook roller and the locking shaft rotates to a more open position or (2) the failure in the Subject Aft Cable.”¹⁸

Figure 25a (left) and 25b (right): Lifeboat No. 6 locking shaft. Credit: DNV-GL.

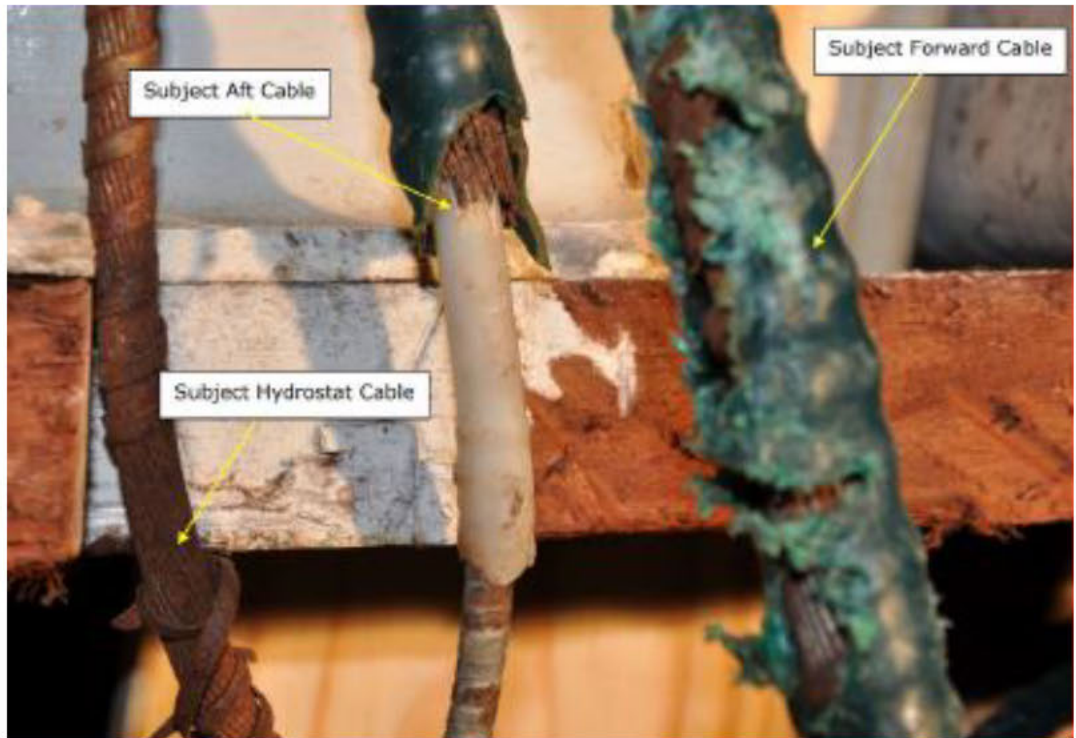
4.2.4.4.2. Significant damage to the aft control cable was found approximately .72 to 1.34 feet from the hook release station conduit cap. The outer green conduit cover, steel strands and polyethylene liner were totally separated. Only the inner member remained intact (see Figure 27).

Figure 27: As-found condition of Lifeboat No. 6 control cables after reassembly at DNV-GL facility. Credit: DNV-GL.

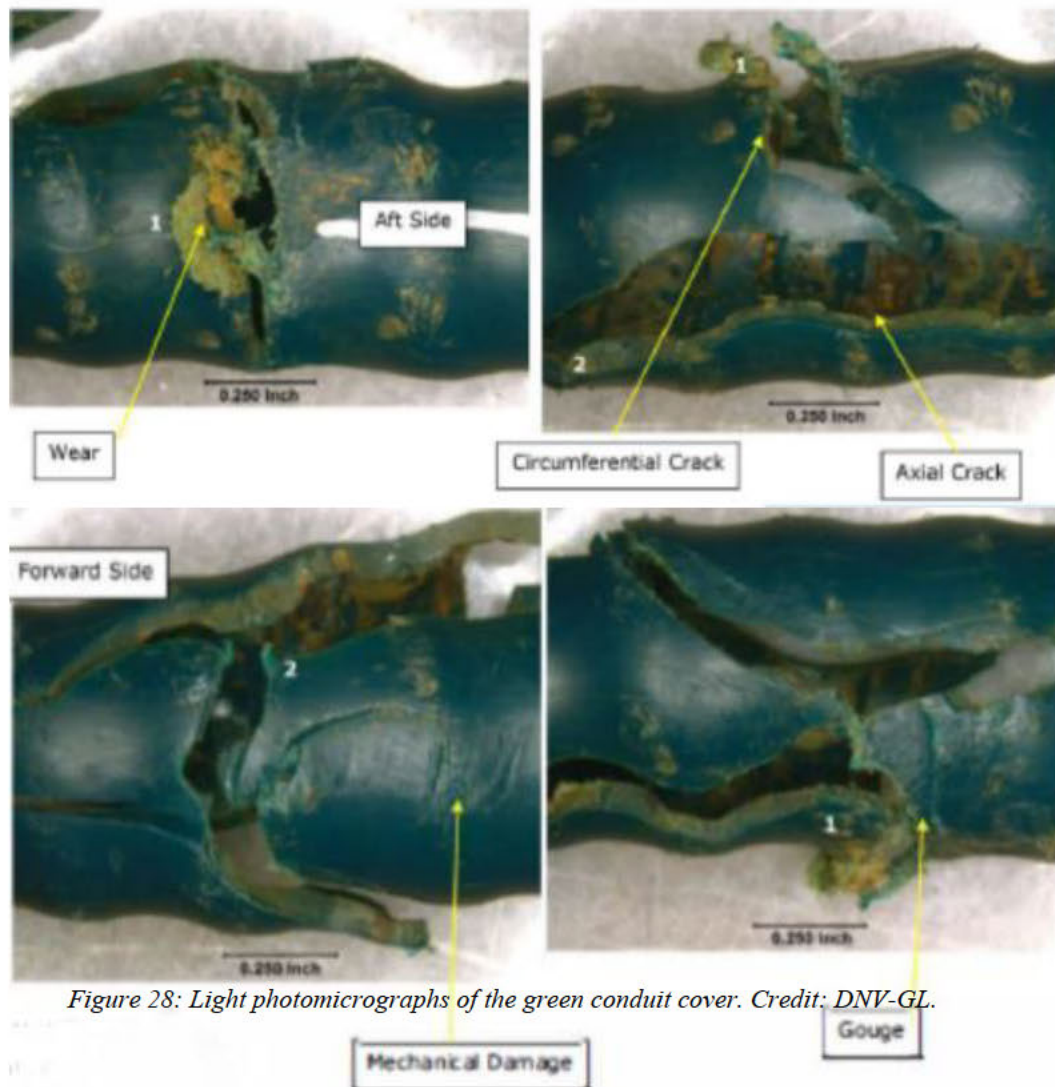
Figure 28: Light photomicrographs of the green conduit cover. Credit: DNV-GL.

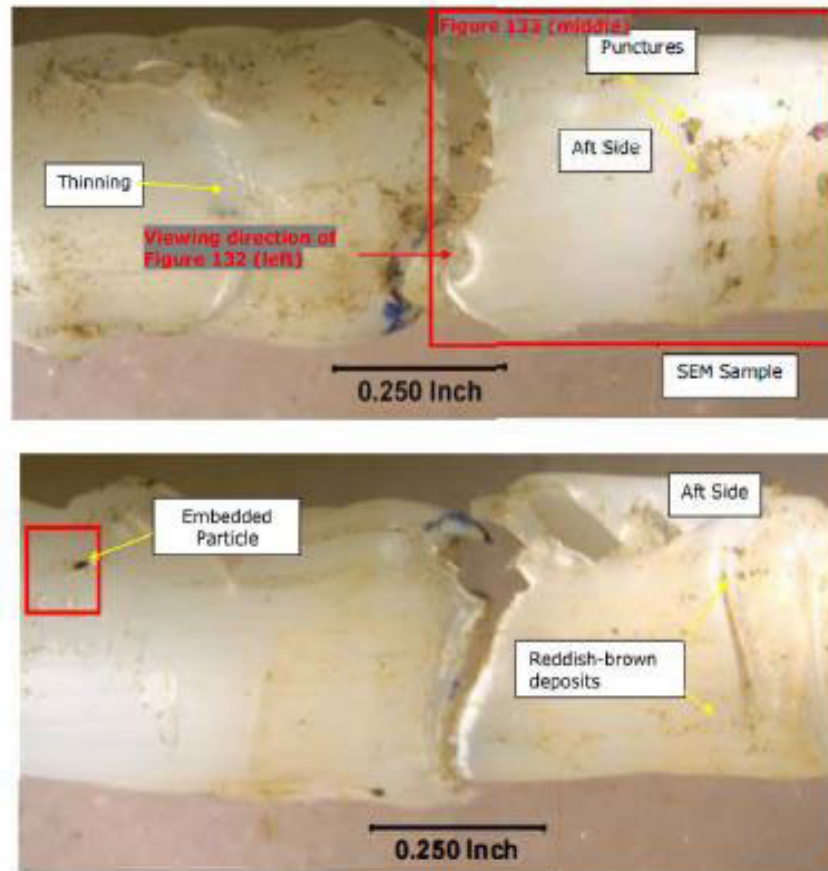
“Fracture paths are primarily circumferential in nature. The previously noted tearing and buckling are visible in the micrographs. The buckling suggests that the liner layer had been compressed; however, the morphology of the fracture surfaces indicate that the tube failed in tension. Additionally, a thinned area on the aft side of the Subject Hook Release side of the failure is visible. A reddish-brown, embedded particle, as well as reddish brown deposits, are visible near the failure on the external surface of the liner. Punctures are visible on the aft side of the Subject Aft Hook side of the failure, and correlate with the size and spacing of the individual wires that make up the conduit.”²³

Figure 29: Light photomicrographs of the white polyethylene liner. Credit: DNV-GL.

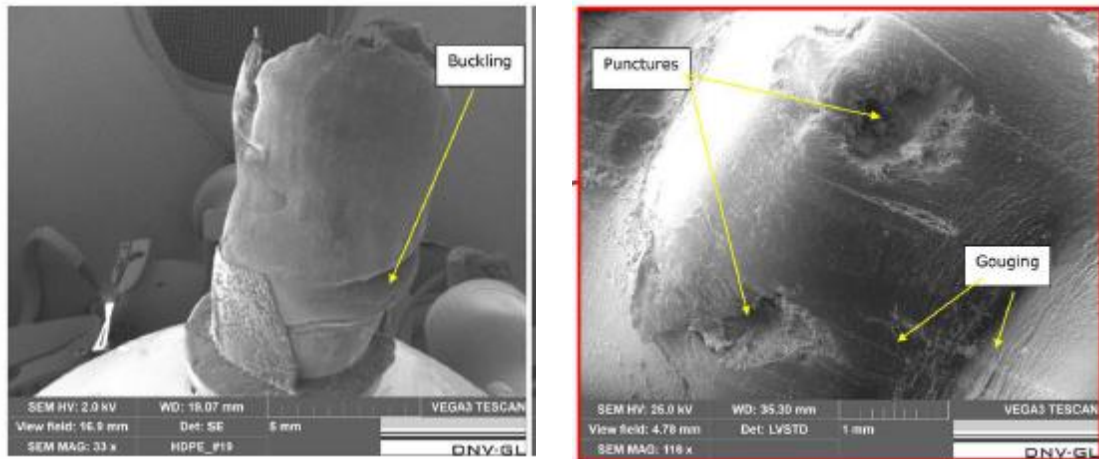
found the punctures spaced 35 to 45 mils from one another, which is similar to the spacing identified between the tips of the corroded conduit wires.²⁴

Figure 30: SEM images of white polyethylene liner. Credit: DNV-GL.

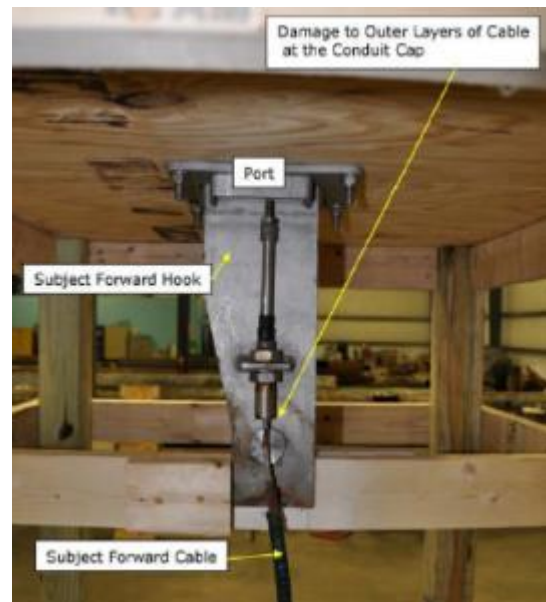
4.2.4.6.1. The forward hook was found in the open position²⁵, dangling from the lifeboat, attached to the boat by the control cable. The forward hook control cable showed damage at the conduit cap, exposing the inner member (see Figure 31). The outer green cover, wire, and white polyethylene liner did not show significant mechanical damage.

Figure 31: Forward control cable at hook conduit cap. Credit: DNV-GL.

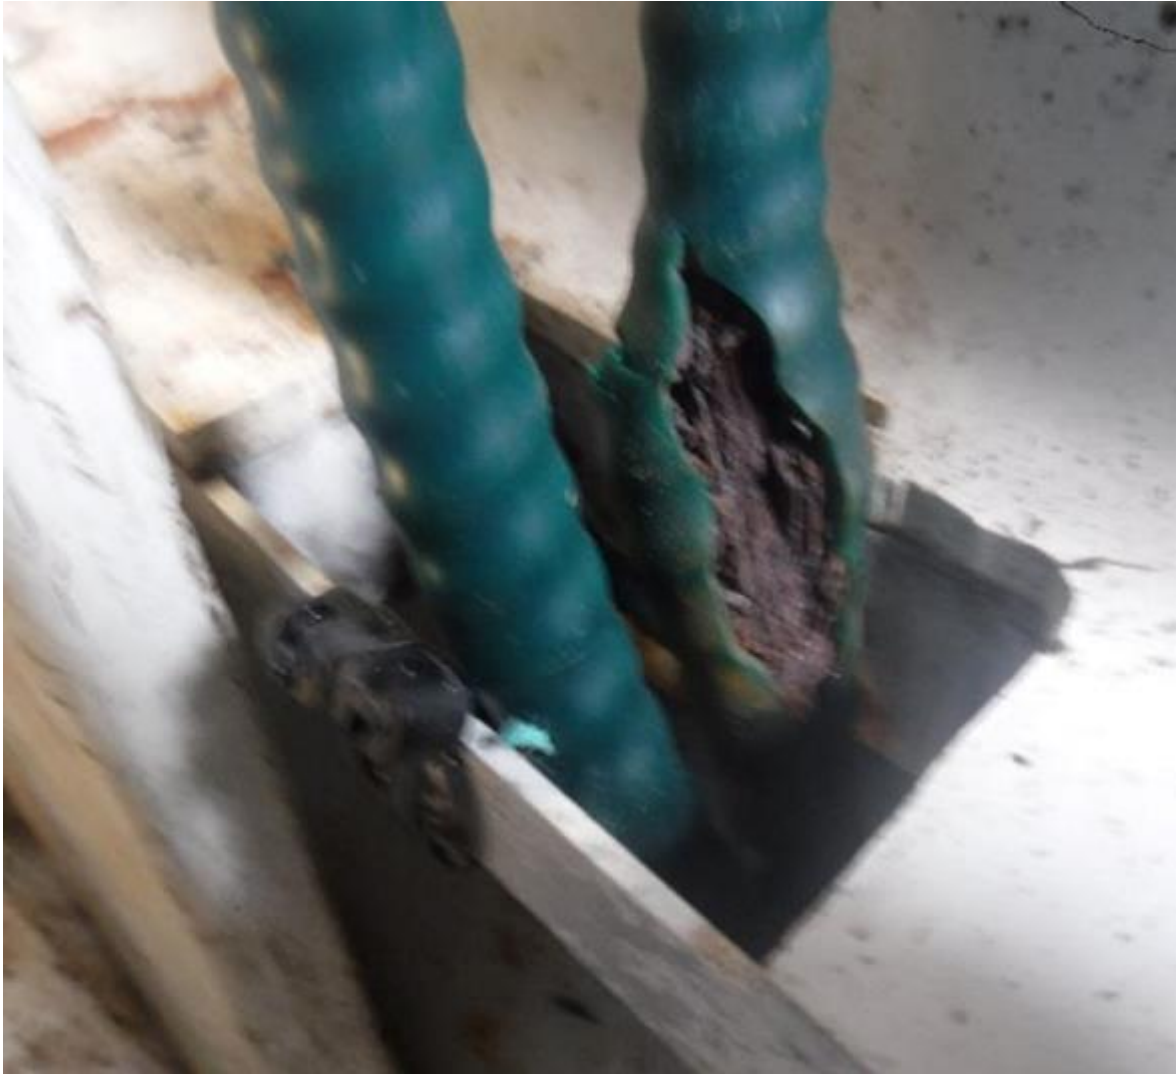
Figure 35: Photo of Lifeboat No. 6 aft control cable. Taken on June 6, 2019. Credit: Palfinger.

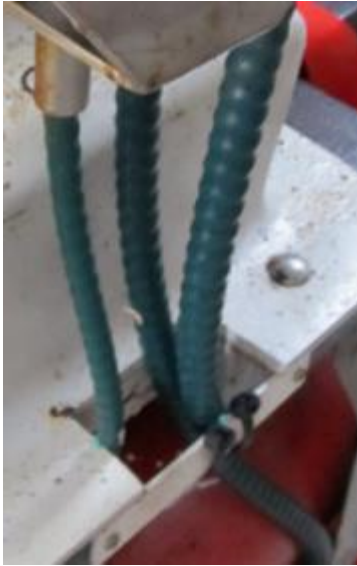
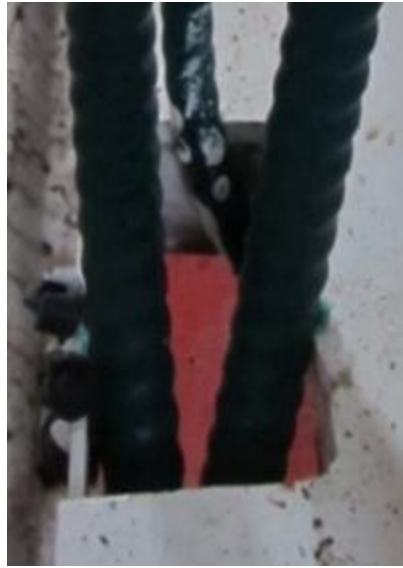
Figures 38 (left) and 39 (right): Photos of aft control cables in or around 2014. Credit: Shell.

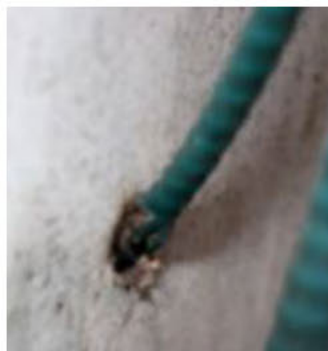
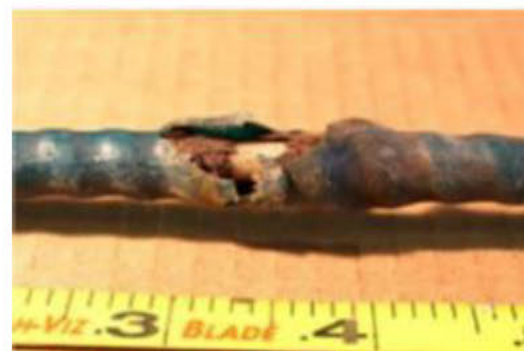
Figures 40 (left) and 41 (right): Photos of Lifeboat No. 7 hydrostat control cable. Credit: CG and DNV-GL.

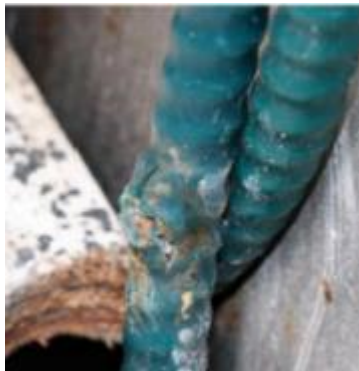
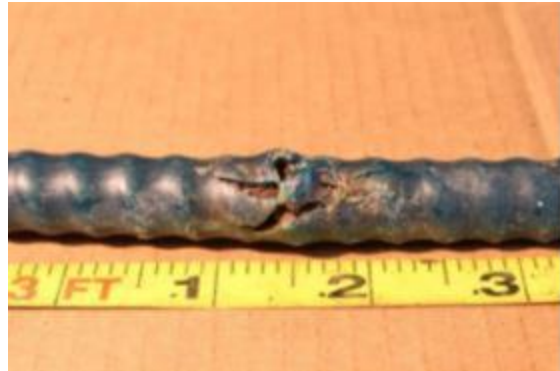
Figures 42 (left) and 43 (right): Photos of Lifeboat No. 8 forward control cable. Credit: CG and DNV-GL.

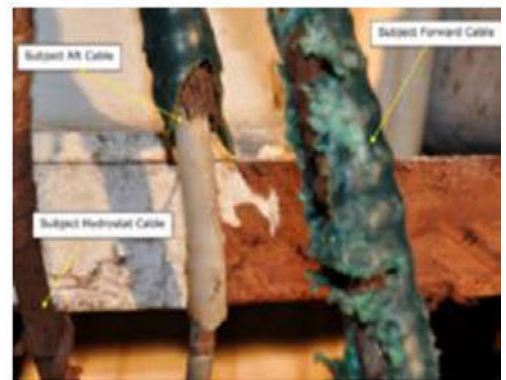
Figure 49: Lifeboat No. 6's aft hook control cable after the casualty. The aft cable is in the center of the picture. Credit: CG.

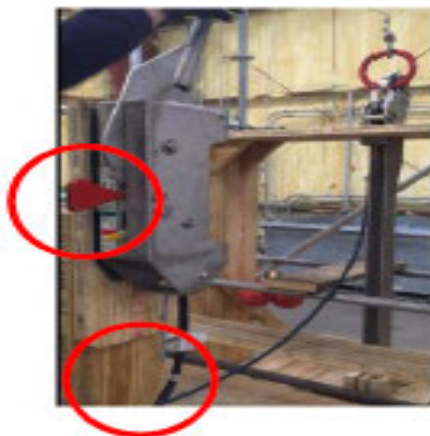
Image 50: The release handle is in the locked and closed position. However, the cable is damaged.

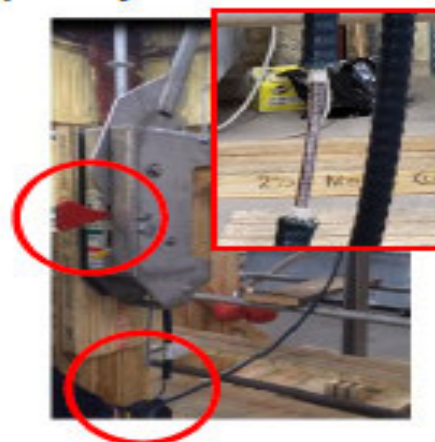
Image 51: Forces cause the outer layers of the cable to separate. The release handle stays closed.

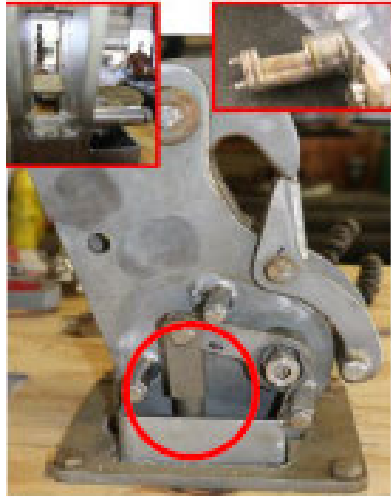
Image 52: At the hook end, the cable end rod moves. This causes the locking shaft to rotate.

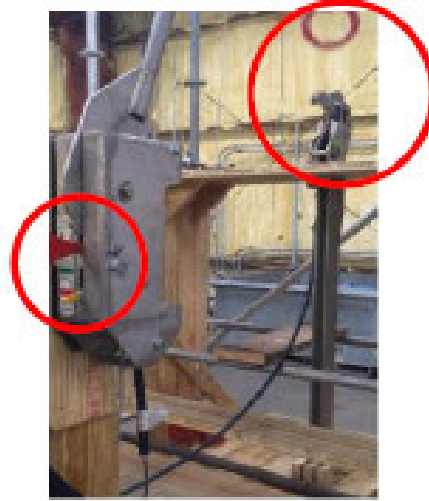
Image 53: If the locking shaft turns enough, the hook will release, even as the release handle stays locked.

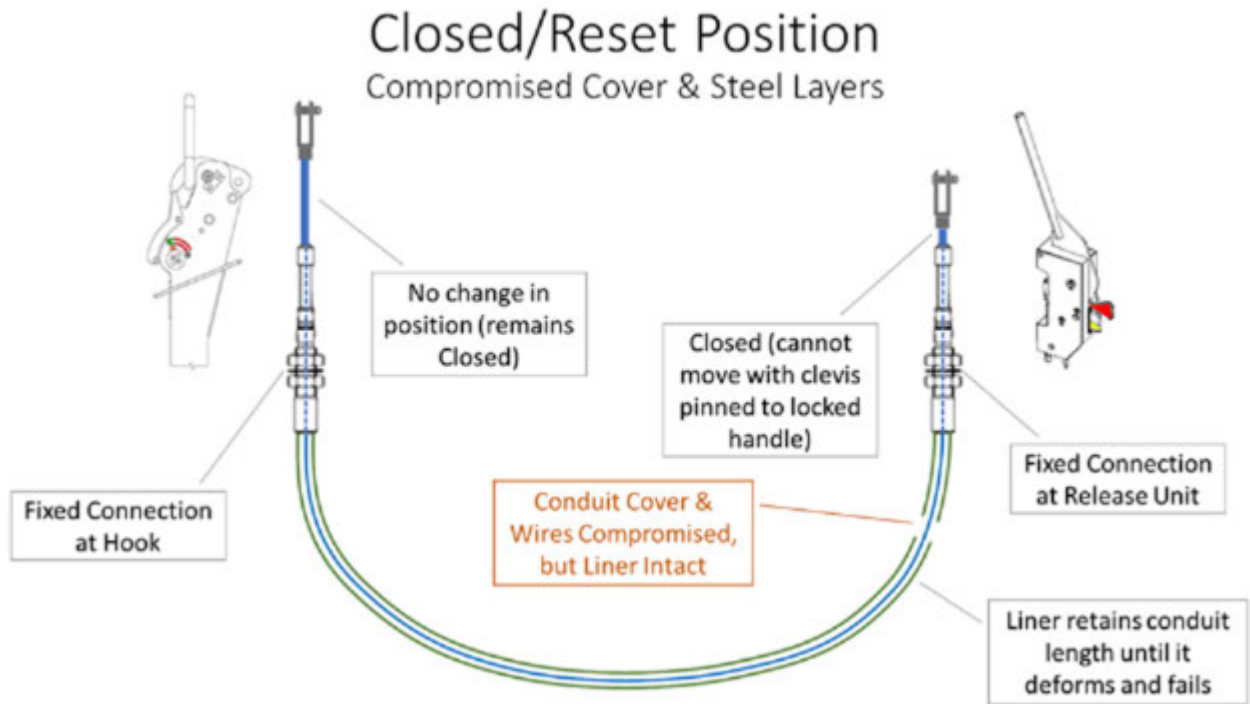
Figure 56: In this figure, the hook is closed or locked. The conduit is damaged, but the white polyethylene liner is intact. Credit: CG

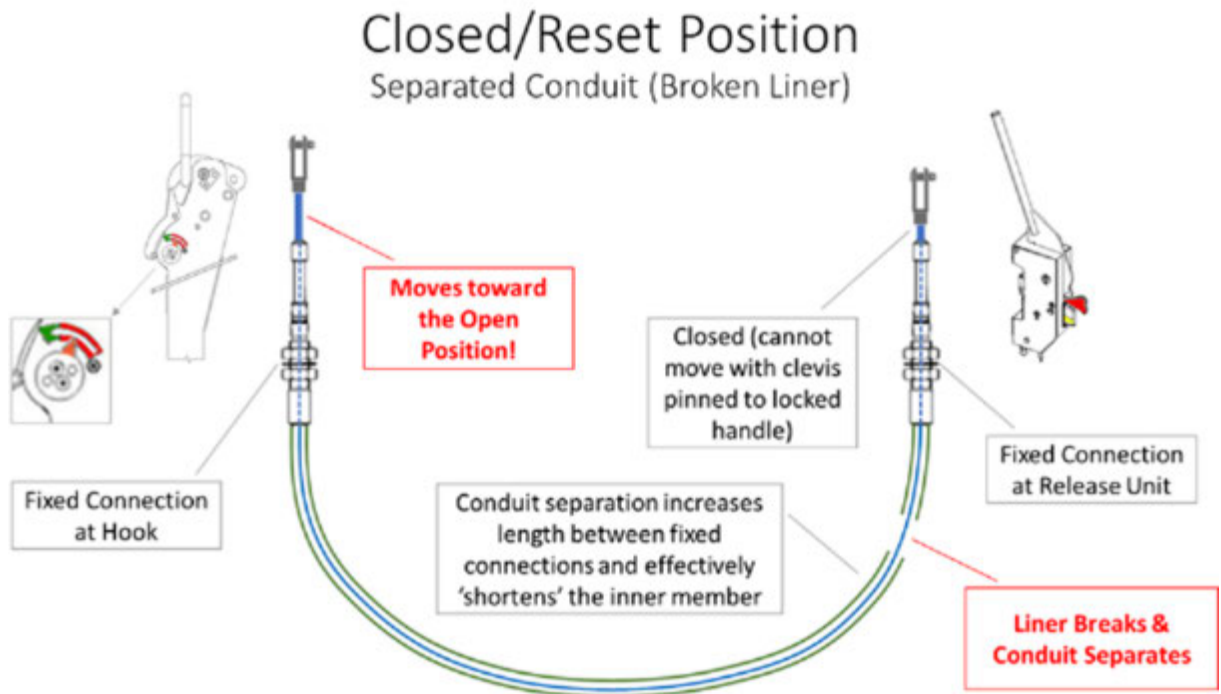
Figure 57: In this figure, the conduit separates. After an initial reset, the locking shaft now rests at an "almost open" position. Credit: CG

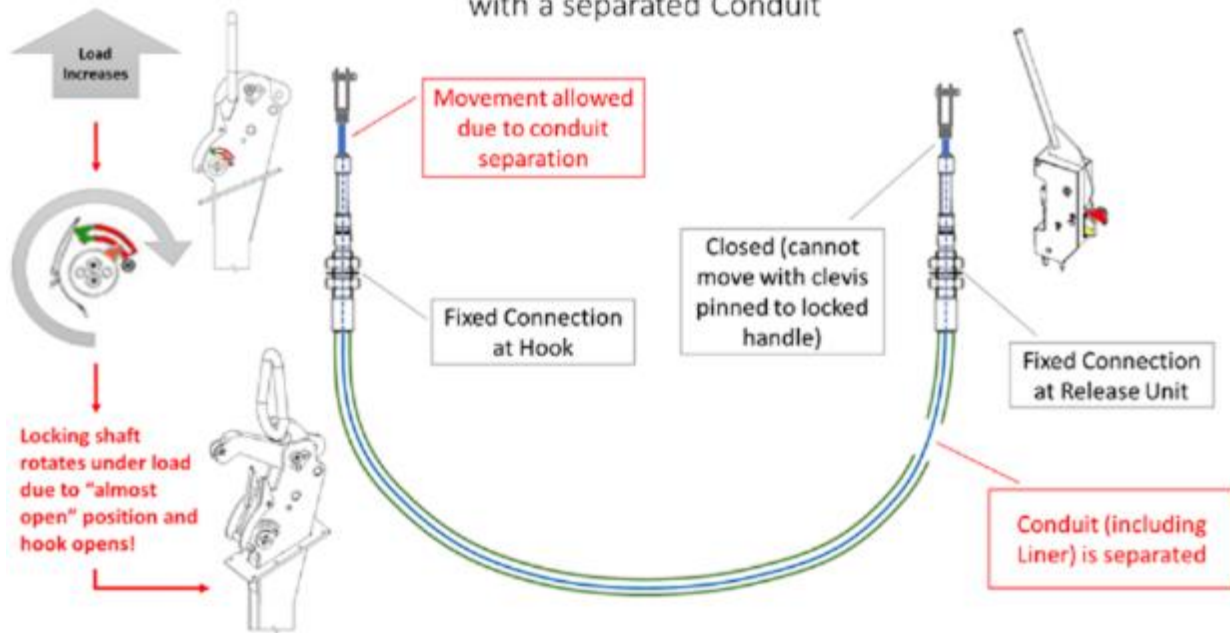
Figure 58: In this figure, the load is increased on the hook, as a result the locking shaft turns from "almost open" to open. Credit: CG

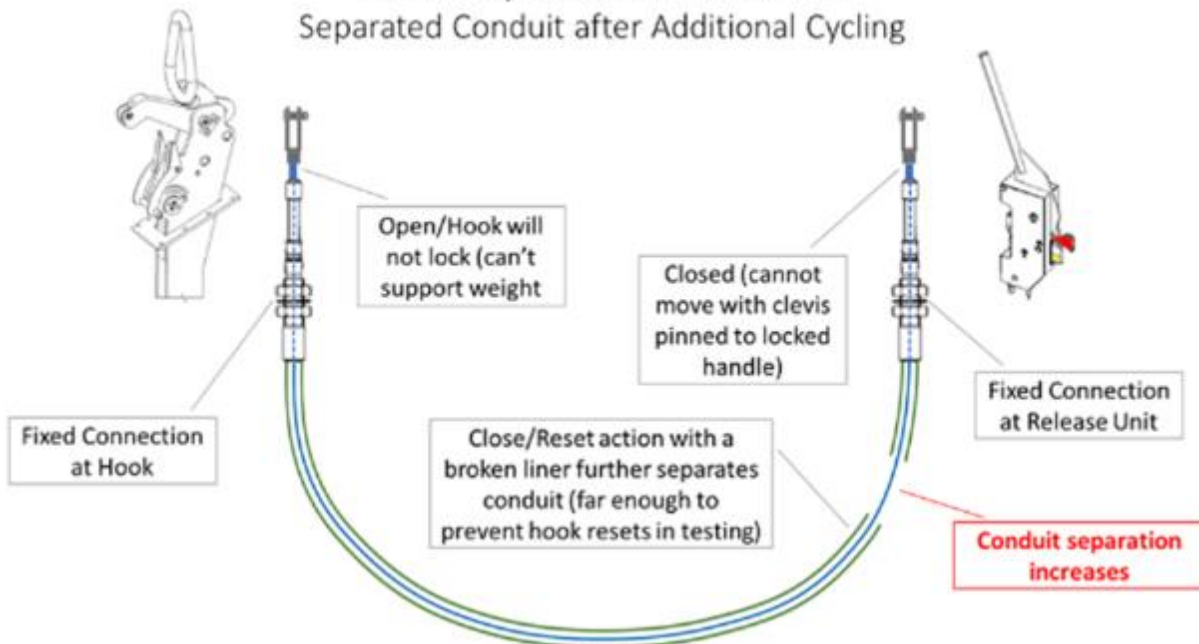
Figure 59: In the Coast Guard experiment, after one reset with a separated cable, the hook would not lock again. The conduit separation was so great that the locking shaft would not return to the "almost open" position, rather, upon reset, it would return to the open position. Credit: CG

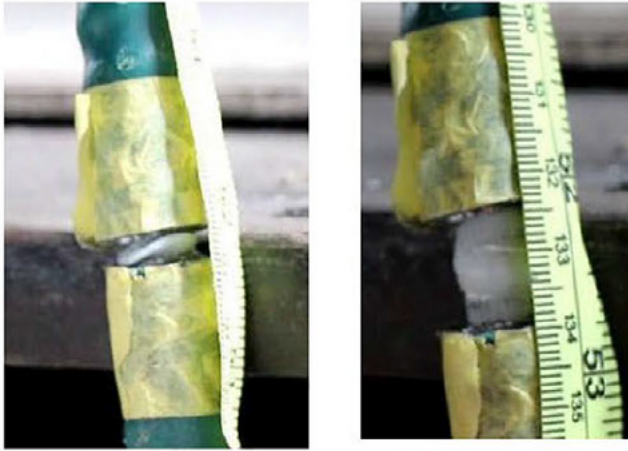
Figure 60 (far left) and 61 (right): The white polyethylene liner evidencing forces of compression and stretching after the wire layer is fully compromised. These photos were taken during the Coast Guard's experiment at MSTC. Credit: CG.

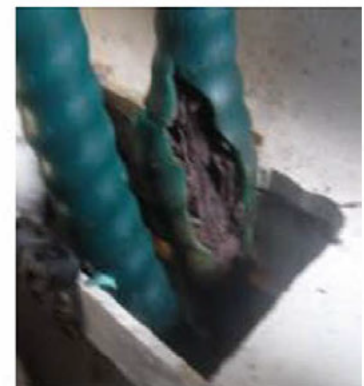
Figure 63: Lifeboat No. 6's aft control cable on June 6, 2019. Credit: Palfinger.
