UNITED STATES COAST GUARD

REPORT OF INVESTIGATION INTO THE SINKING AND LOSS OF FOUR CREW MEMBERS ABOARD THE COMMERCIAL FISHING VESSEL LADY OF GRACE

IN NANTUCKET SOUND ON JANUARY 26, 2007

MISLE ACTIVITY NUMBER: 2863457

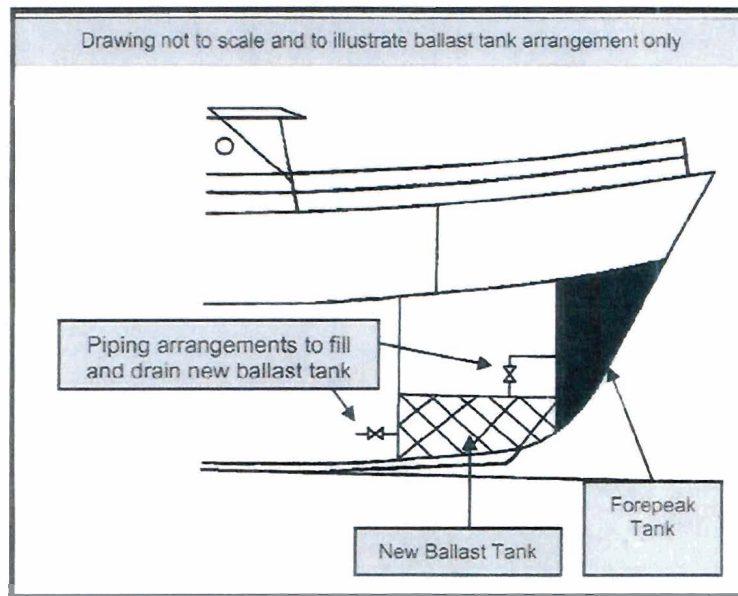
Drawing 2: Ballast Tank Modification Drawing

A new steel ballast tank with a capacity of 2,324 gallons was built integral to the vessel's hull in July 2006. The tank was constructed with one steel baffle plate through the center of the tank and was located on the vessel centerline forward of the engine room. This is located beneath the storeroom and directly behind the forepeak tank. The tank was provided with a bolted access plate for inspection and cleaning of the tank.

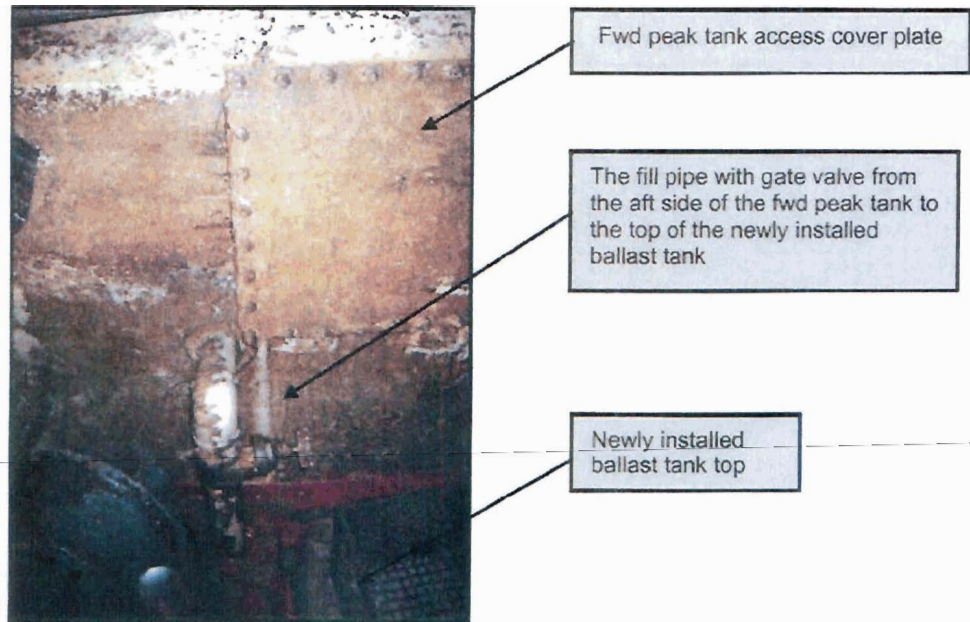
Photo 3: Ballast Tank Fill Pipe Picture

A pipe with a two-inch gate valve was installed from the aft bulkhead of the forepeak tank into the top of the new ballast tank. Filling of the ballast tank was accomplished by opening the fill valve and allowing water to gravity feed from the forepeak tank. To empty the ballast tank, the aft end of the tank was fitted with two pipes, one on each side of the tank and each fitted with a gate valve. These pipes led to the engine room bilge. The tank was drained to the engine room bilge and pumped overboard through the vessel's installed bilge system.

The Naval Architect stated he was not aware of the new piping installation or the procedure for filling the ballast tank and assumed the forepeak to be empty while the vessel was operating.

At the time of the incident the LADY OF GRACE was not operating as a day scallop fishing vessel and therefore not required to maintain the operating condition in accordance with the Stability Letter. However, there was an apparent verbal miscommunication between the Naval Architects who performed the inclining stability and the owner of the vessel. According to the owner, the normal operating condition for the forward peak tank had been approximately 50% full of fresh water. Following the installation of the new integral ballast tank the owner was under the impression the forward peak tank should be maintained no more than 60% full and stated he had marked the tank at the 60% level to ensure compliance with this requirement. The Naval Architects concluded that with the new ballast tank installed, the forward peak tank should no longer be used and assumed this tank to be empty in all their stability calculations.

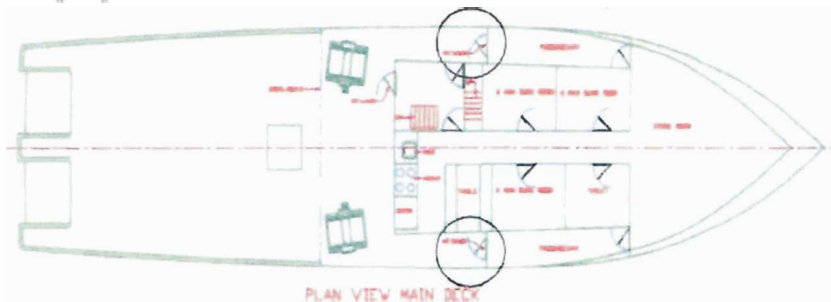
Drawing 3: LADY OF GRACE Watertight doors fitted in accordance with new stability requirements.

In accordance with modifications specified by the Naval Architect, hinged watertight doors were installed on the main deck, port and starboard side of the house in July 2006. These doors led to storage passageways connecting to the forward storage space.

The newly installed watertight doors on the port and starboard main deck were discovered to be in the open position by divers. In addition, the center door from the main deck to the galley was a galley style door (bottom and upper half's swing independently). The bottom half was discovered closed by the divers, but the upper half was open. During the Coast Guard examination following the Salvage of the LADY OF GRACE, the steering gear compartment hatch was also discovered missing.

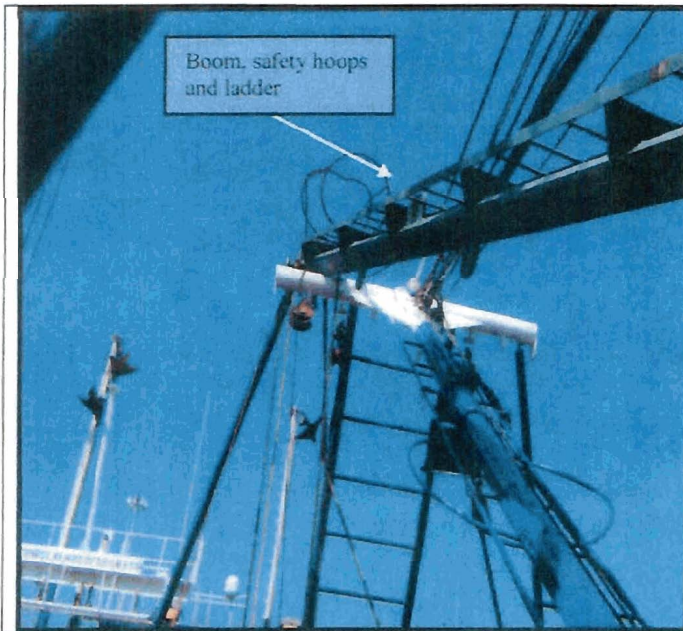
Photo 4: 27 foot boom modification

A 27-foot boom to be used for scallop dredging and a 1.1 long ton 10 foot scallop dredge were installed in July 2006. At the time of the casualty the LADY OF

27 foot boom, newly installed. The boom is cradled and secured against the vessel's "A" frame gallows on the stern of the vessel, its normal underway position when not in use. The boom was installed for scallop dredging and is constructed of six inch square steel pipe of 3/8 inch wall thickness. The boom is fitted with a ladder and safety hoops for access to the blocks and cables .The boom is attached to the main mast with tabernacle and a clevis pin arrangement

The Master had operated the LADY OF GRACE in icing conditions on many occasions in the past. He was familiar with the vessel's limits, handling abilities and characteristics while experiencing ice build-up. However, the recent addition of the 27 foot boom and bulwarks provided additional surface area for a significant increase in ice accumulation. The added weight from this ice located high on the vessel most likely had a significant negative effect on the vessel's stability, specifically its ability to right itself. Also, due to the location and arrangement of the boom, the ability for crew members to effectively remove the ice from the boom would have been extremely difficult and hazardous.

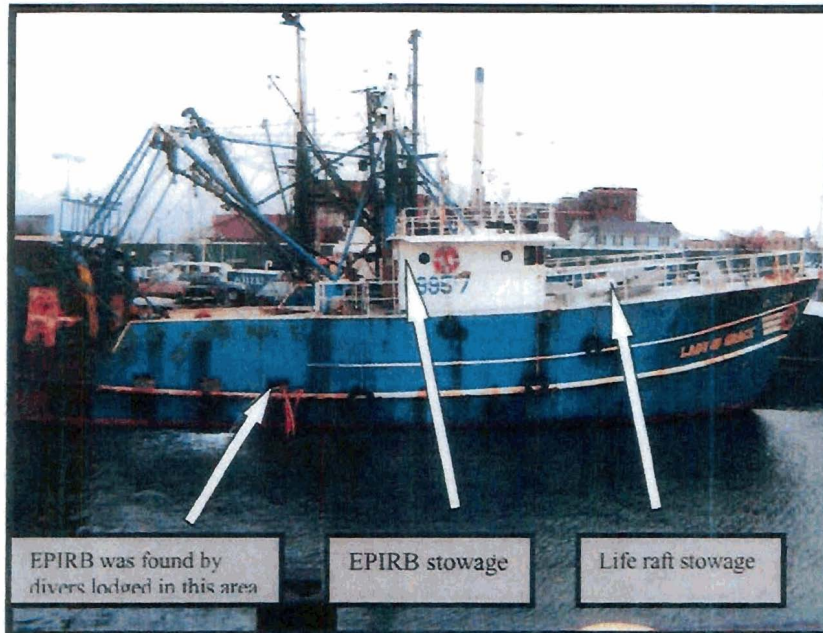
Photo 5: Storage locations of EPIRB and Liferaft

Massachusetts State Police Divers discovered the vessel's EPIRB lodged in a scupper opening in the starboard bulwark, aft of the vessel's superstructure. The EPIRB was normally mounted on the starboard side of the aft wheelhouse bulkhead and was designed to float free at 13 feet of hydrostatic pressure. Divers confirmed the release spring of the hydrostatic release had ejected fully indicating the unit had operated as designed.

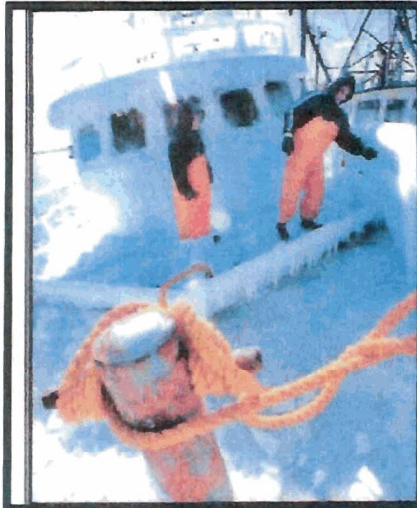
F/V IBERIA II

An example of ice build-up on the F/V IBERIA II, a 70.3 ft, 140 Gross Ton scallop boat. Picture was taken 27 January, 2007 while the vessel was moored in New Bedford 27 January, 2007. This vessel transited Nantucket Sound one day after the LADY OF GRACE casualty.

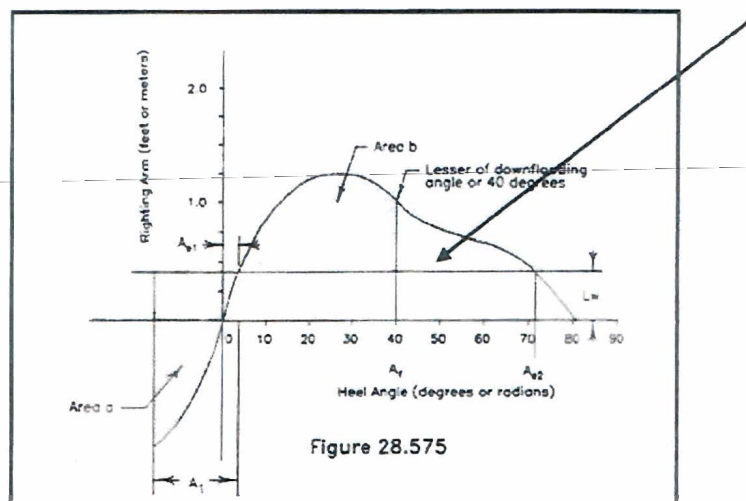
Drawing 4: Graph from 46 CFR Part 28

During the stability technical review by the Coast Guard Marine Safety Center, there were two typographical errors identified in 46 CFR Part 28, specifically, the formula in 28.575 (b) $\frac{K E_n (V_n 2 A_n Z_n)}{W}$ should read $\frac{K E_n (V_n^2 A_n Z_n)}{W}$ also 46 CFR 28.575 (e) (3) reads "the heel angle of 50°" which is not consistent with the heel angle graph on figure 28.575 which is listed as 40°.

Action: We concur with this recommendation. We are aware of the typographical errors in the stability criteria in 46 CFR 28.575 and will initiate a technical amendment to the regulations to correct it.

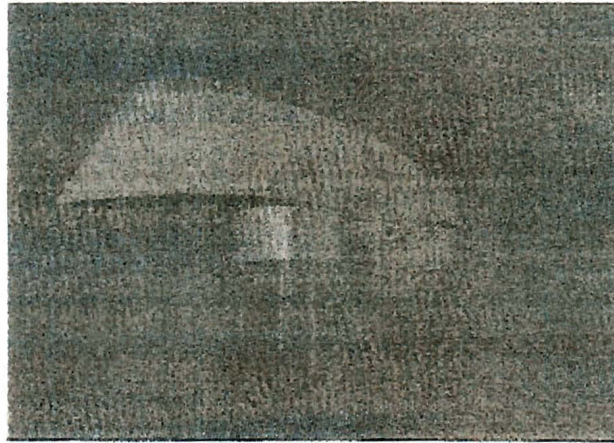
14. Icing Analysis

a. A model analysis was conducted to determine exactly how much icing would cause the vessel to capsize. Since the actual distribution of ice was not known, a uniform distribution was applied to all surfaces above the waterline. In reality, there were likely areas that had much heavier amounts of ice than our model, and conversely, some areas with far less.
