# MEDIEVAL AND EARLY POST-MEDIEVAL MILLS

**A THREAT-RELATED ASSESSMENT 2012-14**

DAT Event Record No. 102665

Report No. 2014/7

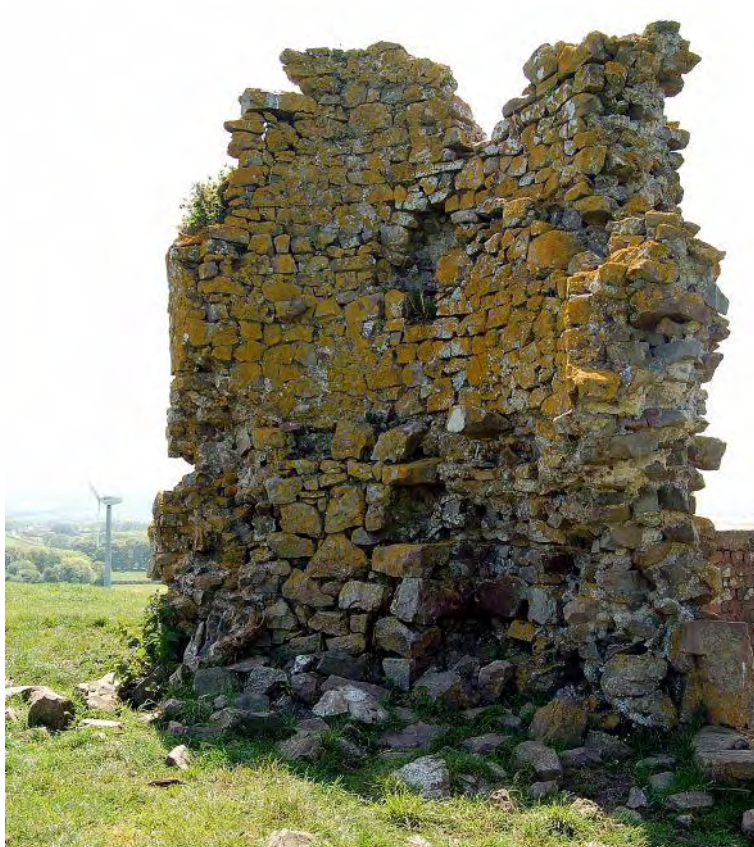
*The ruins of an old windmill (PRN 3528) near Carew, Pembrokeshire*

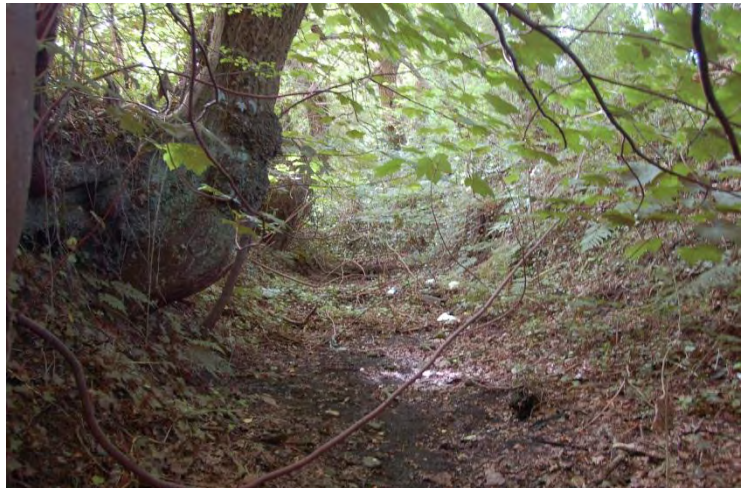
The mill-race was recorded during the Cadw funded Mills Survey of 2012-14. It is diverted from the Afon Gwili to the north of Carmarthen and a public footpath runs alongside it for most of its course. It ranges in character from a substantial, in parts 4m wide at base, steeply cut earthwork to a much narrower, shallower channel, some 1.5 - 3.0m wide at base. A construction bank runs along the eastern side of the race and, for some stretches, the footpath appears to run along the top of it. The race still carries water between the river and Dolgwili Road. Its course appears to be lost to the south of the hospital, where the A40 cuts across it and rear gardens of properties along Brynderwen have encroached upon it. The final section as it approaches the recorded location of the former Priory Mill is also difficult to trace as modern development has altered its course or destroyed it completely (M.Ings, 2012)

The watercourse started from the River Gwili at Bronwydd and followed the natural contours along a man-made ditch to the mills at SN422229 PRN 42. (TAJ,1980). There is no mention of the construction of this watercourse that stretches well over two miles to the head weir near Bronwydd. But the fact that mills are shown at the Priory in the TAXATIO ECCLESIASTICA (1291) and numerous references to a mill ditch in the cartulary of the priory is ample proof to how this watercourse is at least of medieval origins. Its later use as a source of power for a furnace and tin mill meant that it probably saw considerable rebuilding and continuous repair and it is known that the head of weir was raised in c1760 by 21 inches. The cause is easily traced although both the weir and where the watercourse entered the site of the mill have been largely obliterated. (T James, 1976)

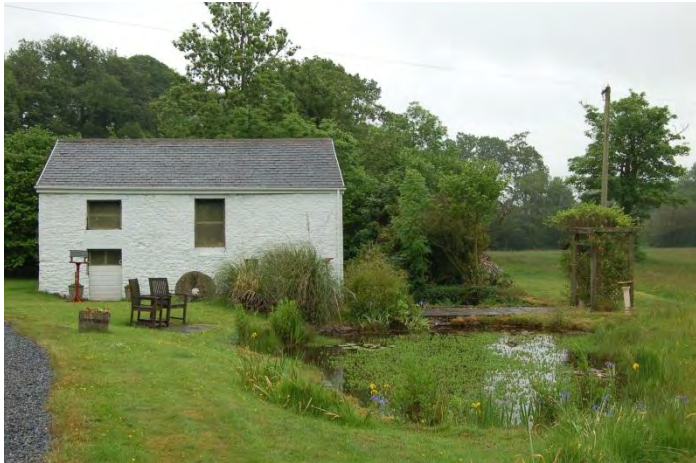
The site was visited during the Cadw funded Mills project of 2012-14. The mill itself, a two-storey, gable-ended stone building with a slate roof, has been restored and converted. The current owners showed me a pre-1902 photograph depicting the mill complete with a wooden waterwheel. The wheel-pit is preserved but the wheel is now gone, and the mill wall has been

infilled with bricks where it was once affixed. Four millstones survive, positioned around the garden. The weir on the Afon Gwilli, where water is diverted into the mill-race, is still intact and comprises undressed stones and pebbles of varying sizes bonded together. The entrance to the mill-race was also evident with a stone wall some 4-5 courses high. The sluice recorded on the 1906 O.S. map has gone. (M.Ings, 2012)

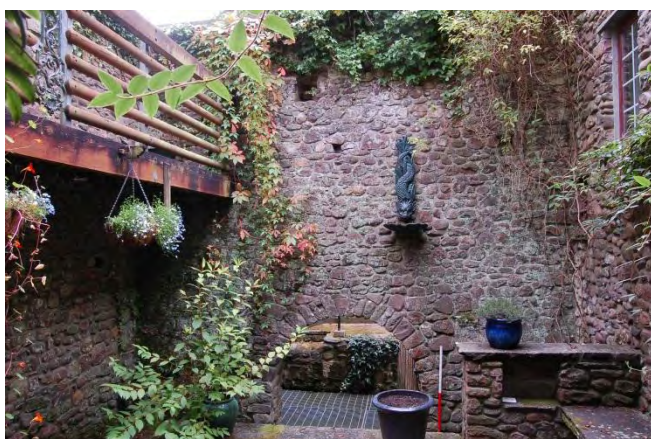
The site was visited as part of the Cadw funded Mills Survey of 2012-14. The current owner has researched the history of the mill and has found it referenced in the 1326 Black Book of St Davids. The mill is shown on an 1816 map of Estates and the town of Llangadog and on the 1841 tithe and apportionment for the Parish of Llangadog. It ceased working in 1957 and was badly damaged by fire in 1970. The ruins have been converted into an enclosed patio by the current owners. A pair of mill stones has been incorporated into steps down to a gateway through the end south wall, where an overshot wheel was originally attached. This drove two pairs of stones. A walkway now leads over the water-filled wheel-pit and tail-race, which runs down to the river

to the west of the mill. The mill pond, located to the right of the property entrance alongside the road, has been infilled by the current owners. The pond supplied water for two leats; one to the wheel-pit, which is now grassed over as a lawn although an overflow ramp survives, and the other to an undershot, iron wheel used to power an electrical generator, located north of the main mill complex. This was installed in the early 20th century and was still working in 1958 when it was bought and destroyed by the Electrical Light Company. The foundations of the generator still survive (M.Ings, 2012)

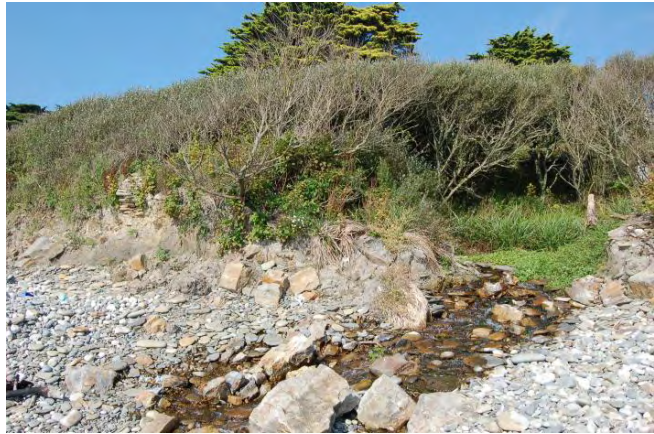
The foundations of what is presumed to be Marros Mill have been observed eroding at

with thick vegetation and it is possible that this obscures further remnant of the building. The small pond noted in 1988 is still preserved, although it is not clear whether or not this is associated with the mill. The nearby farm building, shown on the historical OS. maps to the northwest of the mill, stands as a roofless ruin (M.Ings, 2013)

Remains of walls and floors etc eroding out at top of storm beach. Presumed remains of Marros Mill (KM 1996) Marros Mill is shown as disused in 1891. There is change of alignment of the coast edge by the 2nd edition (A.Gale Feb 1995) Foundations of what were presumably the old mill can be seen eroding at the rear of Marros Beach about 50m to the south of the occupied house. The majority of this mill has been washed away but part of the north wall and traces of a flag stone floor can be seen at SN20650748. To the north of this structure is a small almost totally silted-up pond. The occupied house marked on OS maps is of 19th century date (K.Murphy Dec 1988) The farmer's mother has photographs of the mill (05-07-85)

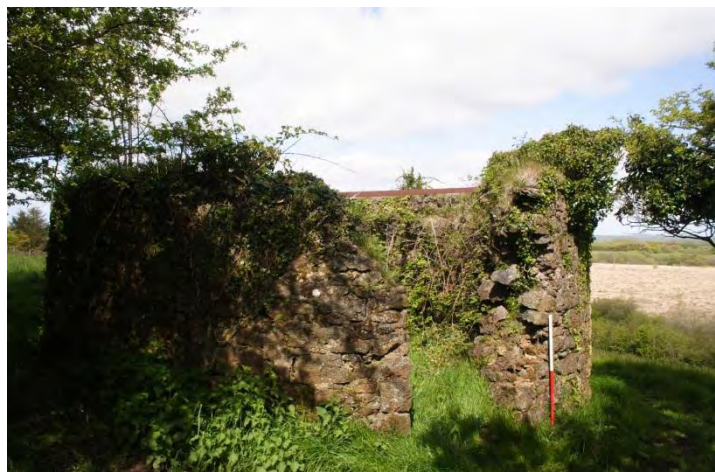
particularly from the internal, southeastern wall (M.Ings, 2012)

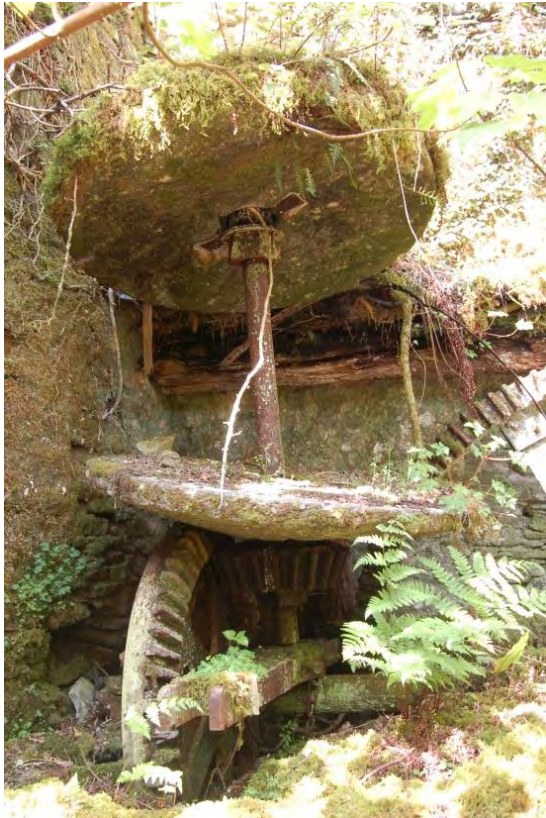
The site was visited during the Cadw funded Mills Survey of 2012-14. The mill is now a substantial ruin with many walls standing to full height, although completely unroofed and with several areas of masonry tumble. The main structure is a two-celled, gable-ended building on a levelled platform above the river. The wheel-pit is located adjacent to the north side wall and water from the mill-race diverted from the Dewi Fawr would have powered an overshot wheel. This has now gone and the wall masonry is partially collapsed where it was originally affixed.

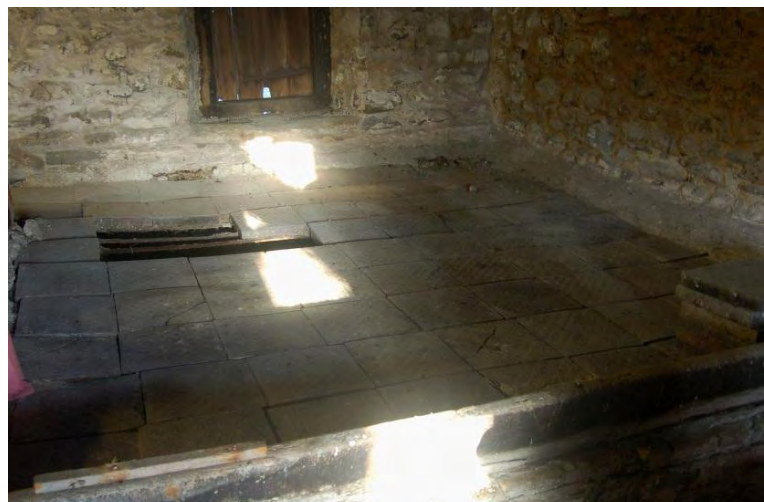
wheelpit against the western gable although the axle is now broken. The interior machinery, including the pit-wheel and gearing, appears intact. A corn-drying kiln is built into the northeast corner with a firebox and flue on the groundfloor below a drying surface of perforated tiles on the first floor. Three pairs of mill stones were housed within wooden hoppers on the first floor, supplied with grain from chutes from the second floor above. The holding pond, behind and above the mill, is now a neighbour's lawn having been filled in during the 1960s. This had caused a flooding problem to the rear of the mill so the council have had to redirect the mill race. The race is still evident, in part, as a hedge-side drainage ditch (M.Ings, 2013)

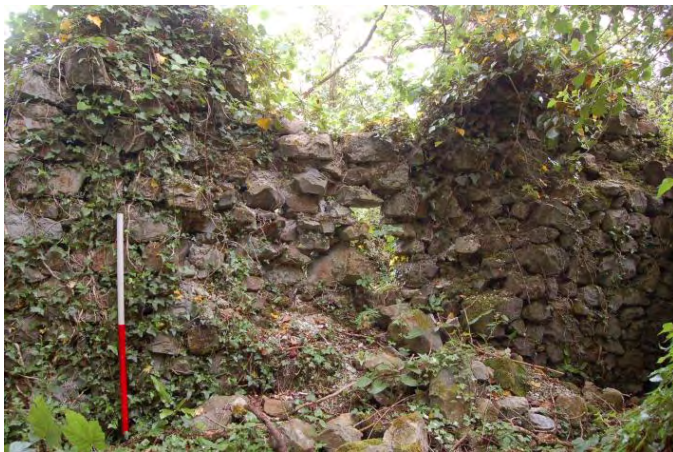
either side, while the east and remainder of the south wall are gone altogether. The wheel-pit identified in 1994 was not evident, although its recorded location, next to the west wall, was heavily overgrown. The cottage, aligned northeast-southwest, is better preserved, with gables standing to almost full height. There is a doorway in the north sidewall and a window in the opposite wall. An open-fronted extension is adjoined to the east sidewall (M.Ings, 2012)

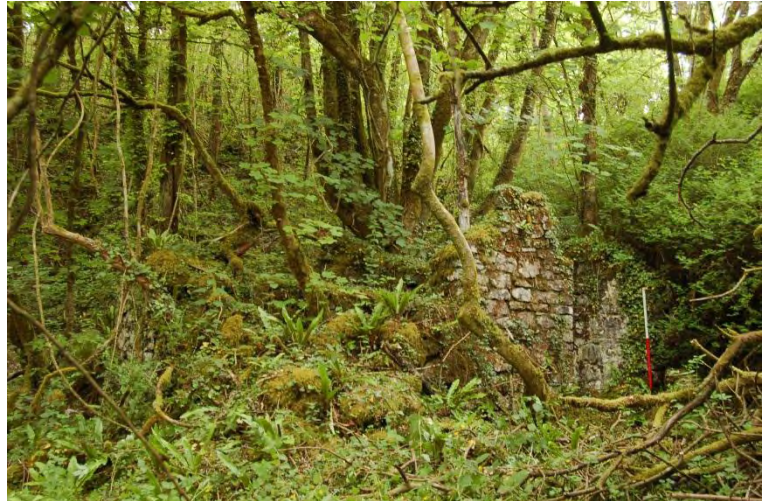
revetted bank that runs at right-angles to the river. The walls are in a ruinous state, generally standing approximately 1 metre high although some sections are higher, and the interior is obscured by tumbled masonry. A possible wheel-pit is sited alongside the west side wall, where there is evidence for a socket, and a stone-revetted channel leads from this to the river. No evidence for a mill-race feeding into this possible pit could be seen as the area is heavily overgrown. The cottage - possibly the mill-house - also appeared to be a two-celled structure with a walled garden along the west side and a chimney breast evident on the north gable. This gable stands to almost full height but the south and east walls are totally obscured by vegetation. The third ruin recorded on the modern map, located to the north of the cottage, was not seen (M.Ings, 2012)

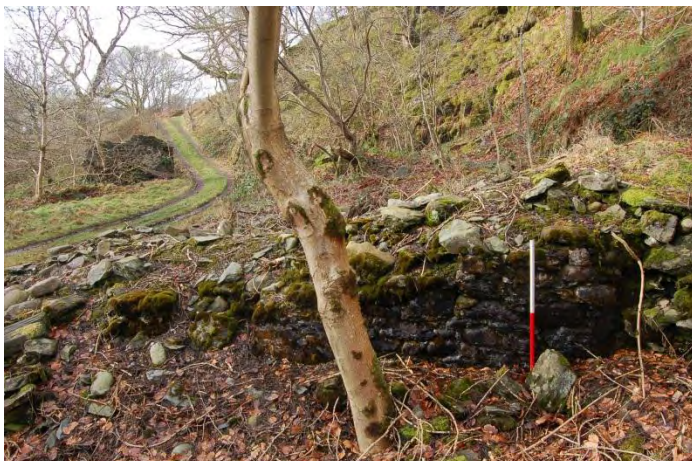
A smaller building to the west has largely disappeared, with only the western gable wall standing to c.2m in height. There is no trace of a third building shown on the parish tithe map, which stood a few metres to the east of the main building. It is worth noting that the level garden/yard area between the buildings and the Ystwyth to the south is evidently in part built up ground. The riverbank in front of the garden has been strengthened by revetting with large stone slabs.

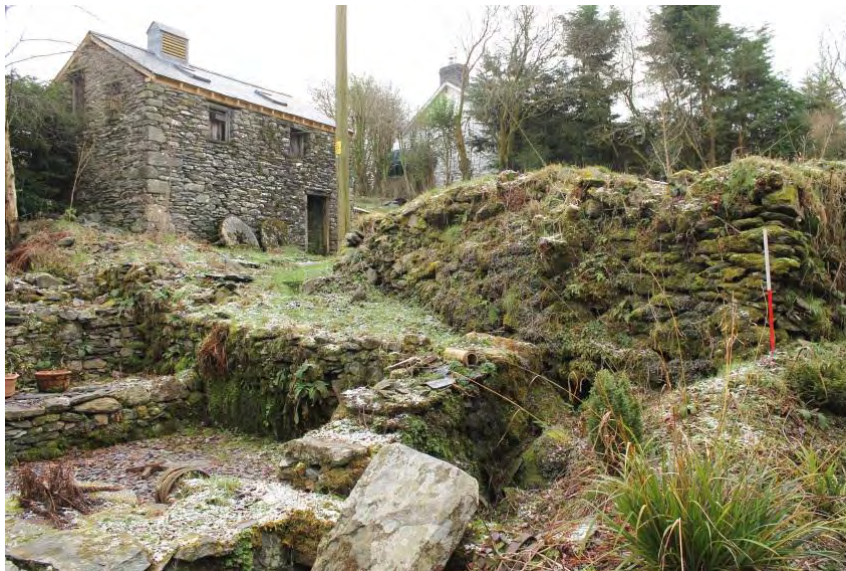
the mill survives, with the walls standing some 1.50 metres high. The wheel-pit still has the wooden wheel axle in situ, although the overshot wheel itself is gone. The tail-race runs into a culvert beneath the house driveway, partly supported by two of the mill-stones. A further pair of stones is still within the mill ruin and another pair are propped against the wall of the nearby corn-kiln (PRN 105370) The retaining wall of the

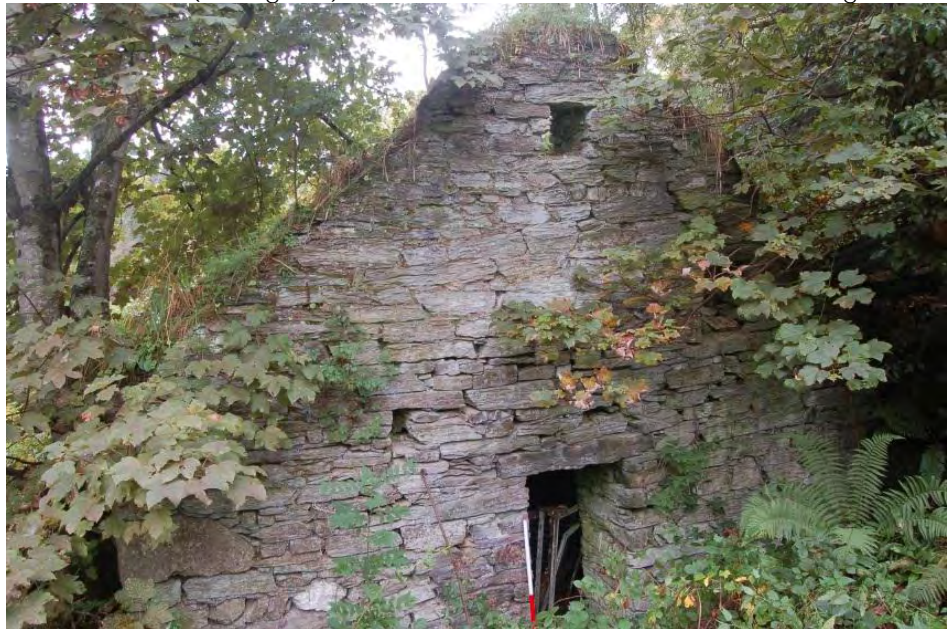
A pair of granite mill stones have been incorporated into the patio of the nearby house, named after the mill. It was evident that a further, now very ruinous, building once adjoined the mill to the south, although this was largely obscured by impenetrable vegetation. Access to this building through the south side wall of the mill had been blocked up, possibly after the adjoining building became disused. The masonry of this dividing wall has been damaged by a falling tree and it has collapsed at its western end.

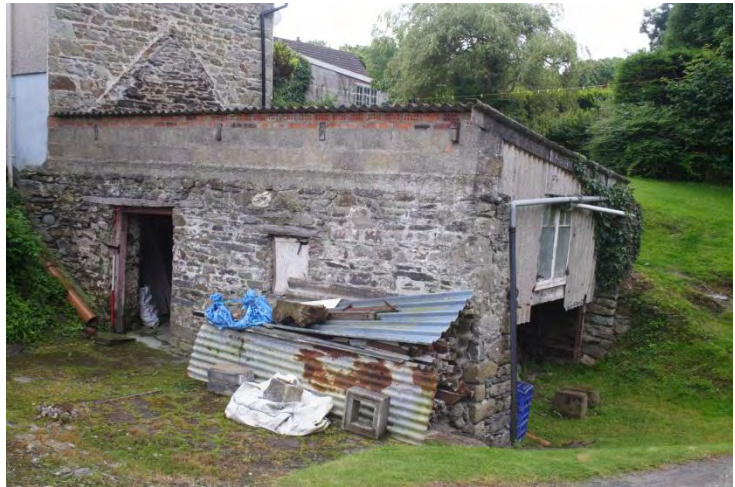
The site was visited as part of the Cadw funded Mills Survey of 2012-14. The plan of the mill survives, adjoining, and downslope from, the farmhouse but the pitched roof has been replaced, in the 1960s, with a flat roof of concrete, breeze-block, red-brick and corrugated iron. The shape of the original east gable is evident on the west gable end of the farmhouse. A.J.Parkinson noted (1984) that there was no lower gable and suggested that the mill may have been converted from a pandy, as several pandai are known with a similar lack of a gable. Too little now remains of the west end of the mill to determine its original appearance. An inscribed date of 1754 appears on the south face of the northeast stanchion, above the now infilled wheel-pit. The metal frame of the overshot wheel can be seen protruding from the ground. The two uprights of the hurst frame (the internal framework supporting the gears and millstones) are recorded as surviving in 1984 but were not seen during this visit. The wheel was powered from an adjacent pond, located to the south and above the mill, now filled in and grassed over. Water was diverted to the pond off the Afon Howni, to the south, and returned to the river to the northwest. The leat has now been infilled (M.Ings, 2012)

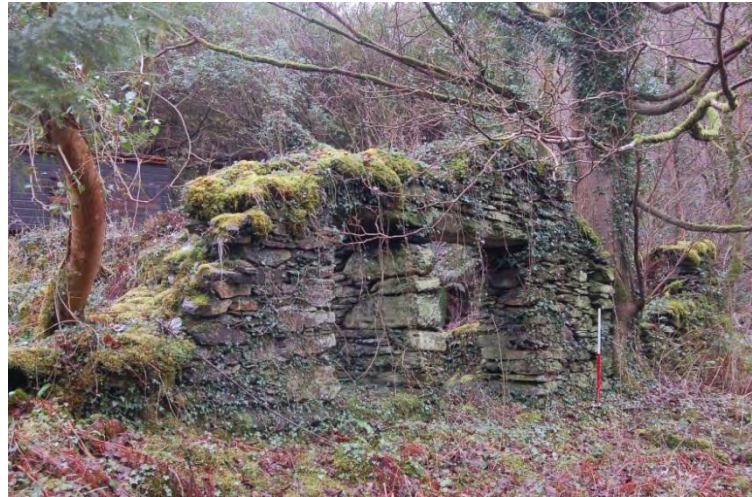
with stone lintels. Each cell is further divided east-west. These internal walls stand lower, at some 0.70m maximum. The interior of the building is obscured by tumbled masonry and thick vegetation and no features or preserved machinery could be discerned. The mill's name suggests that it is later than the 18th century corn mill, Melin-y-cwm (PRN 19569), further upriver (M.Ings, 2013)

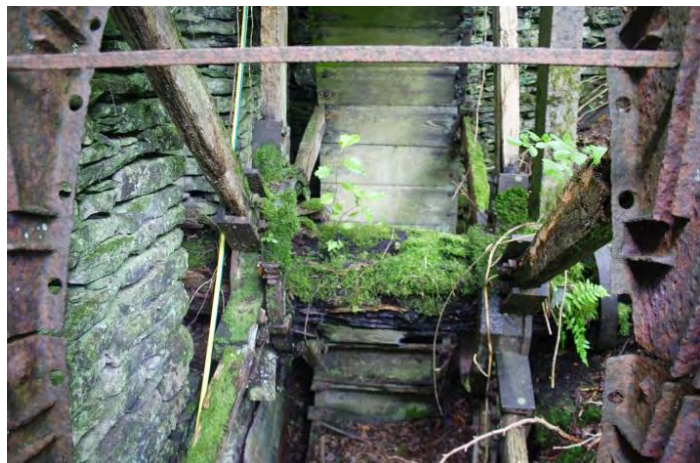
owner told me that the mill-race and mill-pond (above and to the northwest of the mill) have been infilled. The overshot wheel is still in situ, on the rear gable, with a launder in place above it. It was apparently converted to an overshot from a breastshot wheel in the 1830s. The current wheel is cast-iron and its shaft has been repaired at least three times. The internal machinery is mostly intact, with the hurst frame containing the iron pit wheel and stone nut on the the ground floor and a pair of millstones (one now propped against the wall) on the first floor. The roadside room of the building has a fireplace in the front wall. The owner believes this to have originally been an area for butter-blending and was separate from the mill - a doorway has since been inserted through the dividing wall. The adjoining corn-drying kiln, on the southeast side of the mill, is thought to be a later addition built between 1875 and 1905. The mill is currently used as a workshop and for storage (M.Ings, 2012)

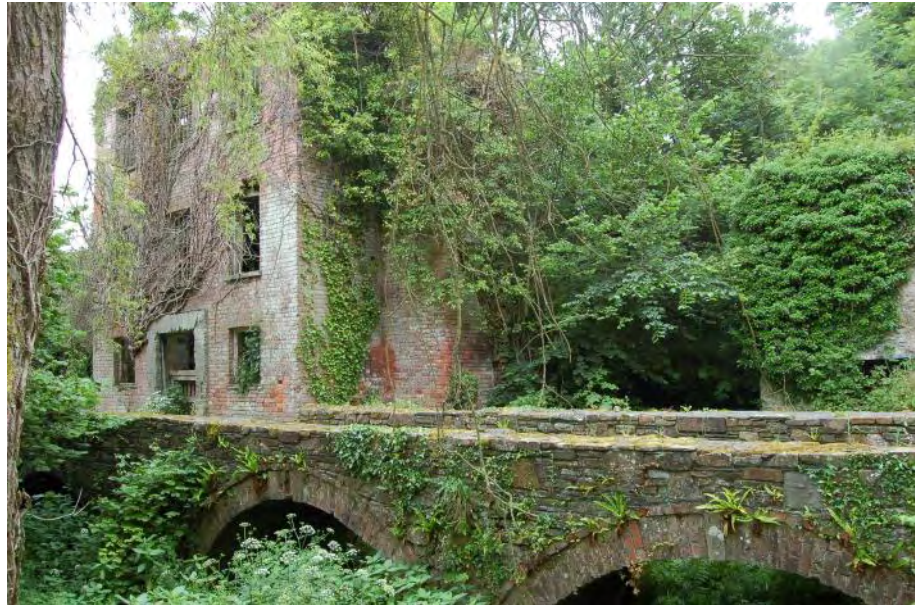
The site was visited as part of the Cadw funded Mills Survey of 2012-14. The owners were away but I was granted permission to view the ruin by a staff member from the business based at the mill house. However, the rear of the building and the mill race were inaccessible. The facade of the mill still stands three storeys high but the rear, seen through the window apertures is far more ruinous and overgrown, being taken over by woodland. The roof has now gone. Fireplaces were evident on the ground and first floors of the main entrance space, part of the later 19th century redevelopment of the paper mill. The main mill building is of red brick, with a later extension to the east side of masonry. The area of the wheel-pit was obscured by vegetation but the tail-race is still well preserved (M.Ings, 2013)

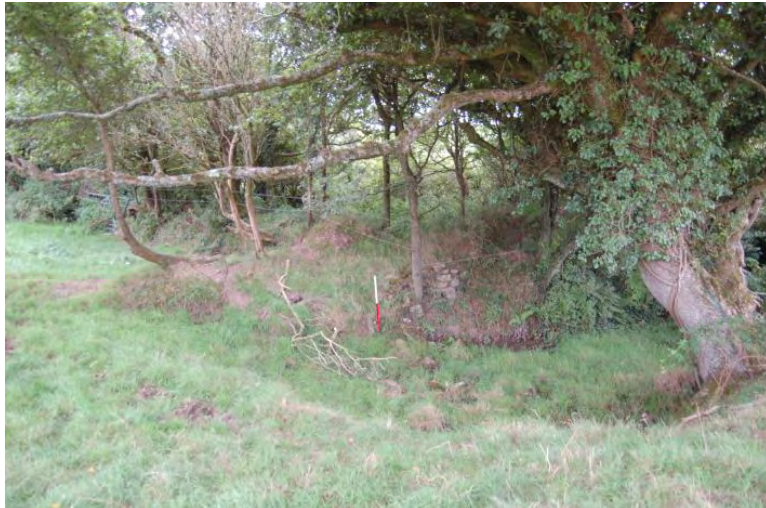
within a pasture field. Although little visible structure remains, with just one small section of masonry preserved, alongside the remnant of the wheel-pit, the platform where the building once stood is evident. The stone from the building has presumably been taken for use elsewhere. The earthworks delineating the extent of the mill ponds to the east of the mill also survive, although the easternmost is now in an area of fenced-off, thick vegetation. The mill-race

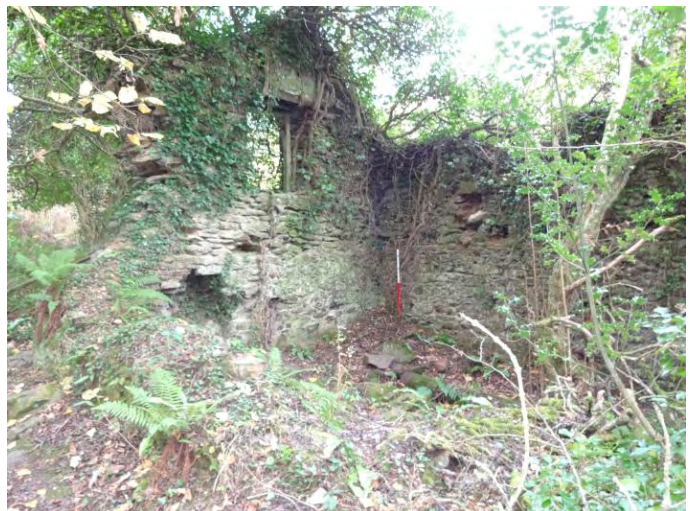
The site was visited as part of the Cadw funded Mills Survey of 2012-14. The mill building is as described in 1997, with the wheel-pit alongside the northwest-facing side wall. Iron brackets are affixed to either side of the pit where the wheel axle would have hung. The remains of the axle still lie within the mill ruins. The channel from the mill pond (PRN 34551) to the wheel-pit has been lined with bricks, possibly when the wheel was replaced by a turbine (M.Ings, 2013)

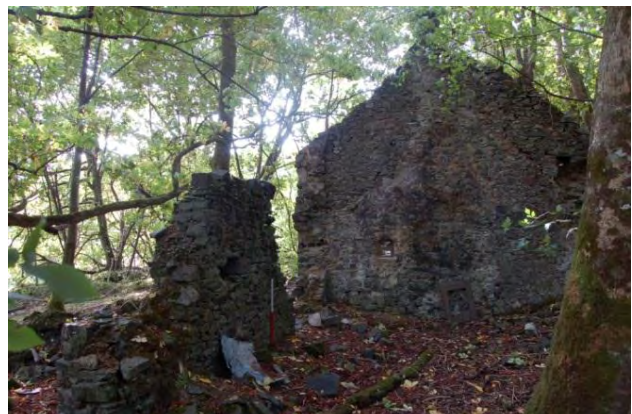
there is a further cottage on the other side. All are ruinous but the mill is the most damaged, with only a section of the southeast-facing wall standing to any height. The northwest wall, which revets the bank cut to form a building platform, survives only to ground level and the northeast-facing end wall has all but gone completely. In contrast, the adjoining dwelling, while roofless, survives to approximate full height. The mill-race, which survives for much of its length as a silted, vegetated earthwork, leads to the northwest corner of the mill, where masonry indicates the location of the wheel-pit alongside the northeast-facing wall. No machinery survives. The tail-race is still evident, running beyond the building to the southeast (M.Ings, 2013)

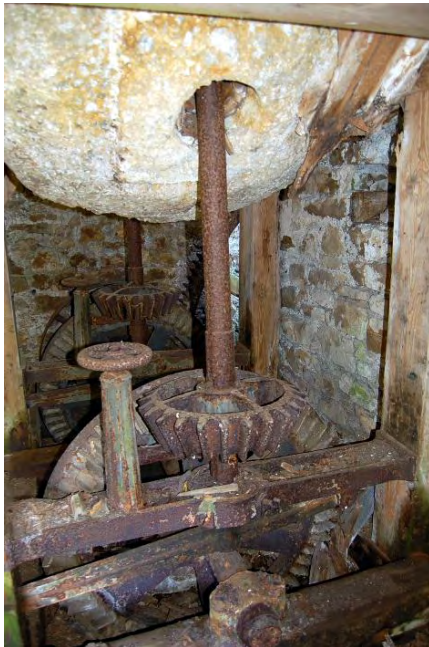
The site was visited as part of the Cadw funded Mills Survey of 2012-14. It is now ruinous but has been bought by the current owner with planning permission to restore it and he is embarking on a 15 year project to not only renovate the mill, but also the nearby mill house, cow shed and barn. The mill still stands complete but there are some structural problems and the roof requires repair. The iron frame of the waterwheel is still within the wheel-pit and much of the internal workings, including the axle-wheel, hurst frame and two pairs of mill-grit stones are preserved. A corn-drying kiln is located within the northeast corner. The mill-race and tail-race are preserved but do not currently hold water. The mill pond has recently been dredged. At some point in the future the owner hopes

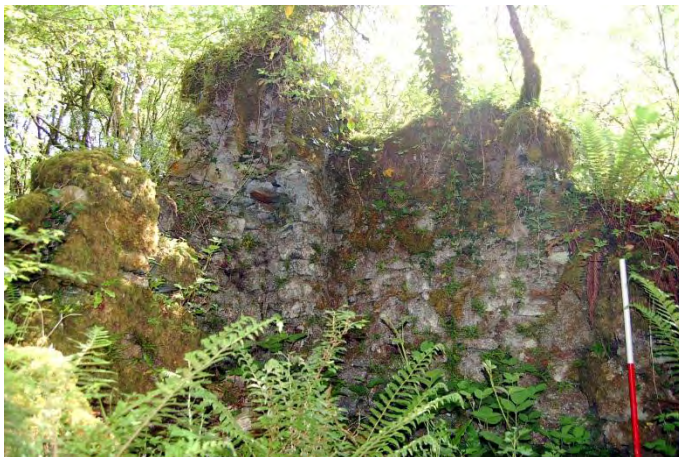
explored further. The interior was obscured by vegetation. The mill stands below a high revetment wall, possibly of the holding pond above. An enclosure or boundary bank was evident to the west of the mill, but again thick vegetation obscured its extent and function (M.Ings, 2013)

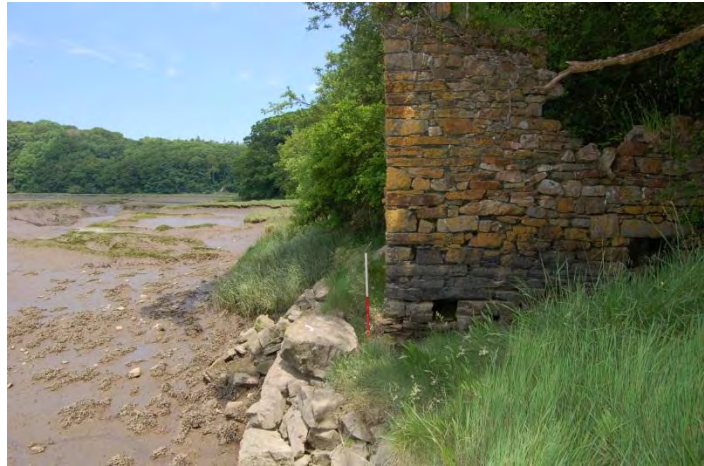
The mill was visited as part of the Cadw funded Mills Survey of 2012-14. It is built of semi-dressed stone right on the edge of the Minwear Pill mud-flats, on a stone-edged platform. It is now in a ruinous condition and the interior is obscured by stone tumble. A stone-lined wheel-pit is preserved alongside the south-facing end wall, which would have accommodated an overshot wheel. The square aperture for the wheel axle was evident within the wall but the wheel, recorded in 2000, has gone. The owner of Minwear Farm told me that when they first moved in there was a mill-stone at the site but this too has since disappeared. A possible internal division was noted, although heavy vegetation on the northwest corner prevented a clear view. A further section of masonry was recorded above the mill, within the woodland to the southeast, possibly the corner of a boundary wall. A holding pond (PRN 105998) is also preserved above and behind the mill, with a substantial bank on its southwestern side and a stone revetment wall to the north. This appeared to be fed by a leat running in from the southeast but it was unclear where this diverted water from as woodland undergrowth made it inaccessible (M.Ings, 2013)
